Report: Sample Report

Confidential Inspection Report

1 Yellow Brook Road

January 15, 2013

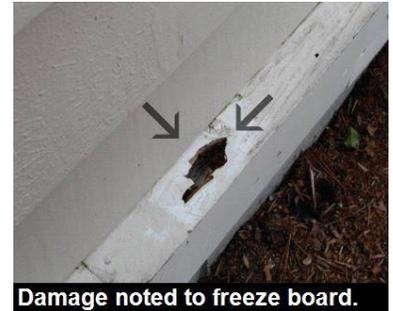
Wood materials. The wood trim on the dwelling was not **Readily Accessible** (that is trim above the 5'-00" level) therefore, comments made on the condition of the trim are based on observations made from the ground. However the following was noted: Deteriorated material is noted at the front and left side of the building, note there is potential for concealed damage. Recommend replacement of all rotted wood: if repairs are not implemented the deterioration is progressive. This condition is conducive to the development of pest infestation.

Damage noted to freeze board.

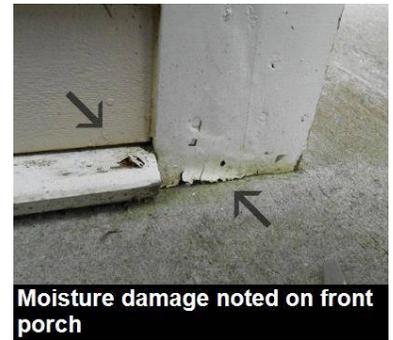
Moisture damage noted on front porch

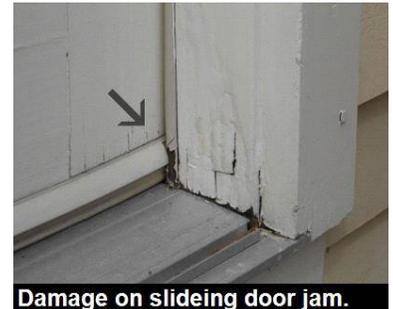
Wood Sliding door installed. Minor rot is noted at the lower portion of the doorframe, note there is potential for concealed damage. Recommend replacement of all rotted wood: if repairs are not implemented the deterioration is progressive. This condition is conducive to the development of pest infestation. A qualified trim carpenter should be called to make further evaluation and repairs as needed.

Damage on slideing door jam.

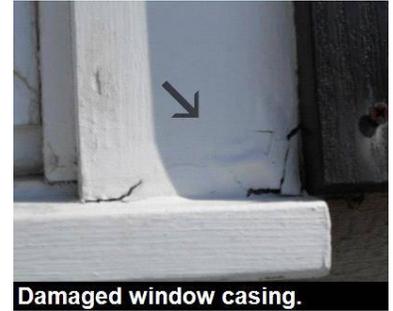
Minor rot is noted at the window sills and/or window casings, note there is potential for concealed damage. Recommend replacement of all rotted wood: if repairs are not implemented the deterioration is progressive. This condition is conducive to the development of pest infestation.

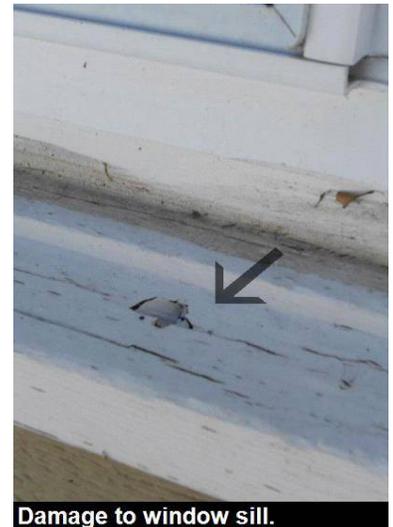
Wood. Wood sills have some minor rot due to water penetration.

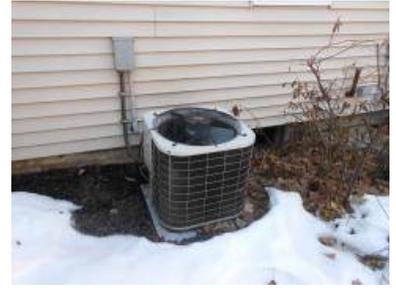
Unit is the one originally installed when the house was built. Condenser cabinets of this type typically have a service life of 10-15 years. As a condenser cabinet nears 10 years of age, it has an increased likelihood of breakdown in the future. Unit is older and has a limited life remaining.

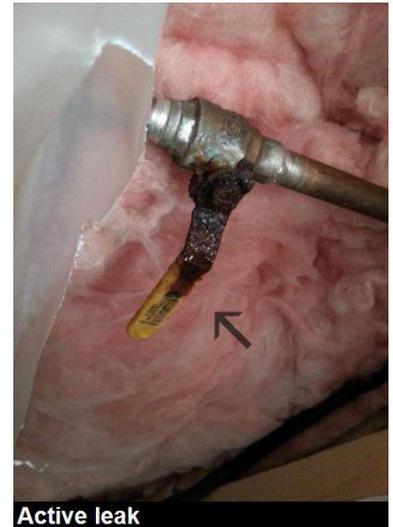
Condition: The concealed water distribution piping (in ceilings, walls and floors) were not **Readily Accessible** and could not be inspected and/or reported on. Leaks are noted at rear hose bib.

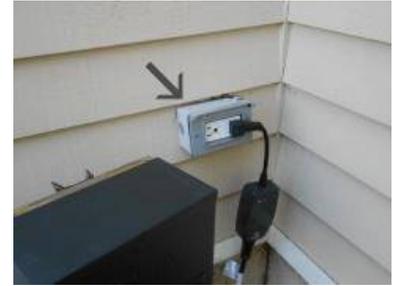
Exterior Walls: GFCI is not operational. Outlet is missing cover.

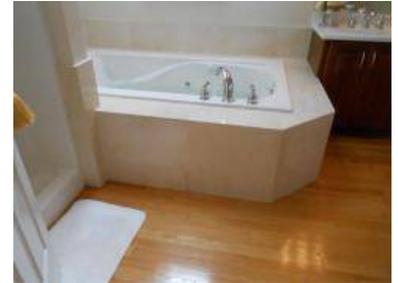
Master Bath: Hydro-spa is functional, but its supply pipes should be periodically flushed with anti-bacterial cleanser. No access panel noted.
