SWIMMING POOL DAMAGE INSPECTION REPORT

January 21, 2022

RE: Baycrest Homeowner's Association Property Tower Hill File #CLM0015504
25422 Galashields Circle
Bonita Springs, FL 34134 Omega Forensic File #20437

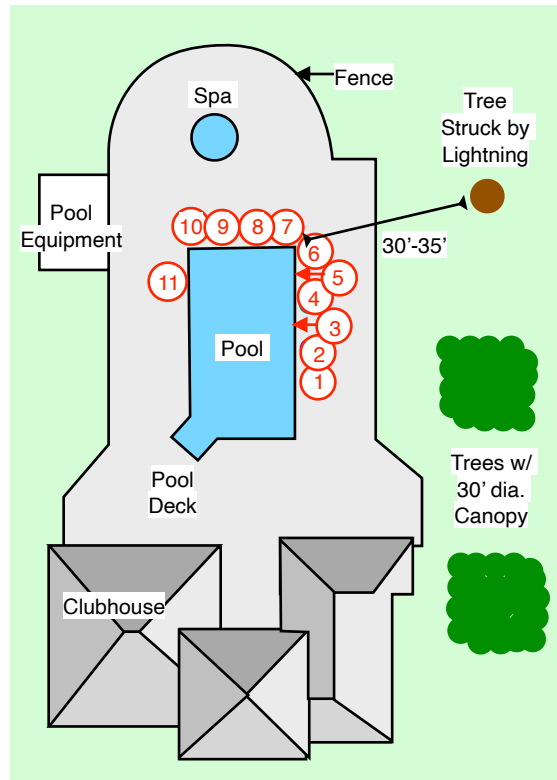
Field Sketch of the Baycrest Property

- ① = 12" dia. Bulge at 28" Depth- .5" Projection
- ② = 22" dia. Bulge at 24" Depth- .25" Projection
- ③ = 14" dia. Bulge at 34" Depth- .5" Projection
- ④ = 12" dia. Bulge at 36" Depth- .25" Projection
- ⑤ = 12" dia. Bulge at 36" Depth- .25" Projection
- ⑥ = 30" dia. Bulge at 38" Depth- 2" Projection
- ⑦ = 16" dia. Bulge at 48" Depth- 3-4" Projection
- ⑧ = 18" dia. Bulge at 48" Depth- 2" Projection
- ⑨ = 36" dia. Bulge at 44" Depth- 3" Projection
- ⑩ = 24" dia. Bulge at 48" Depth- 2" Projection
- ⑪ = 24" dia. Bulge at 42" Depth- 1.5" Projection

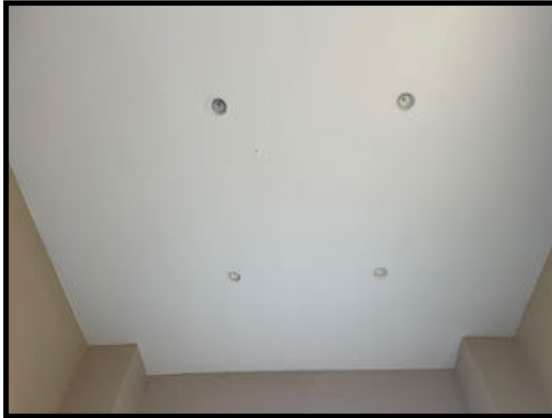
- Entering the clubhouse pool area, we observed **no evidence of lightning damage to the exterior of the clubhouse building.** The stuccoed walls and windows appear to be intact and in good condition. The stuccoed ceiling over the gated entry area is intact, with no indications of cracking.

No Damage on Ceiling Above Entry Area

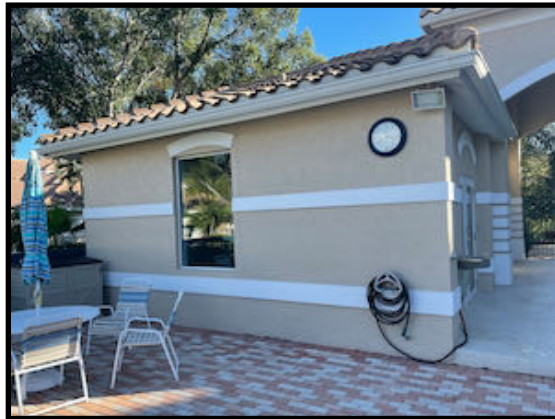
- From ground level, we could see that the **tiled roof over the clubhouse building** appears to be in good condition, with no signs of damage from a lightning strike. The gutters and downspouts around the perimeter of the roof also appear to be intact and in place.
- We could see the in-ground swimming pool is surrounded by **brick coping and a brick paver deck**. There is no evidence of lightning-related damage to the brick pavers or the coping.
- We took measurements around the edge of the pool and found that **the coping bricks are about 9 inches long**. This is an indication that the pool shell beneath the coping is likely about 7 or 8 inches thick.

No Signs of Lightning Damage to Clubhouse

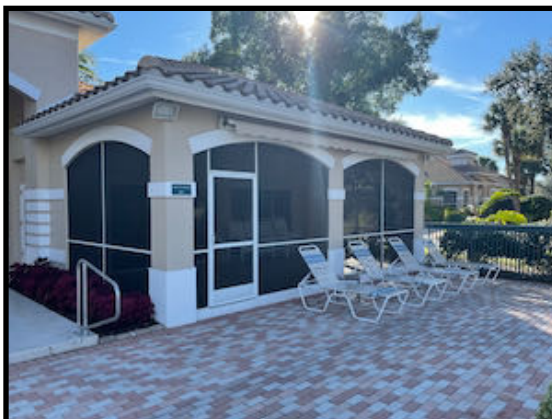
No Signs of Lightning Damage to Clubhouse

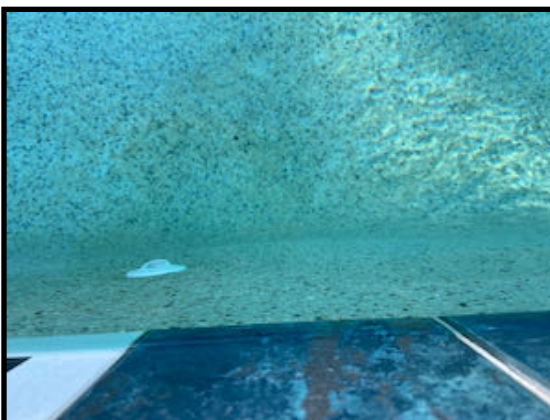
View of Bulge #1

- We found that **bulge #1** in the pool wall is approximately 12 inches in diameter and is about 28 inches deep into the pool. This bulge projects outward from the surrounding pool wall by approximately a ½-inch.

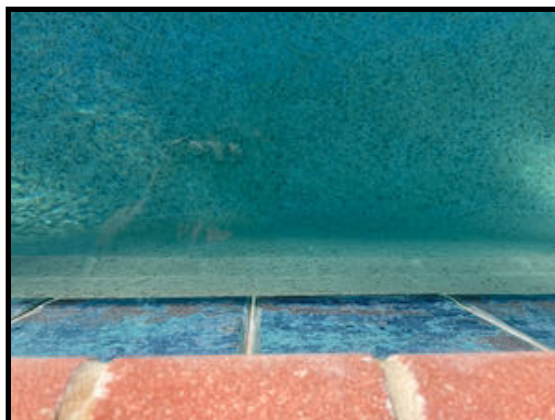
View of Bulge #2

- We could see that **bulge #2** is approximately 22 inches in diameter and is about 24 inches deep. This bulge projects outward from the surrounding pool wall by approximately ¼-inch.

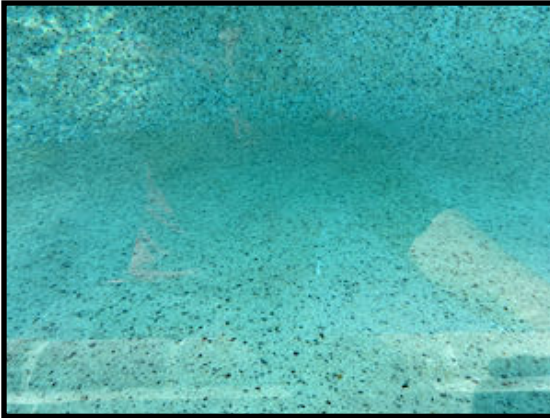
Apparent Calcium Deposit on Bulge in Pool

- We noted that some of the bulges along the east side of the pool exhibit **white spots near their center that appear to be calcium deposits.**

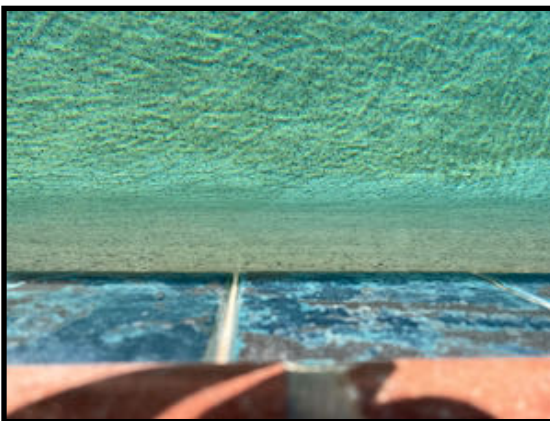
View of Bulge #5

- We found that **bulge #4** is approximately 12 inches in diameter and is about 36 inches deep. This bulge projects outward from the pool wall by approximately ¼-inch.
- We could see that **bulge #5** is approximately 12 inches in diameter and is about 36 inches deep. This bulge projects outward from the pool wall by approximately ¼-inch.
- We observed that **bulge #6**, which is a larger bulge on the east side of the pool located next to the pool ladder, is approximately 30 inches in diameter and is about 38 inches deep. This bulge projects outward from the pool wall by approximately 2 inches. In the same location, we also noted there is some cracking present in the grout line between the coping bricks and the underlying pool shell.

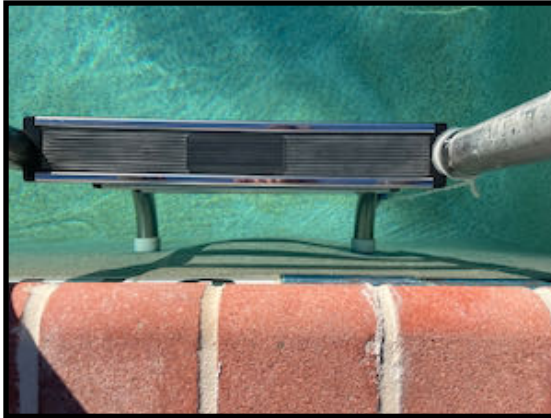
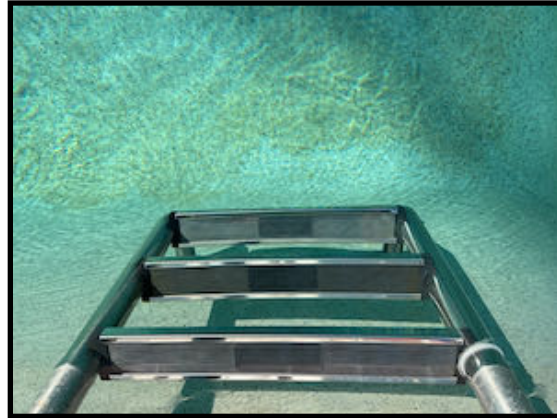
Bulge #6 Next to Pool Ladder

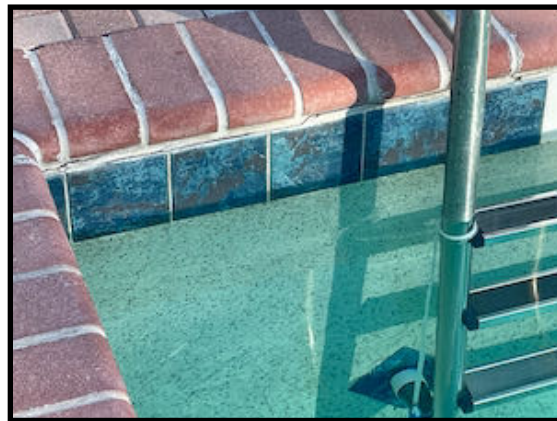
Cracking in Ground Line Under Coping Tiles

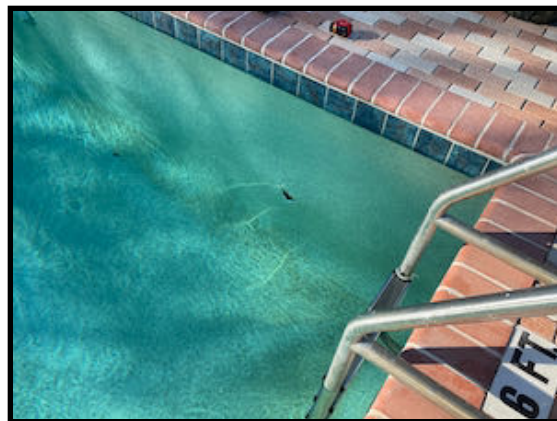
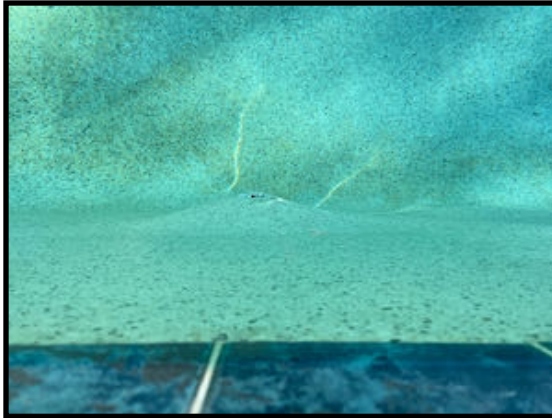
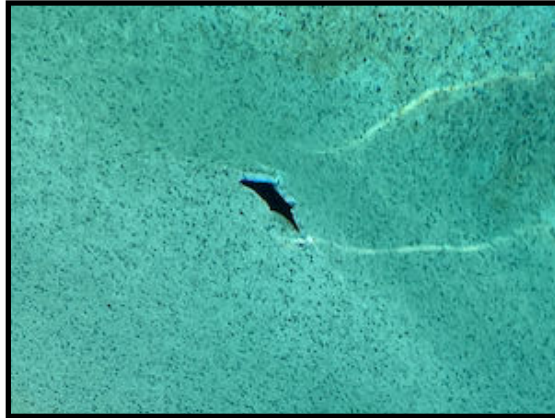
Bulge #7 With Rupture in Finish

- We could see that **bulge #7**, which appears the most severe, is approximately 16 inches in diameter and is about 48 inches deep. This bulge projects outward from the pool wall by approximately 3 to 4 inches, and there is a rupture in pool coating in the damage area. We inserted our tape measure through the delaminating coating and the underlying pool shell felt solid and intact.

The claimed damage at the property consists of eleven bulges in the pool finish that vary in diameter and in the depth that they project out from the pool walls. These bulges are consistent with pool finish delamination that can typically develop due to improper prepping or application of the finish material that was applied to the original pool shell. We noted that some of the bulges inside the pool exhibit white spots near their center that appear to be calcium deposits. This is another common condition that is evidence of routine pool finish failure. The gentleman who accompanied us during our inspection told us that the pool is not losing water, which is an indication the underlying pool shell and piping is still intact and was not ruptured or damaged by the reported lightning strike. In our judgement, it would require destructive testing in the pool to further investigate the cause of the pool finish failure but this type of pool finish failure is not unusual for pool finishes as they age.

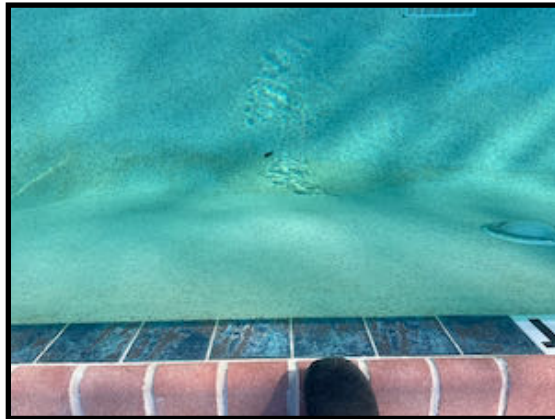
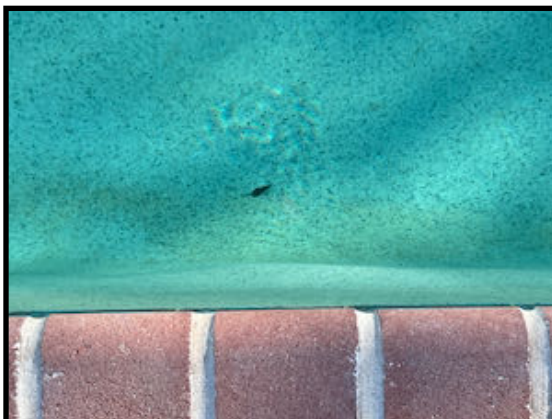
View of Bulge #8

- We found that **bulge #8** is approximately 18 inches in diameter and is about 48 inches deep. This bulge projects outward from the pool wall by approximately 2 inches.

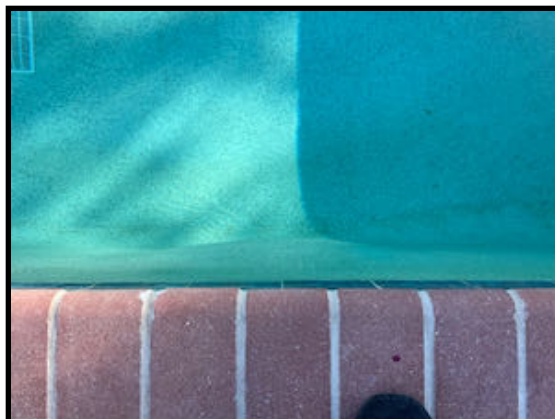
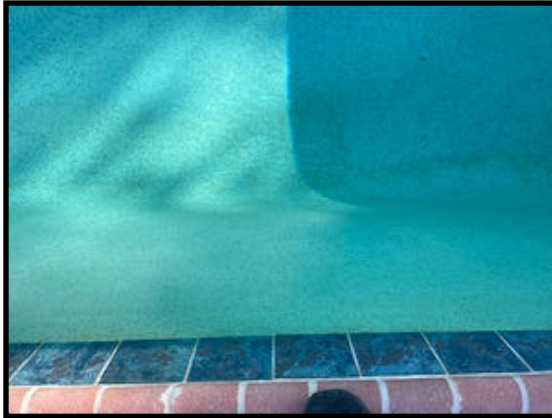
- We could see that **bulge #9** is approximately 36 inches in diameter and is about 44 inches deep. This bulge projects outward from the pool wall by approximately 3 inches.

View of Bulge #9

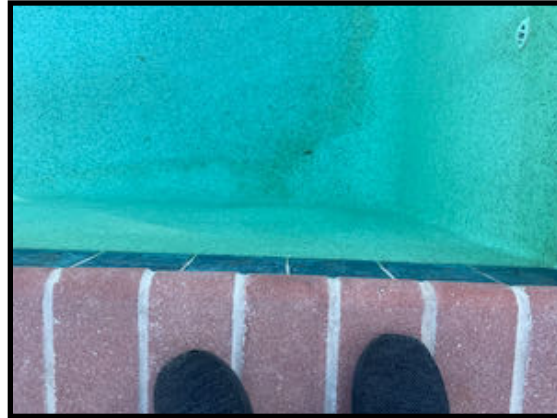
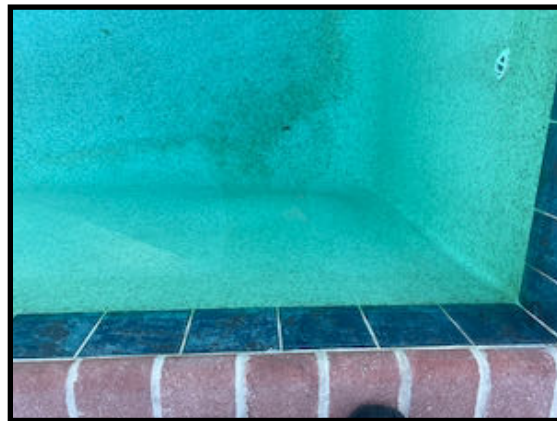
View of Bulge #10

- We observed that **bulge #10** is approximately 24 inches in diameter and is about 48 inches deep. This bulge projects outward from the pool wall by approximately 2 inches.
- We found that **bulge #11**, which is the one bulge on the west side of the pool, is approximately 24 inches in diameter and is about 42 inches deep. This bulge projects outward from the pool wall by approximately 1½ inches.
- We noted there is **spa** located near the north end of the pool deck. There is no evidence of lightning damage inside or around the spa.
- The gentleman who accompanied us during our inspection pointed out the **location of the tree that was reportedly struck by lightning**. There is a tree stump on the

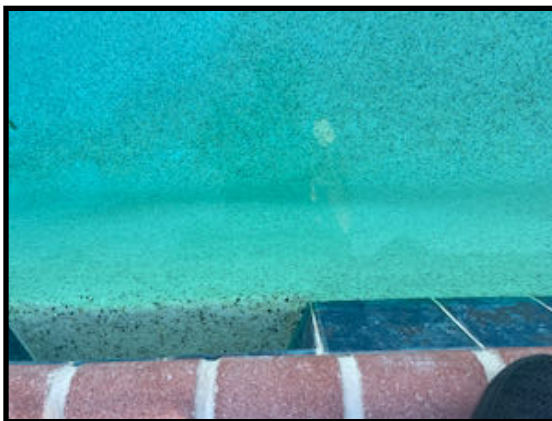
View of Bulge #11

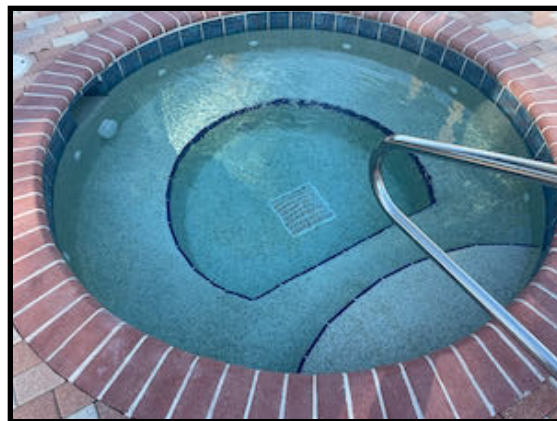
Spa Area With No Indications of Damage

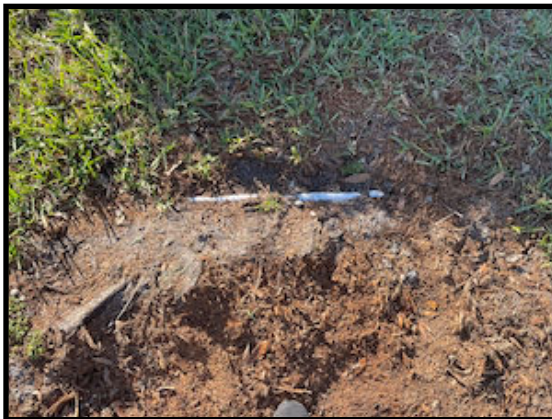
- We noted there is an **irrigation pipe** in the soil adjacent to the tree stump. The gentleman who accompanied us told us the original pipe at this location was ruptured during the lightning strike and has since been replaced. The old pipe that was reportedly damaged was not available for our inspection.

Irrigation Pipe in Soil

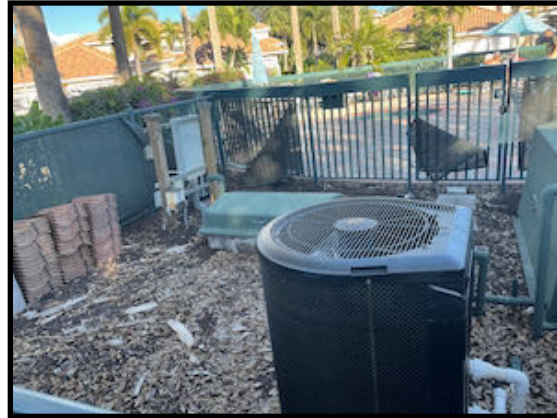
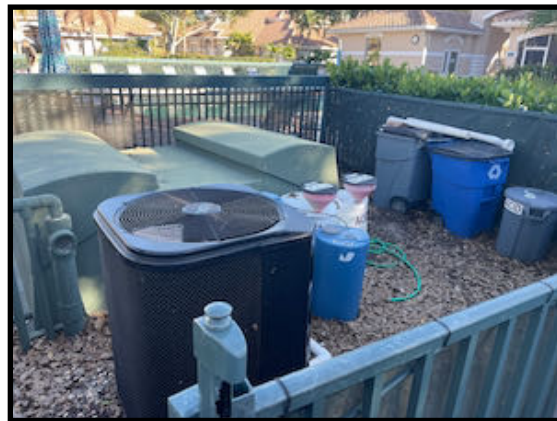
No Indications of Damage to Pool Equipment

- The **pool equipment** is located within a fenced area on the west side of the pool deck. There is no evidence of lightning damage to the pool equipment, and none has been reported by the Association.
- The gentleman who accompanied us pointed out the property across the road from the tree that was reportedly struck by lightning and told us **the owner of the home reported that one or two palm trees in his yard died as a result of the lightning strike.** We noted there are many other palm trees in closer proximity to the tree that was reportedly struck by lightning that show no indications of damage.
