(Final Report, Revised May 10, 2021)
**Condition Assessment
&
Reserve Fund Plan Update
2021**

Hiddenbrook
Community Center
Herndon, Virginia

RE: **CONDITION ASSESSMENT AND RESERVE FUND PLAN UPDATE 2020**
Hiddenbrook Homeowners Association
(Final Report, Revised May 10, 2021)
Herndon, Virginia
Project No. 9151

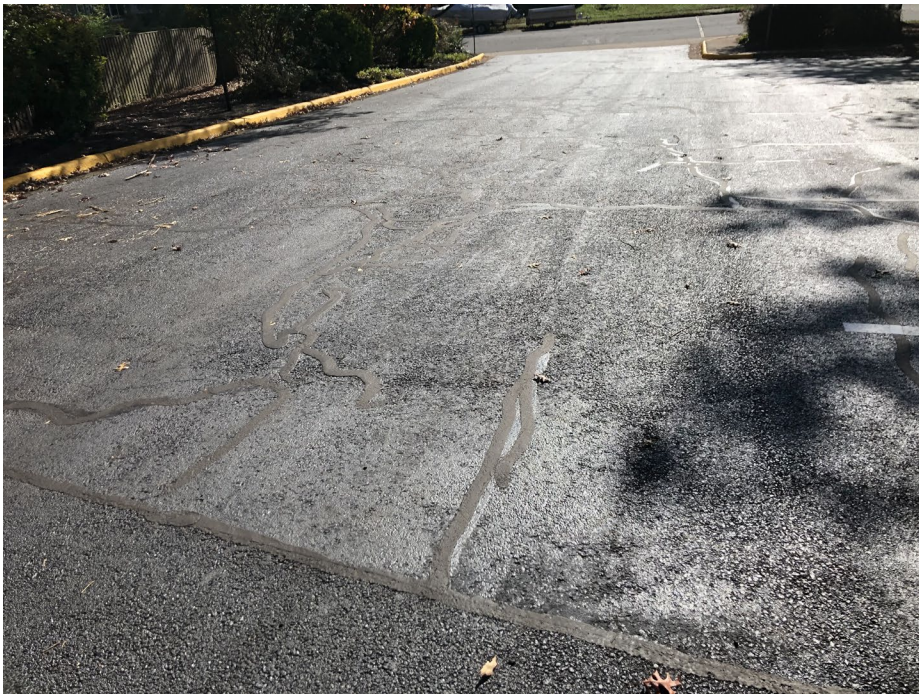
PHOTO #1
The asphalt driveline and parking bays were recently crack filled and coated with asphalt rejuvenator. The asphalt appears to be heavily cracked, but no deflection was observed. We have scheduled the restoration project after another five years of service.

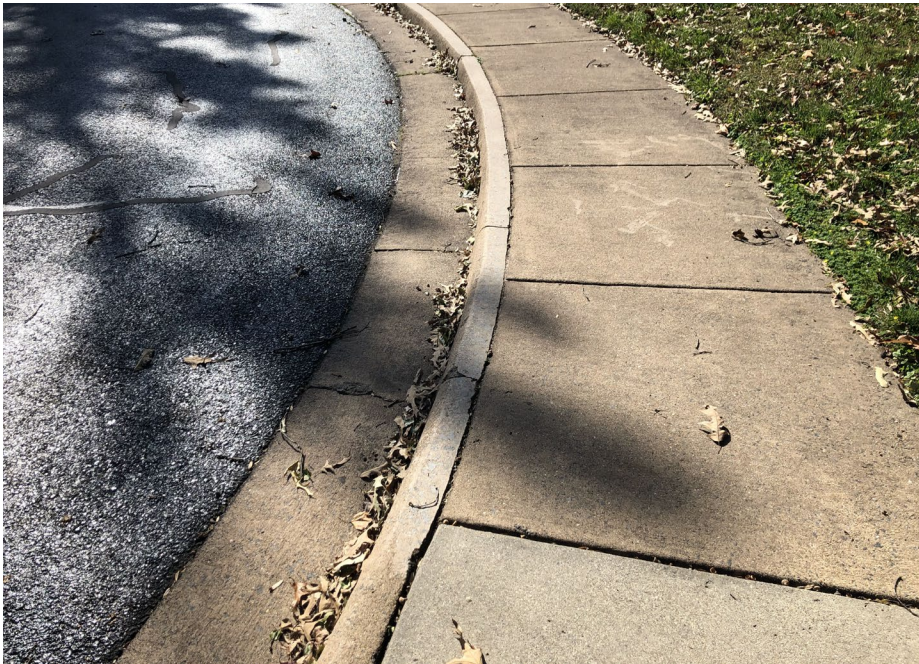
PHOTO #2
The sidewalks and curbs and gutters are in very good condition with no significant deficiencies observed.

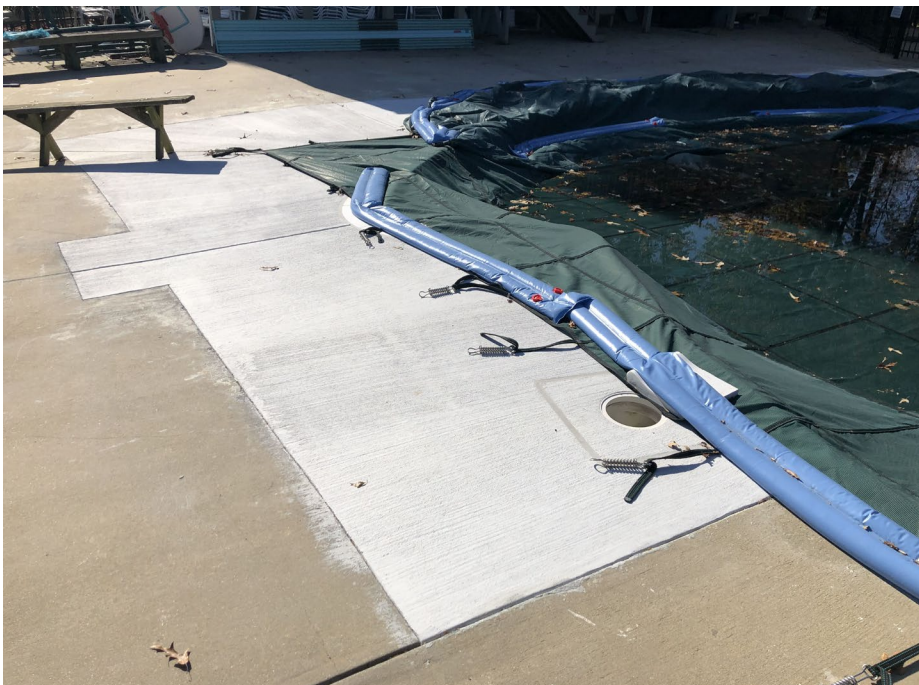
PHOTO #3
The pool deck is in generally good condition with some repairs, both filled and unfilled cracking, and it was recently modified to make room for new pool access stairs.

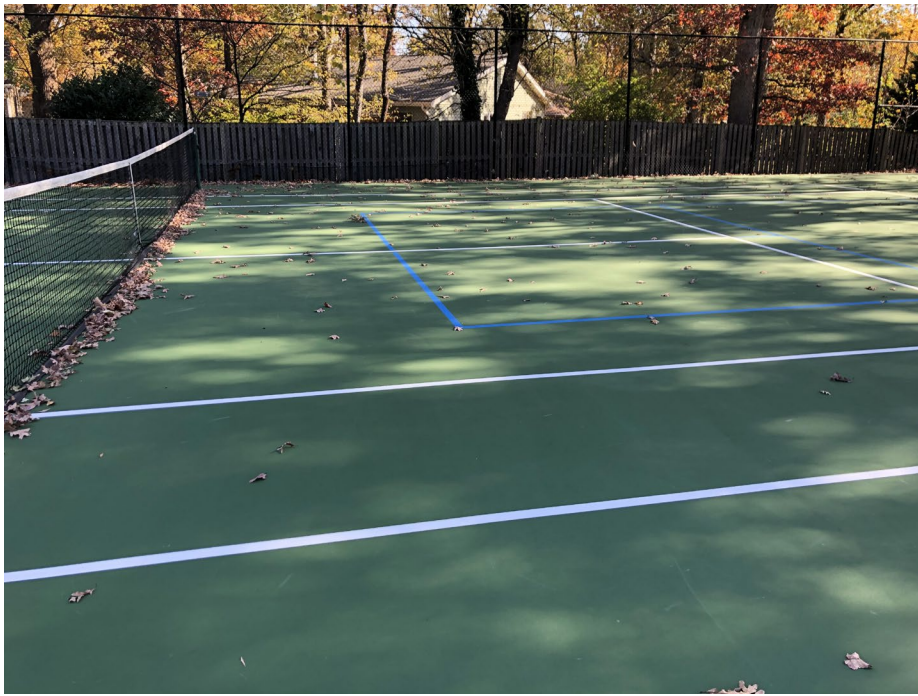
PHOTO #4

The tennis court was color coated and all cracks were repaired recently. Net post tension appears to have been relaxed and no net post footing cracking was observed.

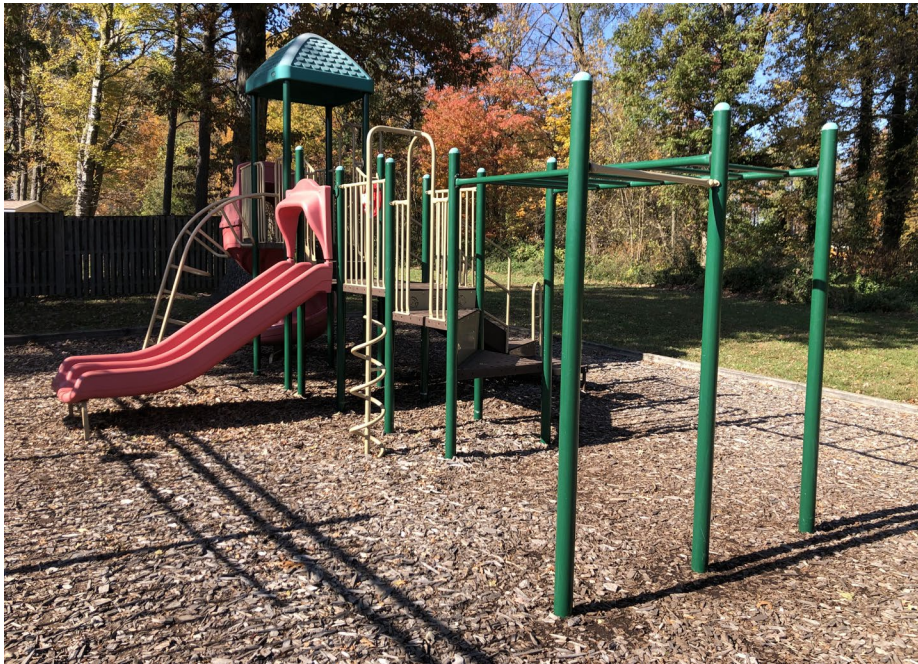
PHOTO #5

The tot lot is in serviceable, but dated condition. We have scheduled its replacement after a few more years of service. Frequent inspection should be conducted to ensure a safe environment is maintained.

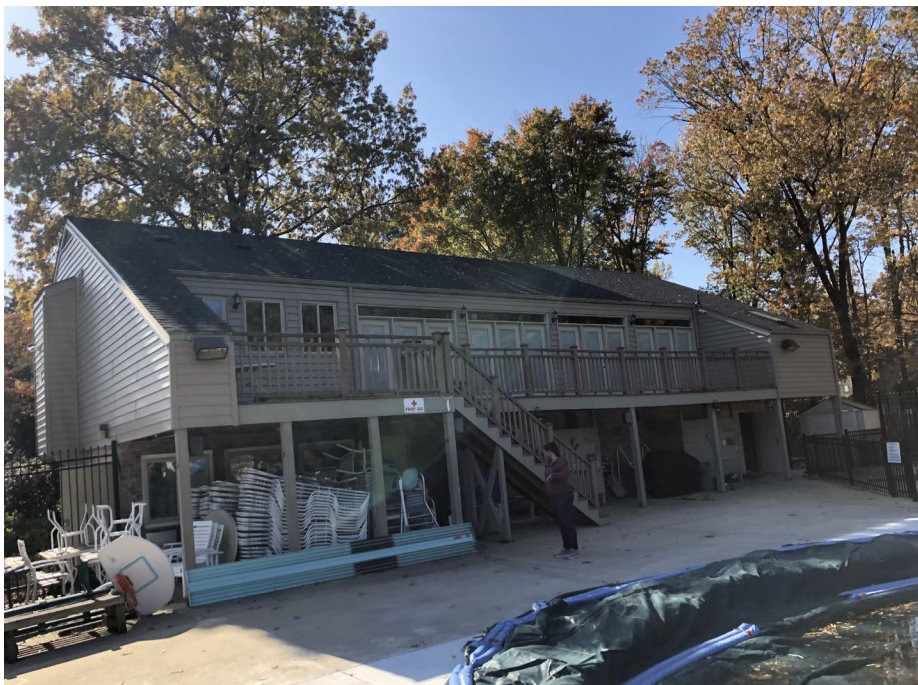
PHOTO #6

The asphalt shingle roofing was replaced in 2017 and appears to be in excellent condition.

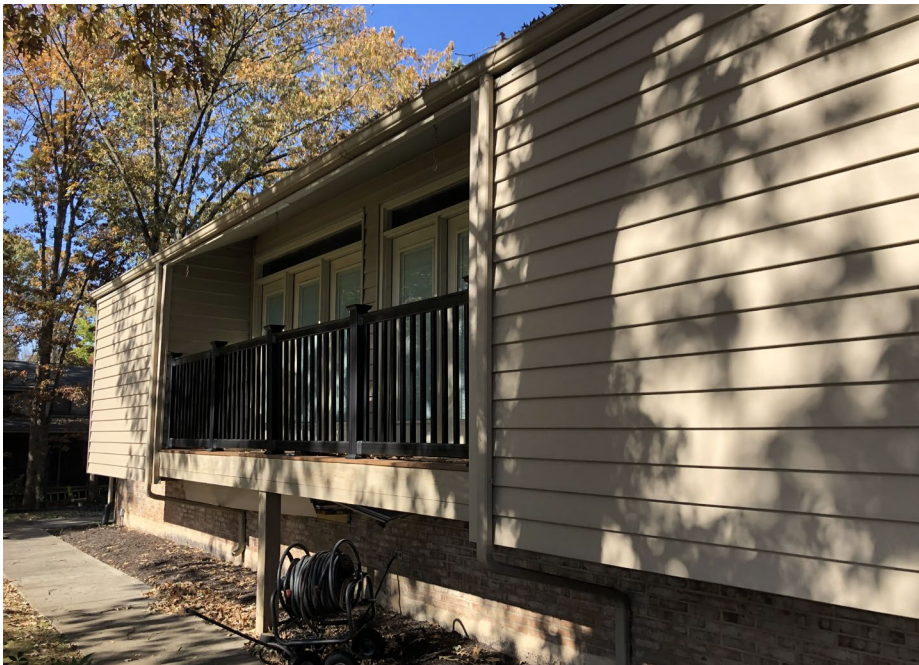
PHOTO #7

The siding as well as the deck boards and railings have also been replaced with composite materials. The workmanship appears to be very good and these components should provide a long service life.

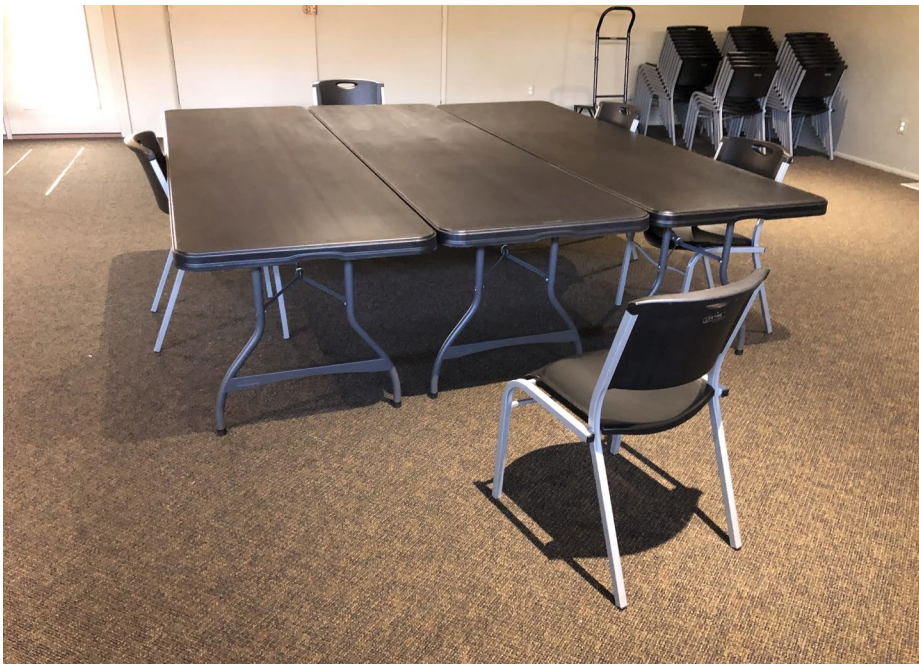
PHOTO #8

The folding tables and chairs as well as the carpet was replaced, and no deficiencies were observed.

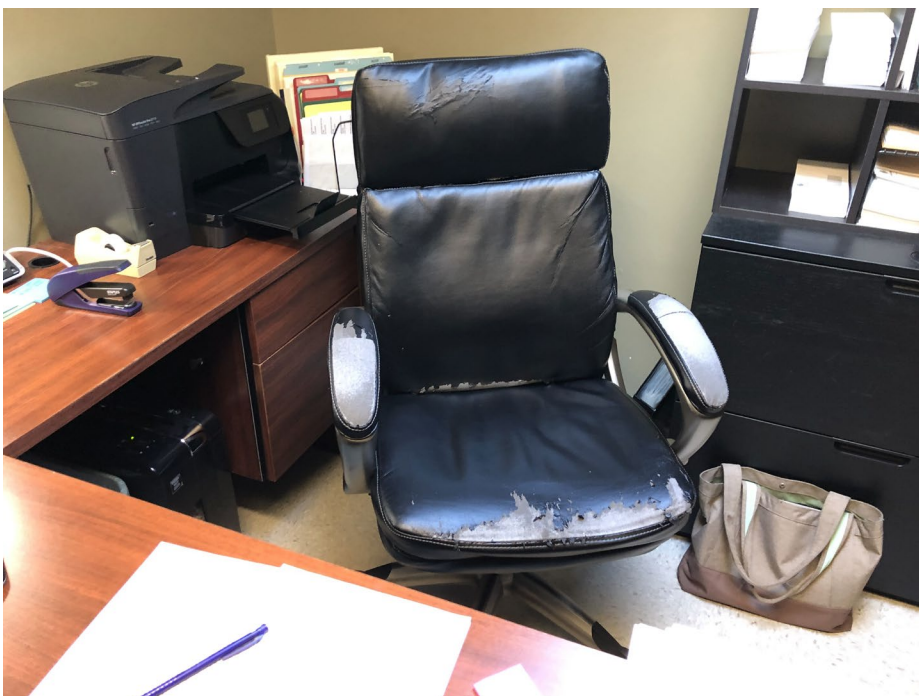
PHOTO #9

We have scheduled a modest near-term expenditure to address the replacement of the worn/dated office furnishings and equipment.

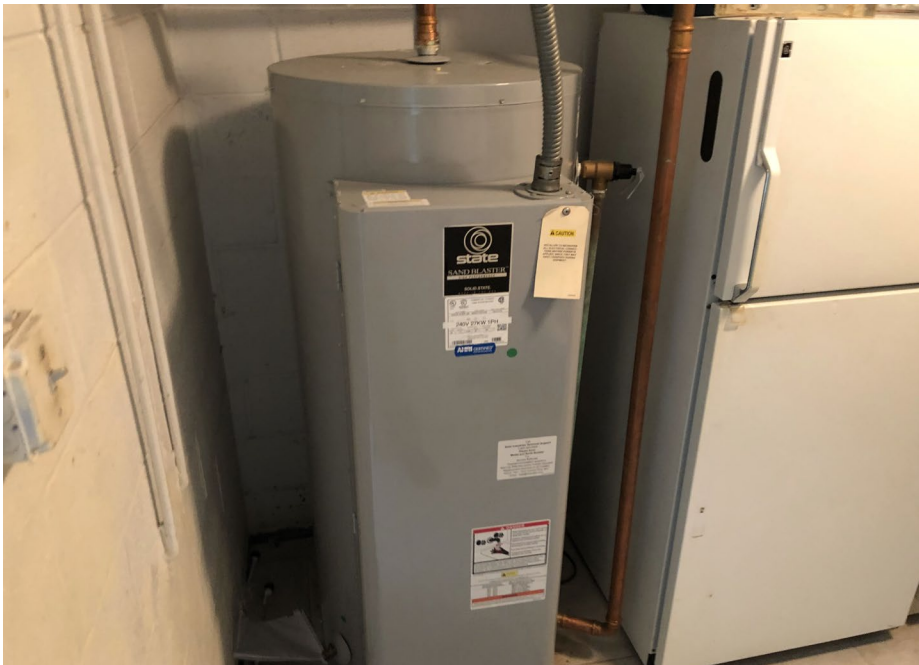
PHOTO #10

The water heater was replaced in 2020. No problems were reported though the previous unit did not achieve a typical service life.

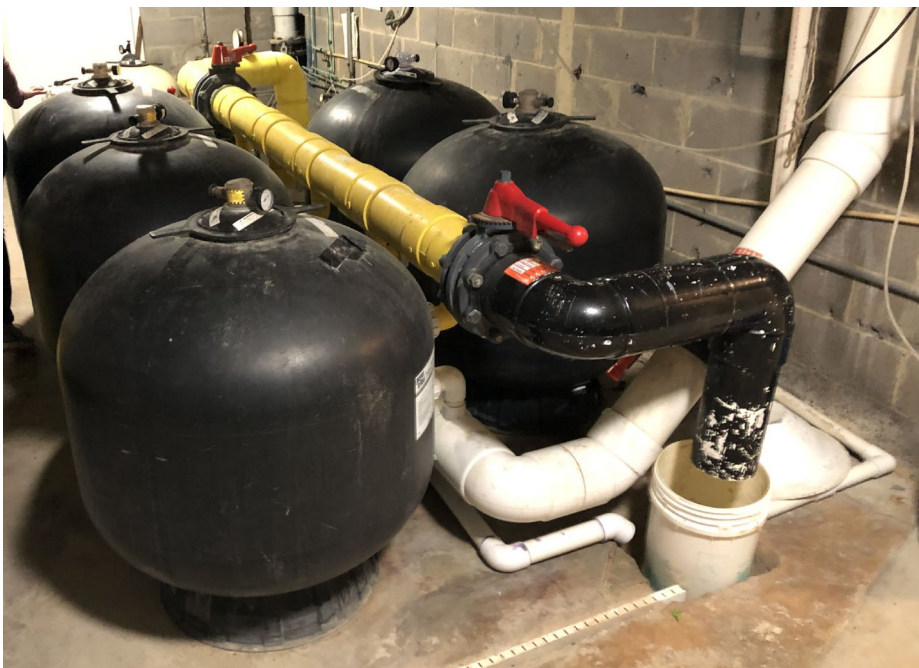
PHOTO #11

The pool pumps and ancillary equipment all appear to be in good condition and no problems were reported.

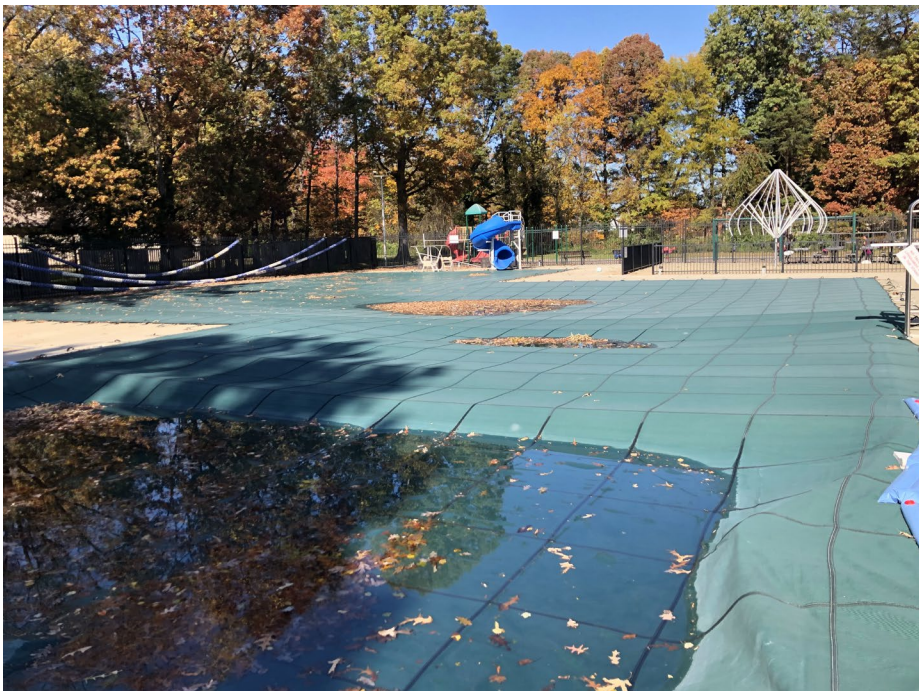
PHOTO #12

The pools was closed for the season and were not observed. However, we understand that the pool structure is in good condition and it was white coated, modified, and all tile and coping was recently replaced.
