Chosen Home Inspections

Property Inspection Report

123 Sample Street, Sample City, CA 98765
Inspection prepared for: Report Sample
Date of Inspection: 11/5/2014 Time: 8:00 am
Age of Home: 2002 Size: 2500
Weather: Cloudy

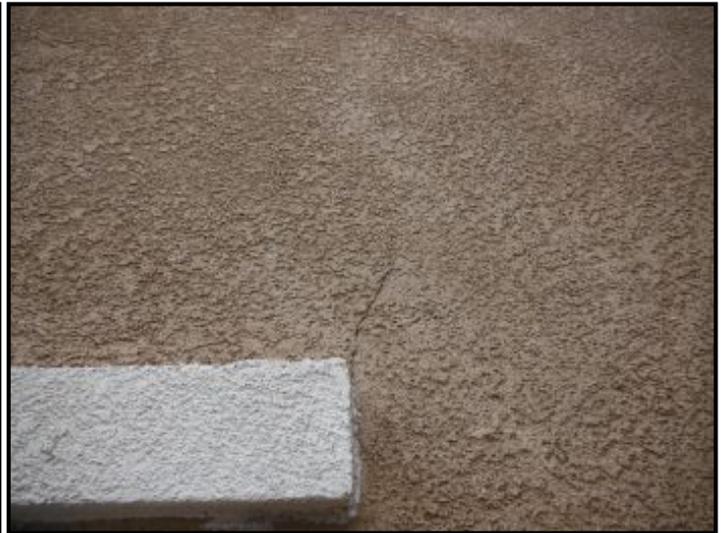
Common Cracks

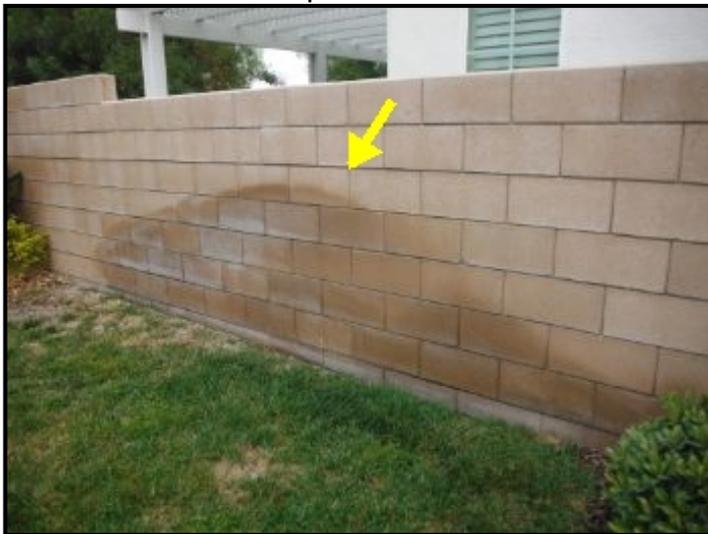
Recommend Adjusting Sprinkler Heads

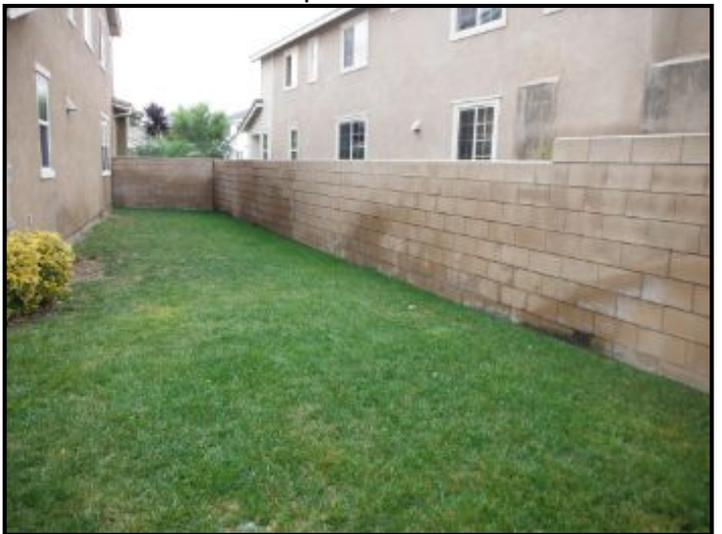
Recommend Adjusting

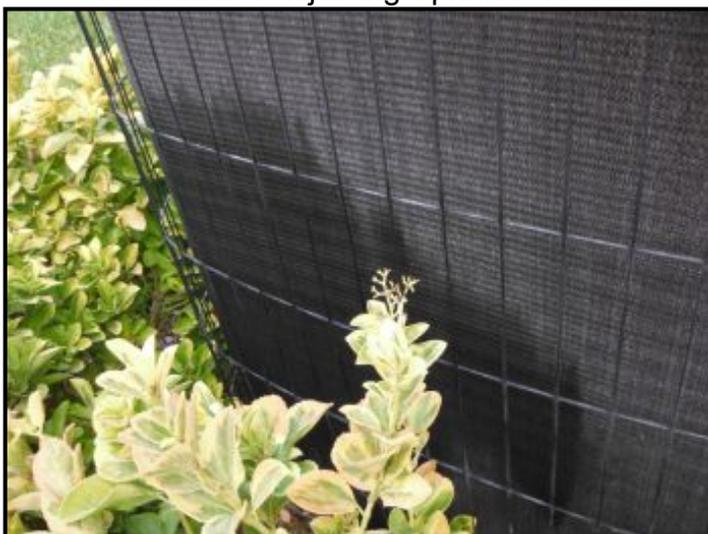
Adjust Sprinkler

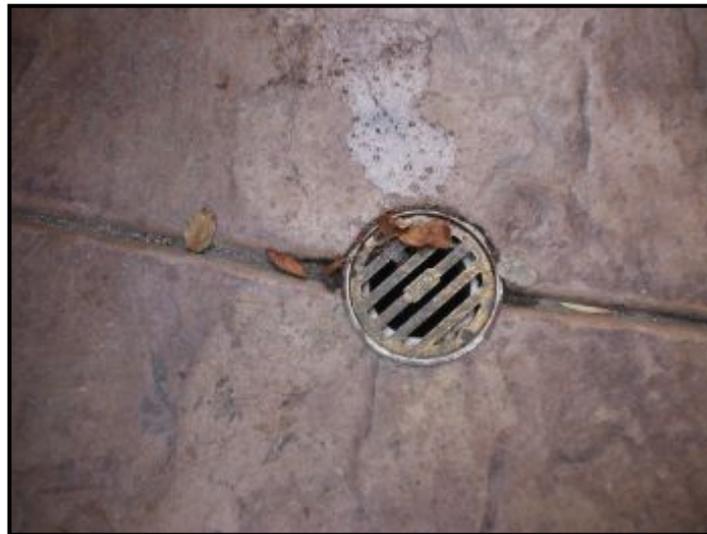
- Surface drains are installed, however underground pipes are not visible and cannot be inspected.*

Surface Drain

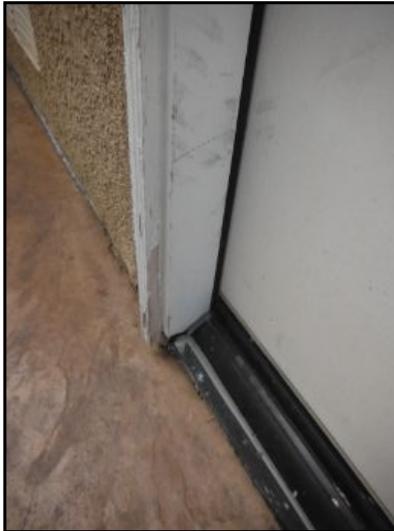
Observations:
 • Peeling paint noted at the garage exterior door jamb.(2)

Peeling Paint

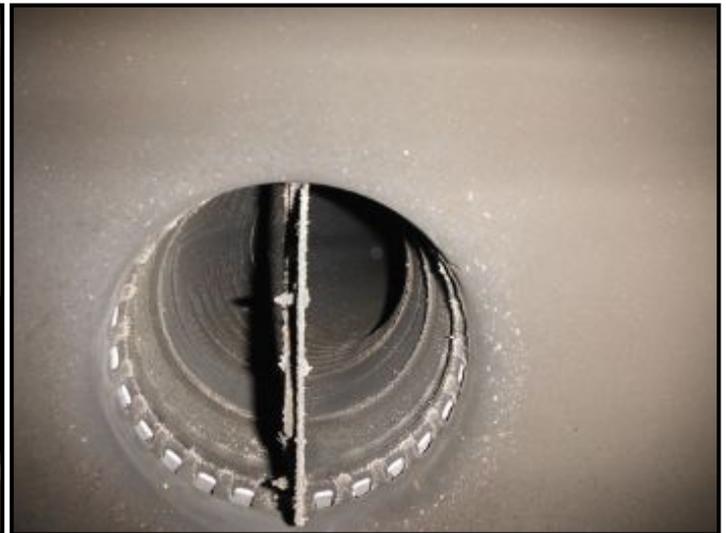
- Missing safety clamp at the fireplace damper.(2)(4)

Missing Safety Clamp

Page 15 Item: 6	Fireplace Condition	• Missing safety clamp at the fireplace damper.(2)(4)
-----------------	---------------------	---

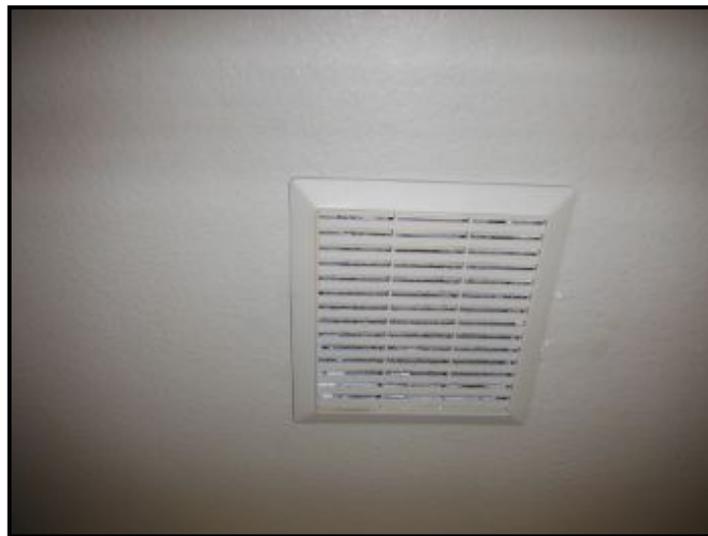
- Recommend cleaning/servicing vent fans.*

Recommend Cleaning

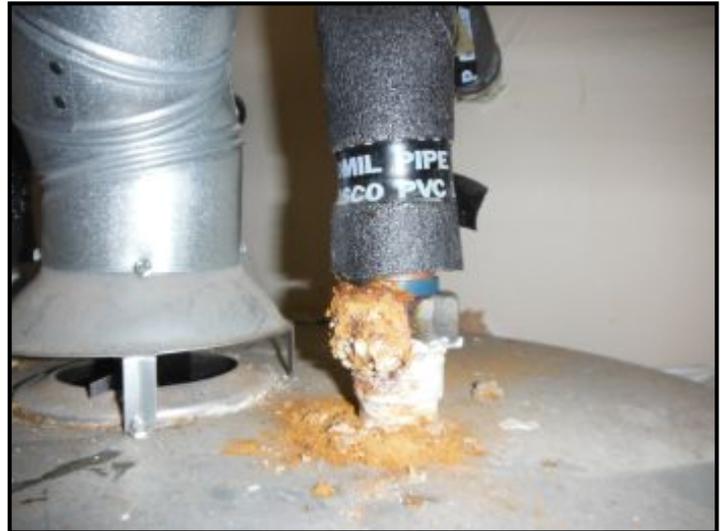
- Corrosion at water heater supply lines.(2)

Corrosion

- Due to the condition of the water heater, we recommend further evaluation by a licensed plumbing contractor
