PRCI Co-sponsored Long-term Composite Repair Study Year 0 Burst Test Progress Report (December 2008)

Prepared by: Chris Alexander (chris.alexander@stress.com and 281-897-6504)
 Prepared for: Air Logistics (3-year study participant)
 Subject: Test results for Year 0 burst test involving 12.75-inch x 0.375-inch, Grade X42 pipe. Composite repair of three samples having corrosion depths of 40, 60, and 75% relative to nominal pipe wall thickness.

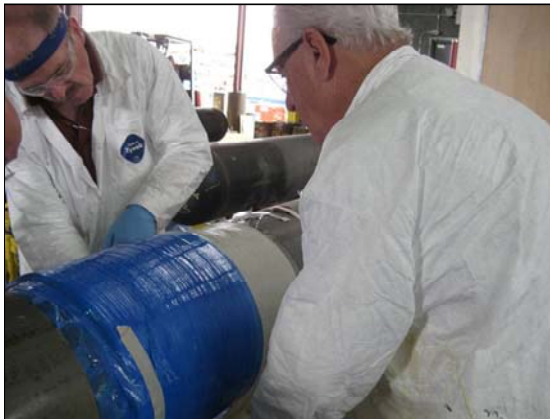
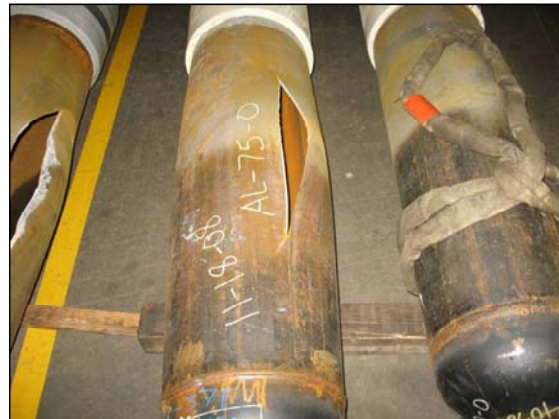
Photographs

All burst test failures occurred outside of the repairs. The recorded strain gage readings were relatively low and would be considered acceptable for design conditions associated with a typical transmission pipeline system

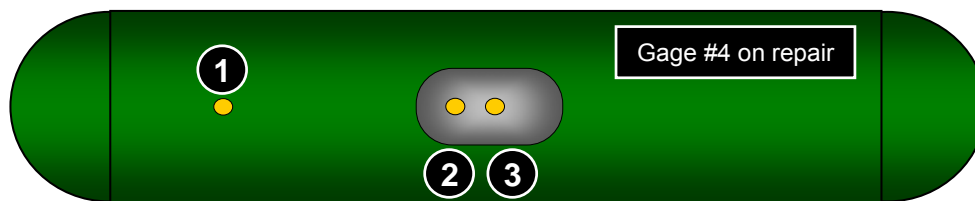
- The pressure levels for the pipe are MAOP = 1,778 psi and SMYS = 2,470 psi.
- Refer to **Figure 1** on the attached page for the strain gage locations. Gage #4 on the outside of the repair is lined up with Gage #3 on the machined corrosion region.
- The strain gage results are in units of microstrain ($\mu\epsilon = 10^{-6}$ in/in). Elastic stress is calculated by multiplying strain by the material's elastic modulus (i.e. 30 Msi for steel). For example, if the strain in the steel is 1000 $\mu\epsilon$, the stress is calculated to be 1000 $\mu\epsilon$ x 30 Msi = 30,000 psi. For the composite material, the elastic modulus will be less than steel.
- The average measured composite thickness values for the 40, 60, and 75 percent samples were 0.690, 0.750, and 0.900 inches, respectively.

Location of strain gages installed on the test sample

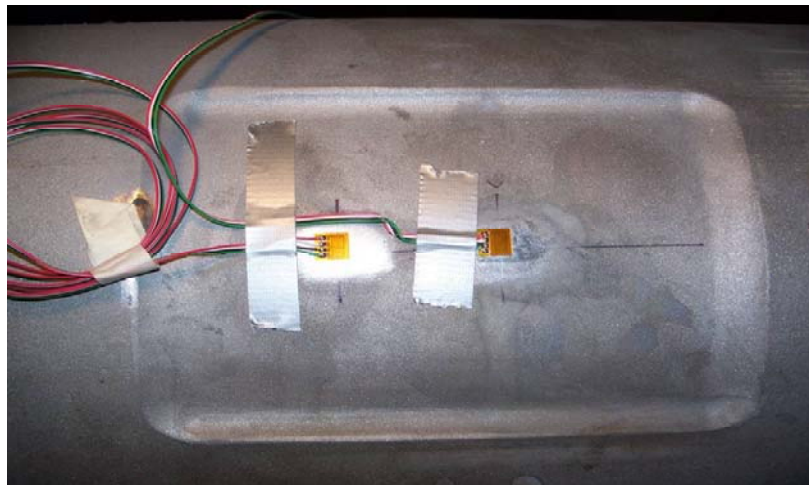
Photograph of strain gages installed in a machined corrosion region
