CCR Unit: SCA #2 Ash Landfill

Owner: Sunnyside Cogeneration Associates

Annual Inspection: January 2020

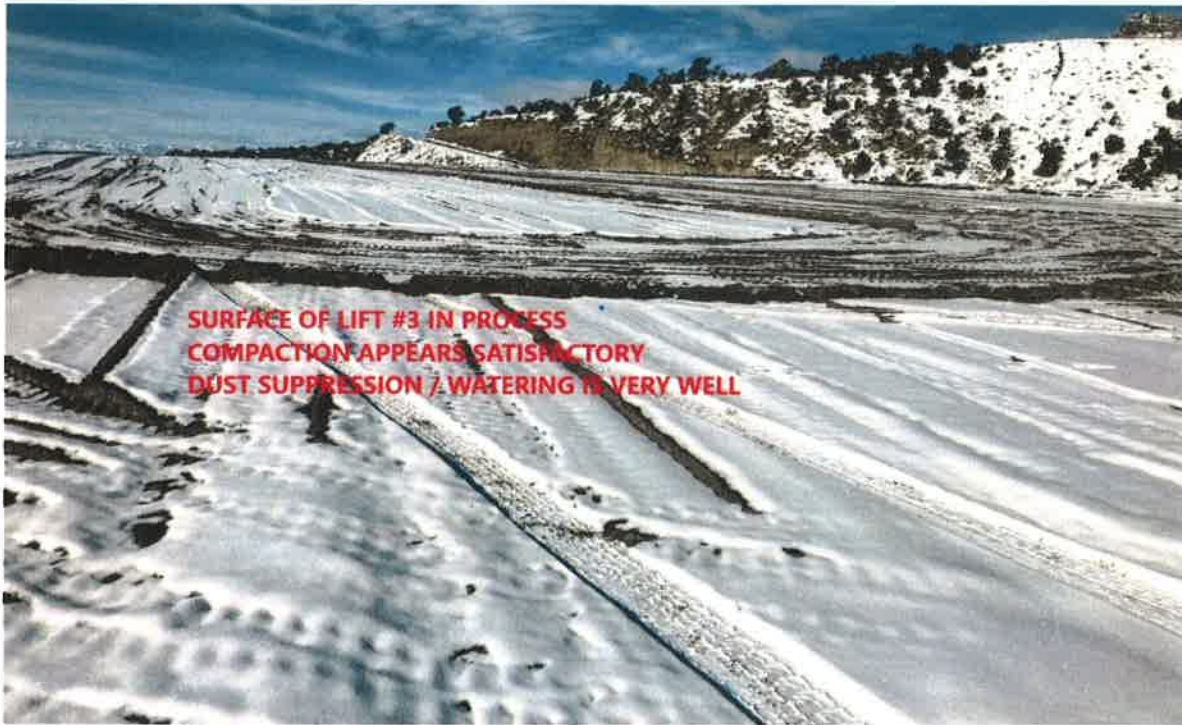
Surface of Lift #3 in process – photo looking northwesterly

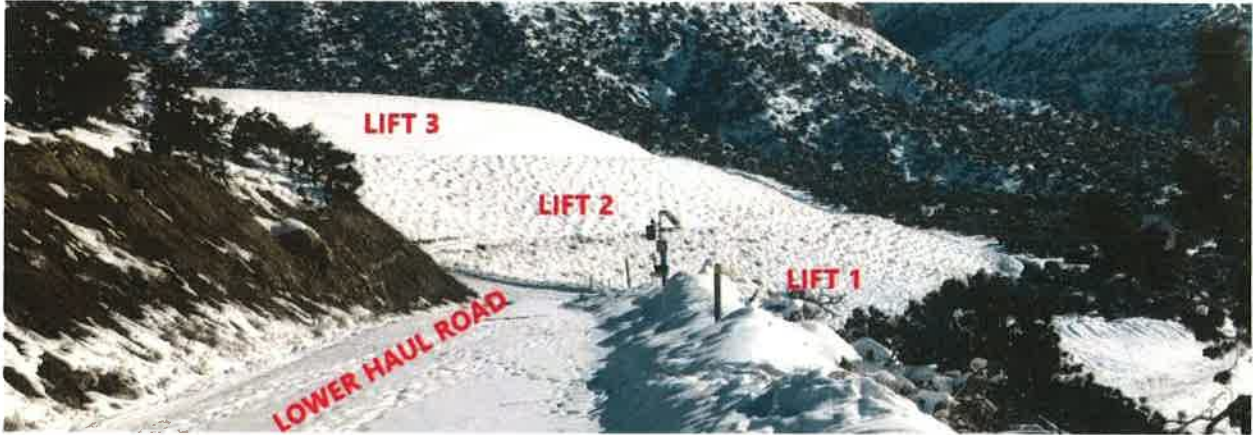
SCA#2 Ash Landfill –looking southeasterly

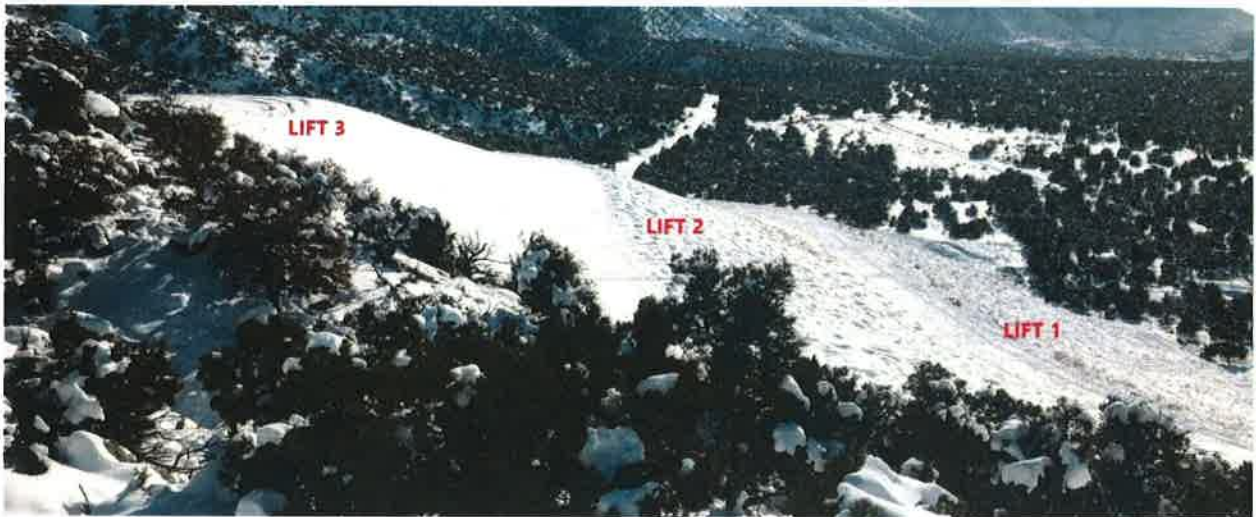
SCA#2 Ash Landfill – west face looking southerly
Lift #1 and #2 covered and seeded. Lift #3 in process

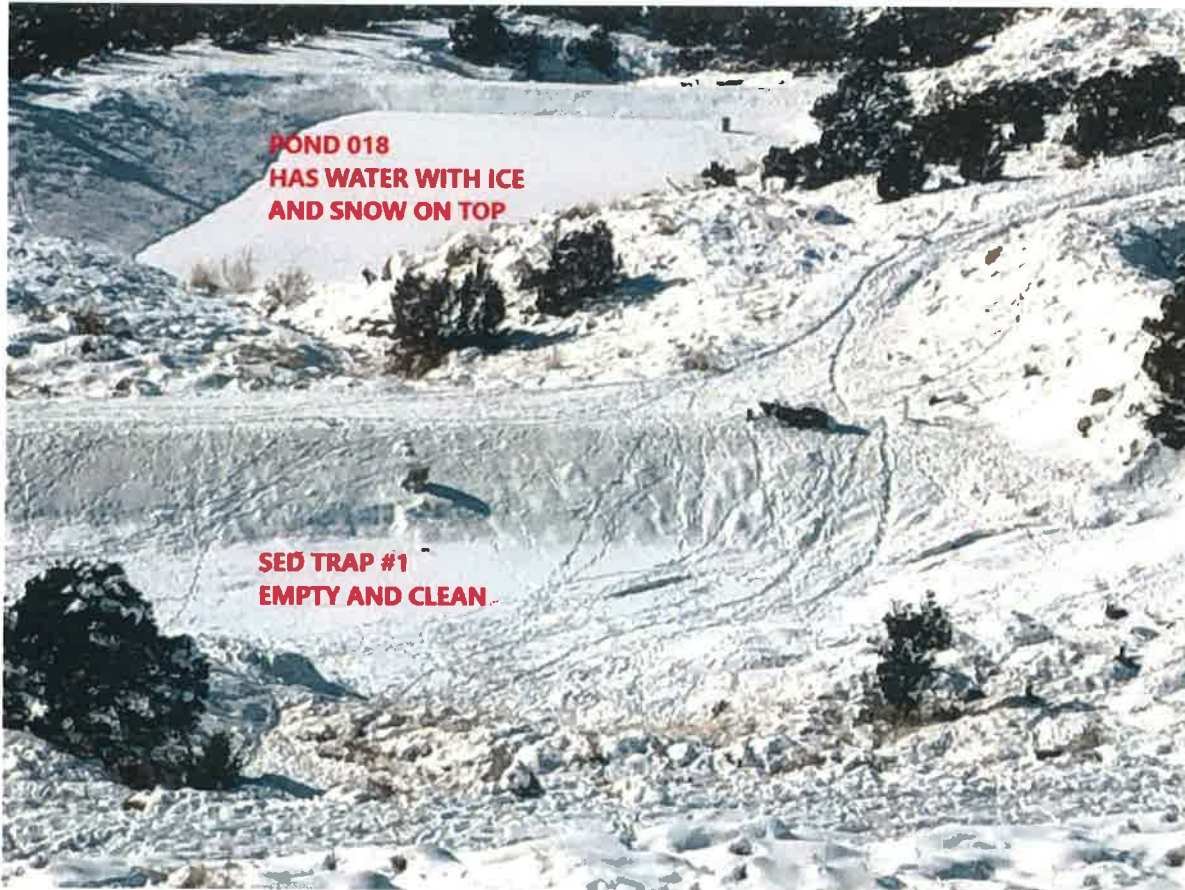
Sediment Pond 018, located west of Sed Trap #1 – photo looking westerly

Pond has water with a surface ice layer and recent snow cover.

No discharge in 2019

Sediment Trap #1 is empty and clean, water flows from trap to pond in normal open condition.
