Part IV: BARANGAY SURVEYS, PENINSULAR & NEAR ISLANDS Methodology

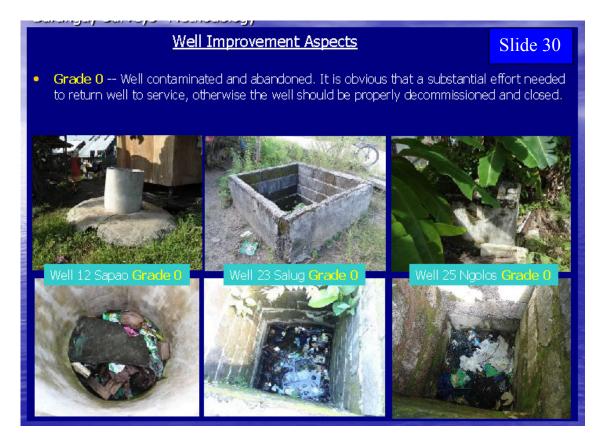
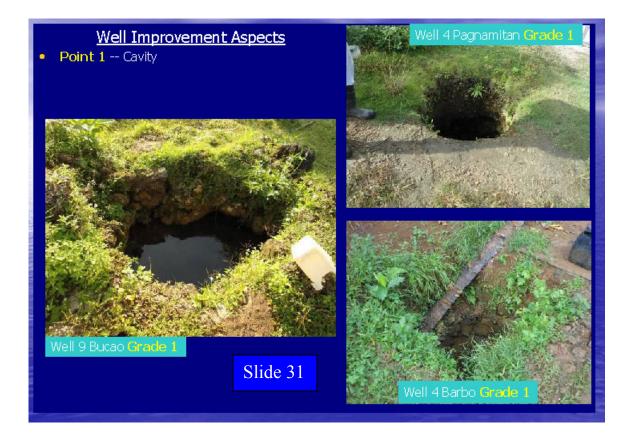
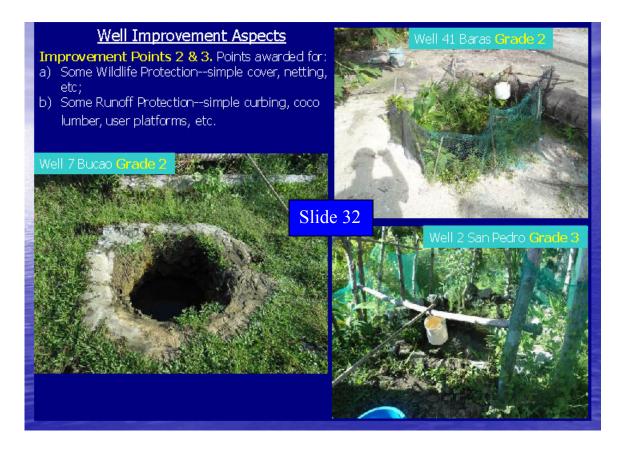
Well Improvement Aspect/Points (Slides 30 to 35).

- 0 -- Well Contaminated: Well contaminated and abandoned. For such wells,
 substantial effort needed to return well to service, otherwise the well should
 be properly decommissioned and closed.
- 1 Cavity: Simple dug hole without improvements.
- 1 -- Some Wildlife Protection: Simple cover, netting, etc.)
- 1 -- Some Runoff Protection: user platforms simple curbing, coco lumber etc.)
- 1 -- Improved Shaft: culvert, hollow blocks, concrete, etc.
- 1 -- Concrete Apron: should be more than user platform, ideally complete around well.
- 1 -- Cover: can be simple, heavy duty, may have been adequate but deteriorated.
- 1 -- Adequate Cover: tight seal, or sealed-not removable.

- 1 -- Serviceable Cover: Cover tight and Serviceable.
- 1 -- Secure and Serviceable Cover: Superior Designed cover prevents contamination.Well can be cleaned and inspected and cover can be safely removed and replaced by women, children, and the elderly.
- 1 -- Pump (manual, electric, etc.)

"+ " dual design for hatch cover makes for easy access.

E – Exempt Well: Wells that are of historical, cultural, or aesthetic significance and/or in a natural setting to deserve preservation in their current state. Also, in areas with mostly improved wells without easy access, these mostly open wells would serve as emergency water sources in contingency planning. Improvement may still be applied but should be designed to ensure preservation of these special wells. Often these wells were among the first water sources in the barangay to clear up in the days following the Typhoon.

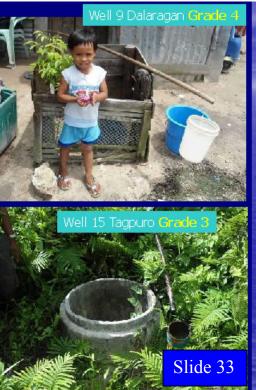
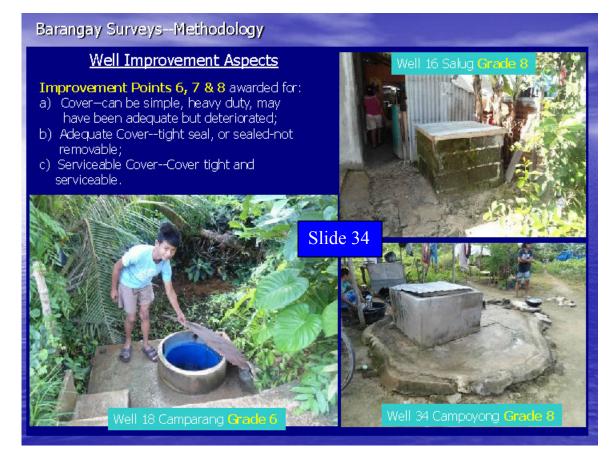
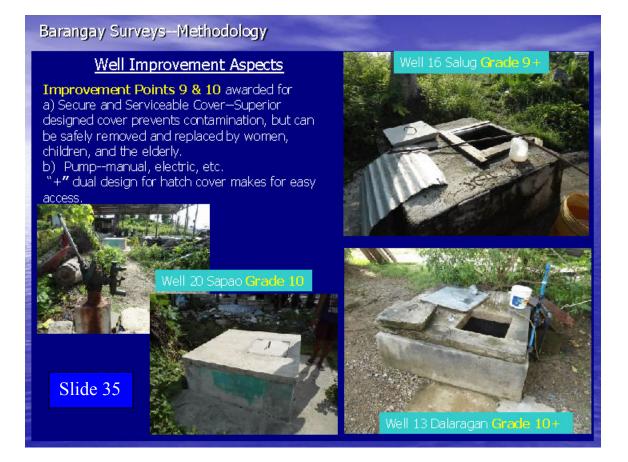
Well Improvement Aspects

Improvement Points 4 & 5 awarded for:
a) Improved Shaft--culvert, hollow blocks, concrete, etc.)
b) Concrete Apron-ideally complete around well, should be more than simple user platform.

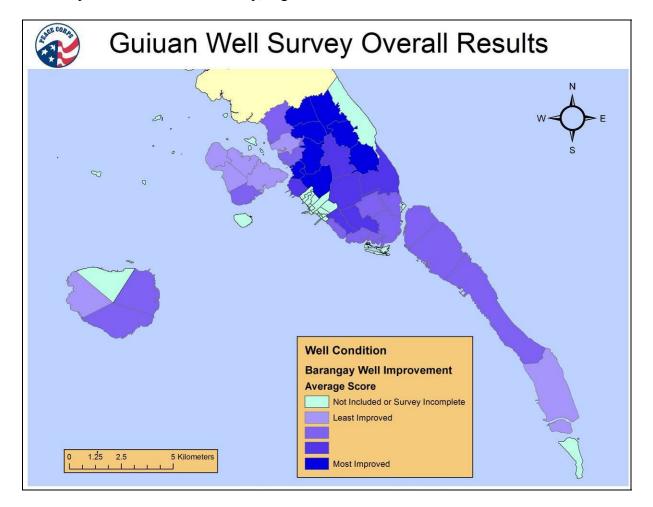
Figure 17: Guiuan Well Survey Overall Results

ecological condition of Victory Island has not been surveyed. The surveyor also omitted the downtown areas. The survey of barangay of Homorawan was finished on July 15, 2018 and Suluan is incomplete with the population center not surveyed. The table in Figure-23 and map in Figure-17 below presents the overall sampling results. The highest most improved wells on average are found in the higher elevations and in barangays with fewer wells. Fortunately, the more improved wells and the most secured are found in the major recharge areas. The sample size is represented in the second map, Figure-18.
