The Madagascar Water Project

MAINTENANCE TRIP REPORT

December 2017

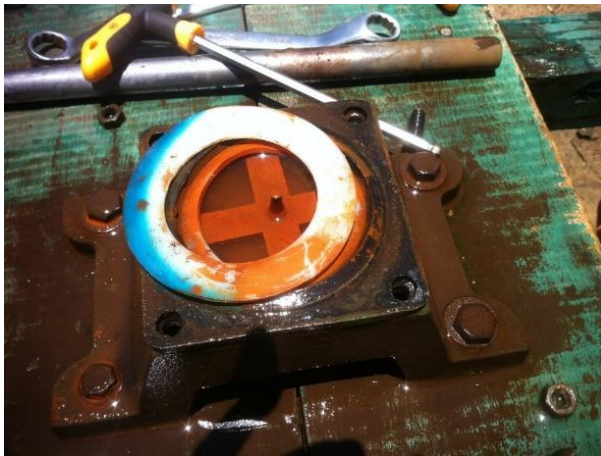
Working well, but leaking at base. Rubber cup still in good condition,

White seal should not be there

Problem: one seal was incorrectly installed at the base of the pump.

Action: unscrewed the body of the pump; took out seal; tighten bolts, nuts and washers.

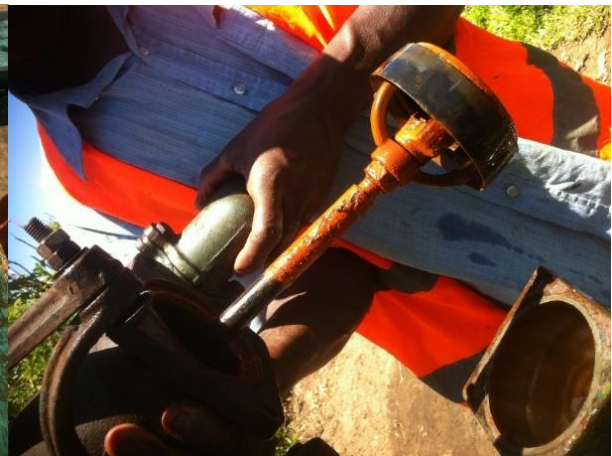
Rubber cup on 9m has shows little wear

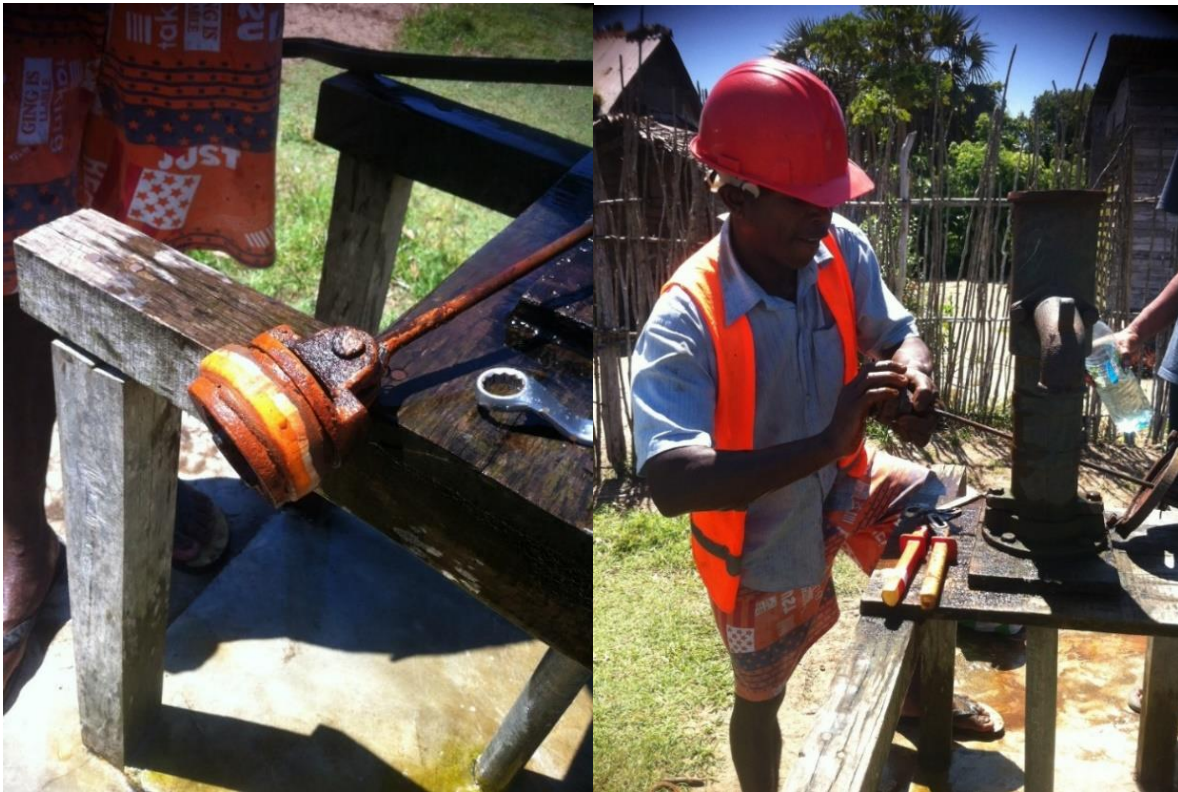
MWP-26 CEG School: BatiMax pump

Working well with leather cup local made, changed to new cup, table needs to be changed

- Change and repair the tables as recommended. The MWP-10 table was completely damaged, and cannot support pump anymore. The following tables need repairs or replacement: MWP-26, MWP-13, MWP-10, MWP-11, MWP-21, MWP-17
- Put a larger cement foundation (same as Bush proof), to permit runoff to go farther away.
- Using Casing is helpful to drill in the south especially when the water table exceeds 7 meters

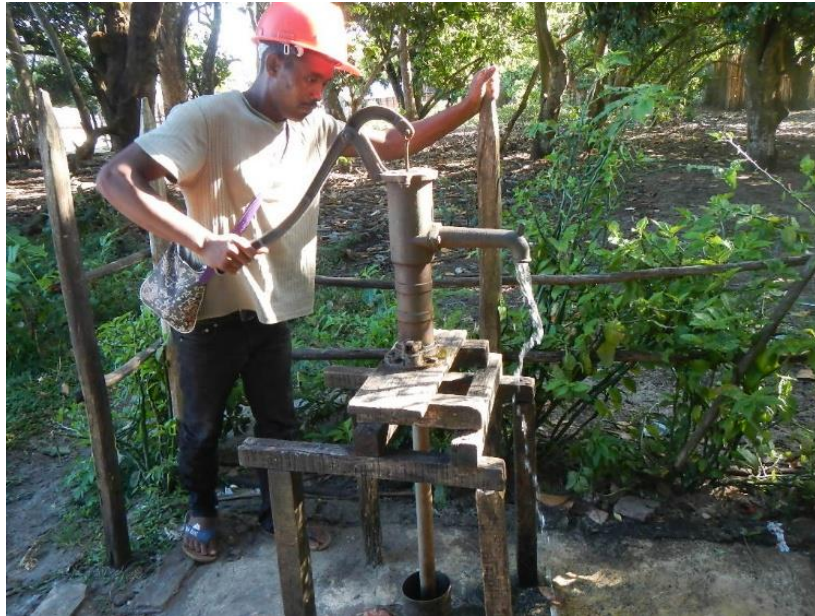
g) AMBILABE Mahanoro**MWP-11:** BatiMax pump

Pump is working well but table needs to be changed, leather cup changed

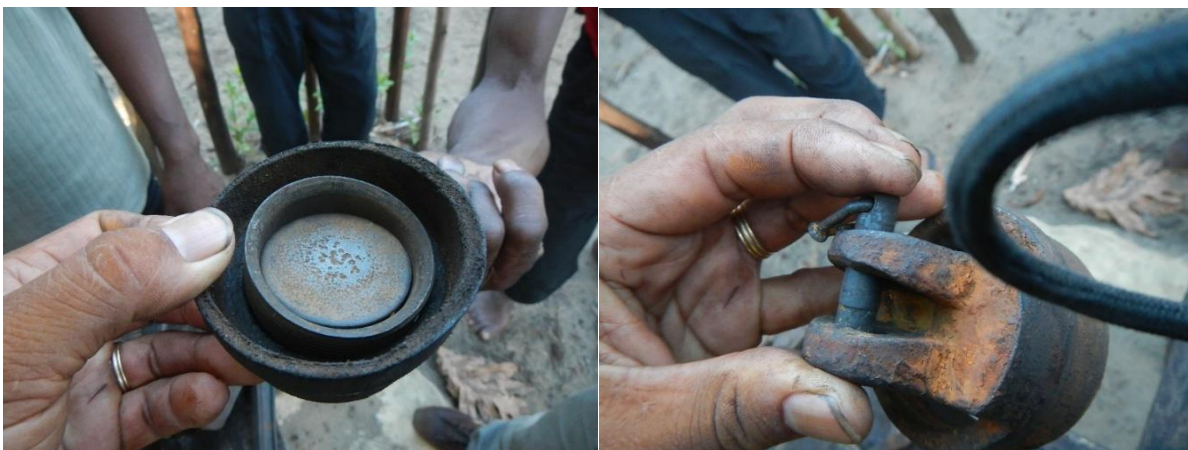
Pump was not working, the plug on the piston had become loose and could not function properly. Replaced piston and cup. Pump now working well. Table needs to be replaced.

Plug loose in the inner piston which caused pressure loss, all kit replaced

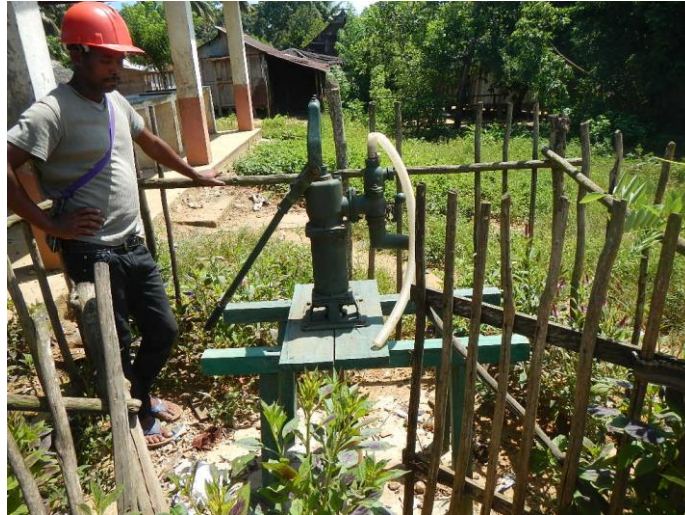
Photo upon arrival

Status upon arrival: the rubber cup was broken, pump did not work, fence fell down and no one took care of the well.

Actions: A meeting was held with the Well Management Committee, later with the Peace Corp Volunteer. Changed 20 meter pump to a BatiMax pump.

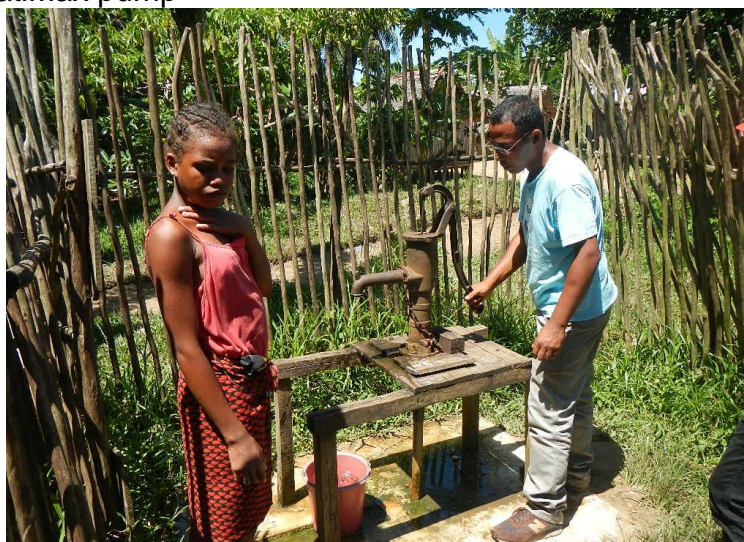
MWP-17 School: BatiMax pump

Pump is working fine but table needs to be repaired, leather cup changed

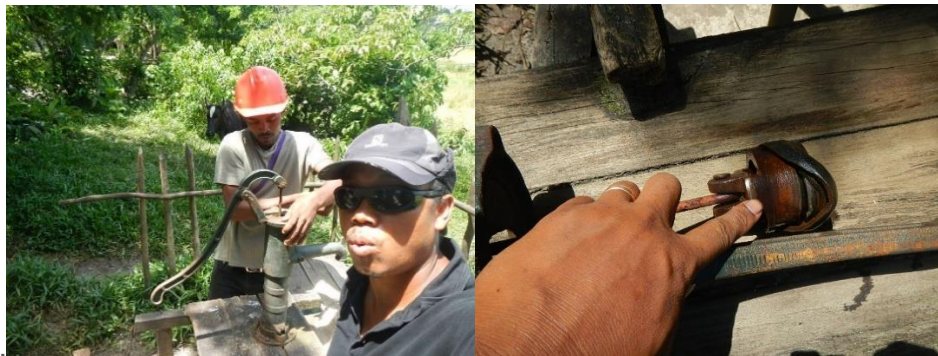
The pump was not working due to the leather cup which is broken. We changed it and it is working now

Broken leather cup

Sedera is changing the leather cup

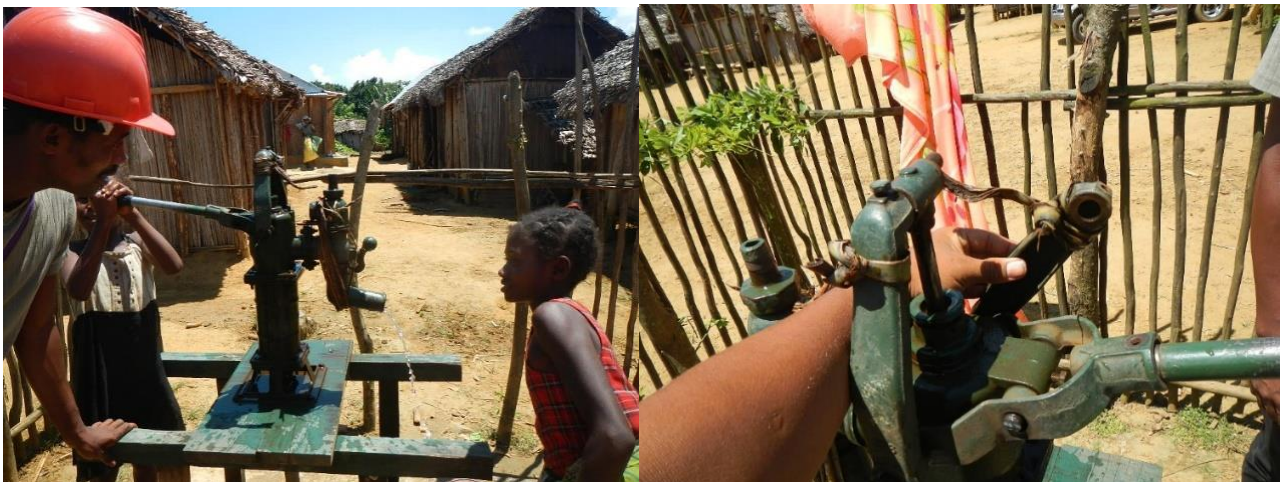
MWP-16: 20 meter pump

pump was working at very low flow, all was unscrewed, village tried to tighten it by using rope

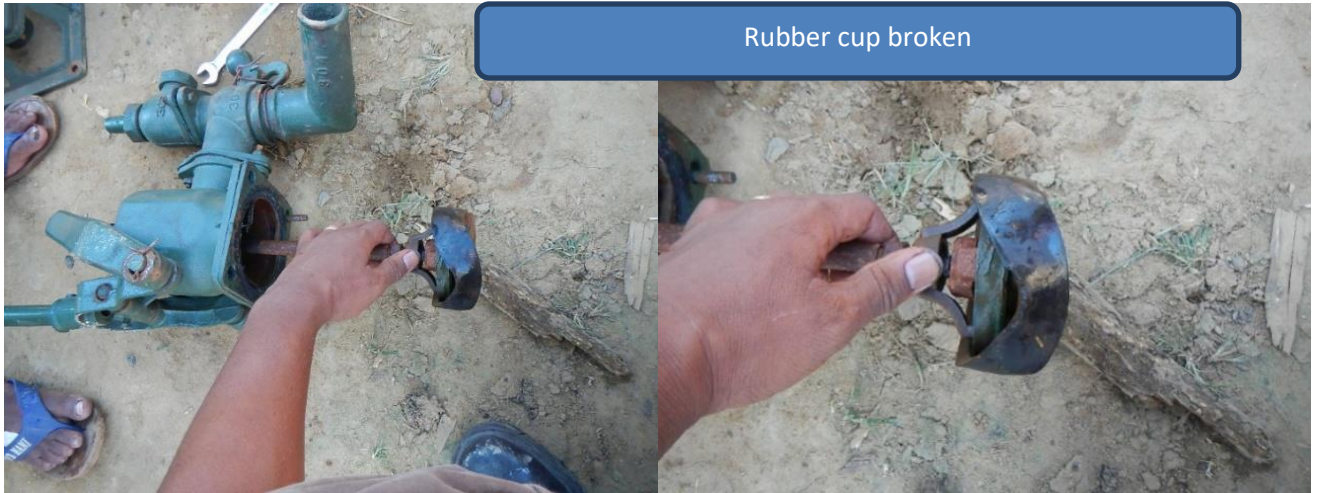
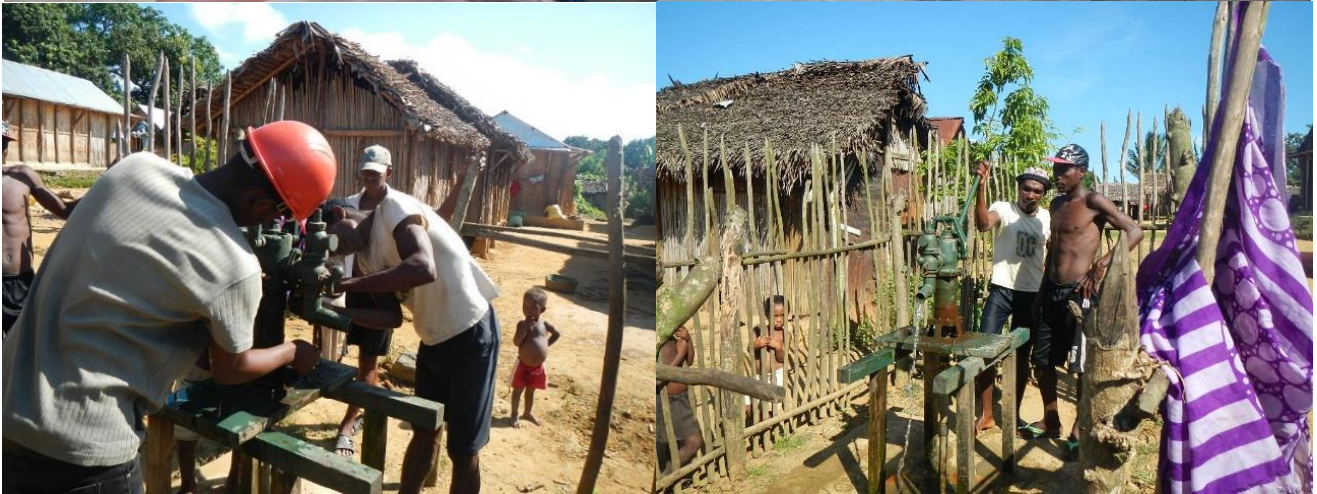
Rubber cup broken

Pump was changed with the 20m pump from Tsivangiana, working well now

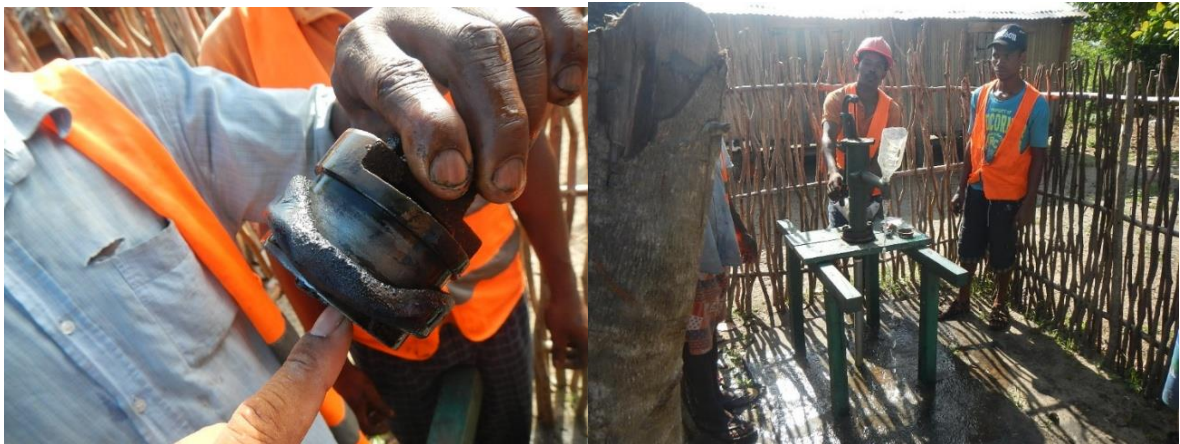
MWP-19 south side of village: BatiMax pump

Pump was working but leather cup was worn, cup changed, working well

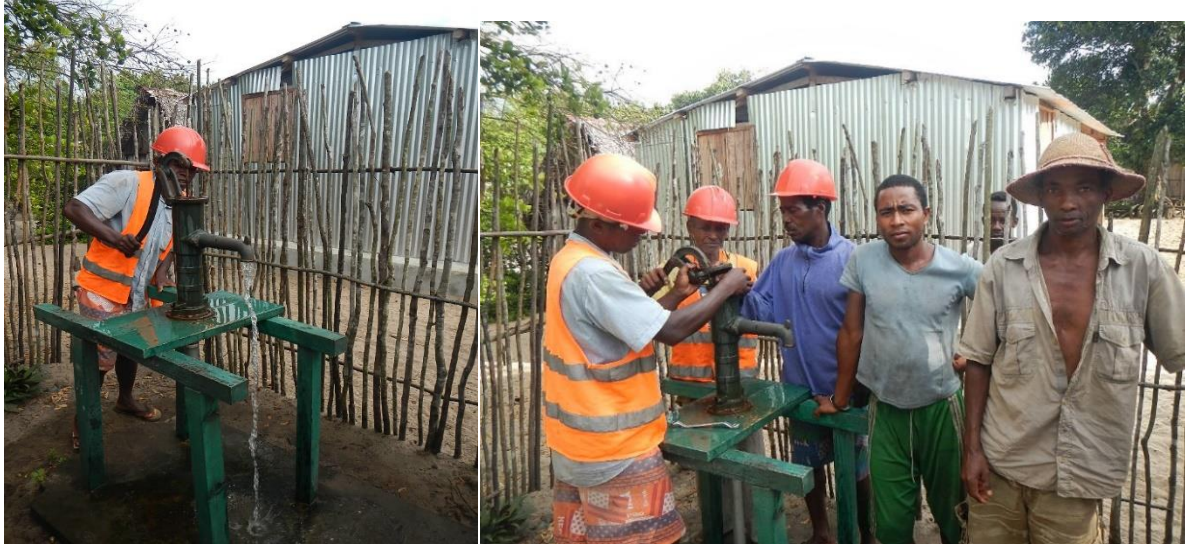
MWP-31 north side of village: BatiMax pump
Replacement well for MWP-18, which seasonally goes dry

Pump working well, replaced leather cup

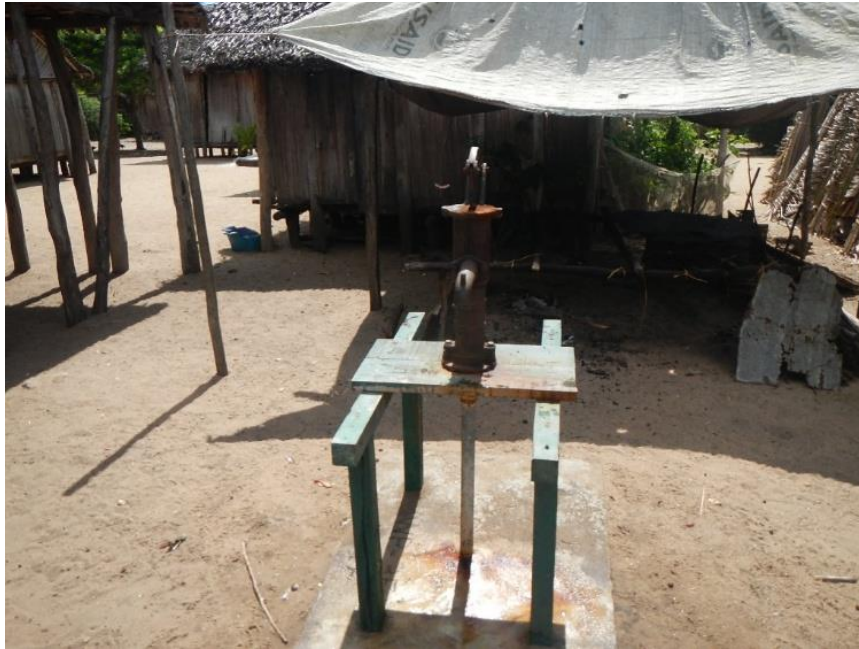
MWP-35: BatiMax pump

The village is located next to the sea and a cut through where the sea intrudes into the Pangalana Channel. Although the well is only 60 meters from the MWP-23 well, this well has always produced sea water. At the request of the villagers, the pump was not taken off so they can use the water for washing.

Water is still salty, slight improvement. People use for washing

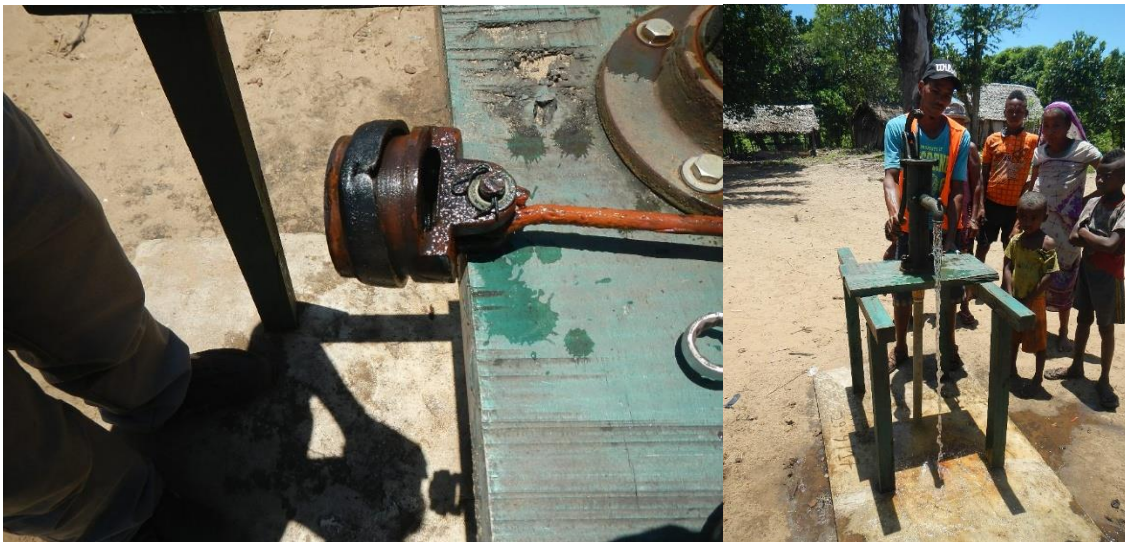
MWP-37: BatiMax pump

Leather cup was broken, we changed to new leather cup and everything is good

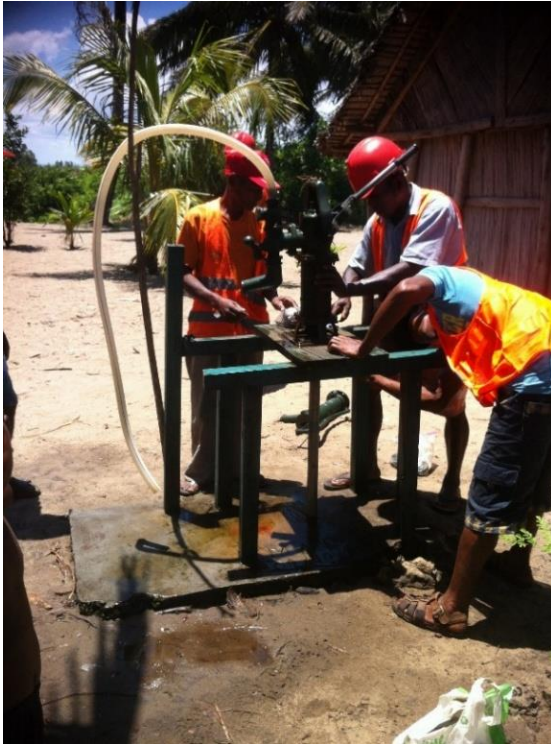
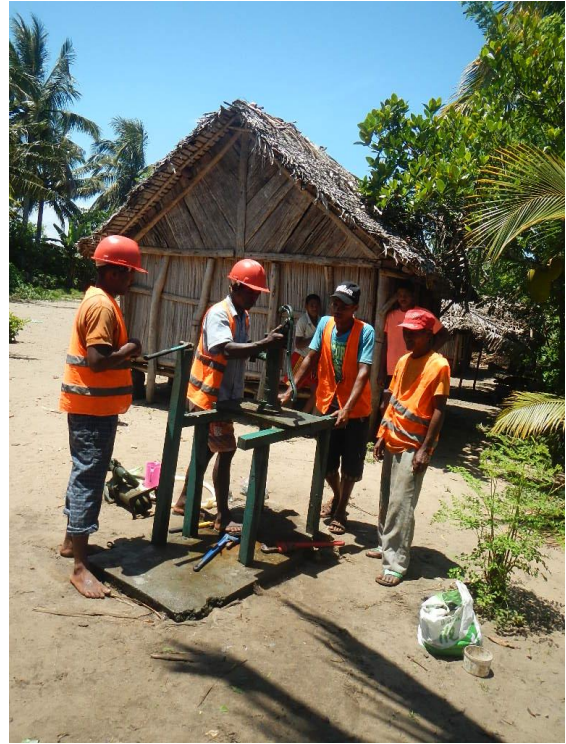
Status: the 20 meter pump was working but falling apart due to extensive use.

Action: changed to a BatiMax pump, trained two local people on maintenance, gave spare leather cup, all working well.

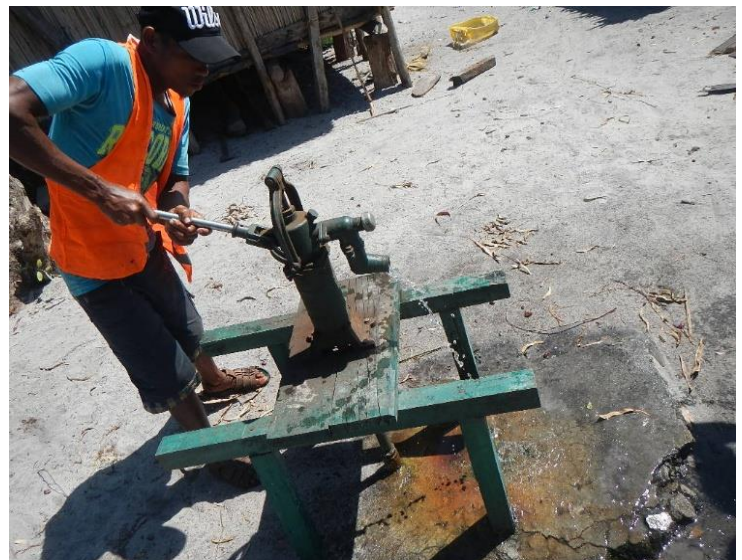
Water is not drinkable as it smells and has a dark and reddish coloration, people use it only for washing,

Note: The Bushproof pump present in the village which has been fixed by the local people, it smells also but not as much as ours, people can use for cooking.
