SERVICE BULLETIN	
Service Bulletin #	AASB-1-12-2012
Superseded Bulletin #	AASB-1-1-2011
Issue Date	12-31-2012
Effective Date	12-31-2012
Limitations for Completion	
Make & Model Affected	Lightning LS-1 SLSA and ELSA
	SN87-133
Page 1 of

1. Applicability: Lightning LS-1 SLSA or ELSA aircraft in the effected serial range of SN87 thru SN133.

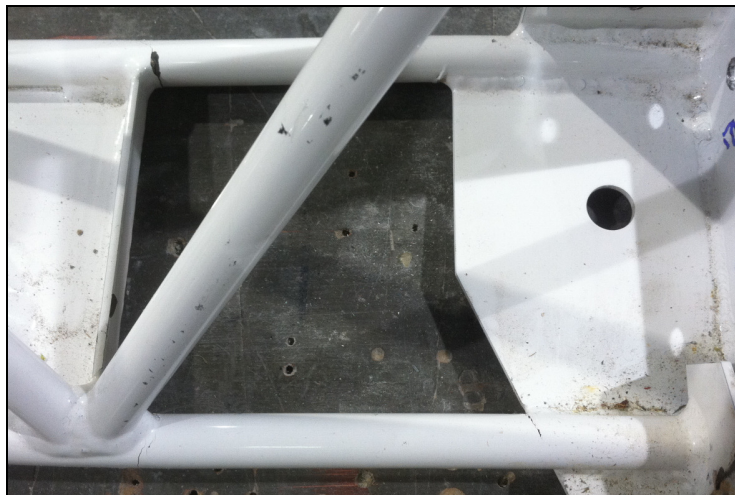
Figure 1. Overview Right side spar box: Affected Box design.

2. Background: Cracking of the lower ½" tubes adjacent to the lower gear exit plates has been noted on some aircraft. **See Figures 1, 2, 3.** Those aircraft in most cases have been subject to higher than expected landing loads. Higher loads occurred during the noted operations: Hard landing, Flight over design gross, operation on extremely rough surfaces, severe main gear leg shimmy. The lower plate adjacent to the main gear leg exit has been re-designed to extend fully to the outboard portion of the spar box, **See figure 4.** This will eliminate any flexing of the tubes should the box be subjected to any of the above mentioned cases and exceed expected loads. See the provided photos below for reference.

Figure 1: Overall view right side of the spar box. Affected box designs have about a 4" open section between the gear leg tube plate and outboard attach plates. Areas prone to cracking are at the plate too tube intersections.

If No cracks are noted in the affected areas no immediate action is needed. The aircraft should have the plates retrofitted however. This must be done with in the next 25hrs or Annual Condition inspection. Contact Arion Aircraft For the plates needed for the retrofit.

Arion Aircraft Must be Notified if Cracks are found. At that time, further instruction will be given as to the Procedures needed to comply with this SB. Authorization will be given to the qualified repair facility or persons performing the work if they meet the requirements of section 5.

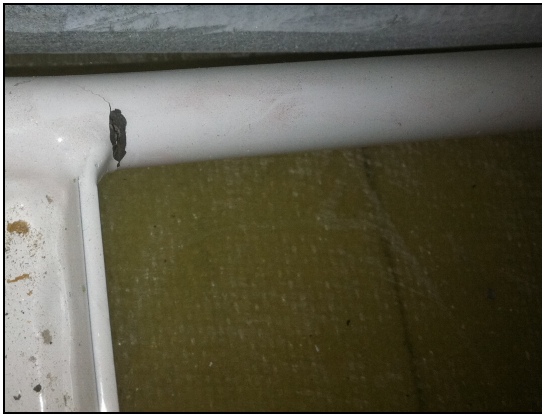
Figure 2. Forward tube at gear plate.

Figure 2: Close up view of the forward tube to plate intersection. Note crack at end plate in the paint.

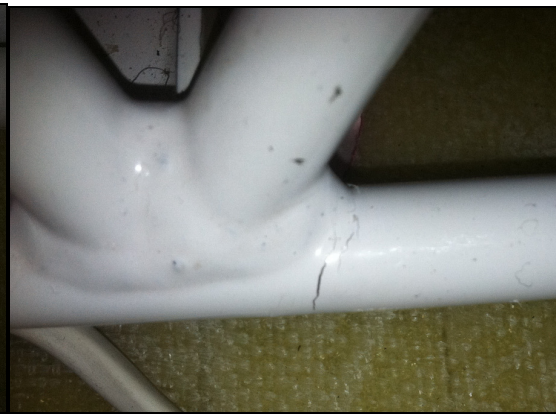
Figure 3. Rear tube at compression V tubes.

Figure 3: Close up view of the rear tube at the plate intersection. Note crack at end plate in the paint.

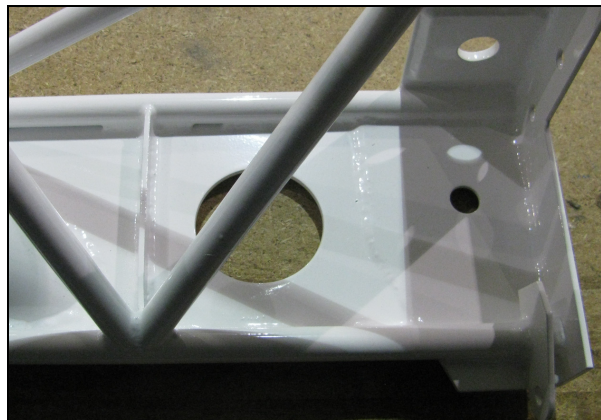
Figure 4. Fully plated section.

Figure 4: Overall view of current designed box with closed in section, 1 piece lower plate. Aircraft fitted with this design are not affected by this SB.
