# PROPERTY INSPECTION REPORT

ng: XXXX Los Robles Drive, Plano, Texas 75074	
(Address or Other Identification of Inspect	ted Property)
By: Jen K Chen (Jake) TREC #20333	X/XX/2019
(Name and License Number of Inspector)	(Date)
·

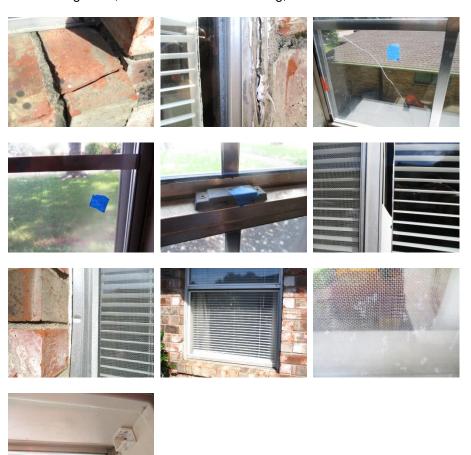
Comments: Opened and closed all windows and checked locks. The exterior window sills are damaged; needs to be repaired. The exterior window needs to be caulked to the brick wall. On the south wall of the upstairs game room, the glass of the lower window is broken; needs to be repaired. The lower right window on the east wall of the study room shows moisture in between the glass; needs to be repaired. The following places have window locks that are inoperable; needs to be repaired: the left window on the east wall of the family room, the window on the south wall of the south left bedroom, the window on the north wall of the master bathroom, the window on the south wall of the sewing room and the window on the north wall of the upstairs game room. Along the east, west and south side, the exterior window's glazing bead shows evidence of damage; needs to be repaired. Along the west and south side, the exterior window's screen frame shows evidence of damage; needs to be repaired. The following places are missing window screens and need to be restored: the right window on the west wall of the family room, the window on the south wall of the south left bedroom, the right window on the south wall of the master bedroom and the window on the south and north wall of the upstairs game room. The following places have window screens that are damaged and need to be repaired: the two windows on the west wall of the dining room, the three windows on the east wall of the study room and the left window on the south wall of the master bedroom. On the west wall of the dining room, the window blind is missing; needs to be restored.
