# Property Inspection Report

123 Main Street

Unit T1

**Terra Home Inspections LLC**

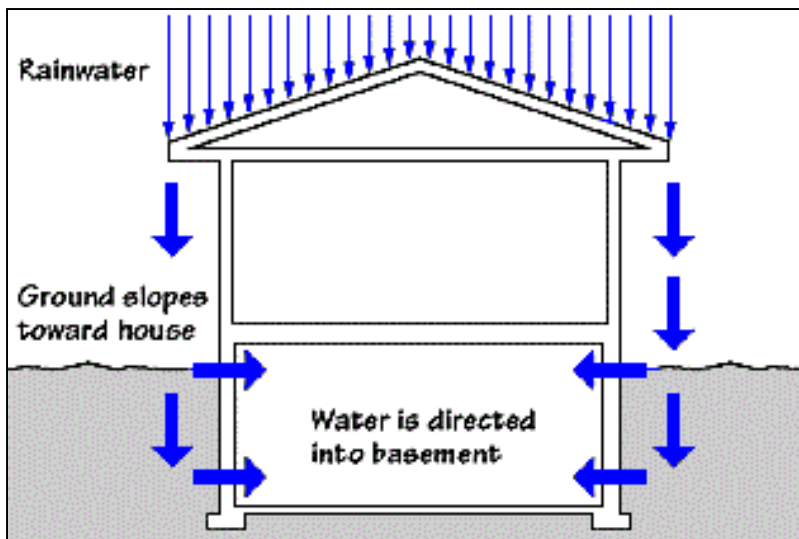
1.2 Item 1 (Picture)

The grading (slope of ground surface) next to the foundation under the deck areas was pitched towards the foundation. The grading whenever possible should be pitched away from the foundation to prevent moisture intrusion from entering the foundation walls and basement. Recommend further evaluation of all of the exterior grading by a qualified, licensed contractor and repair as necessary.

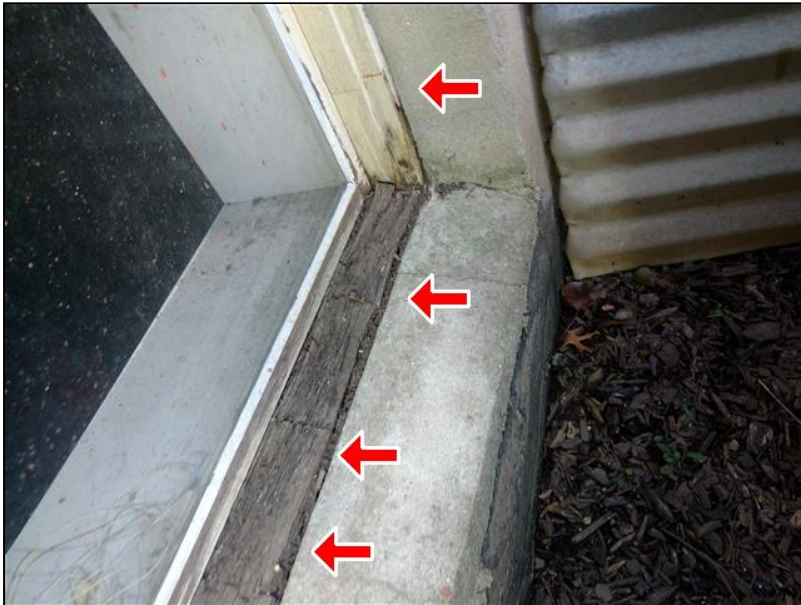
2.0 Item 14 (Picture) Basement window frame deteriorated

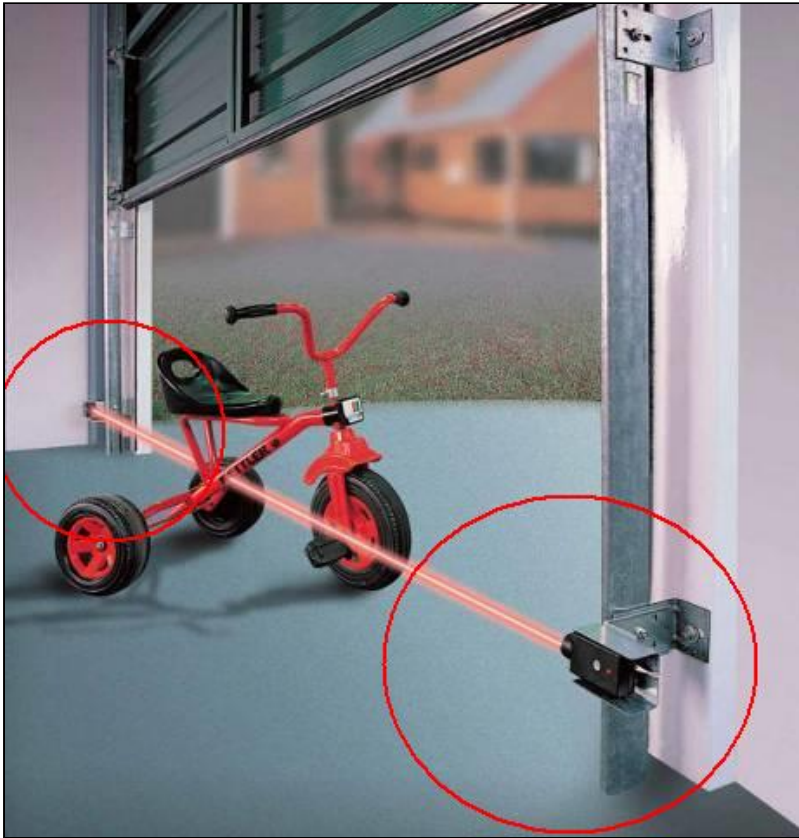
3.3 Item 1 (Picture) Example

The right side garage door did not have the required infrared safety reversing sensor present on the bottom of the door tracks. These sensors prevent the garage door from closing on an object if it is in front of the sensors and are a backup to the automatic reversing mechanism that is present in the garage door opener. **This is a safety concern and this door should not be operated without the required safety reversing sensors in place.** A further evaluation of the garage door, opener and safety features **should be completed by a qualified, licensed garage door professional** and the necessary repairs should be completed.

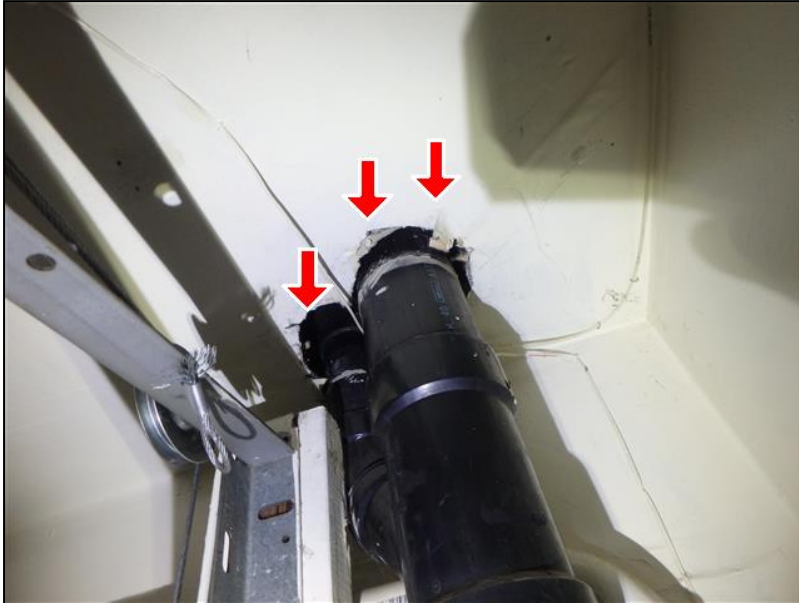
3.9 Item 1 (Picture)

Portions of the walls and/or ceiling surfaces in the garage had numerous cracks, gaps, unsealed joints, deteriorated/damaged areas, holes and/or missing sections. The garage space should be 100% sealed off to the living space to prevent possible carbon monoxide from a vehicle from entering the living space above and also from a fire block standpoint. These noted conditions may worsen if the needed repairs are not completed. Recommend further evaluation by a qualified, licensed contractor and repair as necessary..

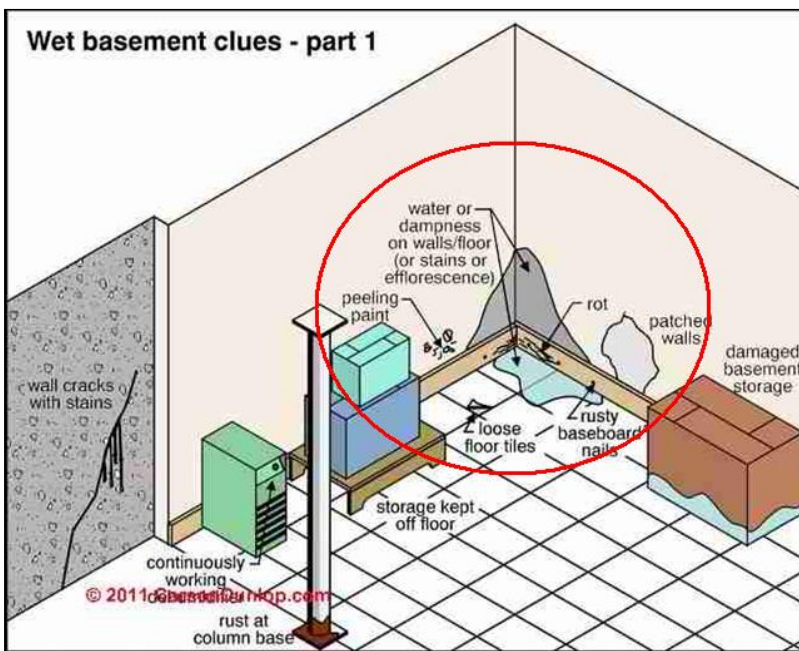
4.0 Item 1 (Picture)

(1) As observed in some of the visible portions of the foundation in the basement, there was evidence of moisture intrusion (efflorescence, staining, peeling paint and/or mortar decay) observed on the foundation walls. Moisture can create high humidity, mold & can damage stored items & finishing materials. There may be some drainage and/or grading issues on the exterior that are contributing to these condition(s). The noted conditions may worsen any needed repairs are not completed. A further evaluation of the entire foundation (both interior and exterior) should be completed by a qualified, licensed masonry contractor and the necessary repairs be completed. **This condition may also exist behind finished basement walls/floor coverings. It may be less severe or worse than what was visible.**

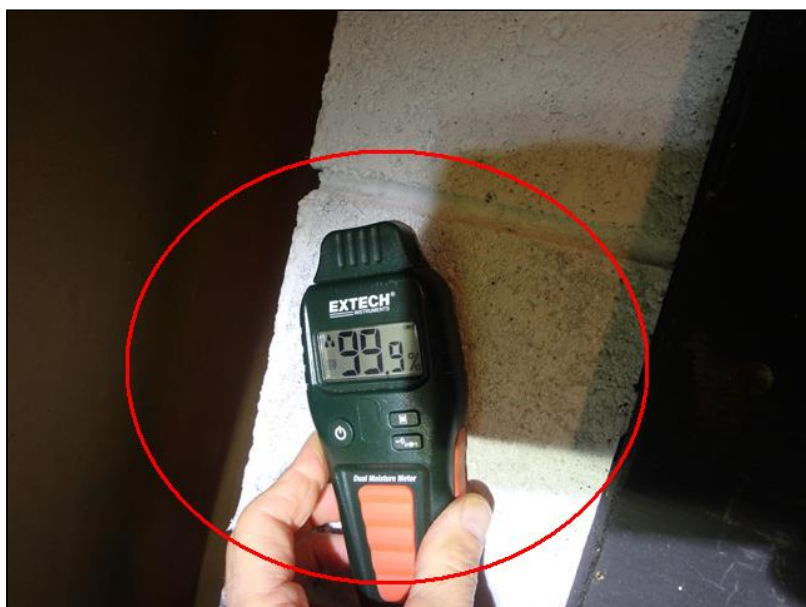
4.0 Item 10 (Picture) 99% moisture content on some of the foundation walls

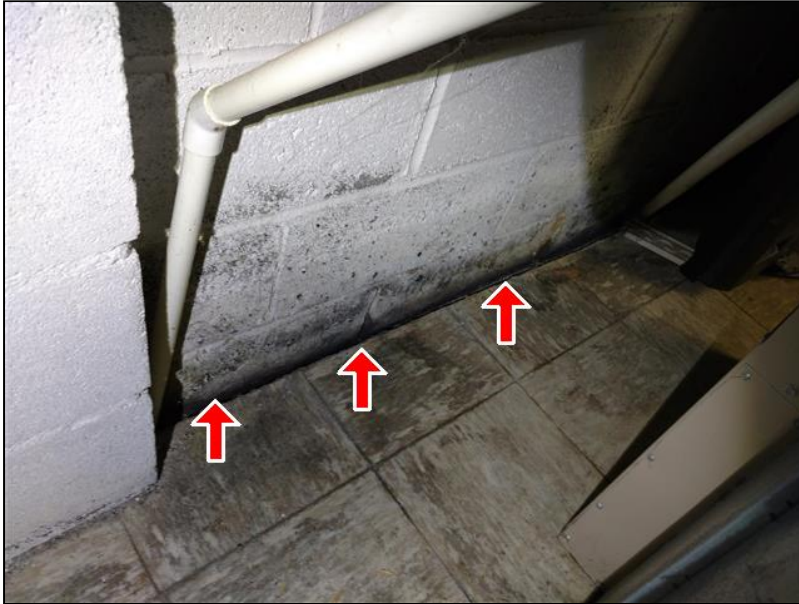
4.0 Item 13 (Picture)

(2) There was what appeared to be a black organic growth condition (possibly mold) on the visible portions of the foundation walls and finished wall structure in the basement. This is a potential health concern as molds have the potential to cause numerous health problems. Molds produce allergens (substances that can cause allergic reactions), irritants, and in some cases, potentially toxic substances (mycotoxins). Inhaling or touching mold or molds spores may

cause allergic reactions in sensitive individuals. These conditions may also worsen if any needed repairs are not completed. **A further evaluation/testing of the ENTIRE basement should be completed by a qualified, licensed environmental contractor and any necessary repairs/remediations be completed.** Additional information from the US EPA pertaining to mold in the home can be review at <http://www.epa.gov/mold/moldbasics.html> **This condition may also exist behind finished basement walls/floor coverings. There may be hidden damage. It may be less severe or worse than what was visible.** Also to note, the walls inside the closet that houses the sump pump were covered with fiberglass reinforced plastic (FRP) panels. This is not typical as finished wall are usually covered with drywall. They may have done this because the drywall may have been getting mold on it because of the high moisture within this closet.

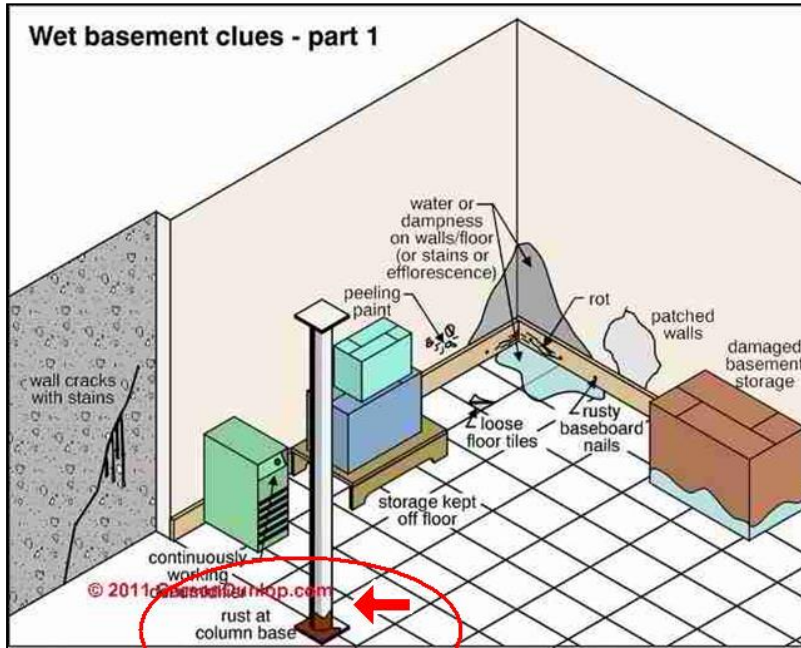
4.1 Item 1 (Picture)

As observed in the garage, one of the steel lally support columns appeared to have numerous rust stains/scabs/cracks towards the bottom of it. This condition is usually caused by moisture that is moving up from the garage floor and through the cement that inside the steel lally column due to capillary action. The inside of the column then rusts out and holes develop. These little scabs then start to allow moisture to weep out and run down the sides of the column. Over time a few things couple happen as a result of this condition. First the column may rust more at the base. The metal can rust out so much the column compresses on itself and may drop a little. This in turn may cause the structure above to drop a little. This may cause minor hairline cracks in the walls, ceiling and/or floor surfaces above. Sometimes the steel column may also split apart. Further deterioration of this column as well as structural damage and/or damage to the finishing materials could occur if the needed repairs are not completed. Recommend further evaluation by a qualified, licensed structural contractor and repair/replace as necessary.

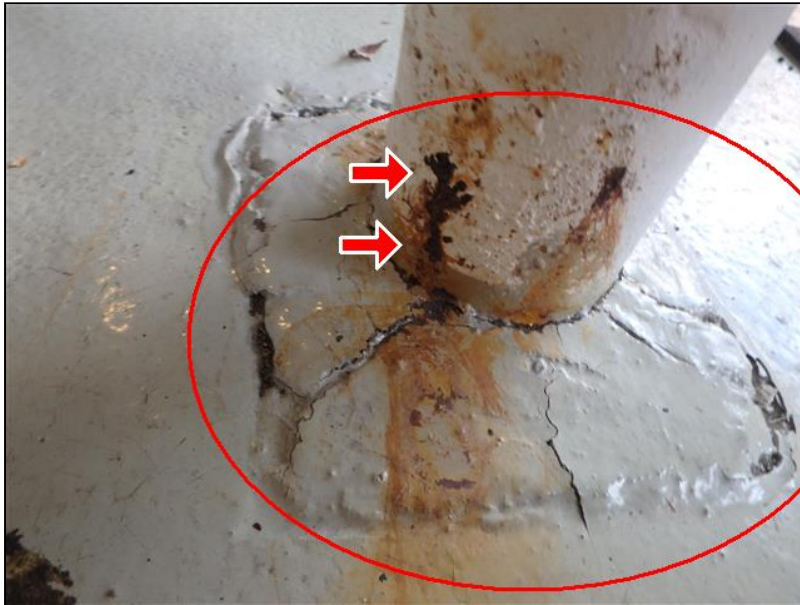
4.1 Item 2 (Picture) Cracked

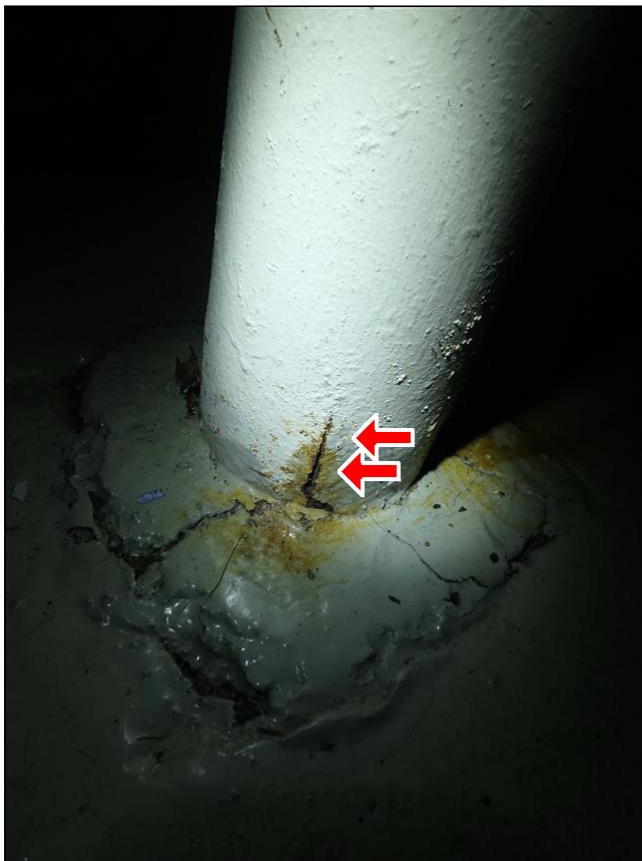
4.1 Item 4 (Picture) Cracked

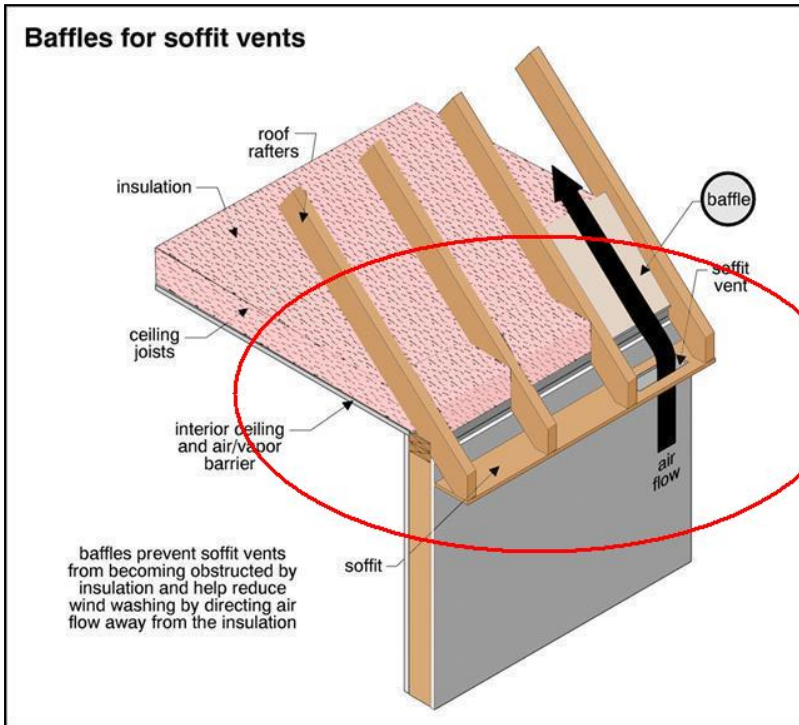
As observed in the attic space, the soffit vents appeared to be blocked with insulation. Recommend adding soffit vent baffles in the attic to avoid premature aging of roof decking/covering and help to maintain proper humidity and temperature control within the attic space. The venting in the attic space currently may not be adequate without the soffit vents being cleared and open for air flow.

6.3 Item 2 (Picture) Example of venting

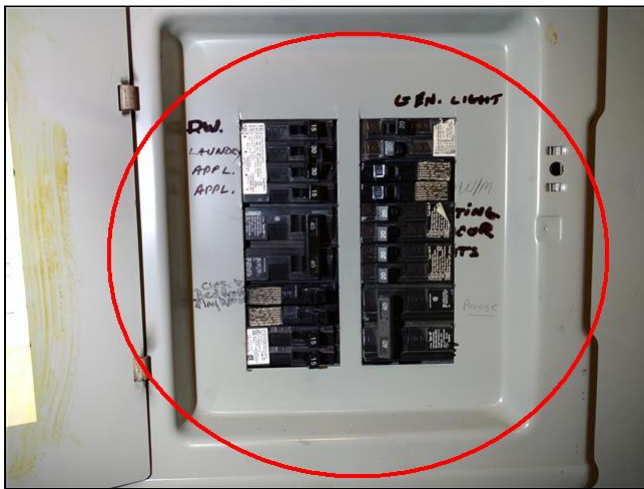
7.4 Item 1 (Picture)

(1) As observed in the electric sub panel, the circuit breaker wiring legend appeared to be in-complete, illegible and/or inaccurate. This legend should be clearly marked identifying which circuit breaker shuts off which particular wiring circuit running throughout the house. This information is needed in case of an emergency or anytime individual circuits need to be turned off. It is recommend a qualified, licensed electrician verify each circuit and label accordingly.

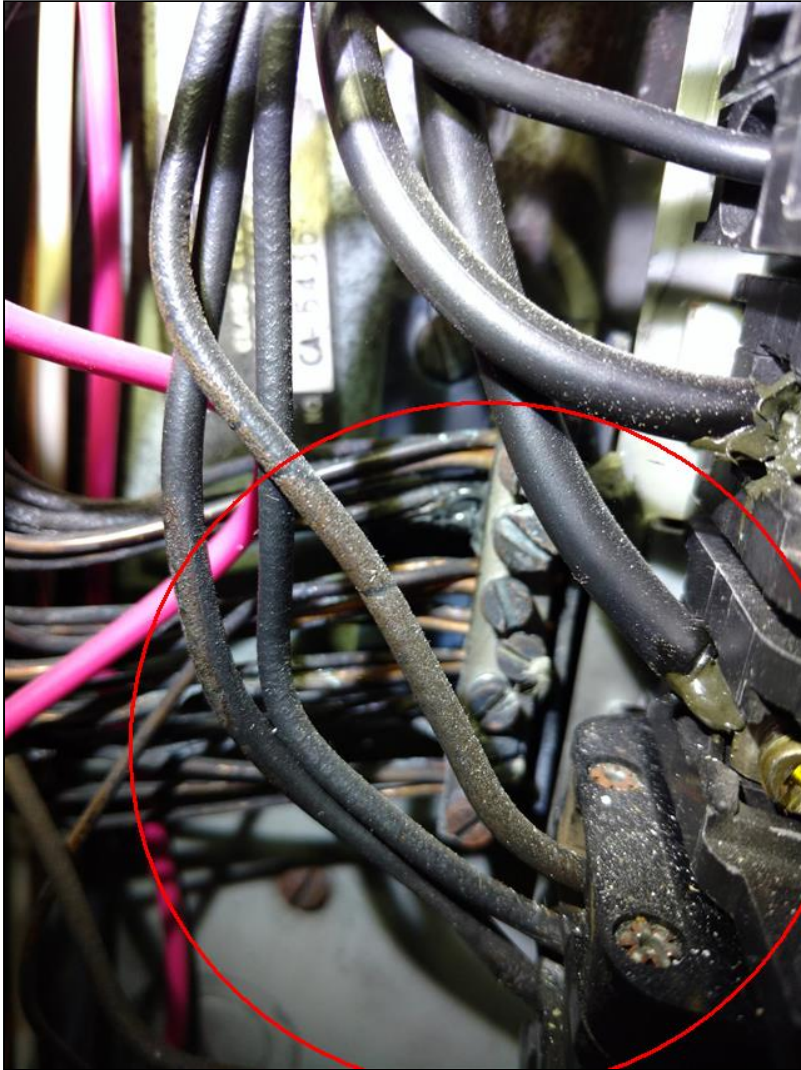
7.4 Item 4 (Picture)

(3) As observed in the sub panel in the basement, there appeared to have been a small fire inside the panel as the internal components were burnt and scorched. **This is a MAJOR SAFTY CONCERN and MAJOR FIRE HAZARD and should be repaired/replaced IMMEDIATELY.** The internal components may have been damaged as a result and there may be future fires within this panel. **Based on these and all of the electric related defects present, a further evaluation of the ENTIRE electric sub panel in the basement and the main electric service panel, main disconnect circuit breaker and the electric meter (which are on the exterior) should be completed IMMEDIATELY by a qualified, licensed electrician and the necessary repairs/replacements completed. The homeowner should be notified of this condition and the need for repairs/replacement immediately.**

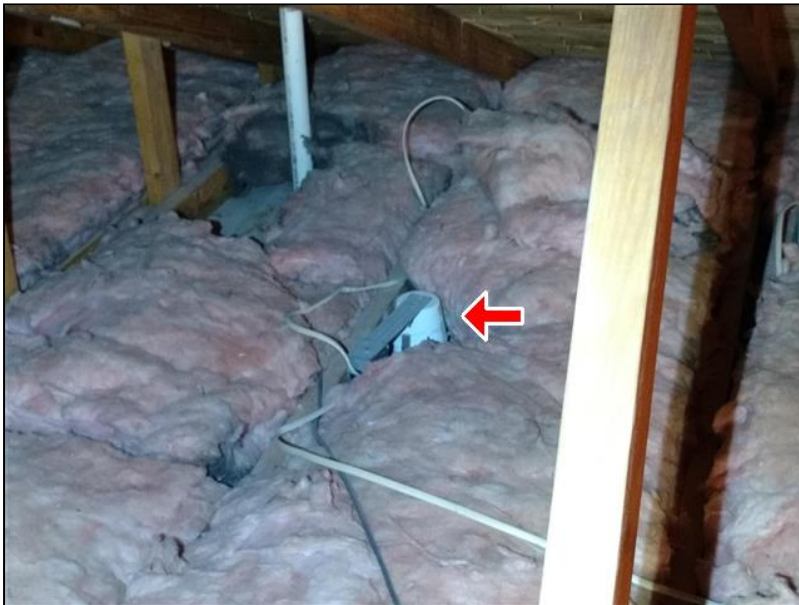
7.8 Item 14 (Picture)

(3) As observed in the attic space, there was at least one of the 2nd floor recessed light housings were covered and/or touching the insulation that was in the floor joist bays. These lights should not be installed with insulation within 3 inches of fixture sides or wiring compartment nor above fixture in such manner to entrap heat. This is a major fire and safety issue. Recommend moving all of the insulation away from the housings as required. **There may be additional light fixtures that were not visible and covered with insulation. ALL of the recessed light housings in the attic should be checked.**

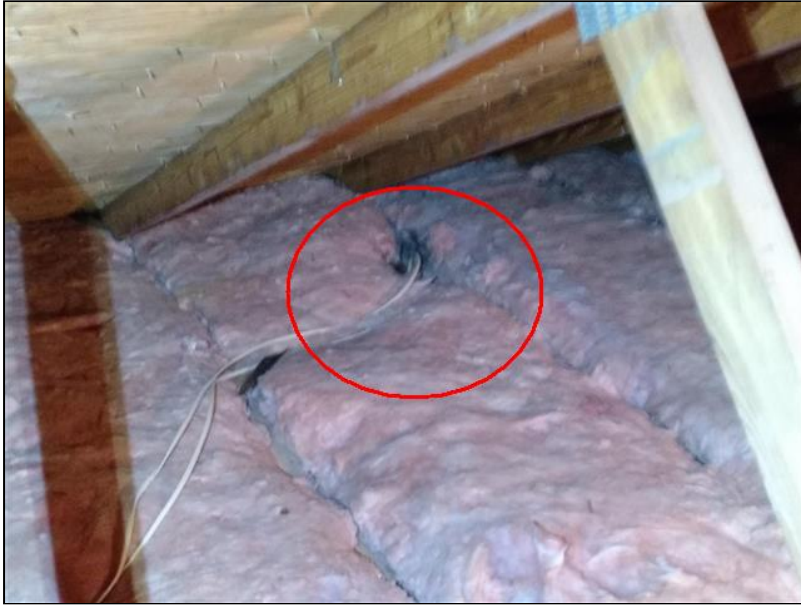
7.8 Item 16 (Picture) Light under there?

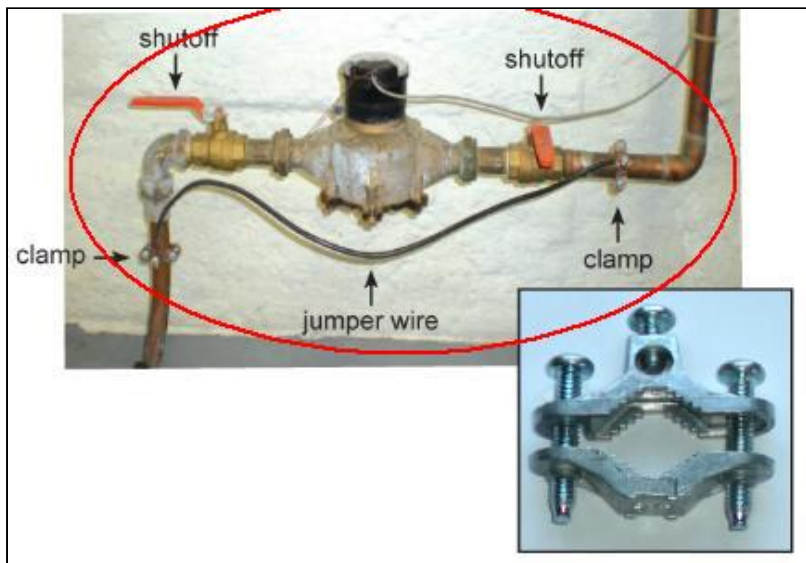
8.0 Item 1 (Picture) Example

bonded water pipe, the current would have such a good path back to the main panel that it would overload the circuit breaker and the breaker would quickly trip. In other words, it protects against electric shocks. Recommend further evaluation for repairs by a qualified, licensed plumber.

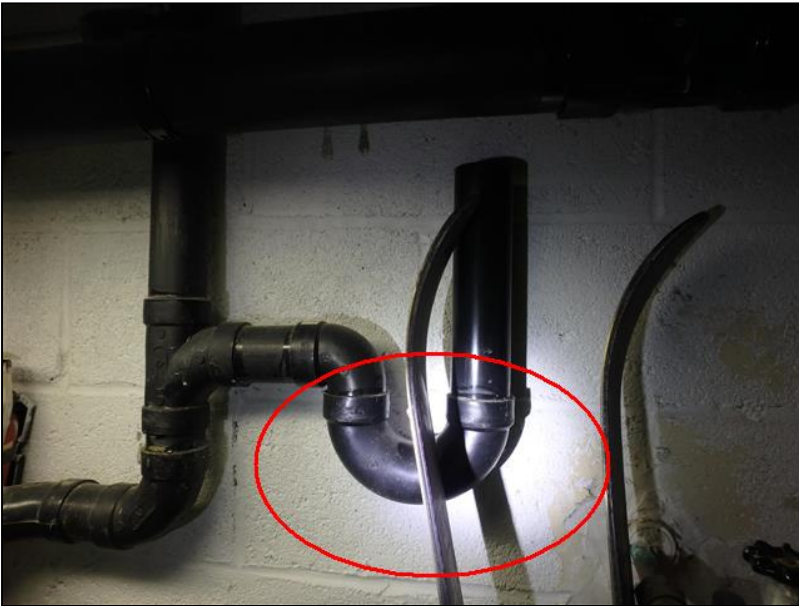
(2) As observed in the basement, there was an open DWV (drain, waste, vent) pipe observed. This is a concern as sewer gases could possibly escape from this opening. Recommend further evaluation by a qualified, licensed plumber and repair/cap pipe as needed.

8.2 Item 2 (Picture) P-trap is probably dry/no water in it

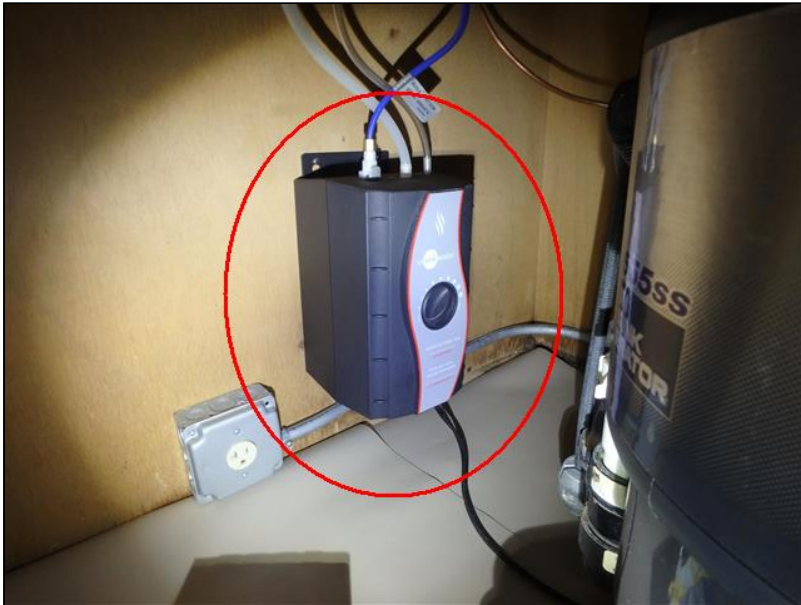
8.3 Item 1 (Picture)

Present at the kitchen sink is an Insinkerator instant hot water dispenser. This unit was unplugged and therefore could not be tested to see if it makes hot water. Also to note, this dispenser is a potential safety concern as the hot water coming out of this dispenser could be as hot as 185 degrees Fahrenheit. This is a safety concern as the water coming out of this dispenser may instantly cause scalding if someone were to attempt to wash their hands with this water or come into contact with this water for any reason. This dispenser should be plugged in and tested.

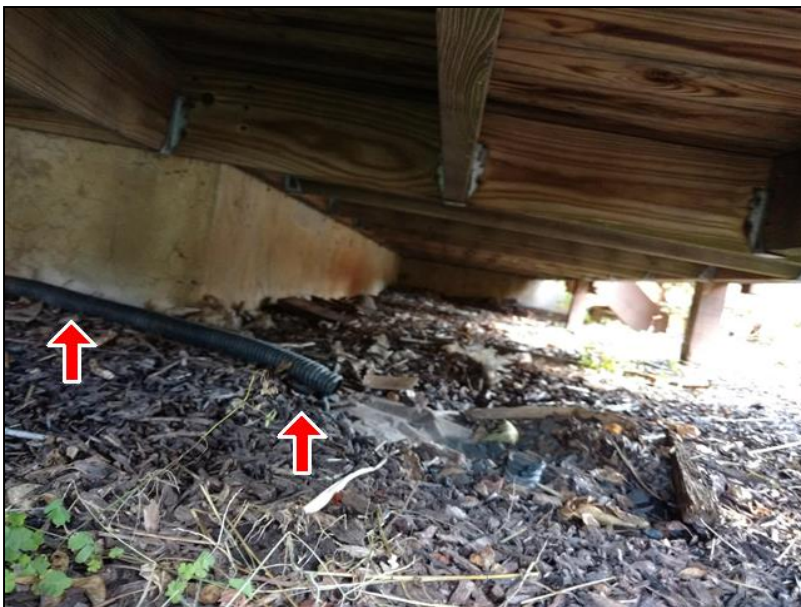
8.5 Item 1 (Picture)

The sump pump drain for the sump pump located in the basement should be extended out at least 6ft from the foundation wall (or as far out as possible). Currently, the discharge piping is discharging the water onto the ground next to the foundation wall. Thus, the water could be seeping down and going into the foundation wall and possibly migrate back into the basement. Recommend further evaluation by a qualified, licensed plumber and repair as necessary.

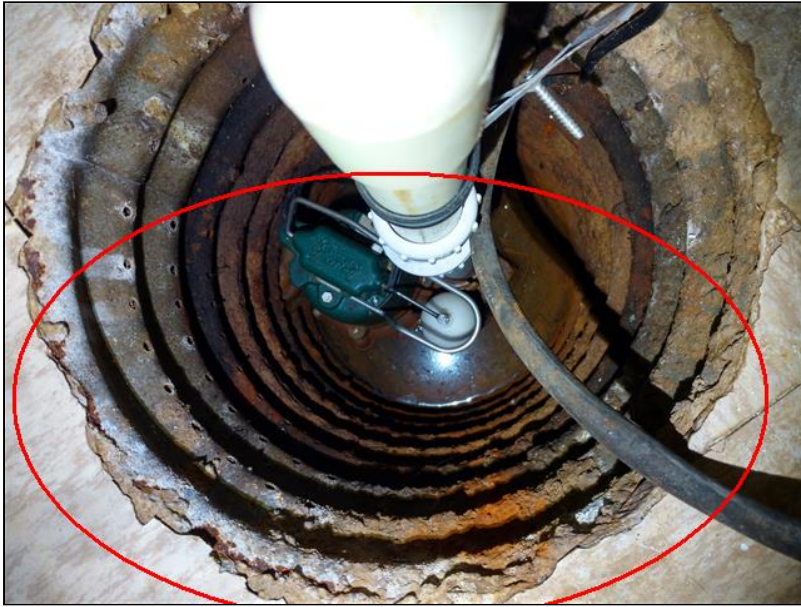
8.6 Item 1 (Picture)

(1) As observed in basement, the sump pump pit/metal basket was severely deteriorated and was in need of replacement by a qualified, licensed plumber. This condition may worsen if the needed repairs are not completed. The current condition of the basket may let dirt/stone debris into the pit which may damage the sump pump.

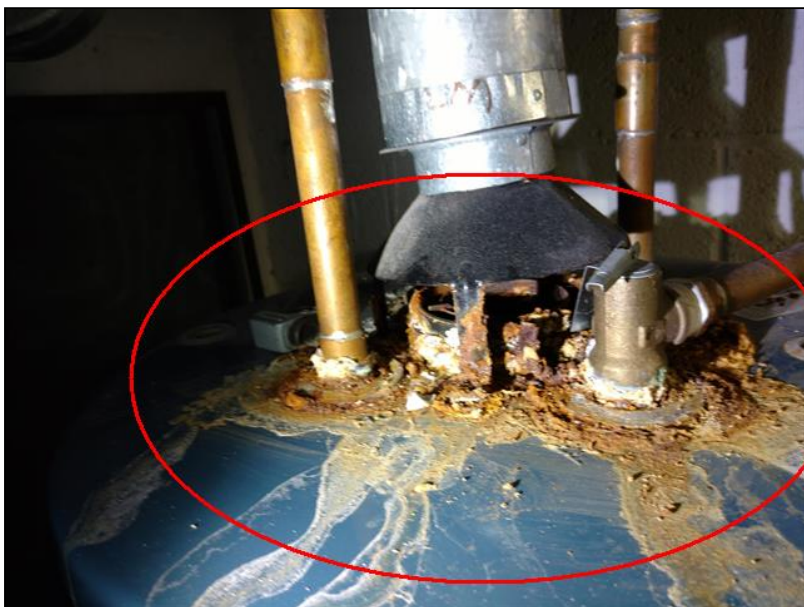
9.1 Item 1 (Picture)

The top of the water heater was severely deteriorated as it appears to be a MAJOR venting issue resulting in the water heater back drafting. **Based on the severity of the deterioration, this is a MAJOR SAFETY CONCERN as combustion by products (carbon dioxide, carbon monoxide and nitrogen oxide) may be entering the dwelling instead of being properly vented out of the dwelling. The bottom of the water heater was also rusted/deteriorated. These conditions may worsen as well as possible flooding of the basement if the necessary replacement is not completed. The water heater should be replaced IMMEDIATELY by a qualified, licensed plumber. The homeowner should be notified of this condition and the need for a replacement.**

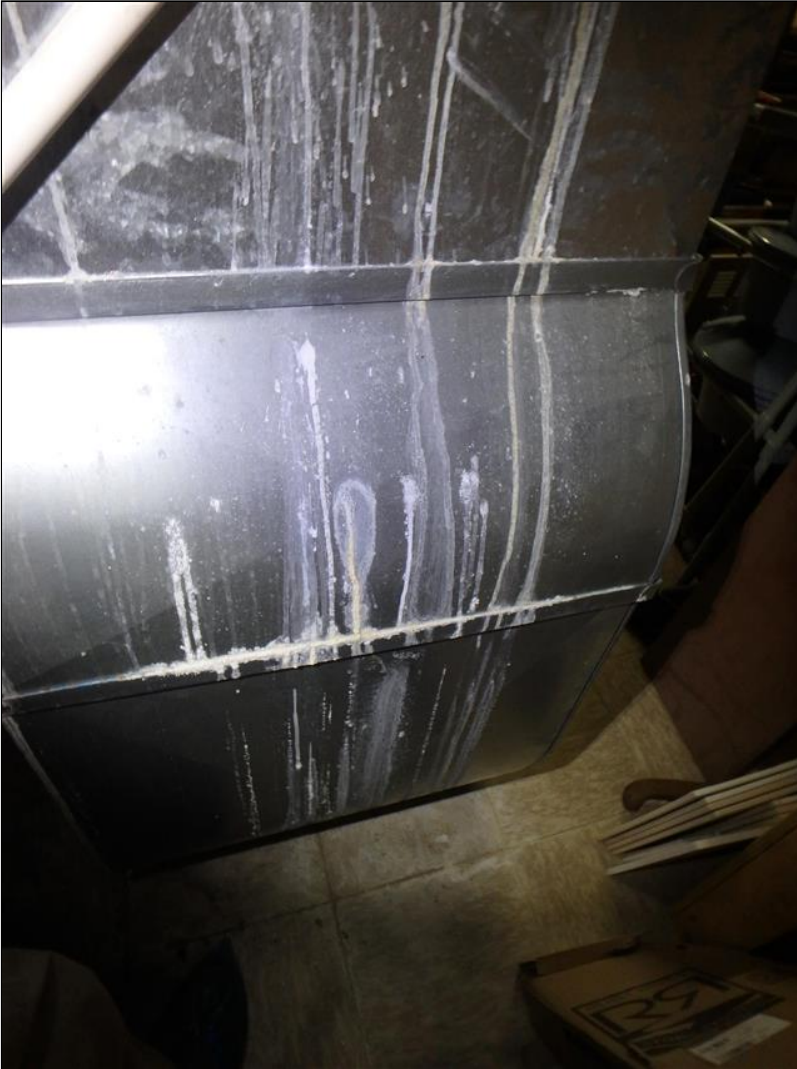
10.1 Item 1 (Picture)

(1) The humidifier pad/filter in the built in humidifier on the side of the furnace was severely deteriorated and is in need of replacement. There was a heavy mineral buildup on the pad/filter. This may effect the performance of the humidifier is the pad/filter is not changed. Also to note, there was a large amount of staining present on the ducting below the unit. The humidifier should not be used until the necessary repairs are completed by a qualified, licensed HVAC professional.

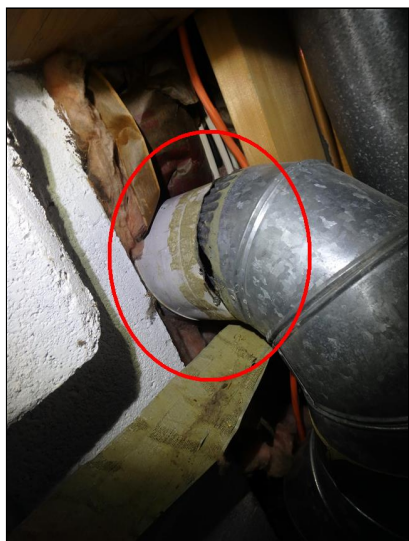
10.1 Item 5 (Picture)

(2) As observed in the basement utility room, there was an HVAC supply air duct that was semi-disconnected. This condition if not repaired, will have an affect on the air flow in the room where this duct is running to. Also, there were debris in the duct in the kitchen in front of the refrigerator. This should be cleaned out. Recommend further evaluation by a qualified, licensed contractor and repair as necessary.

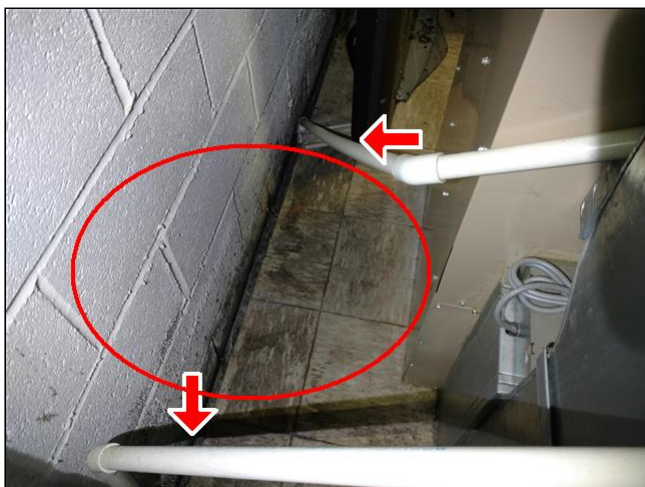
11.0 Item 3 (Picture)

(3) The main condensate drain pipe for the central air conditioning system was draining the condensate (water) it produces into the gap in between the basement floor slab and the masonry foundation wall. The humidifier was also draining into this gap. These are not good arrangements as the condensate may cause the earth under the basement concrete floor to undermine which may cause damage to the basement floor. **It may also cause an excessive amount of unwanted moisture in the basement and possible moisture damage to the foundation walls.** There was a suspect mold condition on the foundation walls in this area. A condensate pump should be installed next to the HVAC unit and the condensate will then be pumped by the condensate pump into the DWV system or to the exterior. Recommend further evaluation by a qualified, licensed HVAC professional and repair as necessary.

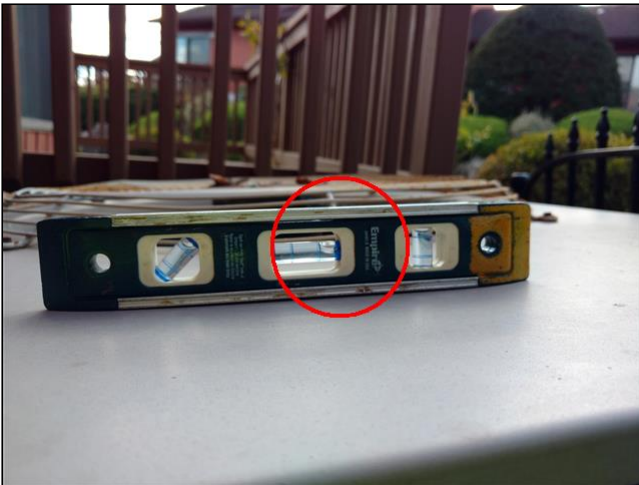
11.0 Item 6 (Picture)

(4) The central air conditioning system exterior condenser unit was out of level. Being out of level may cause the components inside to fail prematurely and may also prohibit the air conditioning system from functioning properly. Recommend further evaluation by a qualified, licensed plumber and repair as necessary.

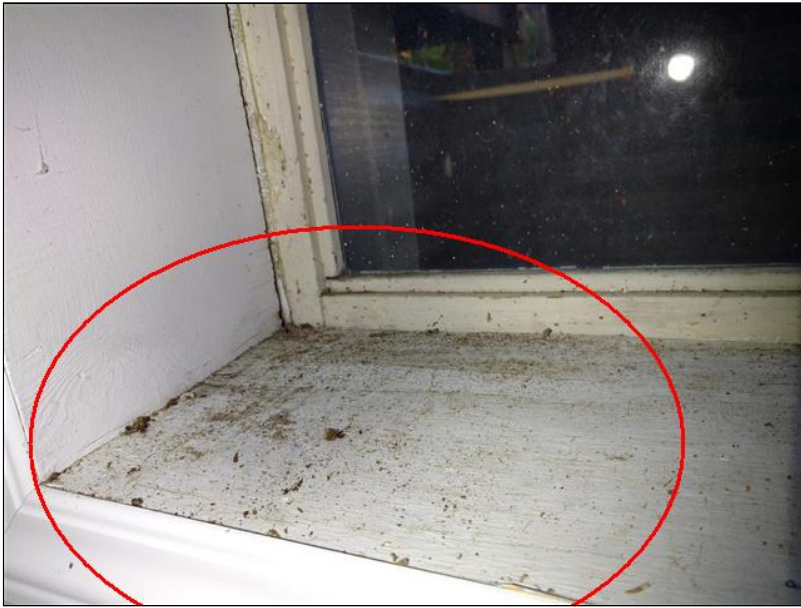
12.2 Item 11 (Picture) Moisture damaged basement window which doesn't open

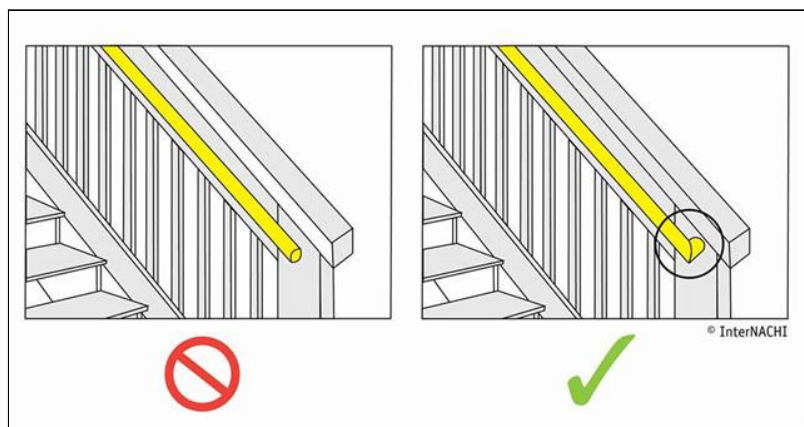
12.5 Item 1 (Picture)

(1) The handrail(s) did not have the required returns at the ends to the wall which is a safety concern. The ends of the handrail may catch on loose fitting clothing, purses, bags, jewelery, etc. and could contribute to personal injury. Recommend further evaluation by a qualified, licensed contractor and repair as necessary. Also to note, the baluster spacing was greater than the 4" that is permitted. This is another safety concern.

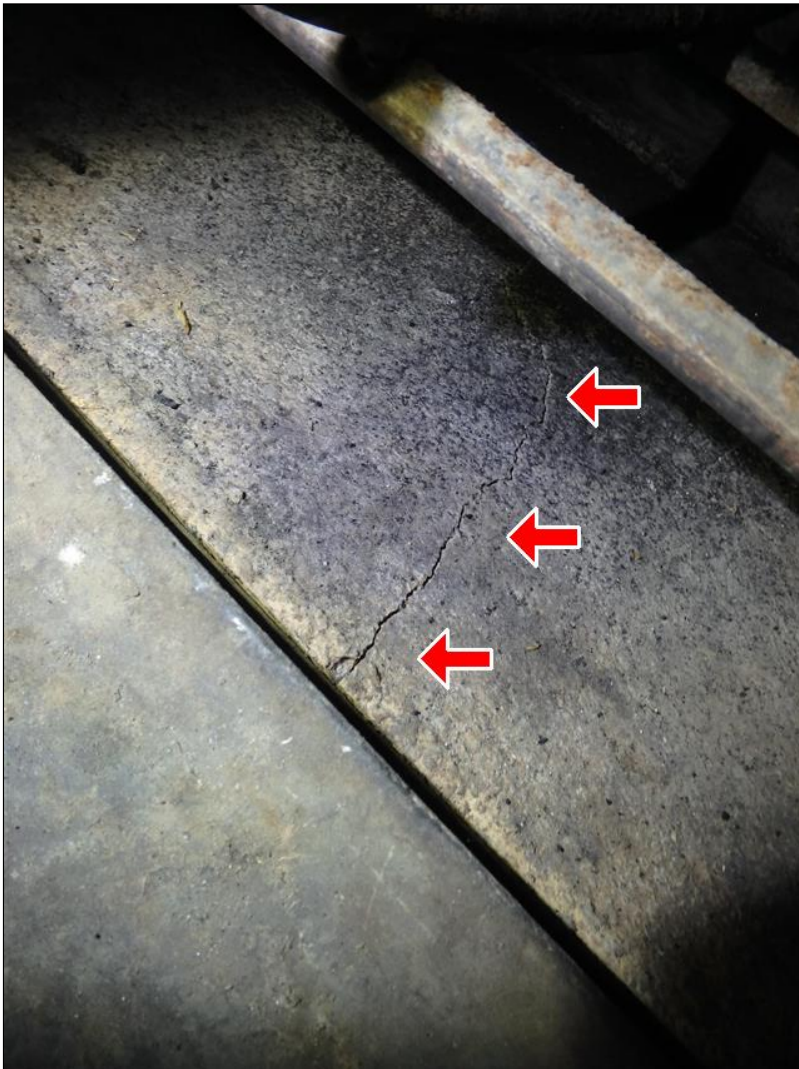
12.8 Item 1 (Picture)

(2) As observed in the wood burning fireplace, the bottom insert refractory panel had a crack in it. This is a safety concern as this panel keeps the fire inside the firebox. Recommend further evaluation by a qualified, licensed fireplace professional and repair as necessary. As a precaution, the fireplace should not be used until the necessary repairs are completed and a level 2 chimney inspection is completed.

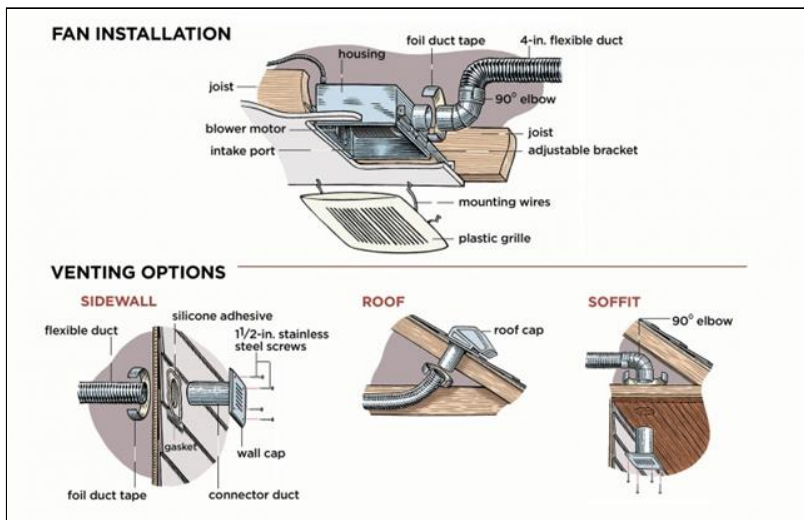
13.1 Item 2 (Picture)

The exhaust fan for the master bathroom was venting into the attic space. This condition may cause a buildup of moisture and mold in the attic. This exhaust fan should be venting to the exterior. Recommend directing the vent towards the exterior to allow for proper ventilation to be performed by a qualified, licensed contractor. Also to note, the venting of the main level bathroom exhaust fan is suspect. There was no visible termination point on the exterior for this exhaust fan. So, it is suspected that the exhaust fan may be venting into the ceiling space above the bathroom. This venting should be terminated outdoors and may cause moisture damage/a mold condition to the surrounding structure if the needed repairs are not completed. This fan should also be further evaluation by a qualified, licensed contractor and repaired if necessary.

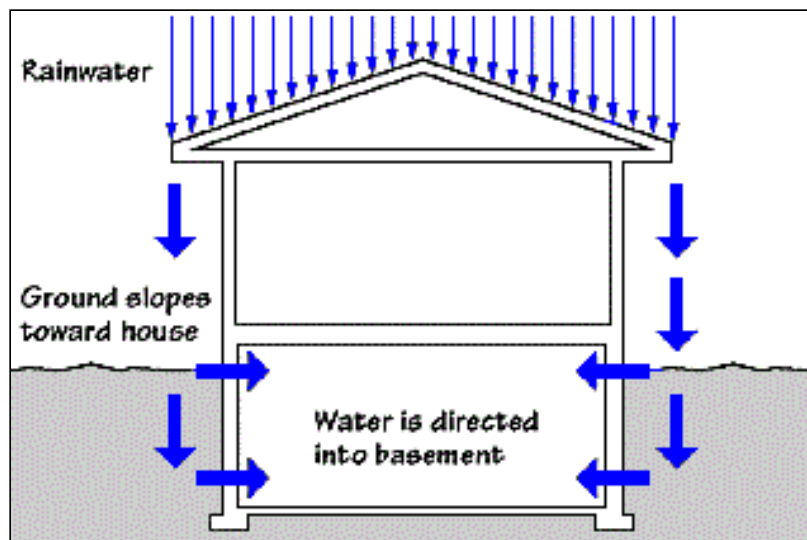
1.2 Item 1 (Picture)

intrusion from entering the foundation walls and basement. Recommend further evaluation of all of the exterior grading by a qualified, licensed contractor and repair as necessary.

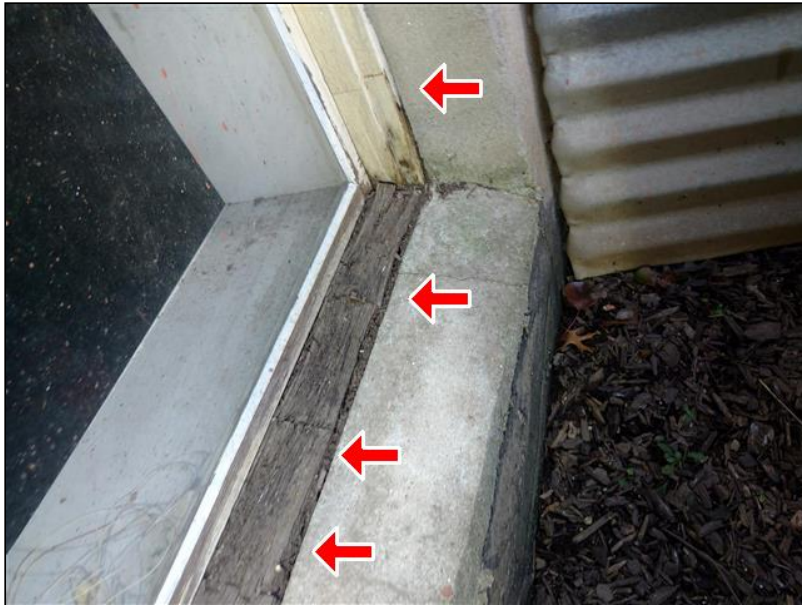
2.0 Item 14 (Picture) Basement window frame deteriorated

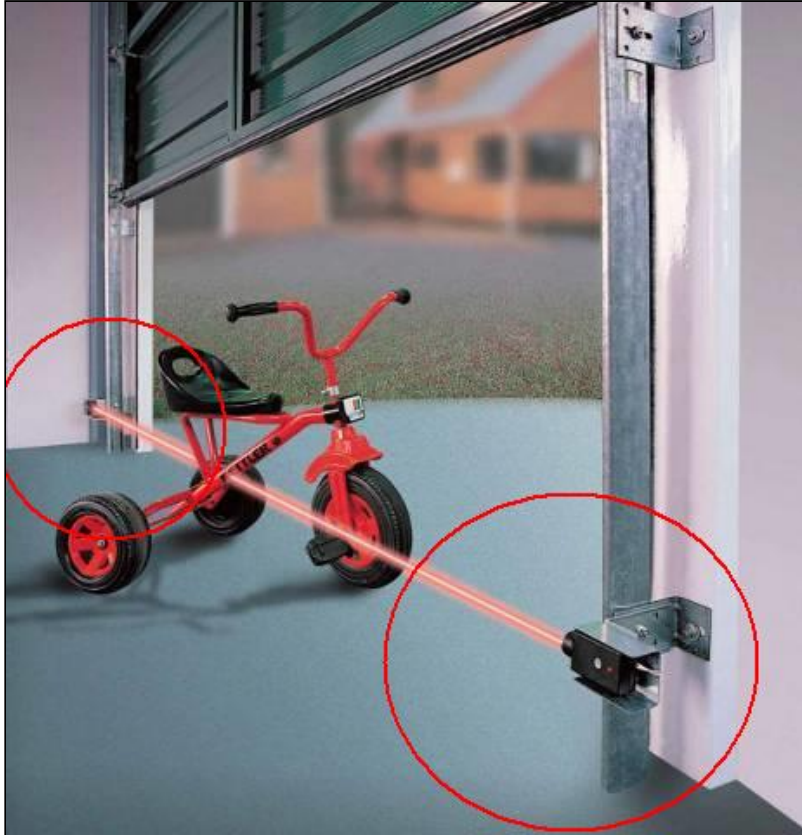
3.3 Item 1 (Picture) Example

The right side garage door did not have the required infrared safety reversing sensor present on the bottom of the door tracks. These sensors prevent the garage door from closing on an object if it is in front of the sensors and are a backup to the automatic reversing mechanism that is present in the garage door opener. **This is a safety concern and this door should not be operated without the required safety reversing sensors in place.** A further evaluation of the garage door, opener and safety features **should be completed by a qualified, licensed garage door professional** and the necessary repairs should be completed.

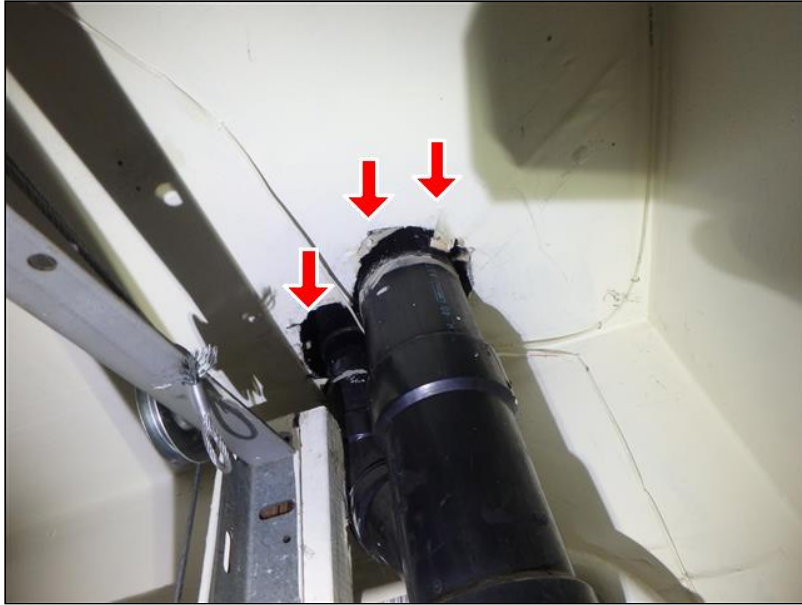
3.9 Item 1 (Picture)

standpoint. These noted conditions may worsen if the needed repairs are not completed. Recommend further evaluation by a qualified, licensed contractor and repair as necessary..

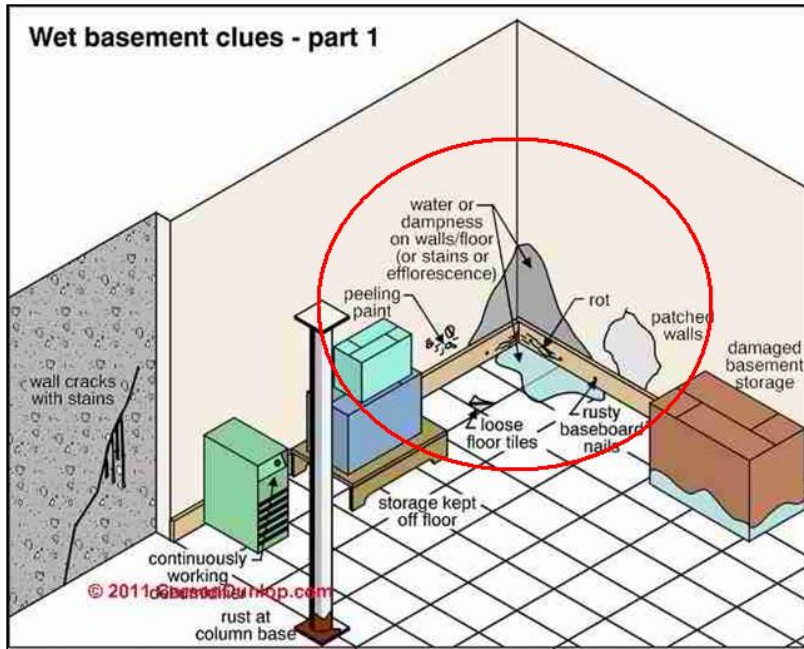
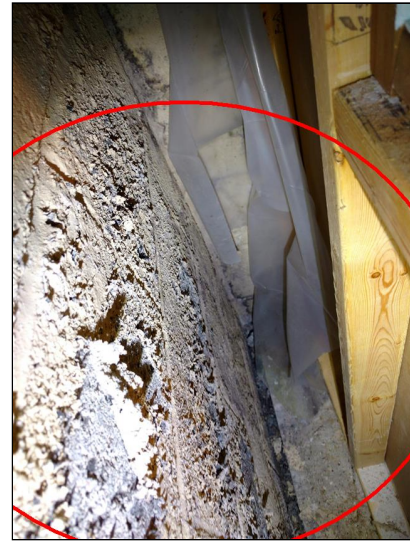
4.0 Item 2 (Picture)

(1) As observed in some of the visible portions of the foundation in the basement, there was evidence of moisture intrusion (efflorescence, staining, peeling paint and/or mortar decay) observed on the foundation walls. Moisture can create high humidity, mold & can damage stored items & finishing materials. There may be some drainage and/or grading issues on the exterior that are contributing to these condition(s). The noted conditions may worsen any needed repairs are not completed. A further evaluation of the entire foundation (both interior and exterior) should be completed by a qualified, licensed masonry contractor and the necessary repairs be completed. **This condition may also exist behind finished basement walls/floor coverings. It may be less severe or worse than what was visible.**

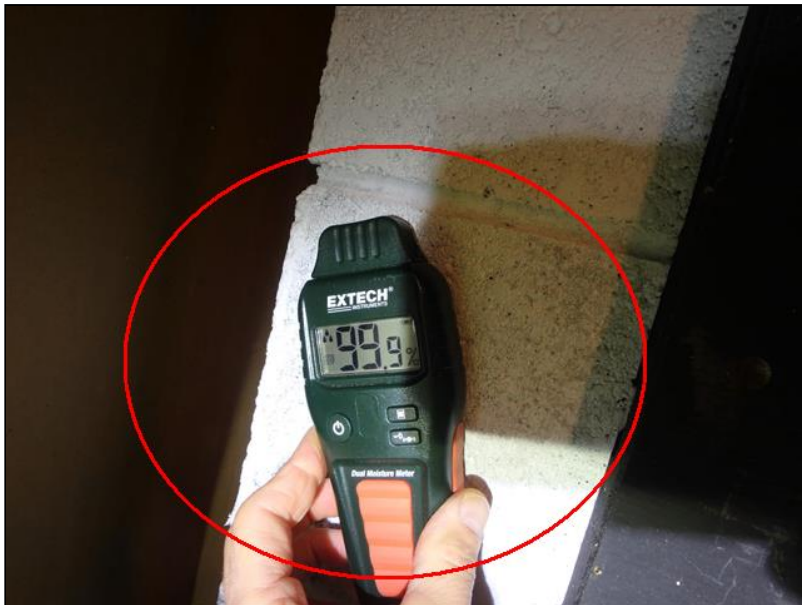
4.0 Item 10 (Picture) 99% moisture content on some of the foundation walls
