# Property Inspection Report

123 Main Street

Unit T1

**Terra Home Inspections LLC**

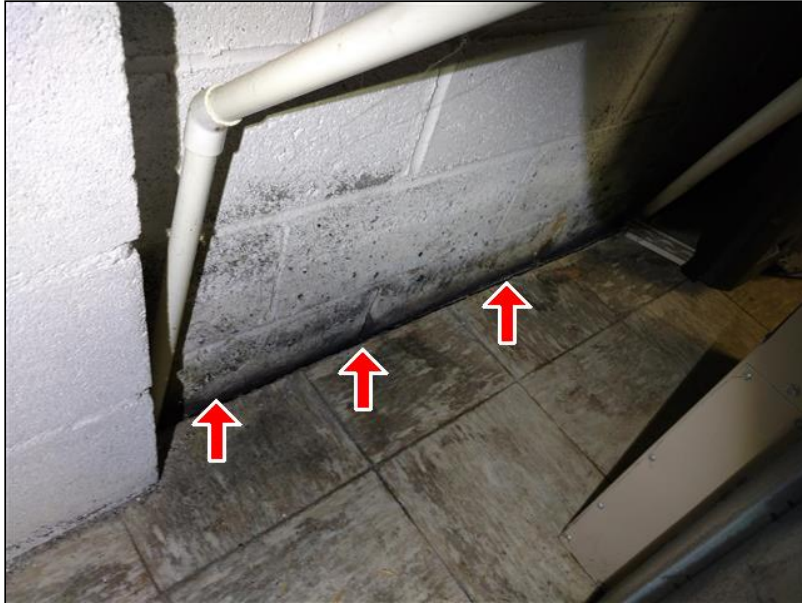
4.0 Item 13 (Picture)

repairs are not completed. **A further evaluation/testing of the ENTIRE basement should be completed by a qualified, licensed environmental contractor and any necessary repairs/remediations be completed.** Additional information from the US EPA pertaining to mold in the home can be review at <http://www.epa.gov/mold/moldbasics.html> **This condition may also exist behind finished basement walls/floor coverings. There may be hidden damage. It may be less severe or worse than what was visible.** Also to note, the walls inside the closet that houses the sump pump were covered with fiberglass reinforced plastic (FRP) panels. This is not typical as finished wall are usually covered with drywall. They may have done this because the drywall may have been getting mold on it because of the high moisture within this closet.

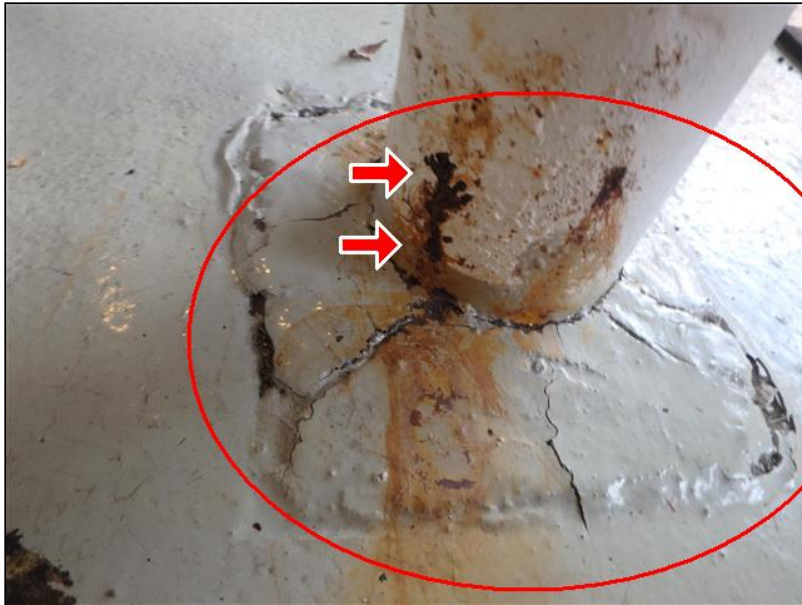
4.1 Item 2 (Picture) Cracked

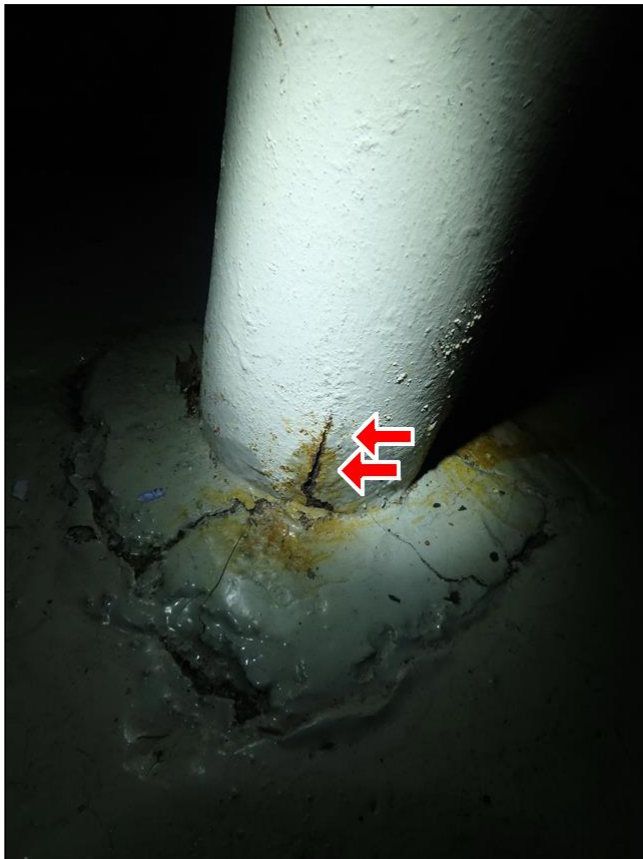
4.1 Item 4 (Picture) Cracked

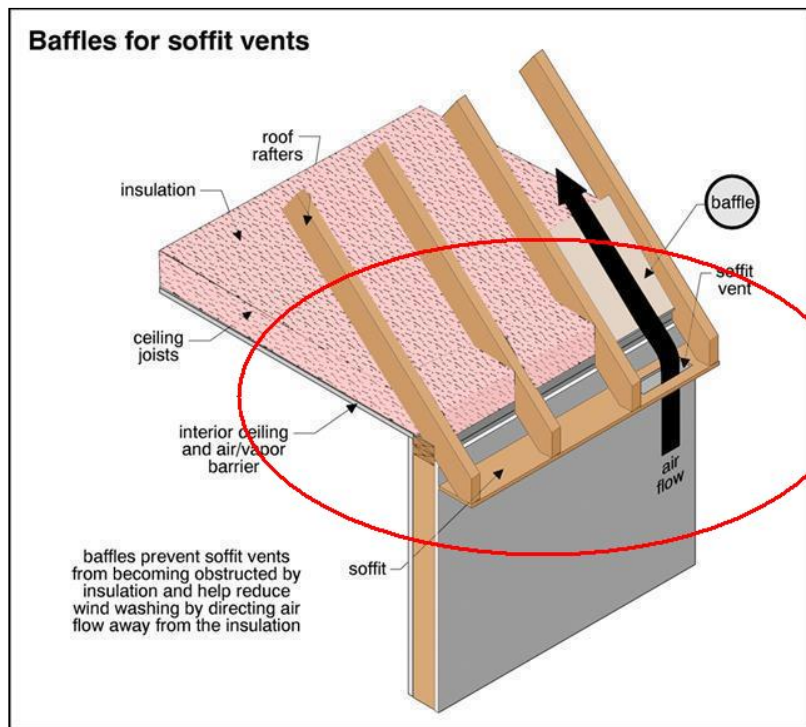
As observed in the attic space, the soffit vents appeared to be blocked with insulation. Recommend adding soffit vent baffles in the attic to avoid premature aging of roof decking/covering and help to maintain proper humidity and temperature control within the attic space. The venting in the attic space currently may not be adequate without the soffit vents being cleared and open for air flow.

6.3 Item 1 (Picture) Example of venting

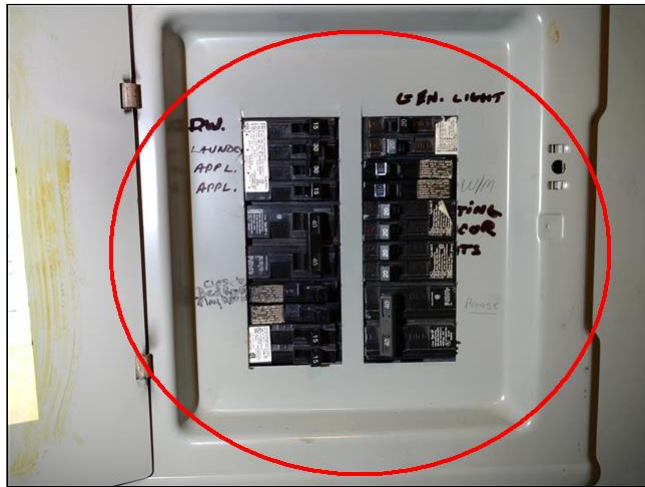
7.4 Item 1 (Picture)

(1) As observed in the electric sub panel, the circuit breaker wiring legend appeared to be in-complete, illegible and/ or inaccurate. This legend should be clearly marked identifying which circuit breaker shuts off which particular wiring circuit running throughout the house. This information is needed in case of an emergency or anytime individual circuits need to be turned off. It is recommend a qualified, licensed electrician verify each circuit and label accordingly.

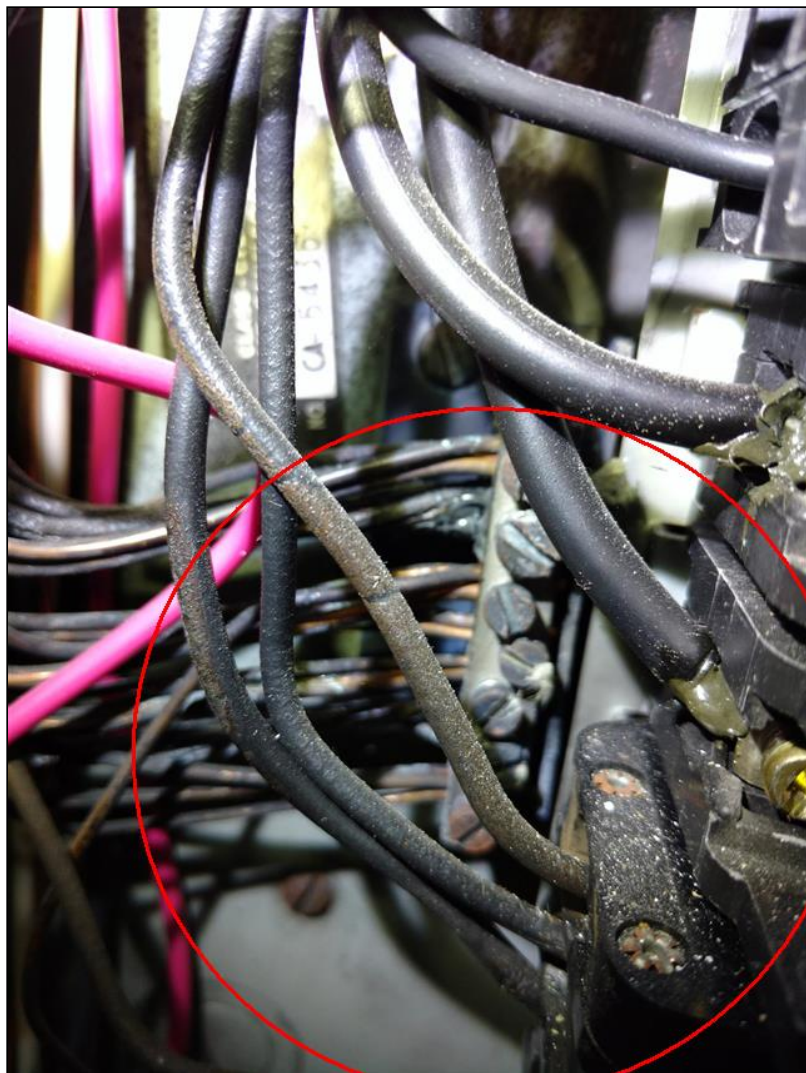
7.4 Item 4 (Picture)

(3) As observed in the sub panel in the basement, there appeared to have been a small fire inside the panel as the internal components were burnt and scorched. **This is a MAJOR SAFETY CONCERN and MAJOR FIRE HAZARD and should be repaired/replaced IMMEDIATELY.** The internal components may have been damaged as a result and there may be future fires within this panel. **Based on these and all of the electric related defects present, a further evaluation of the ENTIRE electric sub panel in the basement and the main electric service panel, main disconnect circuit breaker and the electric meter (which are on the exterior) should be completed IMMEDIATELY by a qualified, licensed electrician and the necessary repairs/replacements completed. The homeowner should be notified of this condition and the need for repairs/replacement immediately.**

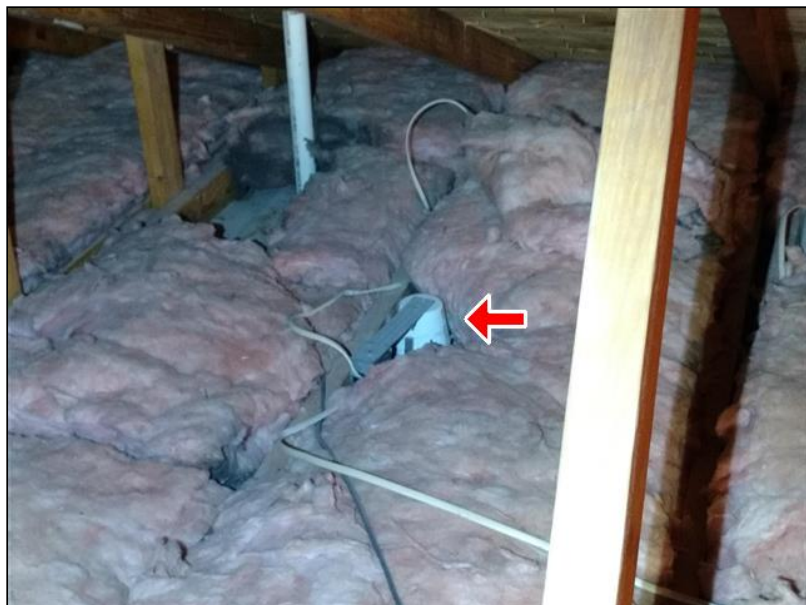
7.8 Item 14 (Picture)

(3) As observed in the attic space, there was at least one of the 2nd floor recessed light housings were covered and/or touching the insulation that was in the floor joist bays. These lights should not be installed with insulation within 3 inches of fixture sides or wiring compartment nor above fixture in such manner to entrap heat. This is a major fire and safety issue. Recommend moving all of the insulation away from the housings as required. **There may be additional light fixtures that were not visible and covered with insulation. ALL of the recessed light housings in the attic should be checked.**

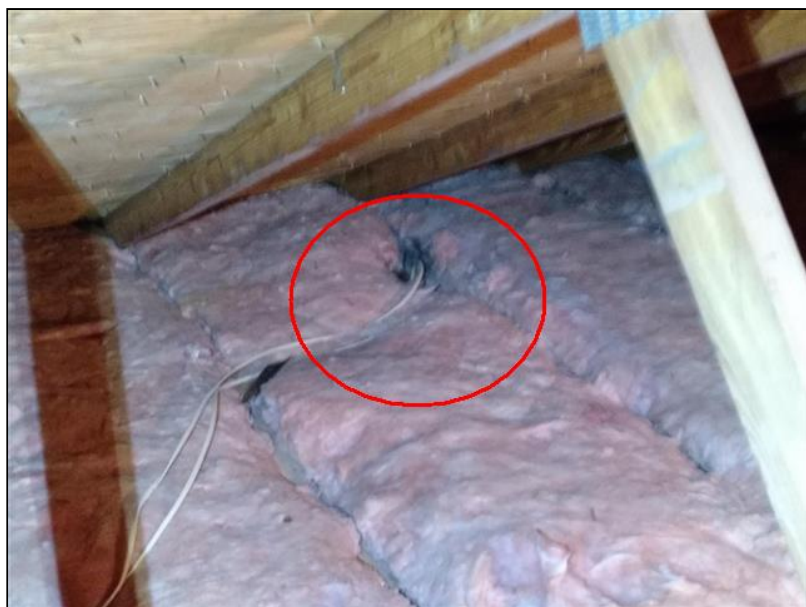
7.8 Item 16 (Picture) Light under there?

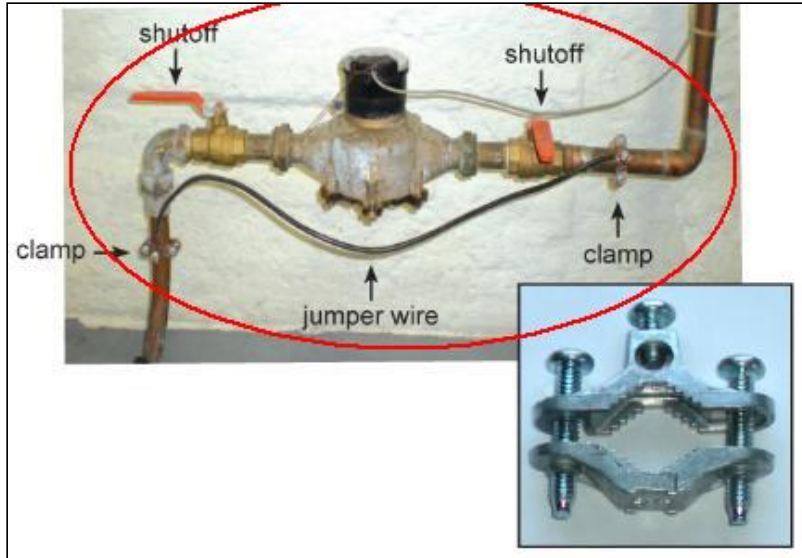
8.0 Item 1 (Picture) Example

(1) The water meter was missing a bonding wire. A bonding wire is used to electrically bond the water distribution pipes throughout the house. Part of the reason that the water distribution piping in the home gets bonded is to make sure the pipes can't accidentally become energized. If an ungrounded (aka hot) conductor came in contact with a properly bonded water pipe, the current would have such a good path back to the main panel that it would overload the circuit breaker and the breaker would quickly trip. In other words, it protects against electric shocks. Recommend further evaluation for repairs by a qualified, licensed plumber.

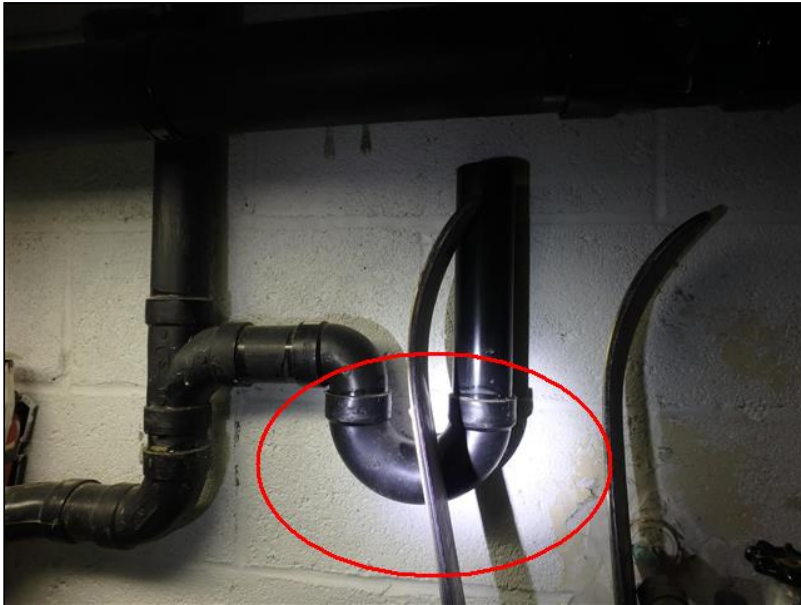
(2) As observed in the basement, there was an open DWV (drain, waste, vent) pipe observed. This is a concern as sewer gases could possibly escape from this opening. Recommend further evaluation by a qualified, licensed plumber and repair/cap pipe as needed.

8.2 Item 2 (Picture) P-trap is probably dry/no water in it

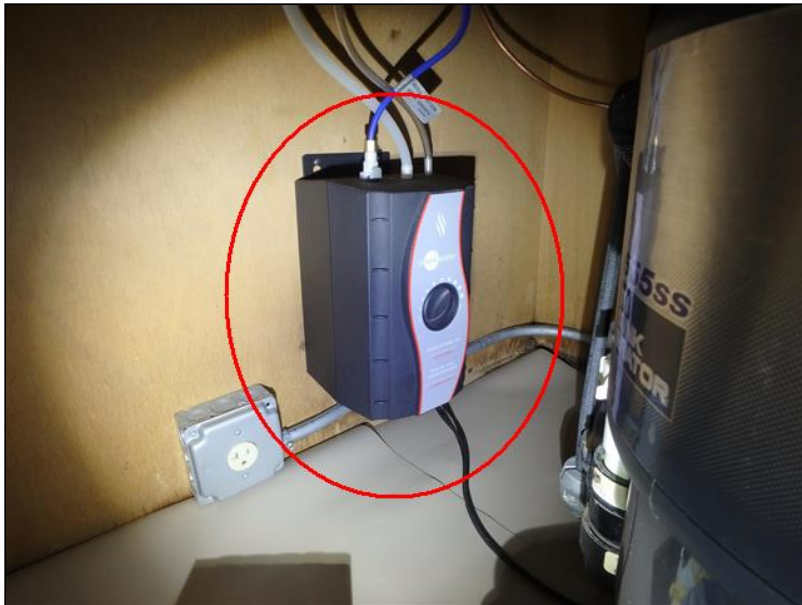
8.3 Item 1 (Picture)

water coming out of this dispenser may instantly cause scalding if someone were to attempt to wash their hands with this water or come into contact with this water for any reason. This dispenser should be plugged in and tested.

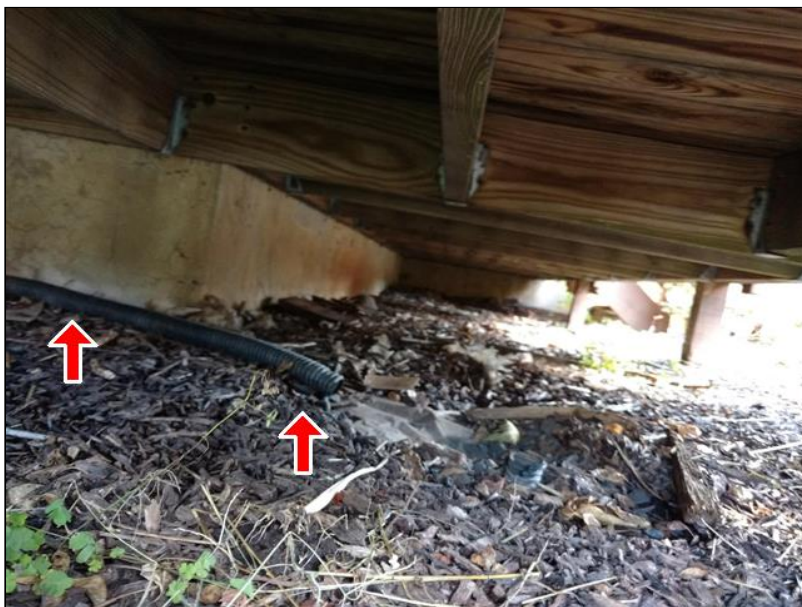
8.5 Item 1 (Picture)

The sump pump drain for the sump pump located in the basement should be extended out at least 6ft from the foundation wall (or as far out as possible). Currently, the discharge piping is discharging the water onto the ground next to the foundation wall. Thus, the water could be seeping down and going into the foundation wall and possibly migrate back into the basement. Recommend further evaluation by a qualified, licensed plumber and repair as necessary.

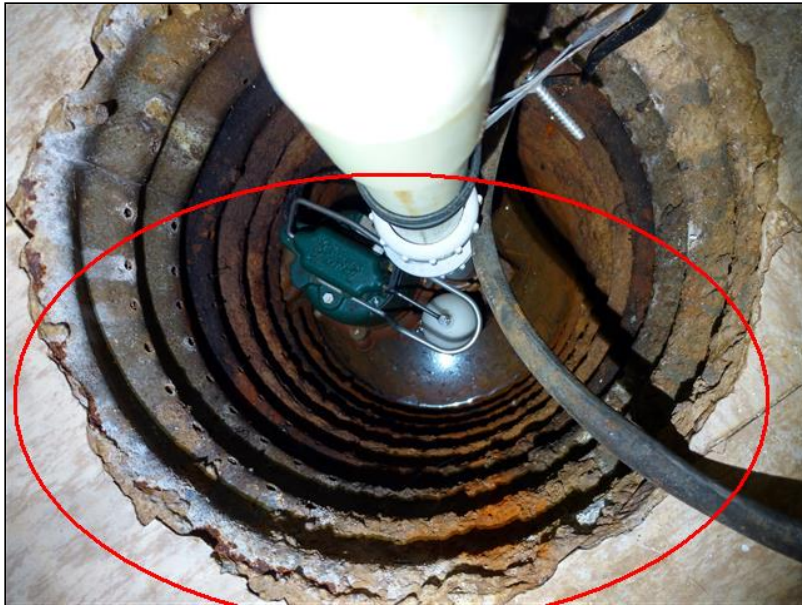
8.6 Item 1 (Picture)

(1) As observed in basement, the sump pump pit/metal basket was severely deteriorated and was in need of replacement by a qualified, licensed plumber. This condition may worsen if the needed repairs are not completed. The current condition of the basket may let dirt/stone debris into the pit which may damage the sump pump.

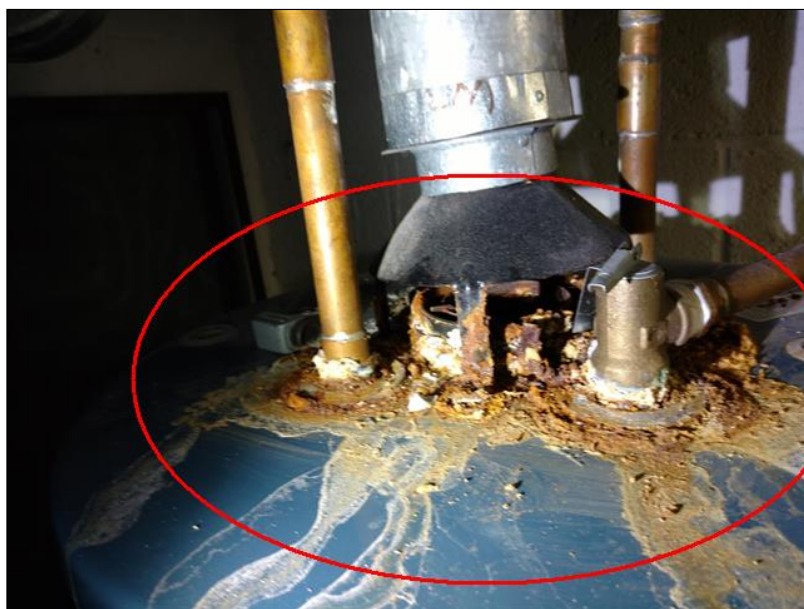
9.1 Item 1 (Picture)

The top of the water heater was severely deteriorated as it appears to be a MAJOR venting issue resulting in the water heater back drafting. **Based on the severity of the deterioration, this is a MAJOR SAFETY CONCERN as combustion by products (carbon dioxide, carbon monoxide and nitrogen oxide) may be entering the dwelling instead of being properly vented out of the dwelling.** The bottom of the water heater was also rusted/deteriorated. These conditions may worsen as well as possible flooding of the basement if the necessary replacement is not completed. **The water heater should be replaced IMMEDIATELY by a qualified, licensed plumber. The homeowner should be notified of this condition and the need for a replacement.**

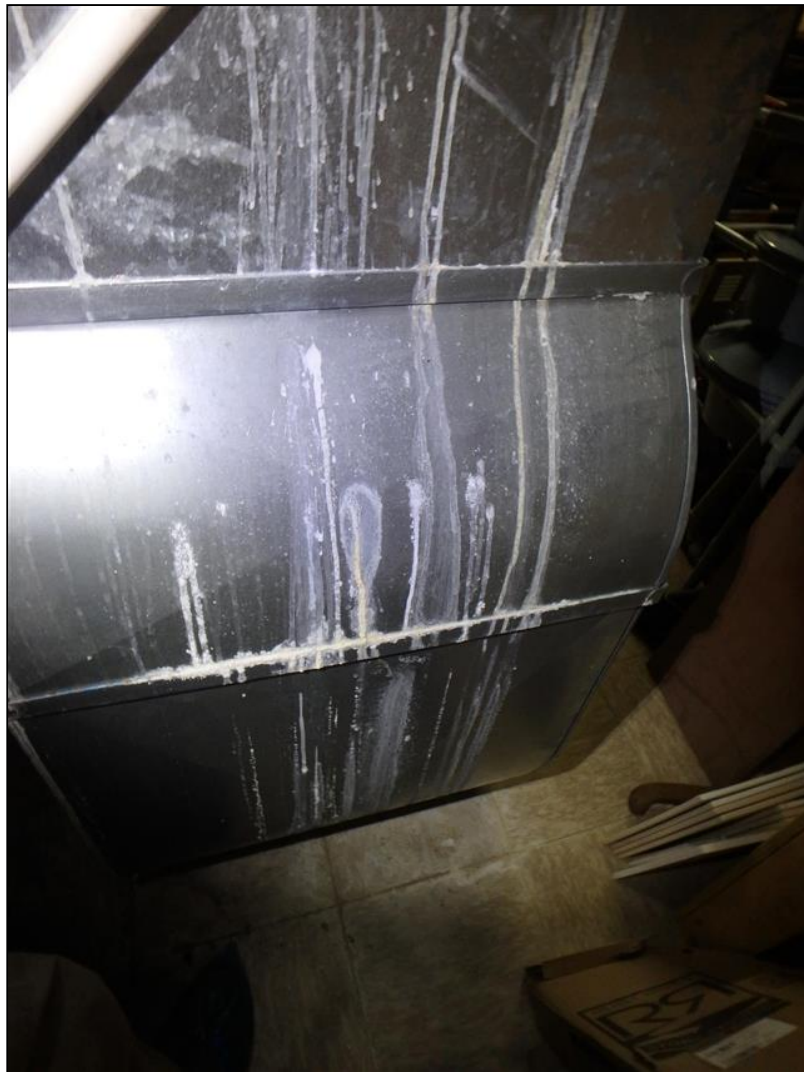
10.1 Item 1 (Picture)

(1) The humidifier pad/filter in the built in humidifier on the side of the furnace was severely deteriorated and is in need of replacement. There was a heavy mineral buildup on the pad/filter. This may effect the performance of the humidifier is the pad/filter is not changed. Also to note, there was a large amount of staining present on the ducting below the unit. The humidifier should not be used until the necessary repairs are completed by a qualified, licensed HVAC professional.

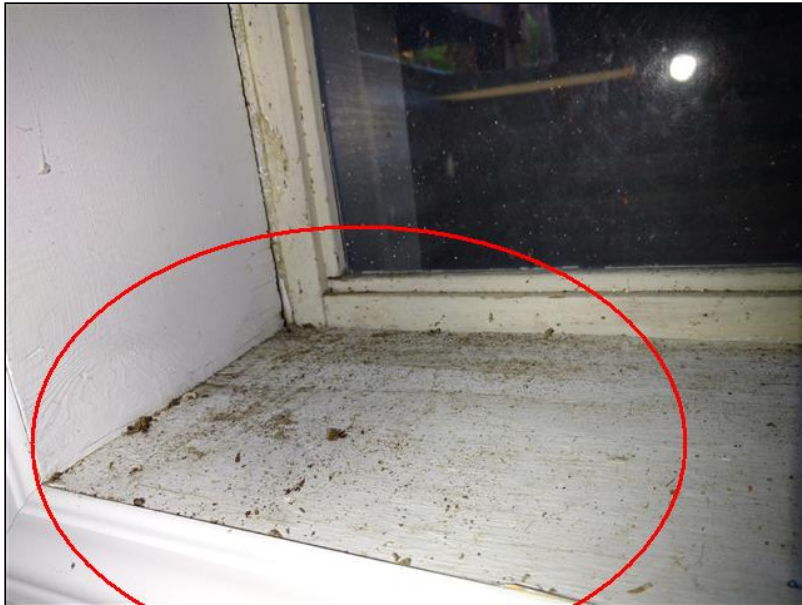
12.2 Item 11 (Picture) Moisture damaged basement window which doesn't open
