ROOF AJAR - DIC

By Ed Borland - 1/2014

ROOF AJAR TEST

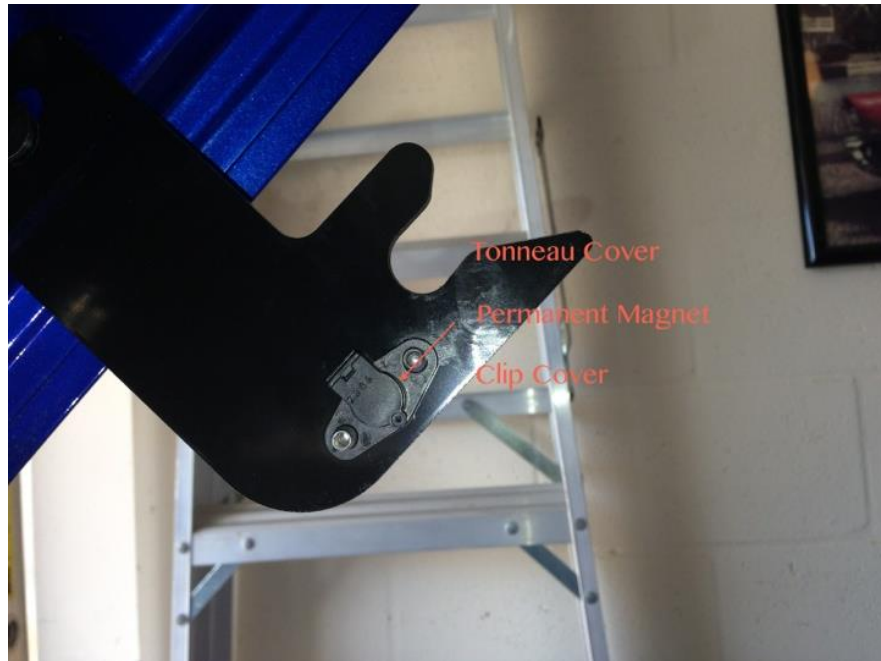
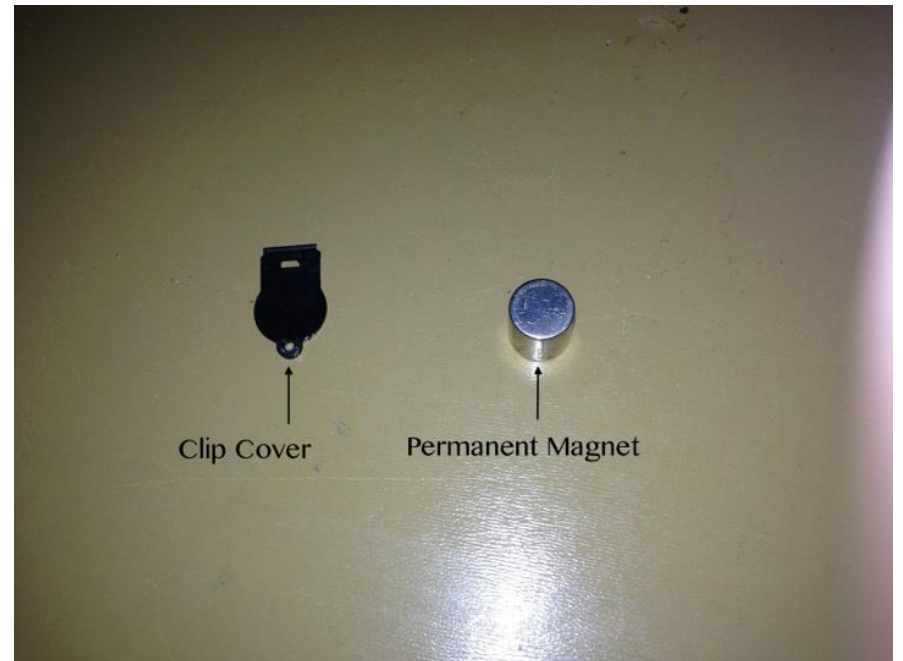
Test 4 Set Up

Removed the Tonneau latch assembly
“Hall Effect Switch” permanent magnet
from the drivers side.

Tonneau latch HES magnet removed

Got the “Roof Ajar” DIC.

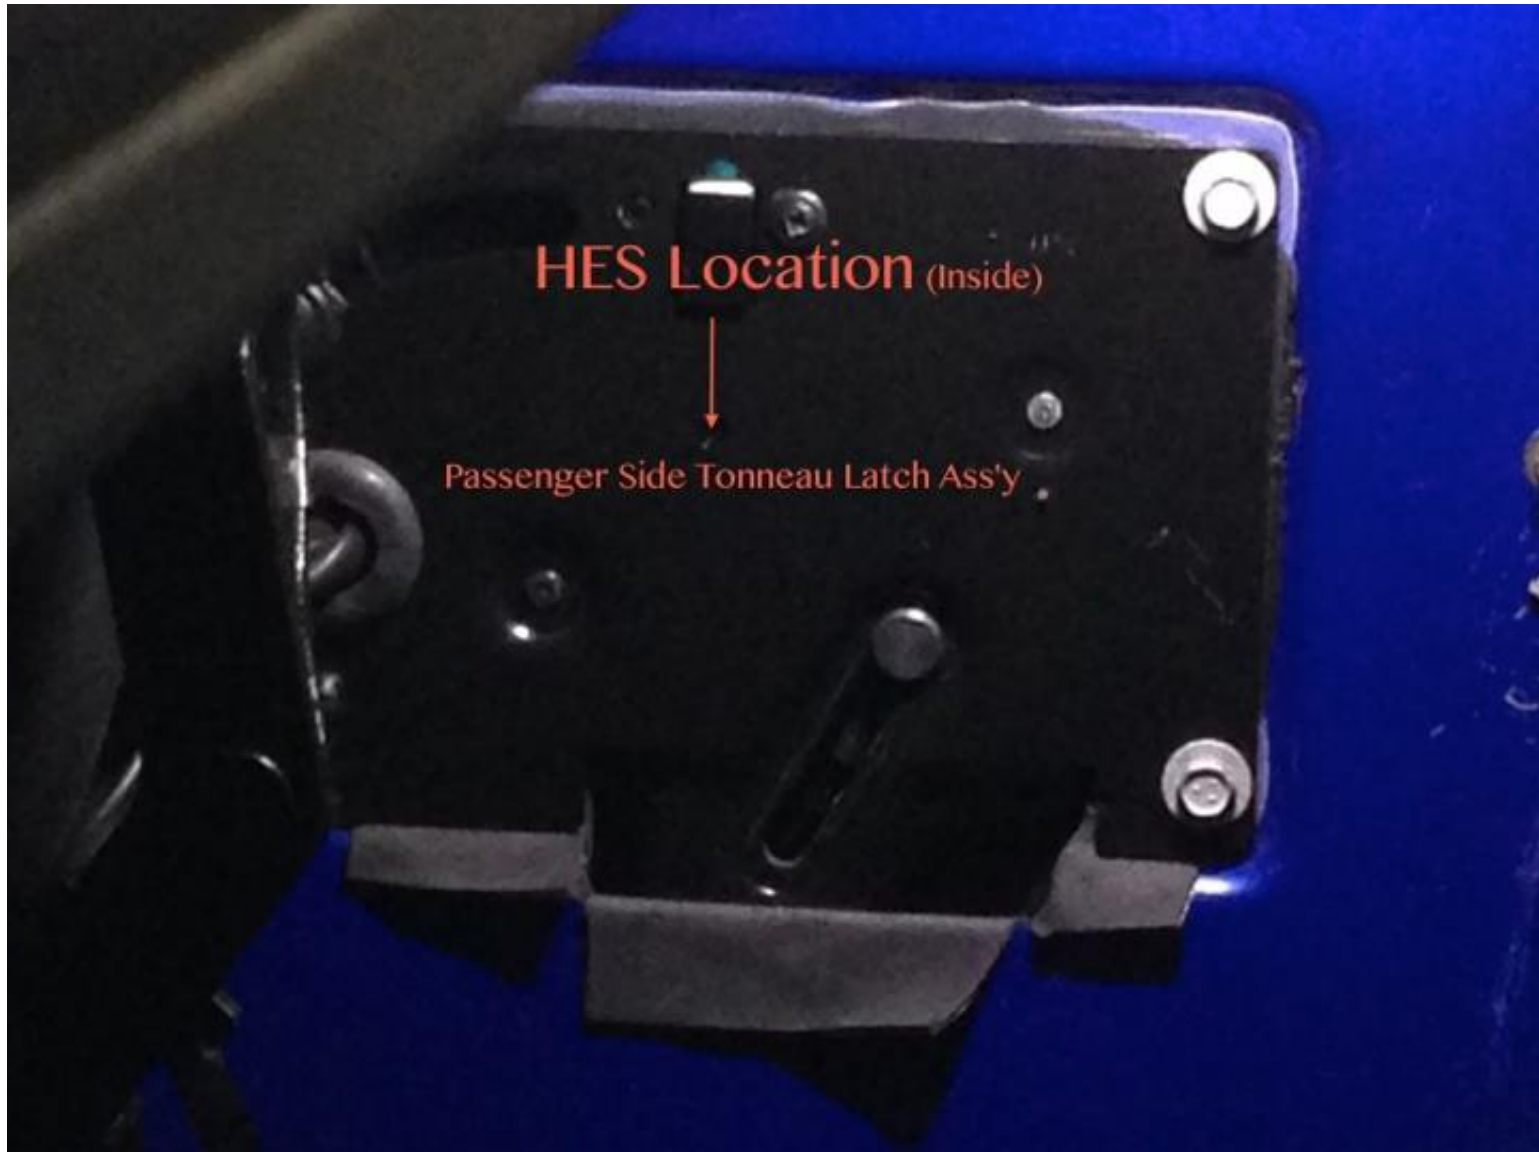
2 - Tonneau Latch Assemblies.

1 - Left Side, 1 - Right side

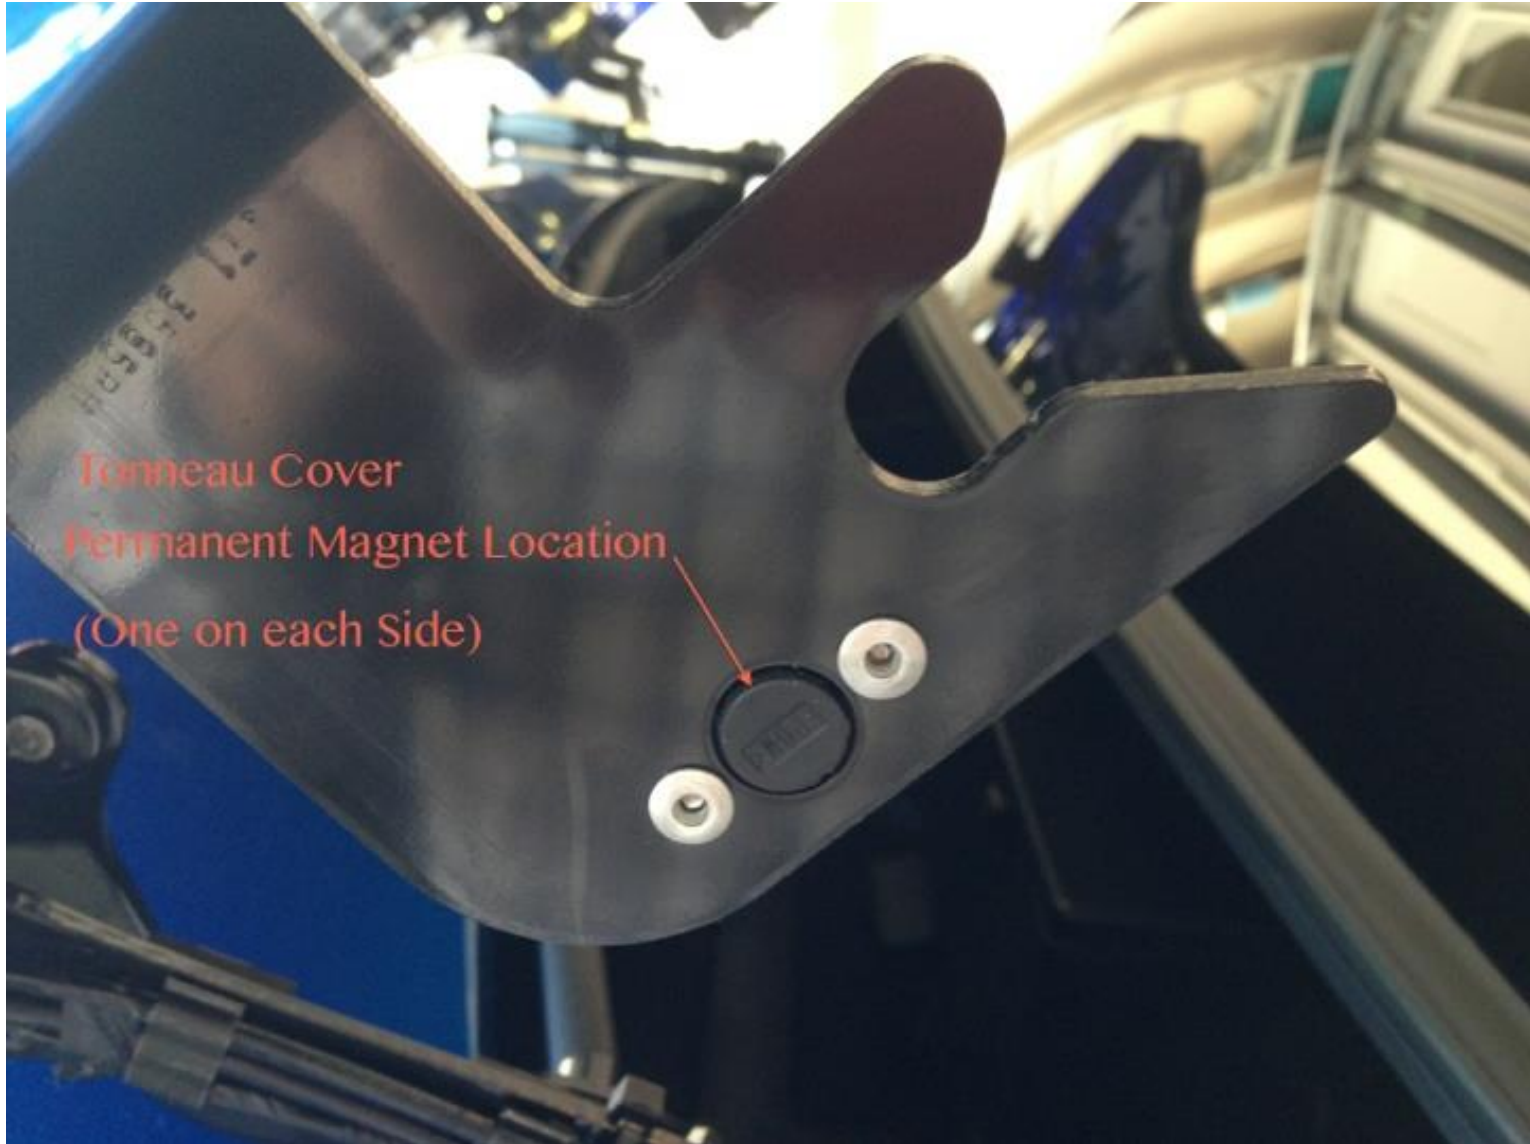
Tonneau Latch Hall Effect Switch - Permanent Magnet

1 - Left Side, 1- Right Side

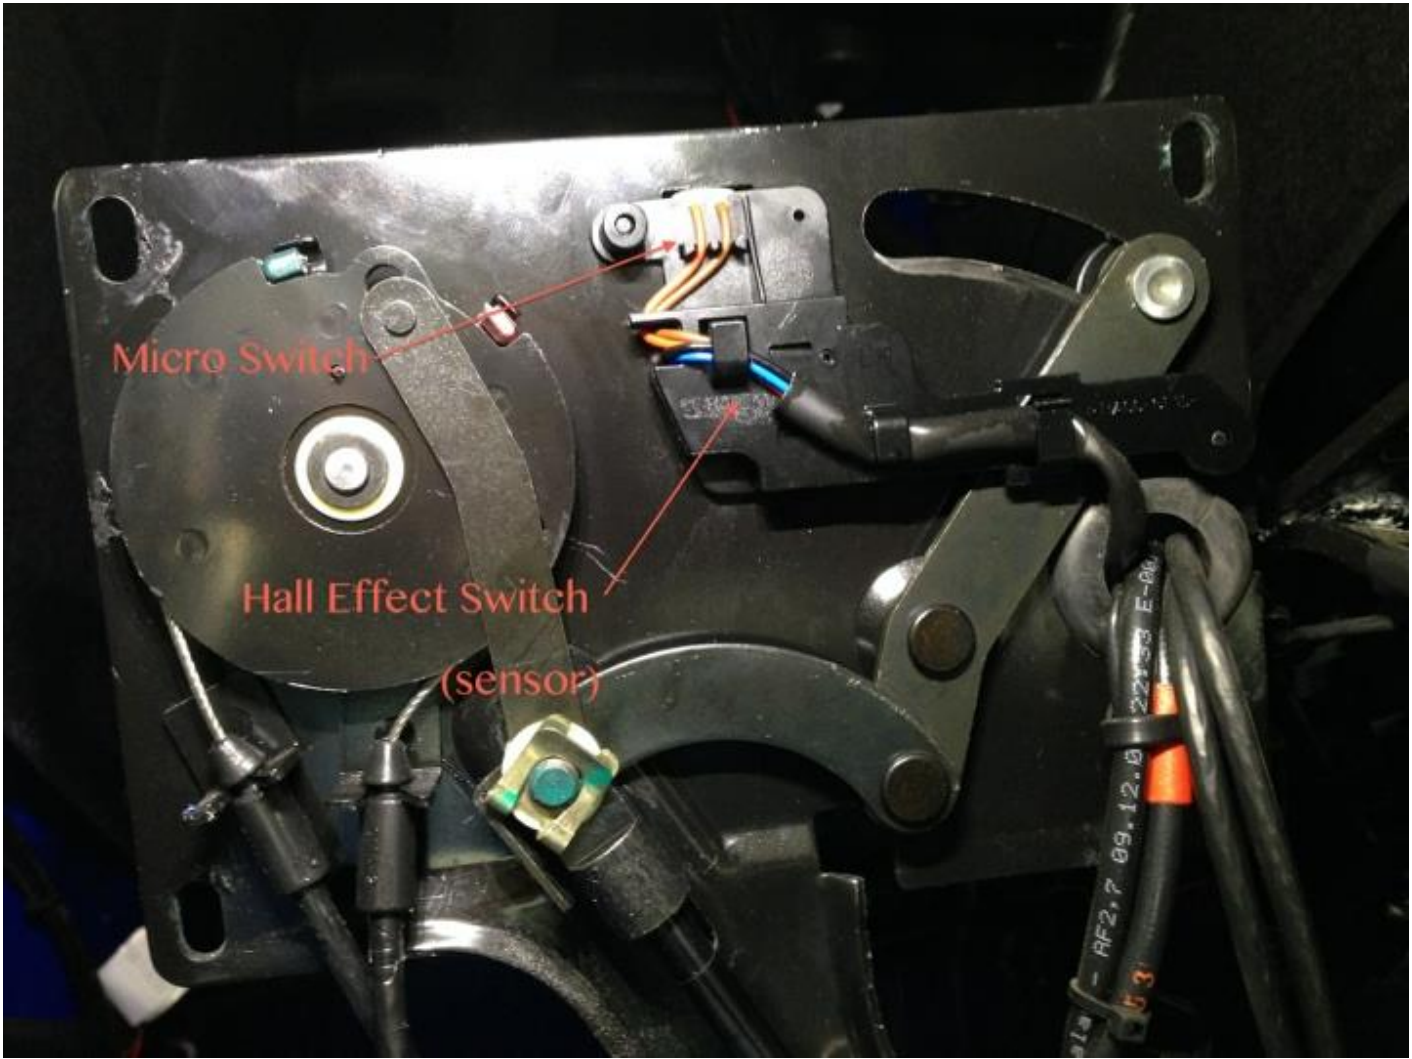
2 - Tonneau Latch Hall Effect Switches.

1- Left Side, 1 - Right Side

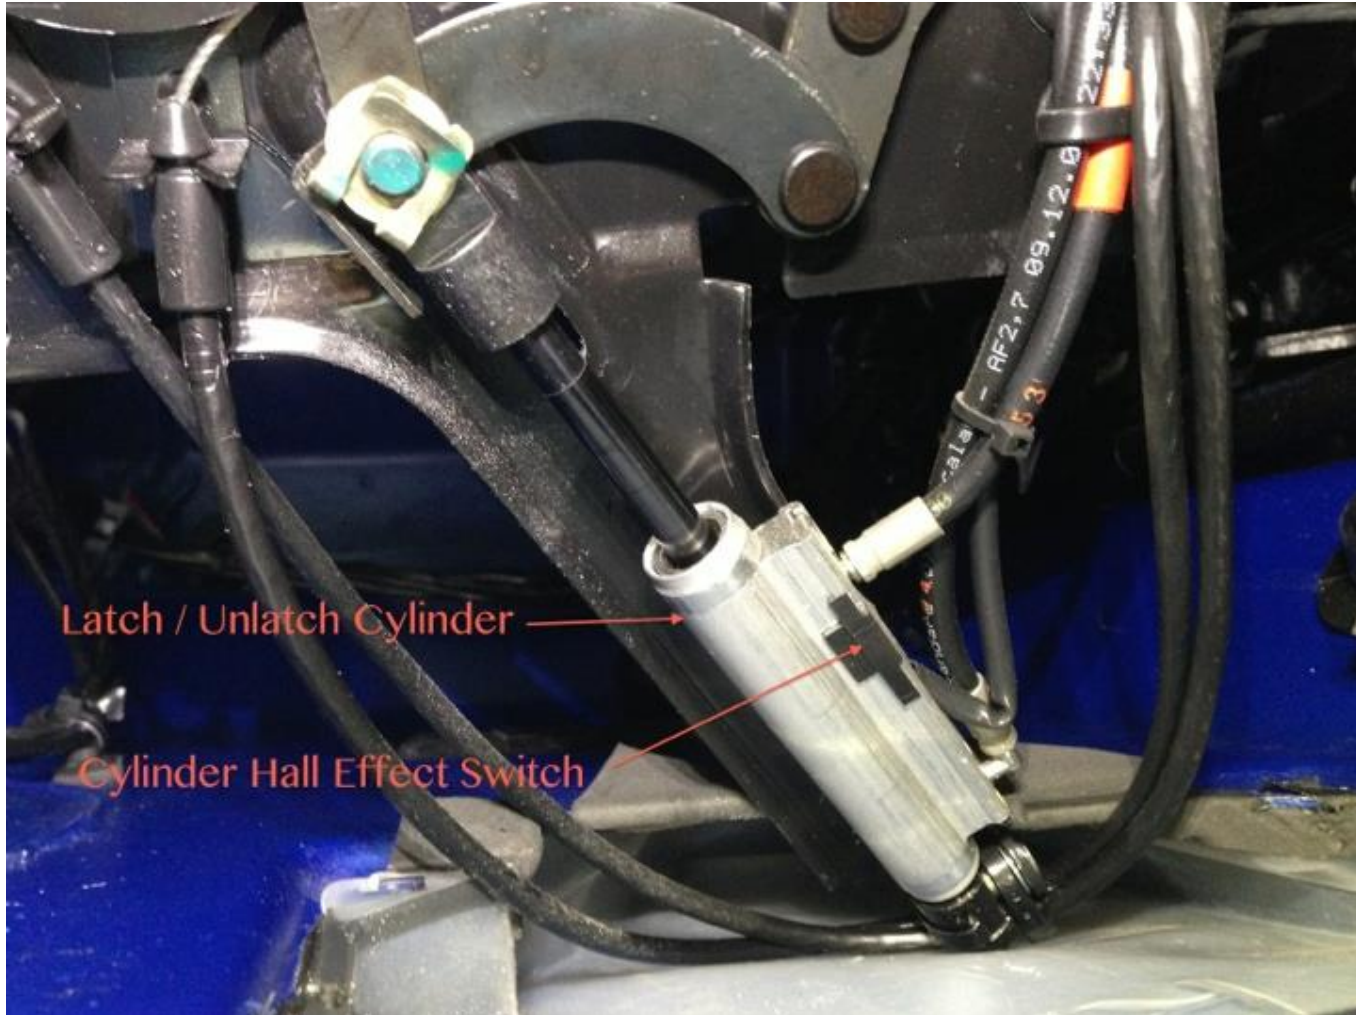
2 - Tonneau Latch Cylinders.
1- Left Side, 1 - Right Side

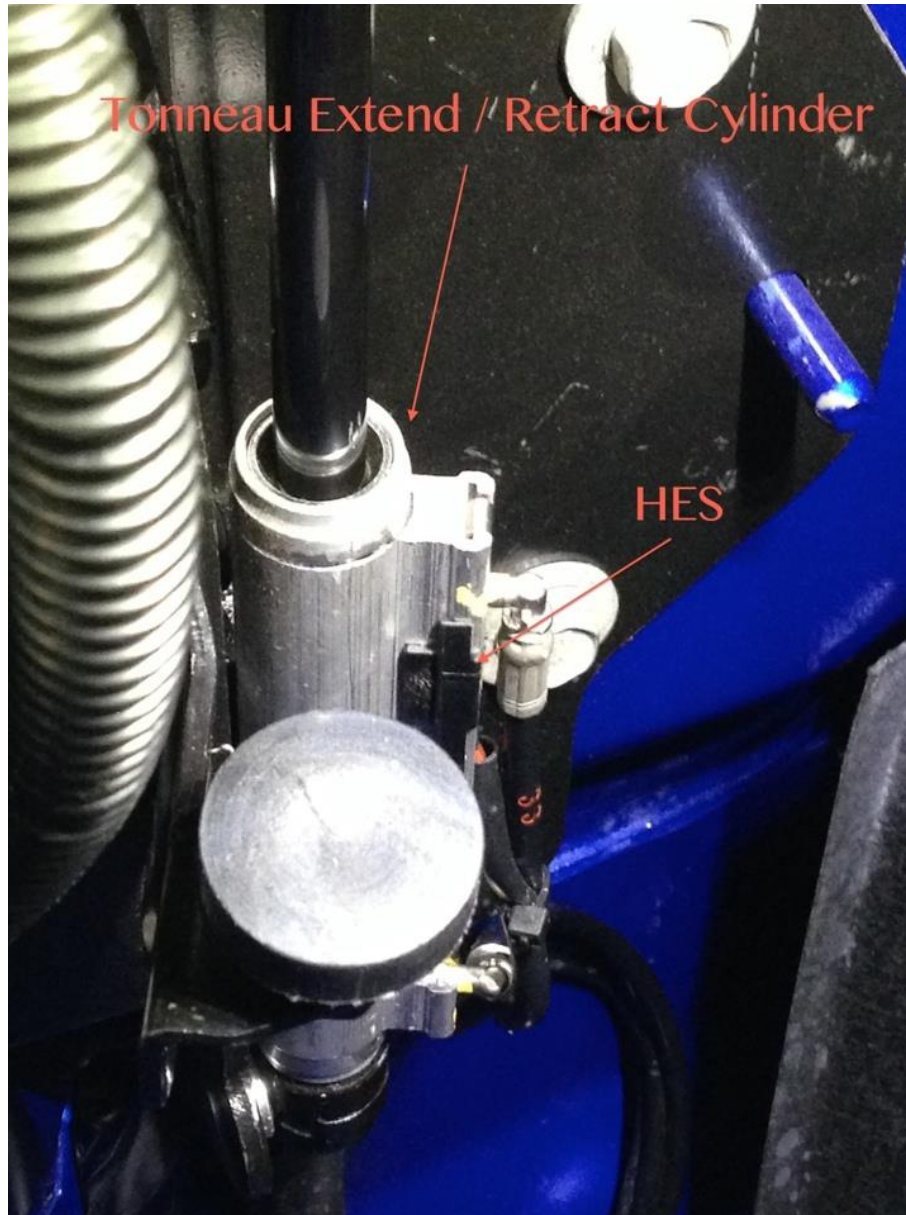
1 - Tonneau Extend / Retract Cylinder position HES

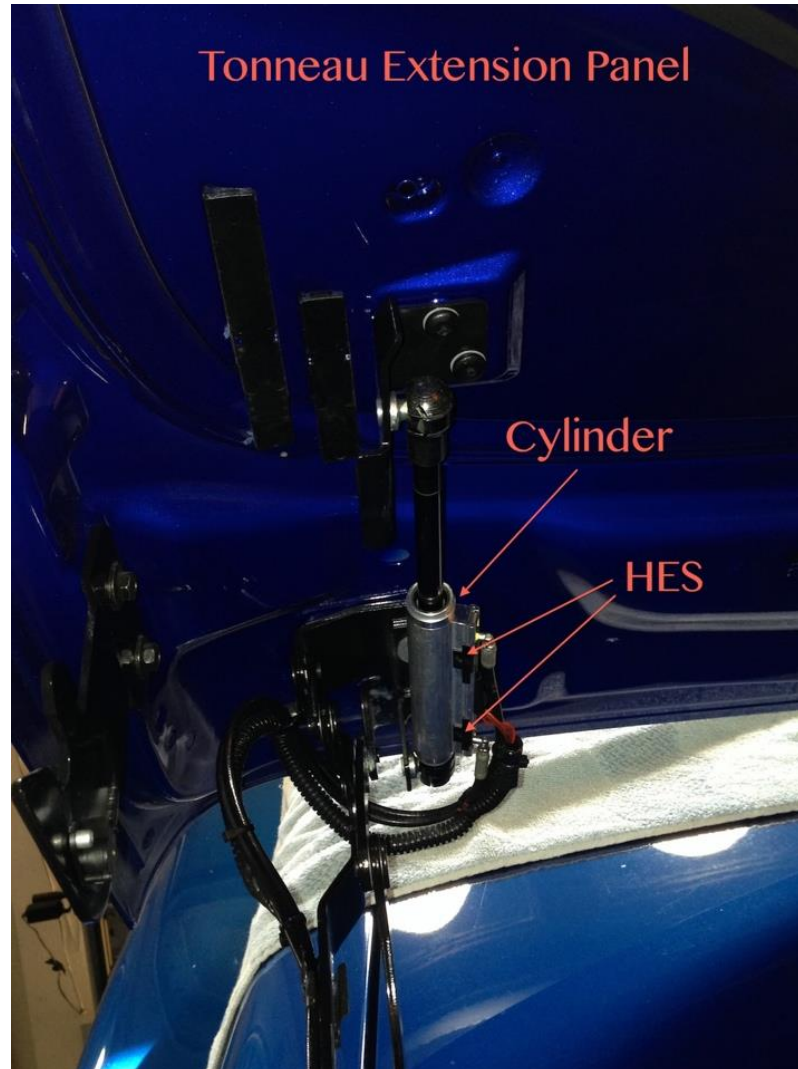
- 2 - Tonneau Extension Panel Cylinder position HES.
- 1 - for lid extension extended
- 1 - for lid extension retracted

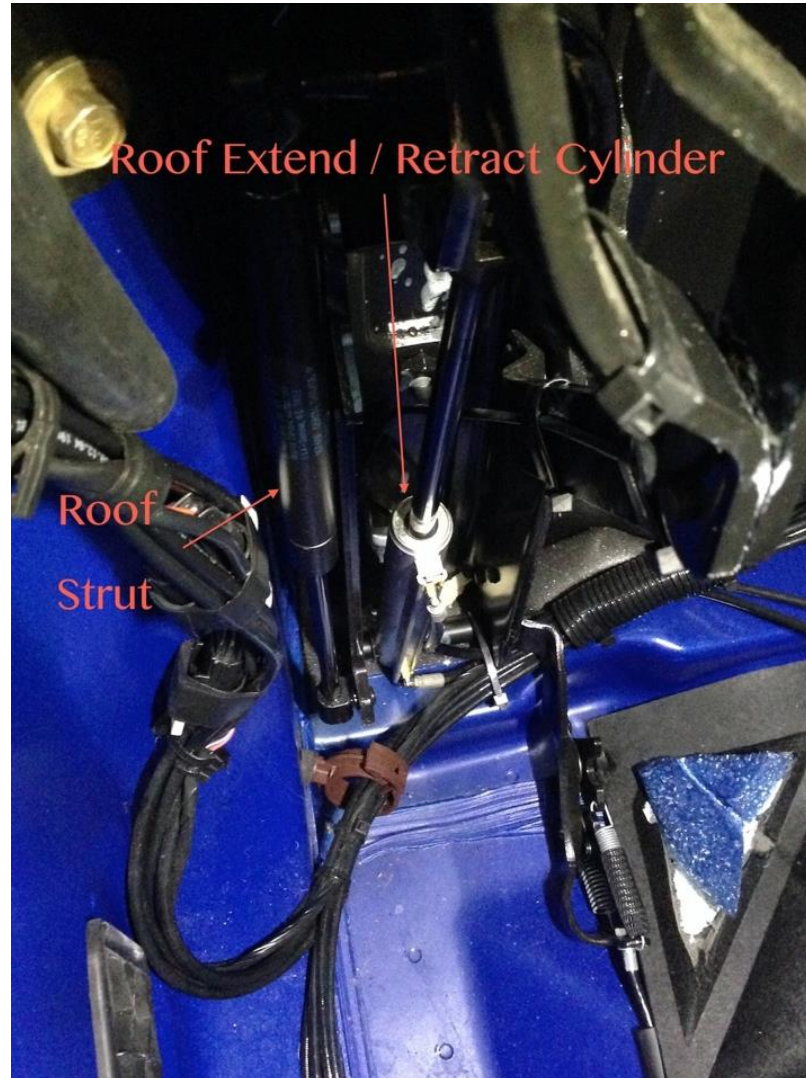
2 - Roof Raise / Lower Cylinder position HES
1 - for roof extended, 1 - for roof retracted
