Property Inspection Report

Property Address:
1000 Springfield Avenue
Samletown NJ 05555

Terra Home Inspections LLC

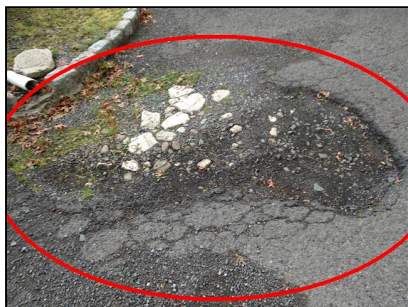
1.0 Item 1(Picture)

The asphalt driveway has numerous areas that were cracked and deteriorated. Further deterioration could occur if the needed repairs are not completed. Recommend further evaluation for repairs by a qualified, licensed driveway contractor.

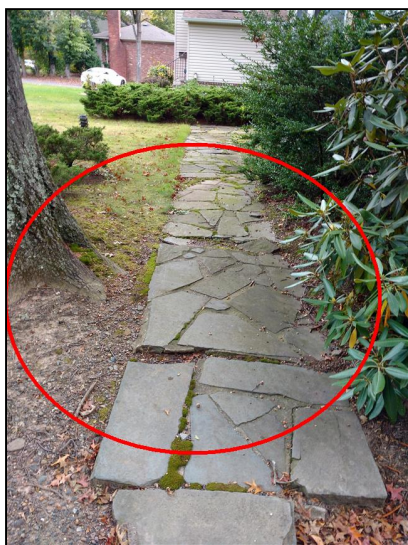
1.1 Item 1(Picture)

The front walkway had one large section that is raised which is causing a trip hazard (which is a safety issue). It appears the tree roots from the large tree are pushing this section of the walkway up. Recommend further evaluation for repairs by a qualified, licensed contractor.

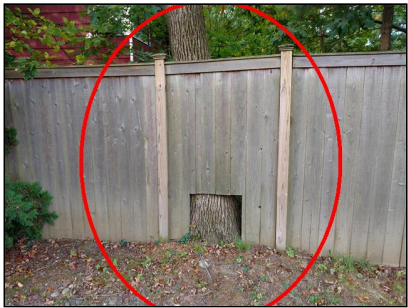
1.3 Item 1(Picture)

There was a large tree on the front side of the house with tree limbs within 10ft of the house, some were hanging over the roof slightly. This tree also appeared to be damaging the front walkway. Trees in contact or proximity to house can provide pathways for wood destroying insects, as well as abrade and damage the exterior cladding, windows, screens and roofs. They will also fill the gutters up with tree debris. Also, the roots from trees close to the foundation of the house could possibly damage the foundation of the house, side walkways and underground sewer piping. There was also a tree along the right side property line that appeared to be growing through the fence. This may damage the fence in the future. Recommend removing/trimming back these trees as necessary.

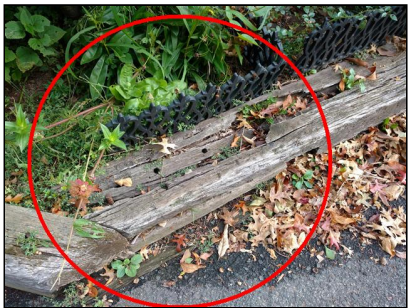
1.4 Item 1(Picture)

Comments: Repair/Replace
Portions of the small wood tie retaining wall in the rear was deteriorated. If not repaired, further deterioration of the retaining wall could occur. Recommend further evaluation for repairs by a qualified, licensed contractor.

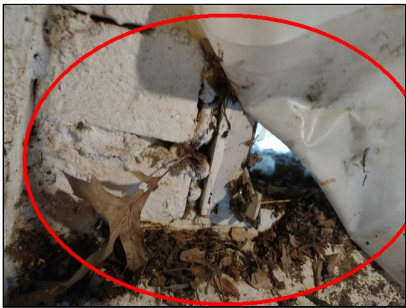
2.3 Item 1(Picture)

Comments: Repair/Replace
(1) As observed in the basement, there were several windows that would not open, were missing or boarded up. Boarded up windows are an issue because water could possibly migrate into the basement if the wood used to board up the window opening is not properly sealed up and coated against the elements. If water is getting in behind the wood, it could potentially rot out the window sill and/or window frame. Missing windows are also an issue because this could let unwanted wildlife, insect and the weather into the dwelling. Recommend further evaluation of all of the basement windows by a qualified, licensed contractor and repair as necessary.

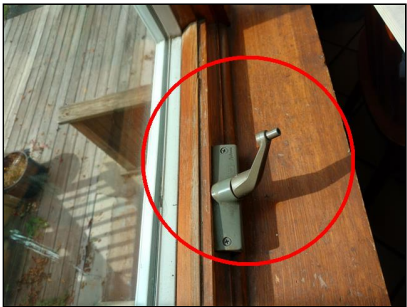
2.3 Item 16(Picture)

(3) As observed in the 2nd floor kitchen, some of the hardware on the casement windows was missing and/or damaged. Therefore, these windows will not function as intended as a result. The window lock on the 2nd floor front bedroom was also damaged. Recommend further evaluation by a qualified, licensed contactor and repair as necessary.

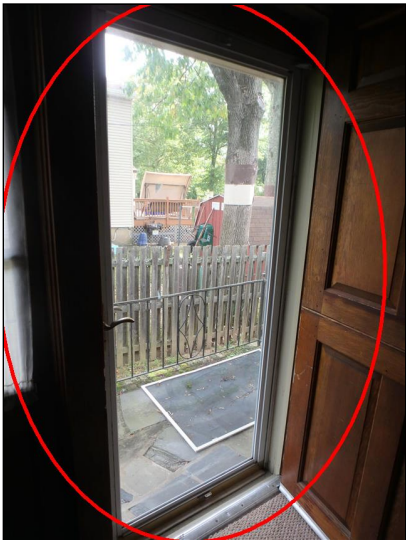
2.4 Item 1(Picture)

The self closer's on the left side entry door were missing. This is a safety issue. Also, the exterior door on the 1st floor to the deck was not functioning. It would not open. Recommend further evaluation by a qualified, licensed contractor and repair as necessary.

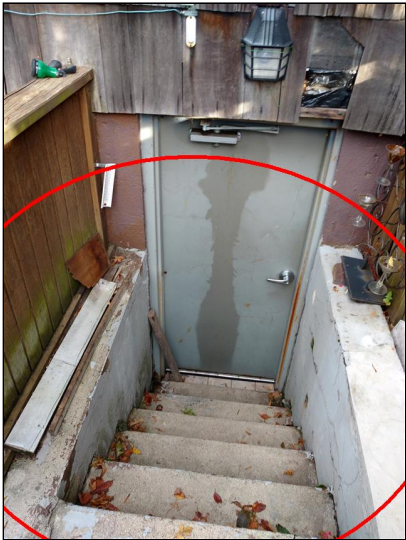
2.7 Item 7(Picture)

(2) The rear masonry staircase leading to the basement door had numerous cracks and deterioration present throughout the structure. Further deterioration of the staircase could occur if the needed repairs are not completed. Also, it appears water is running down the stairway and under the basement door and into the basement. The basement floor in the area under the basement door was sloped towards the basement. This could be a future concern. There was evidence of moisture damage inside the basement in the area of the basement door. The guardrail assembly surrounding this stairwell was extremely loose which is a safety concern. The stairwell also did not have a handrail. Recommend further evaluation by a qualified, licensed masonry contractor and repair as necessary.

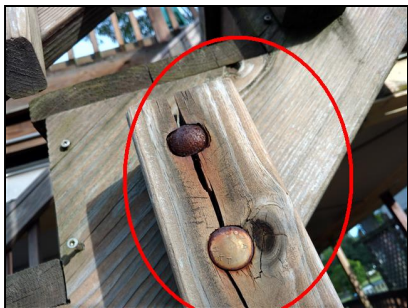
2.10 Item 1(Picture)

Numerous issues were observed pertaining to the rear wood deck structure(all levels);

- 3) The stair stringers/staircases appeared to be loose and moved excessively when the staircases were walked on. The stair stringers should have the required mechanical connectors connecting it to the main deck structure.

- 4) The lower ground level deck area appears to have been built in the fashion that the wood is lying on the ground. This could promote WDI damage as well as dry rot. There was numerous areas that appeared to be damaged/deteriorated. Wood should not be in contact with the ground soil.

- 5) Some of the handrail and guardrail assemblies were loose.
- 6) The handrails were not graspable. All handrails should be equivalently graspable to the 2-inch circular handgrip. The hand grip shape should provide a vertical graspable surface. It should allow the user to maintain a consistently secure natural grasp on the handrail without twisting the fingers or requiring release.

- 7) The top portion of the deck was built over an existing structure with a flat roof membrane roof covering. The top portion of the deck may have to be removed to replace the roof covering in the future.

- 13) The lower deck was built over an existing masonry staircase that was still present. This staircase appeared to have numerous cracked areas present. This is a concern as the staircase may divert water into the foundation/basement.

These are all safety concerns and the needed repairs should be completed ASAP to insure the structure is safe for the occupants. Especially, since this deck structure is the only means of egress for the 2nd floor tenants. Recommend further evaluation of the entire deck structure (all levels) by a qualified, licensed deck contractor and repair as necessary. Additional information pertaining to deck construction and safety can be found at <http://www.safestronghome.com/deck/index.asp>

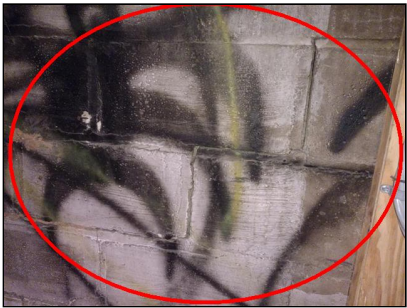
4.0 Item 1(Picture)

There were numerous vertical and horizontal cracks observed in the interior and exterior foundation wall surfaces. The front foundation wall as viewed in the basement, appeared to be heaving inwards as there was a large horizontal crack present. Also in the unfinished basement areas, there was evidence of previous moisture intrusion (efflorescence/ staining/peeling paint/mortar decay) observed on the foundation walls. Moisture can create high humidity, mold & can damage stored items & finishing materials. These areas appeared to be dry at the time of the inspection. Further deterioration of the foundation and possible structural damage to the rest of the dwelling could occur if the needed repairs are not completed. Recommend further evaluation of the entire foundation and house structure by a qualified, licensed structural engineer and repair as necessary.

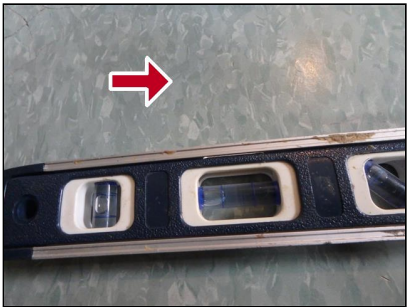
4.5 Item 1(Picture) 2nd floor

As observed throughout the house, there were numerous floors that had a noticeable sloping condition present. The condition of the sloping floors in question could worsen in the future if the needed structural repairs are not completed. Based on this and other structural observations, it is recommended a further evaluation of the entire house structure by a qualified, licensed structural engineer be performed and repaired per their recommendations.

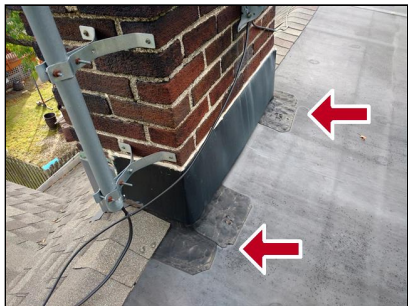
5.0 Item 1(Picture)

Observed on the flat roof in the area below the chimney flashings, two small sections of the flat roof membrane had several blisters/bubbles present. Blisters/bubbles are typically created by voids between the roofing membrane and the roof decking. If these blisters or the seams open up, water could enter the structure below. There were also a few roof peak shingles that had some minor cracking present. Recommend further evaluation of all of the roof covering materials by a qualified, licensed roofing contractor and repair as necessary.

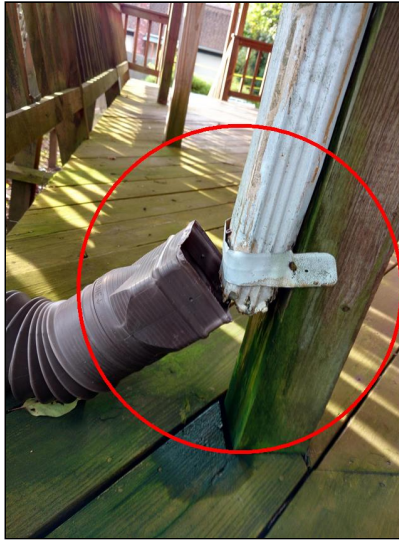
5.2 Item 1(Picture)

The exterior downspouts should be extended at least 6 feet from the foundation of the house. Extending the downspouts helps shed water away from the foundation. Water can weaken and deteriorate the foundation and can possibly migrate into the basement. Recommend extending the downspouts as necessary.

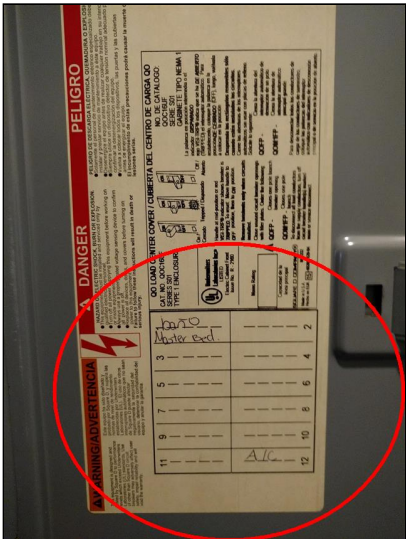
7.3 Item 1(Picture)

(1) As observed in all 3 electric panels, the circuit breaker wiring legends were in-complete and/or appeared to be inaccurate. These legends should be clearly marked identifying which circuit breaker shuts off which particular wiring circuit running throughout the house. This information is needed in case of emergency's or anytime individual circuits need to be turned off. It is recommend a qualified, licensed electrician verify each circuit and label accordingly.

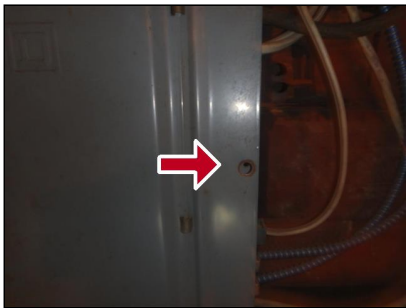
7.3 Item 4(Picture)

(2) There were 2 hold down screws missing from the dead front (front cover) on the main service panel located in the basement. All the required home down screws should be in place to insure all the electrical equipment is held in place. Recommend having a qualified, licensed electrician install the proper manufacturer approved hold down screws.

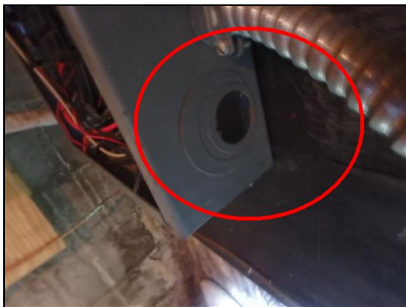
7.4 Item 1(Picture)

(2) There were knockout plugs missing from the electric sub panel located in the basement. Current electric safety standards state that unused openings in such equipment need to be closed. Covering these openings helps prevent accidental shocks, helps prevent hot sparks from escaping if something goes wrong inside the enclosure and helps to prevent pests from entering. Recommend further evaluation for repairs by a qualified, licensed electrician.

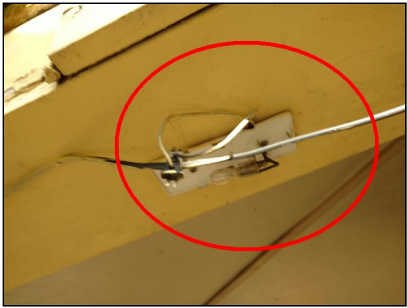
7.8 Item 8(Picture)

(2) Observed throughout the dwelling and on the exterior, there were numerous light fixtures that were either damaged, not functioning, not installed properly and/or missing light bulbs. This are potential safety concerns. Recommend further of all of the light fixtures by a qualified, licensed electrician and repair as necessary.

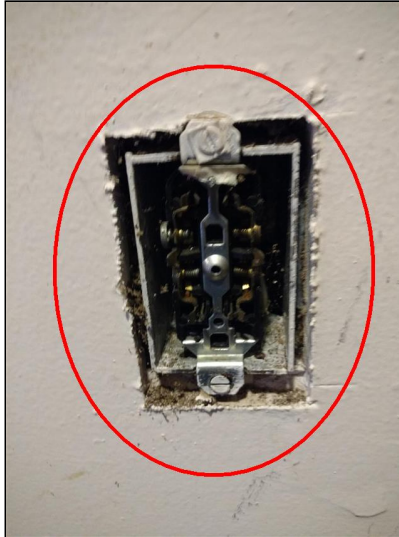
7.8 Item 18(Picture)

(4) There were numerous damaged electrical receptacles present in the basement. These are all safety issues. Recommend further evaluation for repairs by a licensed electrician.

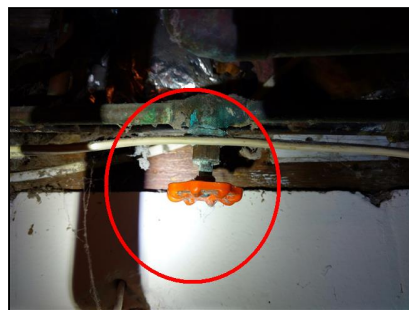
8.1 Item 1(Picture)

Testing of the water shut off valves located throughout the house (especially the ones located in the basement, under sinks, behind toilets, etc.) for functionality is beyond the scope of the home inspection. Due to age, corrosion and/or mineral buildup that may be on them, they may or may not function properly in the future in the event of an emergency or a need to service part of the plumbing system. Several of the water shut off valves that were observed appeared to be frozen when they were turned slightly and would not turn. There were also numerous shutoff valves that were missing their required handles. Recommend further evaluation of all of the water shut off valves in the dwelling (basement, under sinks, behind toilets, etc.) by a qualified, licensed plumber and repair as necessary.

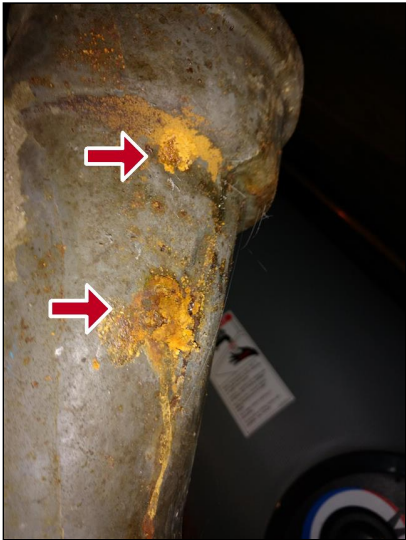
There were numerous rust stains/blisters observed on numerous sections of the cast iron DWV (drain, waste, vent) piping in the basement. These rust marks/blisters are usually caused by tiny pin holes that are in the pipe. As the water leaks out of these tiny pin holes it rusts and forms the blisters. These blisters are usually caused by pitting and corrosion inside the pipe. Also, to note, portions of the DWV piping was galvanized pipe. This has similar characteristics to cast iron as far as the deterioration is concerned. Recommend further evaluation of all of the DWV piping by a qualified, licensed plumber and repair as necessary. In addition, due to the age of the house and since cast iron piping deteriorates from the inside out, it is recommended the main cast iron DWV piping (especially the portion that goes out to the main sewer connection in the street) be scoped by a qualified, licensed plumber to ascertain the integrity of the piping. But, on old cast iron DWV piping systems this sometimes cannot be done without compromising the existing DWV piping system and should not be done if it will compromise the existing DWV piping system. Sometimes the clean out plugs that are needed to be removed to inspect the inside of the piping are frozen or severely deteriorated and will not come off to access the piping.

8.2 Item 1(Picture) Suspected blisters

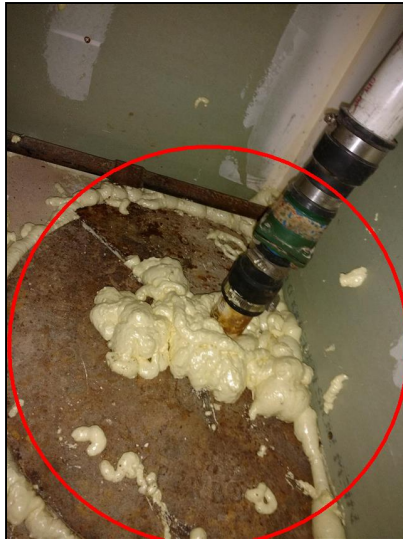
8.5 Item 1(Picture)

As observed in the basement, there was what appeared to be a sump pump present under the kitchen cabinets. It is suspected the water discharge piping for the sump pump was directed into the sanitary sewer piping running out to the sanitary sewer main. The water discharged from the sump pump is not permitted to be connected to the sanitary sewer system. It can be connected to a storm sewer system (which is not present in this dwelling) or directed to the exterior. It is recommended this sump pump discharge piping be directed to the exterior with the discharge point as far away from the foundation as possible. There was no visible discharge piping to the exterior. Also, this sump pump was sealed and therefore, it could not be tested. The inspection was limited. Recommend further evaluation by a qualified, licensed plumber and repair as necessary.

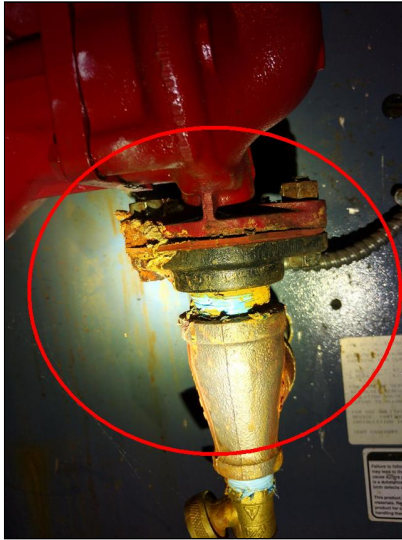
10.1 Item 1(Picture)

As observed in the basement on the side of the boiler, it appears the heating distribution system piping may be leaking in the area of the circulating pump and other pipes. There was no active leaks visible at the time of the inspection. Recommend further evaluation for repairs by a qualified, licensed plumber.

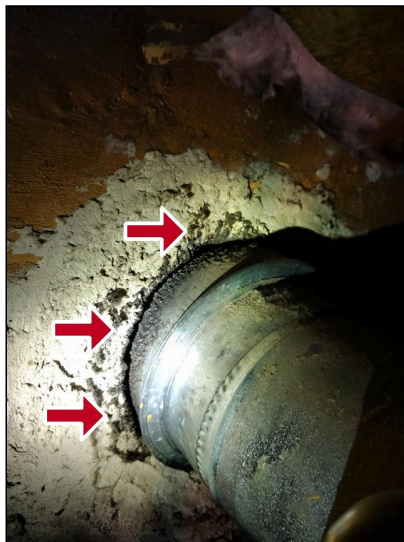
10.2 Item 1(Picture)

The exhaust venting/vent connector for the boiler was not sealed up at all the chimney thimble connection. The vent pipe was just stuck into the chimney opening with large gaps between the vent connector and the chimney thimble opening. There was no sealing material present. This is a **major safety concern** as combustion by products (carbon dioxide, carbon monoxide and nitrogen oxide) may be entering the dwelling instead of being properly vented into the chimney and out of the dwelling. This should be repaired **immediately**. Recommend further evaluation by a qualified, licensed plumber and repair as necessary.

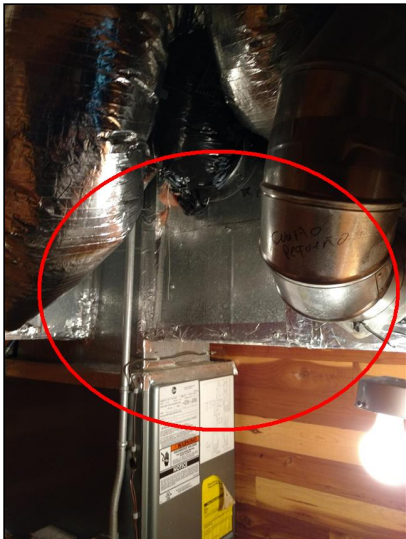
11.1 Item 1(Picture)

As observed in the attic area on the 2nd floor, portions of the HVAC supply ducting appeared to be sweating when operated. Portions of the ducting were wet and there was dry water staining on the ducting and the A/C air handler cabinet. This could be a future concern as the condensation could damage the building materials in this area. Recommend further evaluation by a qualified, licensed plumber and repair if necessary.

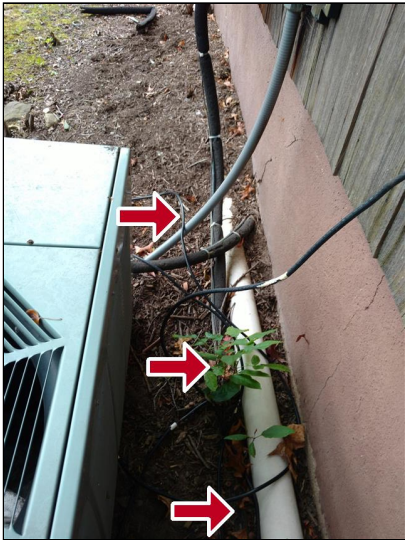
11.2 Item 1(Picture)

The insulation wrap on one of the exterior condenser refrigerant lines was deteriorated/missing in spots. Also, both of the refrigerant lines were buried in the mulch next to the condensers. The refrigerant lines should not be in contact with the ground. This may cause the insulation wrap to deteriorate. In addition, this condition may affect the performance of the air conditioning system if not repaired. Recommend further evaluation by a qualified, licensed HVAC professional and repair as necessary.

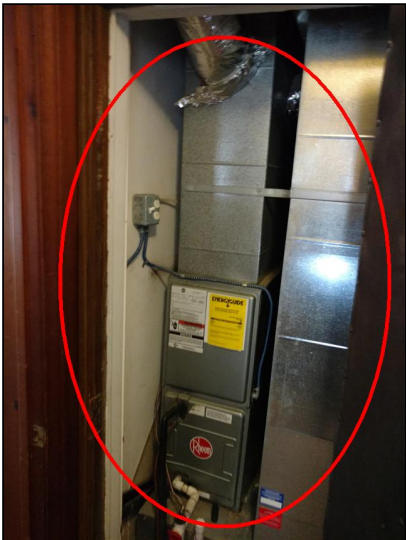
11.3 Item 1(Picture)

The air handler for the air conditioning system for the 1st floor did not appear to have a return air filter. This is an issue as the return air filter keeps the internal parts of the air handler free of dust and debris, it filters the air being circulated within the living spaces and not having one in place will also effect the performance of the air conditioning system. Recommend further evaluation by a qualified, licensed plumber and repair as necessary.

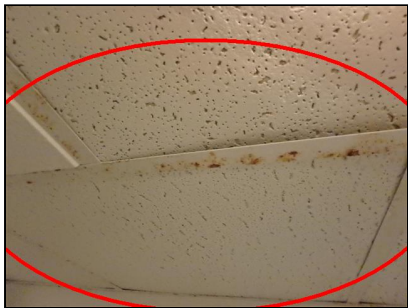
12.1 Item 1(Picture)

(2) There was a drop ceiling present in the 1st floor bathroom which covered the entire ceiling. This is an issue as the metal framing could rusted due to the moisture while taking a shower and also moisture could get trapped in the space above the drop ceiling and the 2nd floor subfloor. Mold could possibly form on the ceiling tiles as well as the space above the drop ceiling. In addition to this drop ceiling being present, it also appears the toilet in the 2nd floor bathroom was or is leaking down into the 1st floor bathroom and hallway closet. The ceiling and wall was wet in these areas. Please keep in mind there may be hidden moisture damage (possible mold) in these effected areas. Recommend further evaluation by a qualified, licensed contractor and repair as necessary. The toilet in the 2nd floor bathroom should also be evaluated.

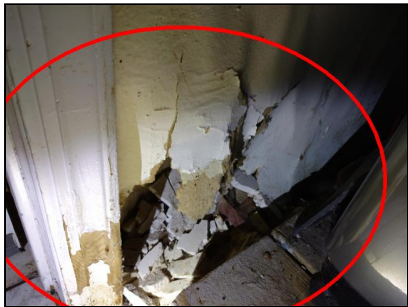
As observed throughout the dwelling, there were small cracks observed in the some of the ceiling and wall surfaces. These types of cracks are common in a house of this age. The condition of these cracks may worsen if the necessary repairs are not completed. There was also a portion of the drywall that was damaged in the basement. Recommend further evaluation of all of the wall/ceiling surfaces by a qualified, licensed contractor and repair as necessary.

12.2 Item 1(Picture) Basement

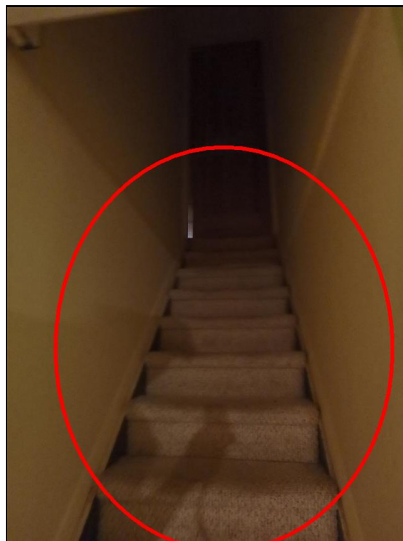
12.5 Item 1(Picture)

As observed in the basement stairwell, there was no handrail present. All stairwells should have handrails which should be continuous from the bottom to the top. The missing handrail is a safety concern. Recommend further evaluation for repairs by a qualified, licensed contractor.

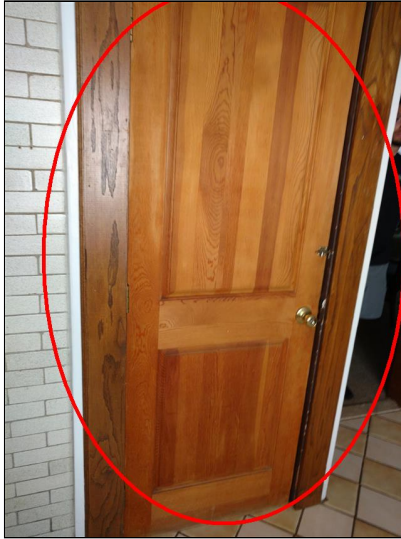
12.7 Item 1(Picture)

The bottom of the interior door leading to the basement was rubbing on the floor. Damage to the door and/or the floor could occur if not repaired. Recommend further evaluation for repairs by a licensed contractor.

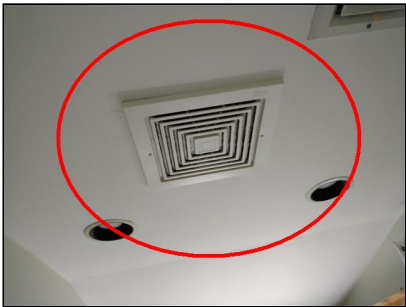
13.1 Item 1(Picture)

(1) The exhaust fans located in the basement and 1st floor bathrooms did not appear to be functioning. A working exhaust fan ensures ventilation of moisture from the bathroom in the event the bathroom window is not open (winter time). This is especially important where bathtubs or showers are present. Recommend further evaluation for repairs by a qualified, licensed electrician.

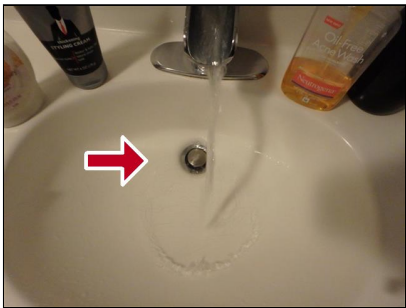
13.2 Item 1(Picture)

The sink stopper in the 1st floor bathroom sink was not functioning properly. It appears it may just need to be adjusted as it was sealing properly. This will prevent you from filling up the sink if you wanted to do so. Recommend further evaluation by a qualified, licensed plumber and repair as necessary.

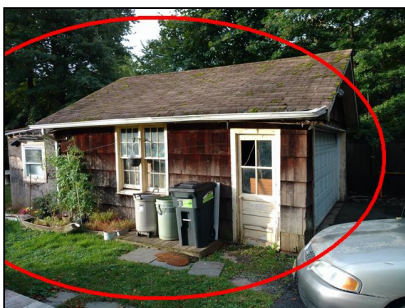
3.0 Item 1(Picture)

- 3.0 Garage
- Comments: Repair/Replace
- (1) Numerous issues were observed on the interior and exterior of the garage:
 - 1) The concrete floor had numerous small cracks present.

- 2) There were numerous sections of the exterior wood cladding/siding, garage structure, windows, doors, roof covering and trim that was damaged, deteriorated or missing.

- 3) The garage vehicle door was not closing properly due to the garage structure being damaged/deteriorated.
 - 4) Some of the gutter assemblies were damaged.

- 5) The paint was peeling in numerous sections of the garage exterior.
 - 6) A portion of the right side wall structure was damaged from what appears to be a tree stump.

- 7) The concrete apron in the front of the garage was cracked in numerous areas.
- The garage interior and exterior was cluttered with storage in sections. Numerous parts of the garage structure could not be viewed. Further deterioration of the noted garage elements could occur of the needed repairs are not completed. Recommend further evaluation of the entire garage (both interior and exterior) by qualified, licensed roofing, general and masonry contractors as well as a structural engineer and repair as necessary.
