RESERVE FUND STUDY

**Meadowlake Village
7410 Breda Dr.
Baytown, TX 77521**

Final Report

December 20, 2015

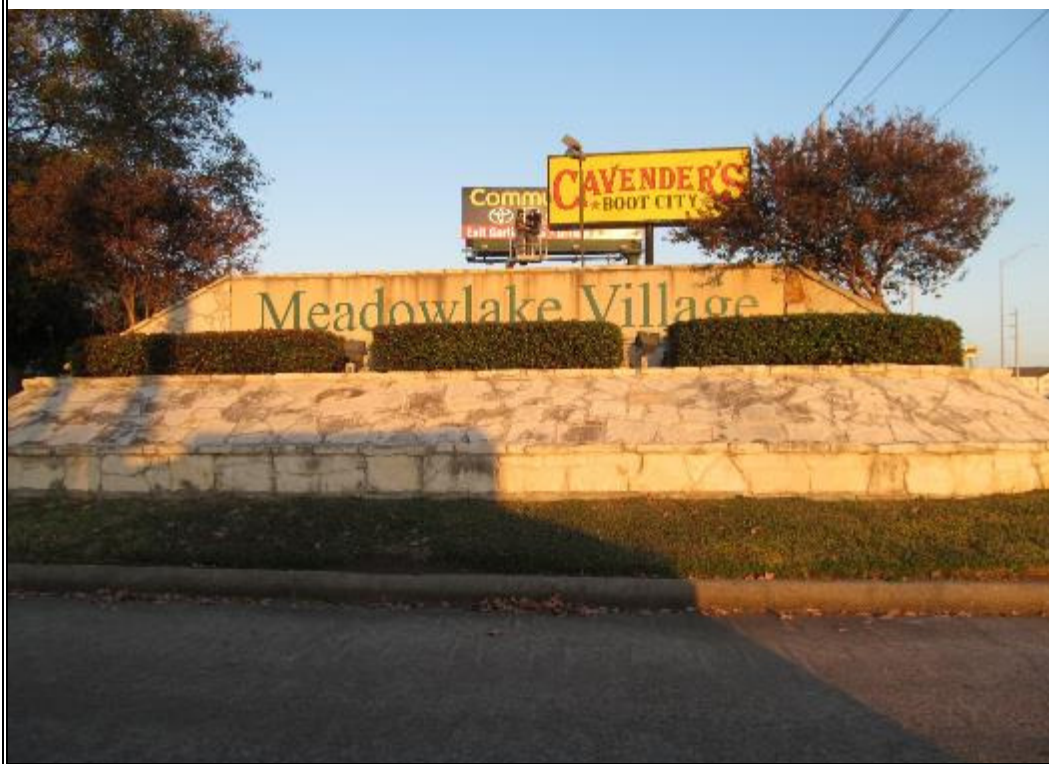
Photo Number
1

The entrance signage including the large monument sign are in good condition requiring only routine maintenance. We understand that the entrance signage has been refurbished within the last three years.

Description:
Breda Drive
monument signage

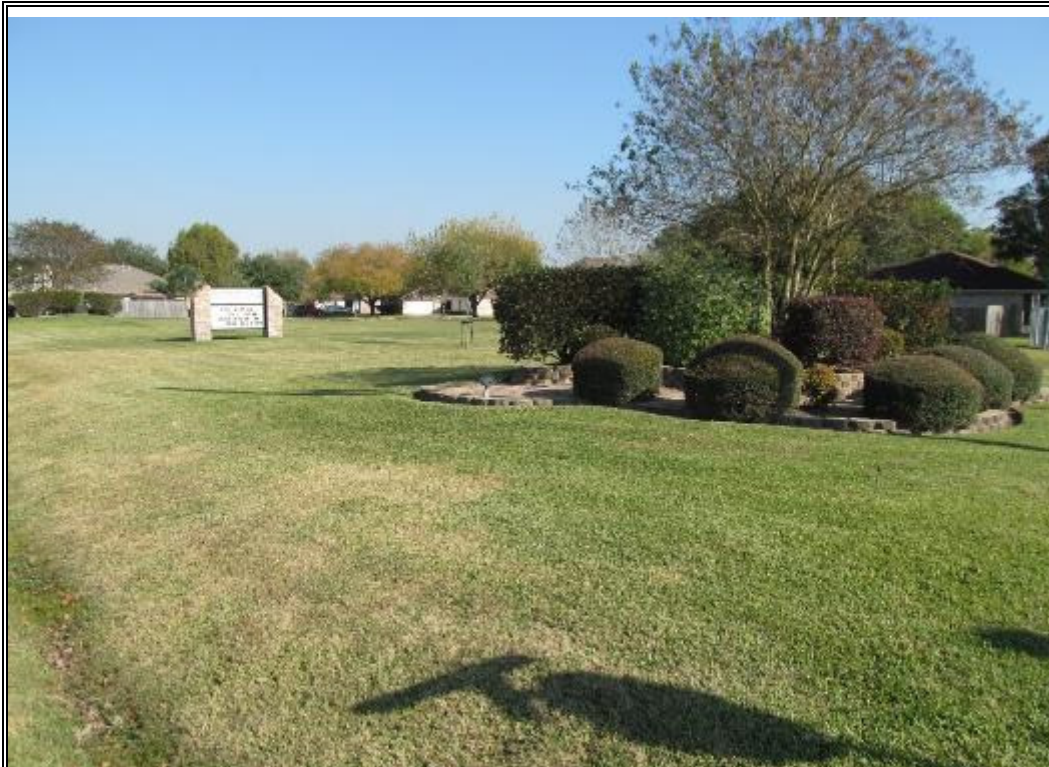
Photo Number
2

Description:
Community
signage at west
side entrances

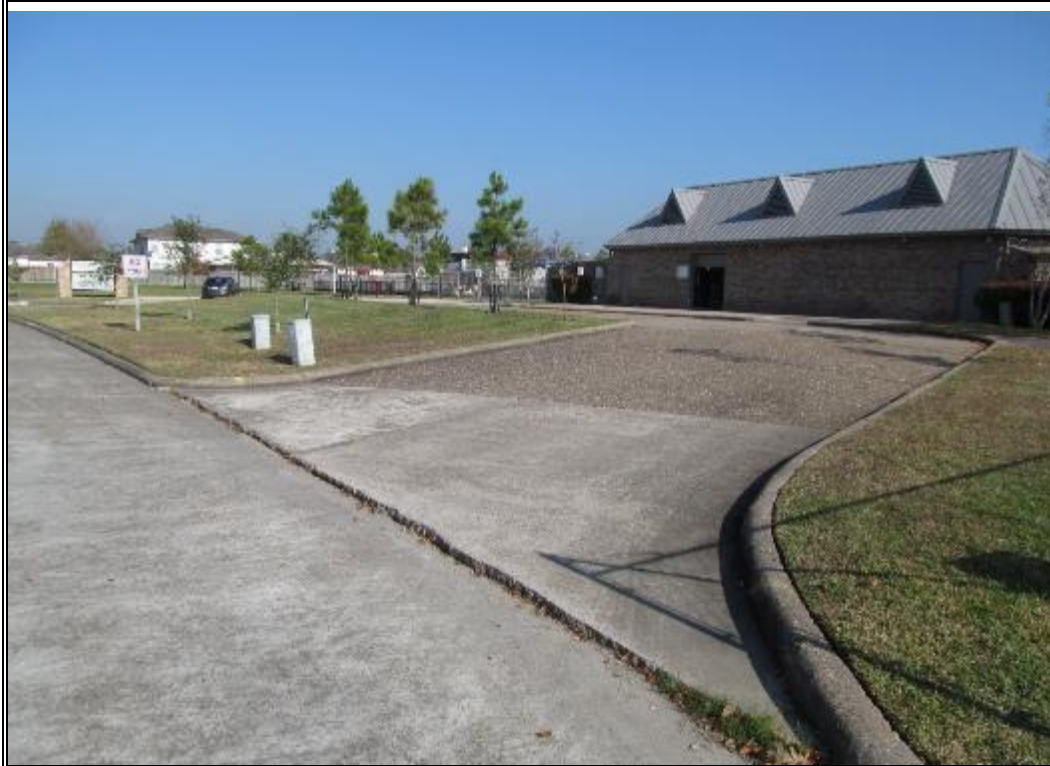
Photo Number
3

The driveway and parking area are in generally good condition requiring only routine maintenance. The left side parking area was installed in 2012.

Description:
Community center
entrance drive

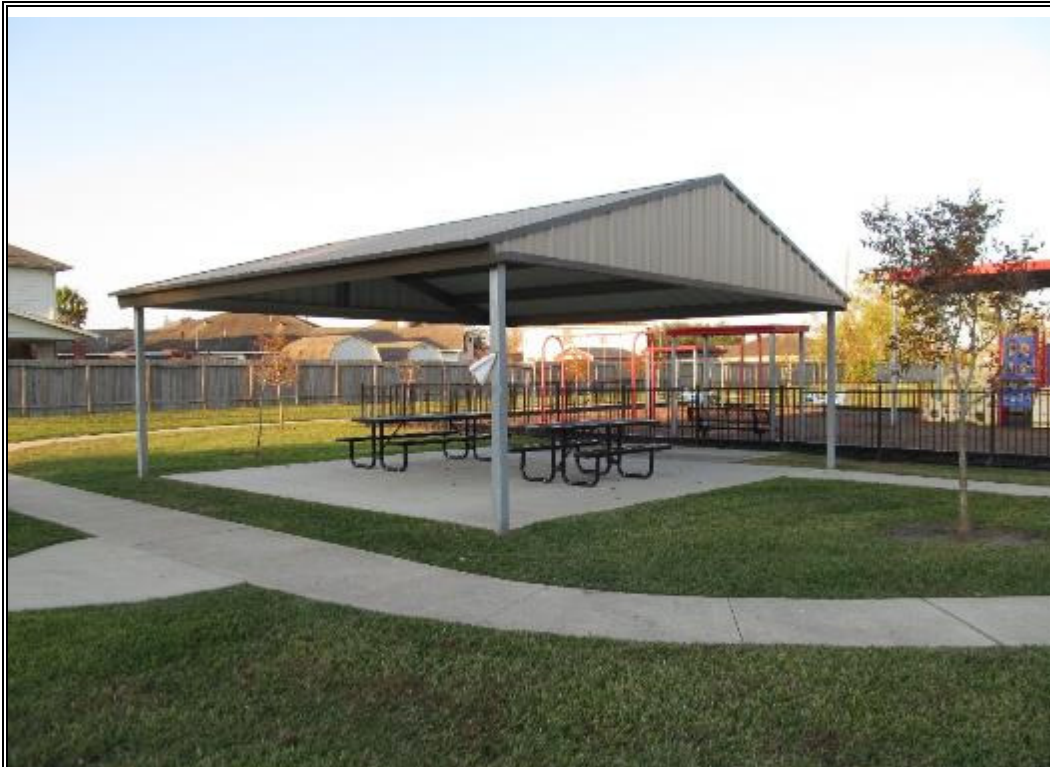
Photo Number
4

The small pavilion is in good condition.

Description:
Pavilion at left side
of clubhouse

- The metal framed pavilion was recently constructed (2012) and is in good condition. We do not anticipate replacement of this structure over the term.

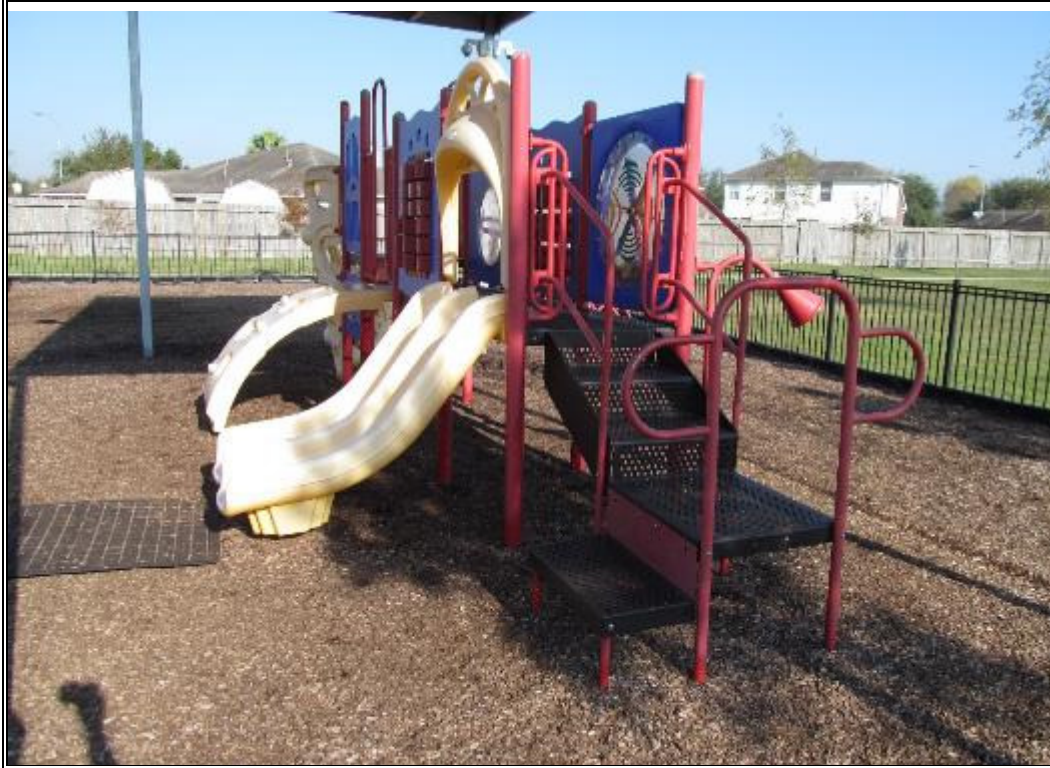
Photo Number
5

The children's play set, swing set and spring rockers are in good condition.

Description:
Large children's
play set

- We anticipate replacement of the large children's play set over the term and have added an amount to the reserves spreadsheet for this item.
- We anticipate replacement of the small spring rocker children's play sets over the term and have added an amount to the reserves spreadsheet for these items.

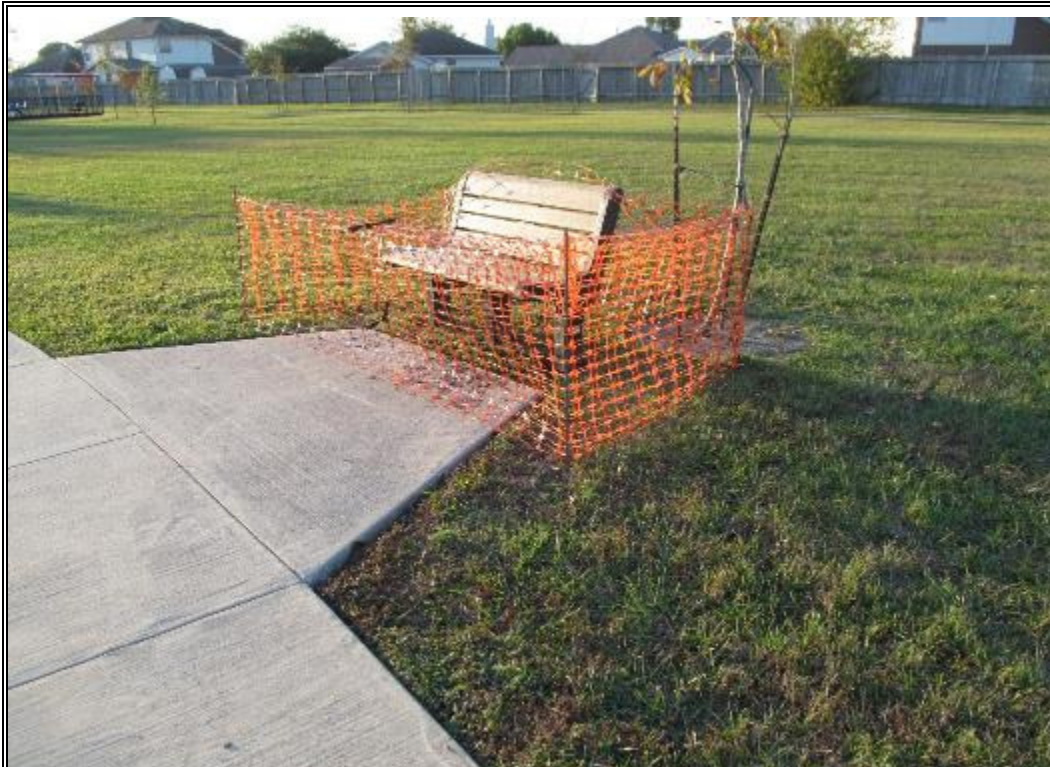
Photo Number
6

The benches and picnic tables are in good condition.

Description:
New recycled
plastic benches
being installed
around walking
path

- We anticipate replacement of the picnic tables over the term and have added an amount to the reserves spreadsheet for this item.
- We anticipate replacement of the metal benches over the term and have added an amount to the reserves spreadsheet for this item.

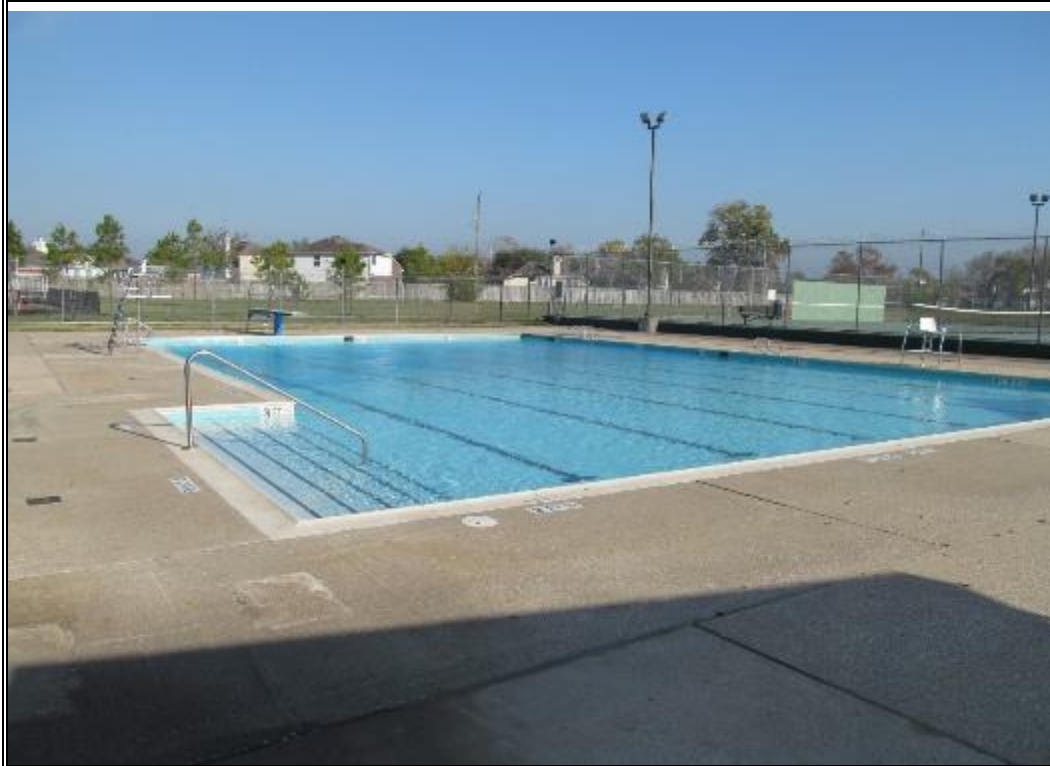
Photo Number
7

The swimming pools are in good condition. It is our understanding that the pools were resurfaced and deco seal replaced in 2012.

Description:
Large swimming
pool

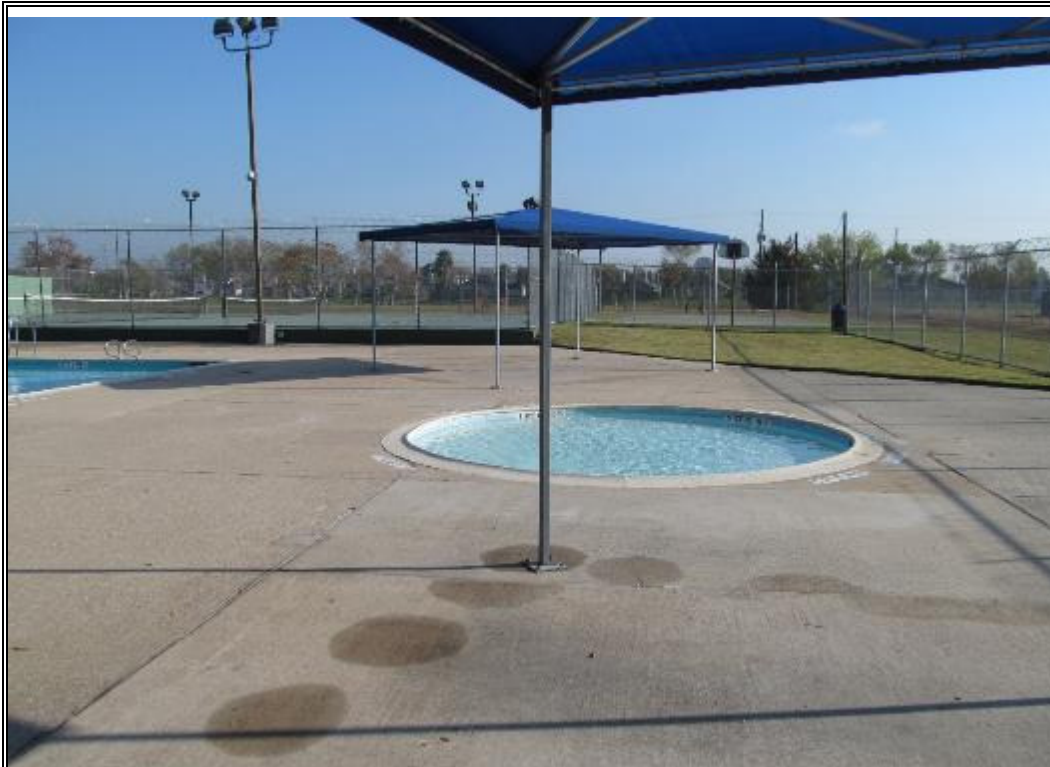
Photo Number
8

Description:
Small wading pool

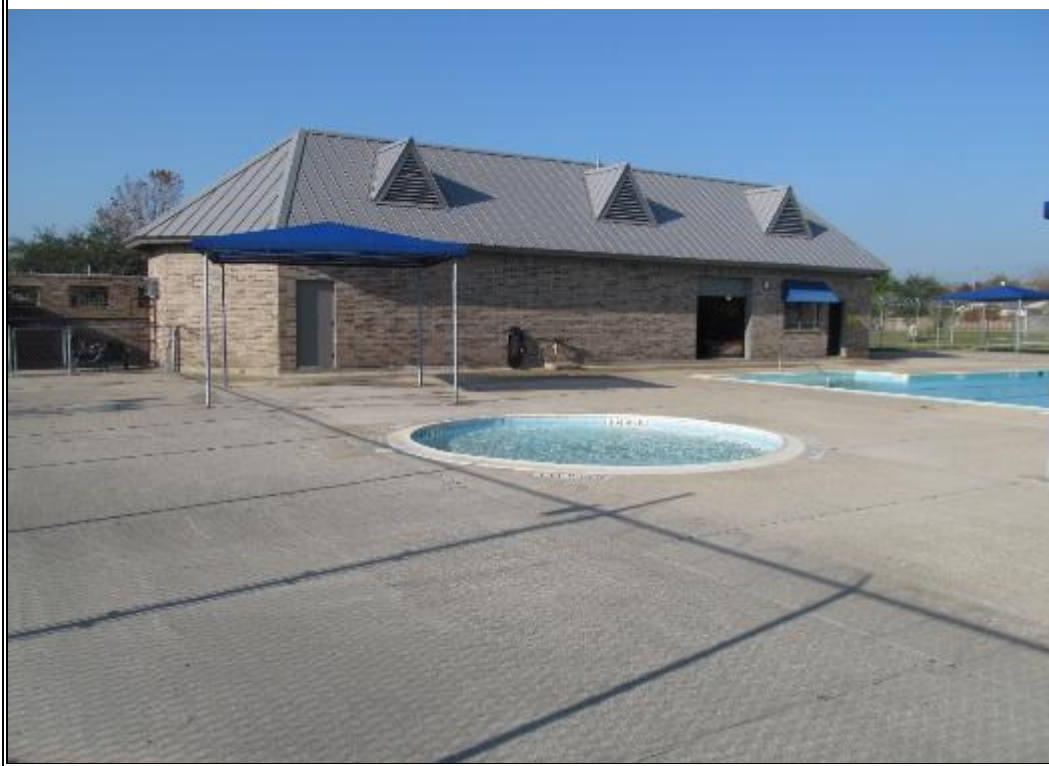
Photo Number
9

The pool deck appears to be in generally good condition.

The pool shade structures appear to be in good condition.

Description:
Clubhouse, pool
deck, and shade
structures

- We anticipate repair/replacement of the concrete pool deck over the term and have added an amount to the spreadsheet for this activity.
- We anticipate replacement of the pool sunshade fabric covers over the term and have added amounts to the spreadsheet for this activity.

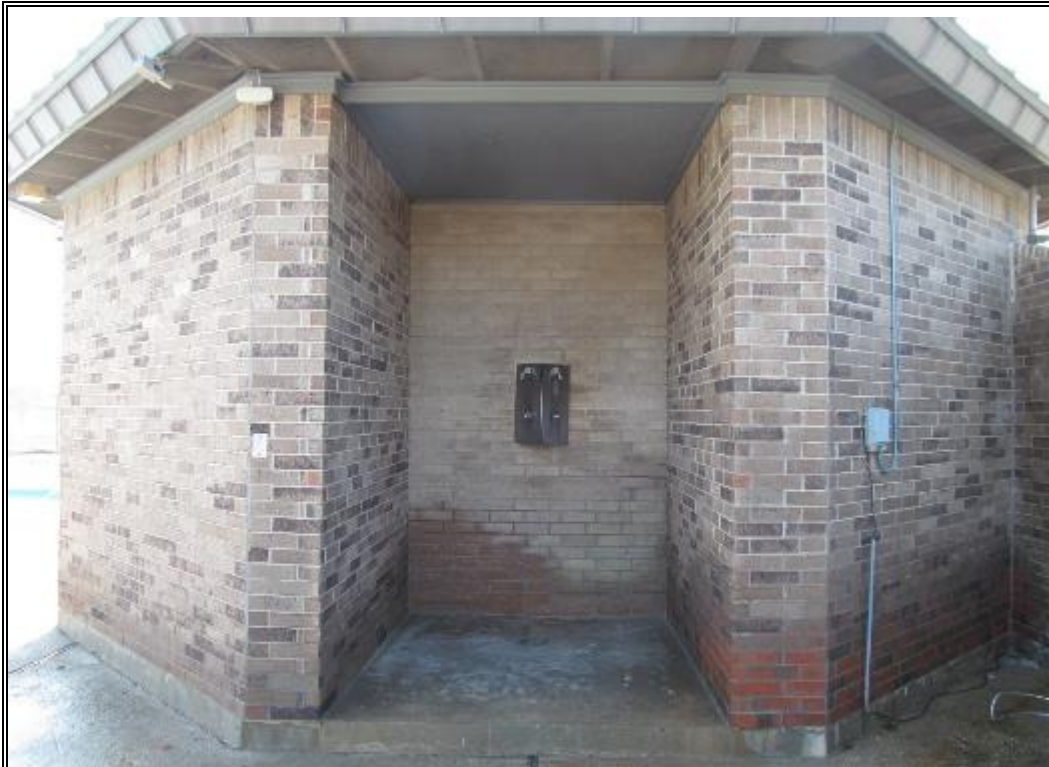
Photo Number
10

The outdoor shower area and fixtures are in good condition.

Description:
Outdoor showers
at north side of
clubhouse

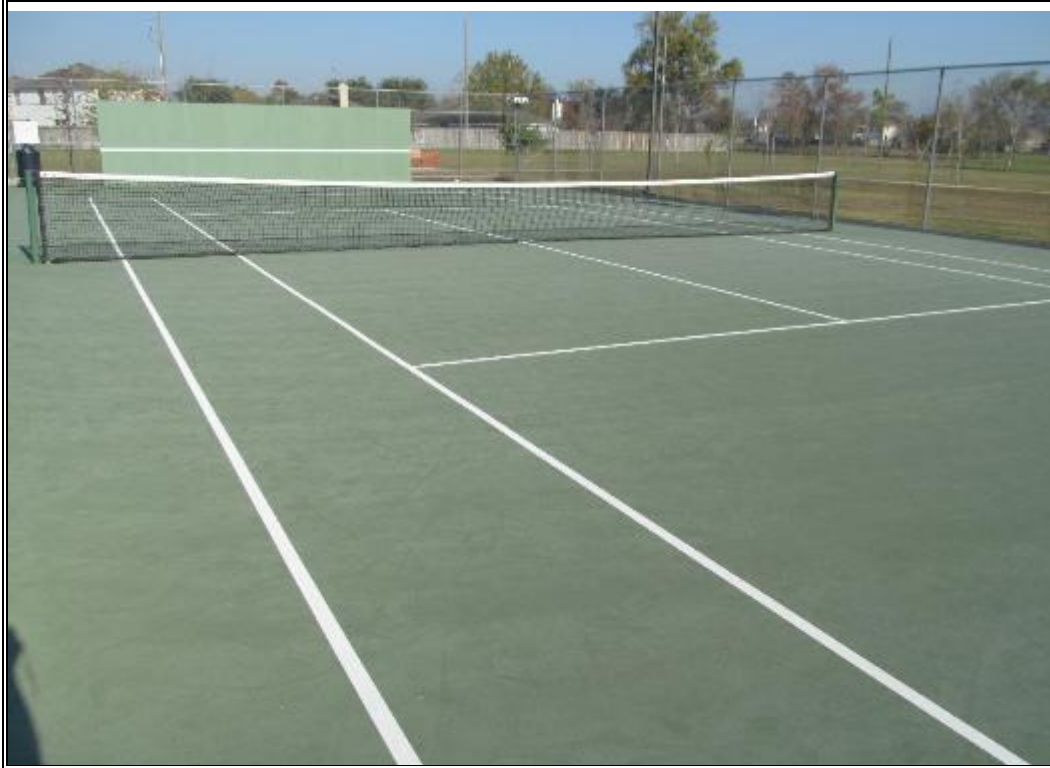
Photo Number
11

The tennis courts including lighting are in good condition. It is our understanding that the tennis courts were resurfaced in 2013.

Description:
View of tennis
courts and practice
backboards

- We anticipate an additional resurfacing of the tennis courts including replacement of nets over the term and have added an amount to the spreadsheet for this activity.

- We anticipate replacement of the tennis court lights over the term and have added an amount to the spreadsheet for this activity.

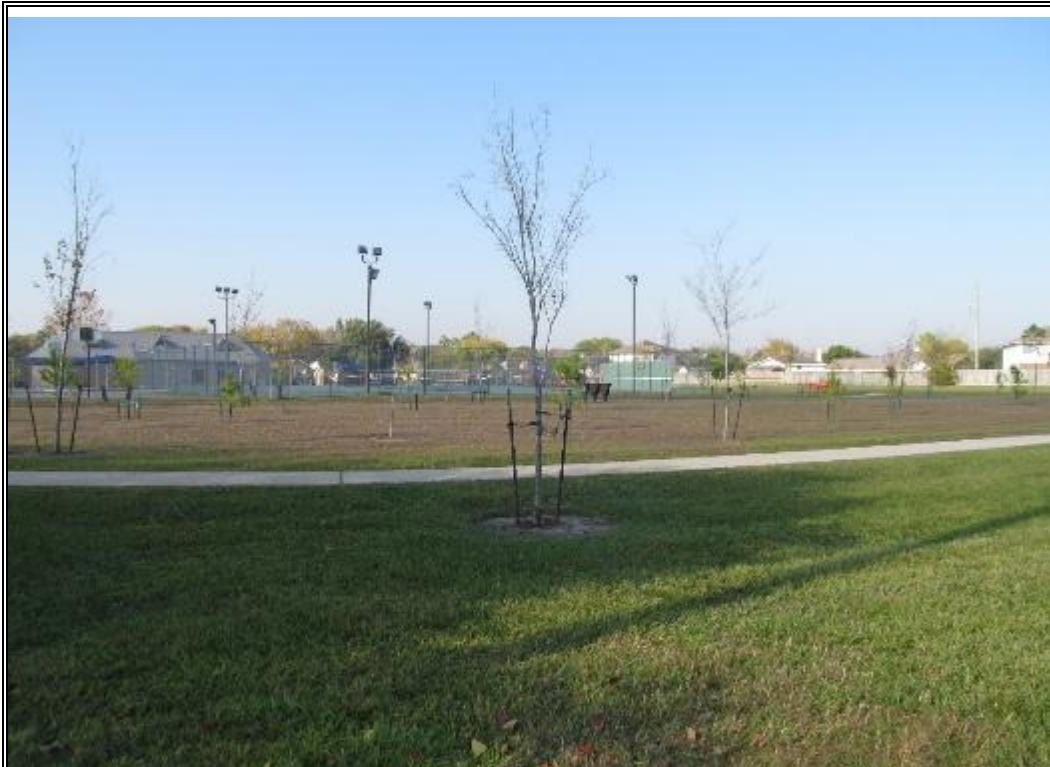
Photo Number
12

The concrete flatwork is in good condition. The walking path was installed in 2012.

Description:
View of walking
path, tennis courts,
and clubhouse
from rear of
property

- We anticipate repair and replacement of cracked and shifted sections of the flatwork over the 20 year term and have added amounts to the spreadsheet for this project.

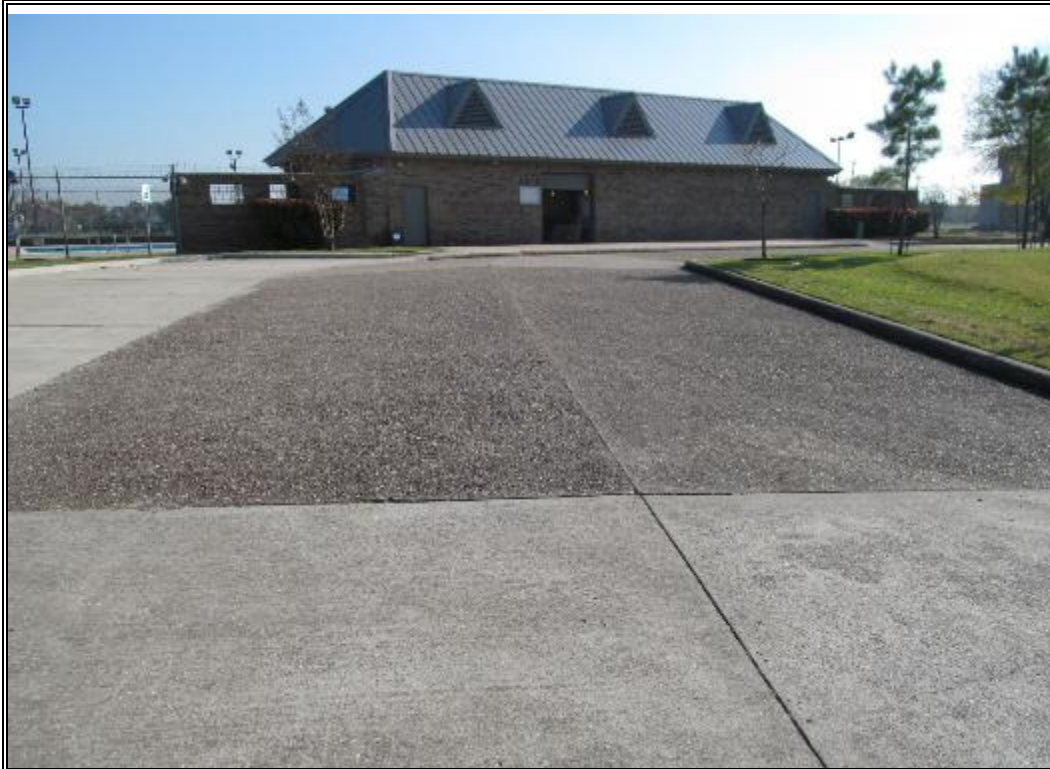
Photo Number
13

Description:
Front drive and left
side parking

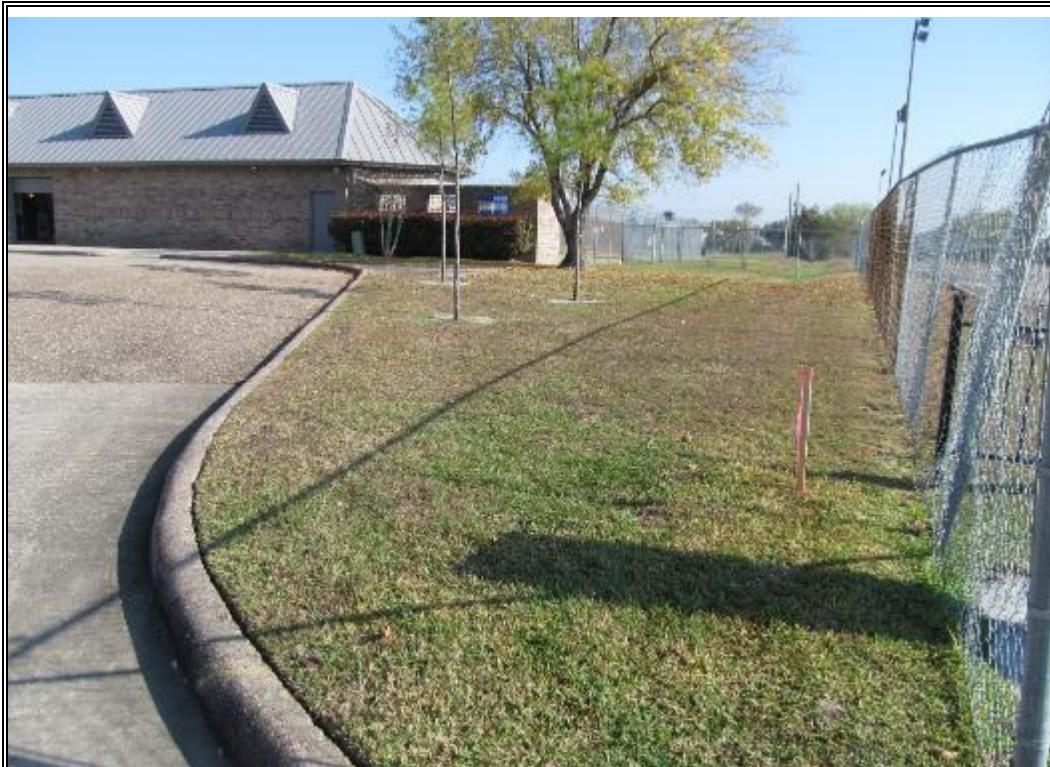
Photo Number
14

Description:
Site of new right
side parking area.

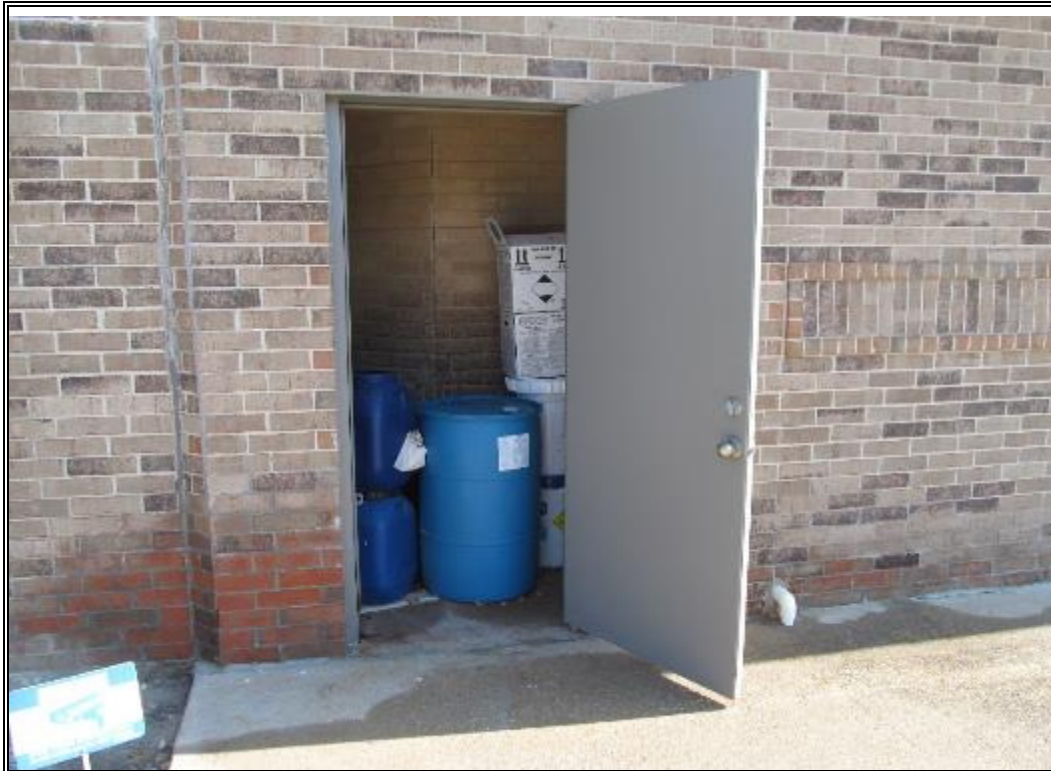
Photo Number
15

Ventilation of the pool filtration room and chemical storage appeared to be good to fair. We observed a buildup of crystallized chlorine on the pool pump and motor.

Description:
Pool chemical
storage room at
left side of
clubhouse.

- We recommend installation of additional ventilation equipment in the pool equipment and pool storage spaces and have added an amount to the spreadsheet for this activity.

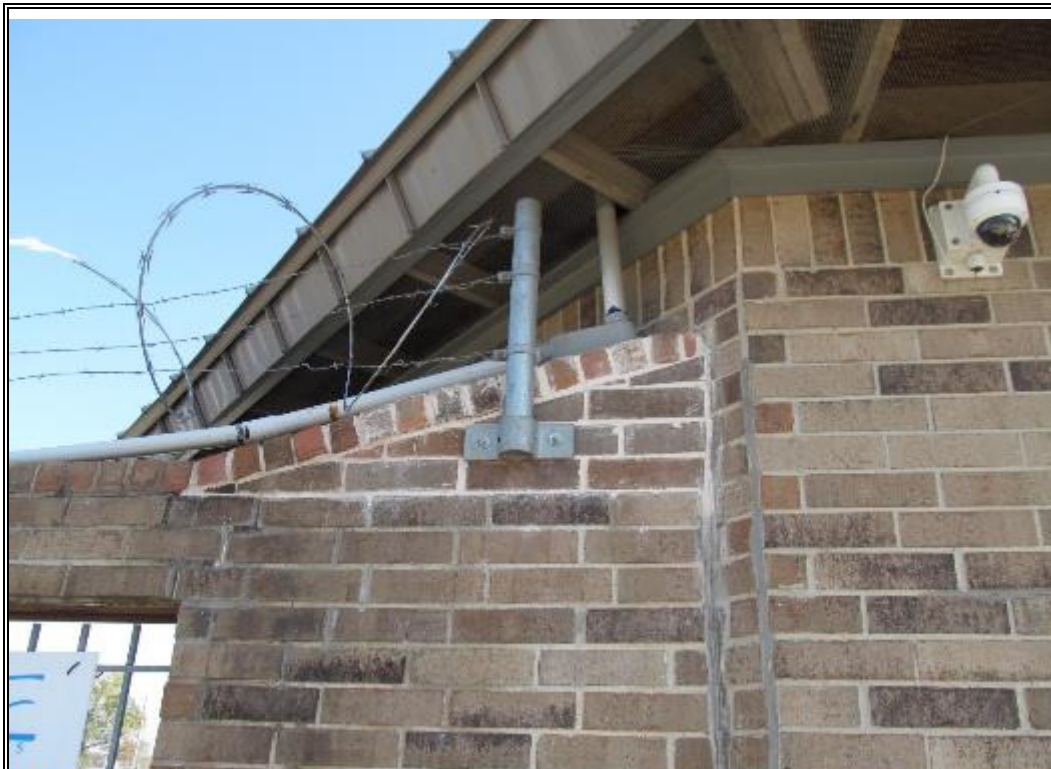
Photo Number
16

In the prior Reserve Study completed in 2012, it was noted that there was evidence of deterioration of the brick veneer mortar joints especially at the front around the door to the chemical storage and around the outdoor showers. This deterioration has since been repaired. The present condition of the brick exterior is good.

Description:
Repaired brick
mortar joints at
front of clubhouse

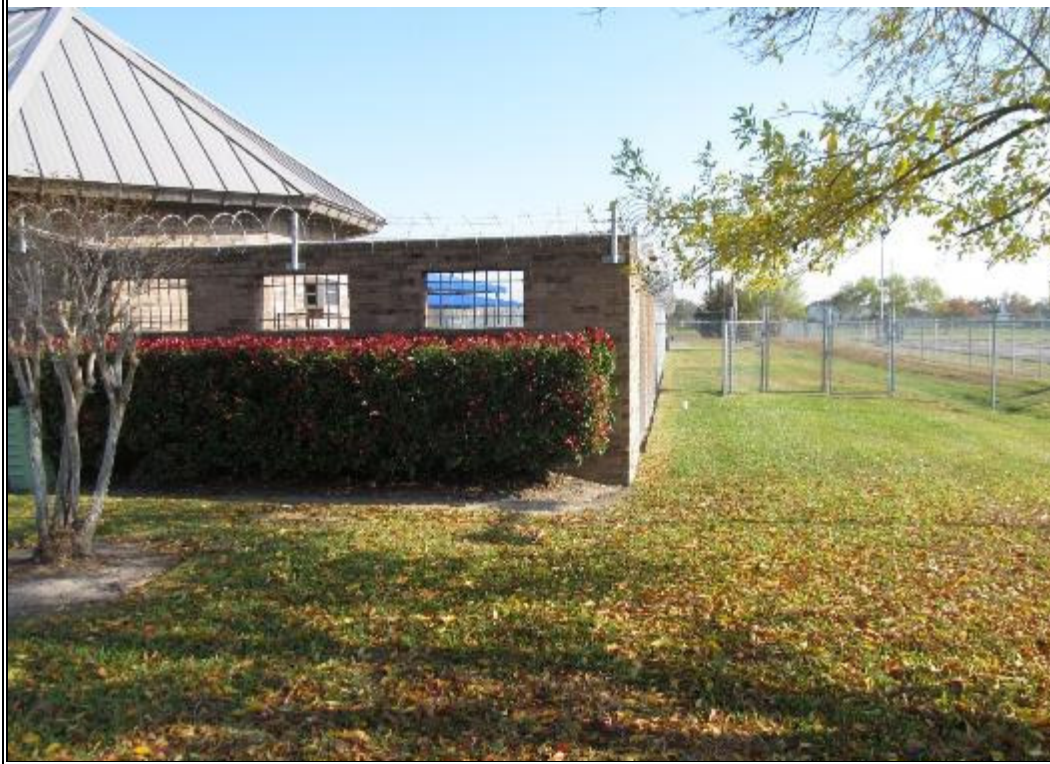
Photo Number
17

Right side of clubhouse looking to the rear along the right side lot line.

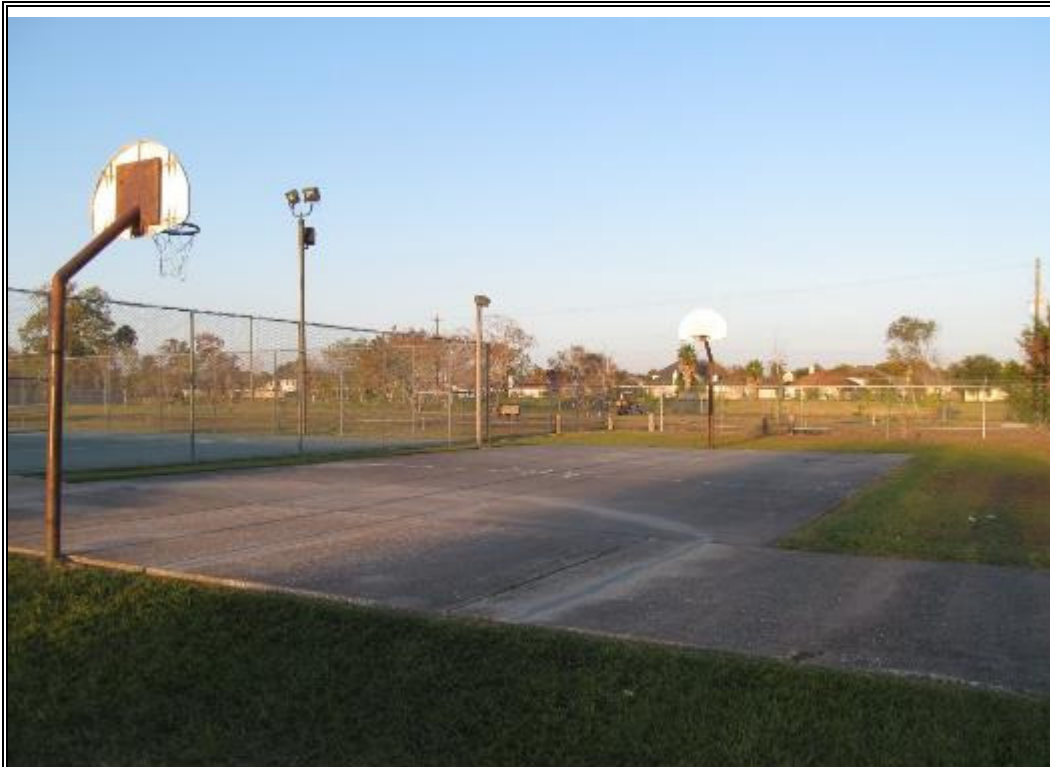
The basketball court appears to be in generally good condition.

Basketball court

- We anticipate refurbishment of the basketball court over the term and have added an amount to the spreadsheet for this activity.
- We anticipate replacement of the pool diving board and lifeguard chairs over the term and have added amounts to the spreadsheet for this activity.

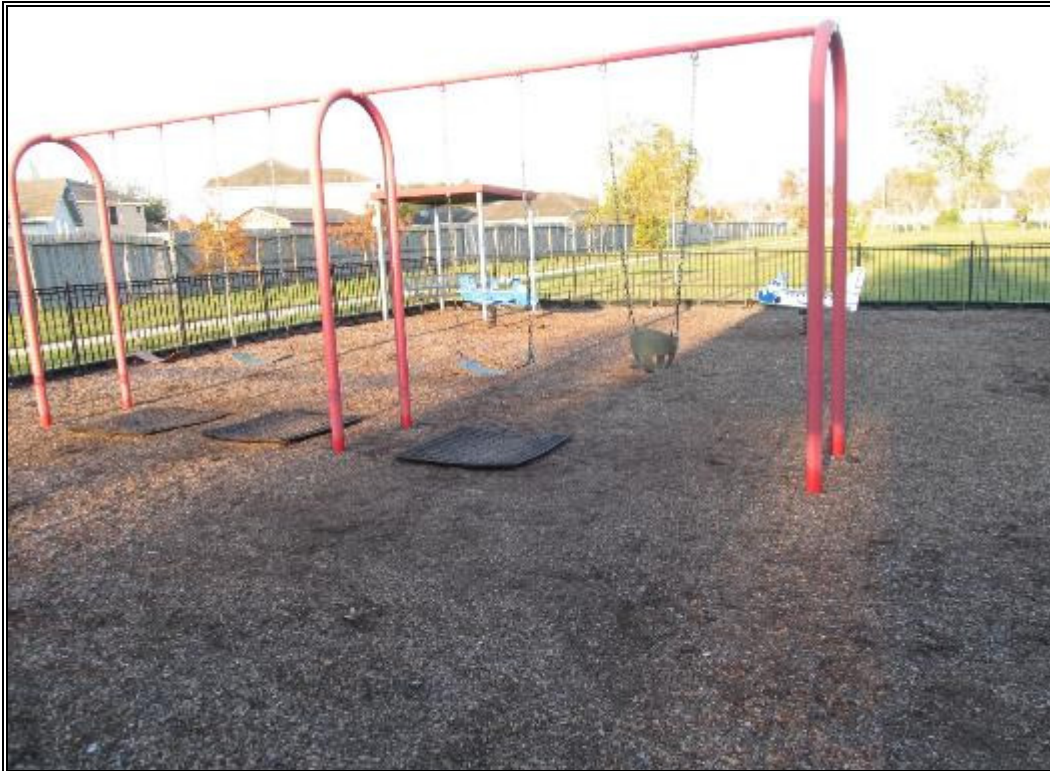
Photo Number
19

Description:
Play area swing set

- We have added amounts to the spreadsheet for the replacement of the cushioning mulch installed around the children's play area.
- We anticipate replacement of the children's swing set over the term and have added an amount to the reserves spreadsheet for this item.

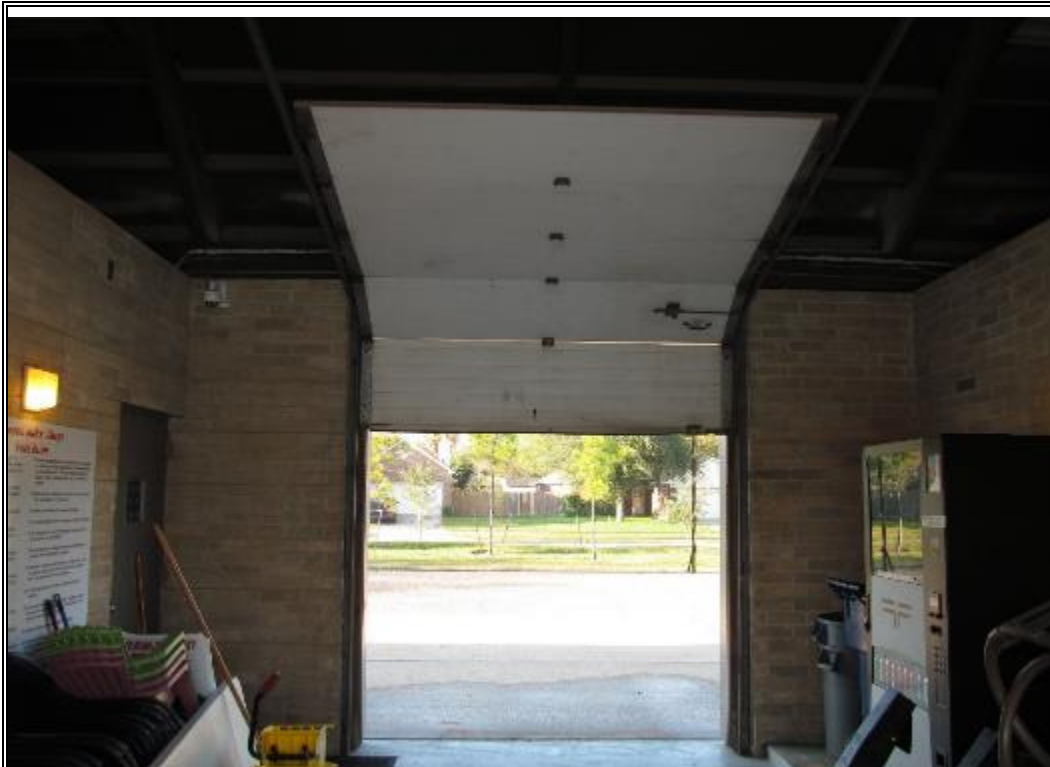
Photo Number
20

The rollup doors are in good condition.

Description:
One of two metal sectional rollup doors installed in clubhouse

- We anticipate replacement of the rollup doors over the term and have added an amount to the spreadsheet for this project.

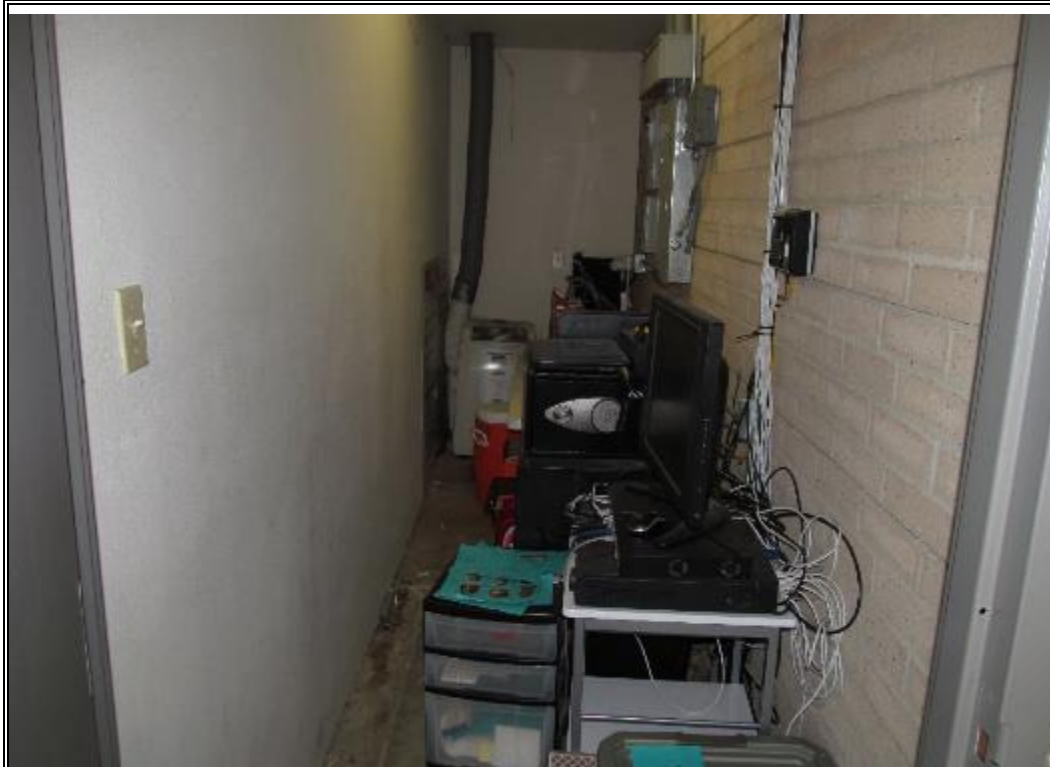
Photo Number
21

Description:
View of security
equipment room
showing main
electrical panel

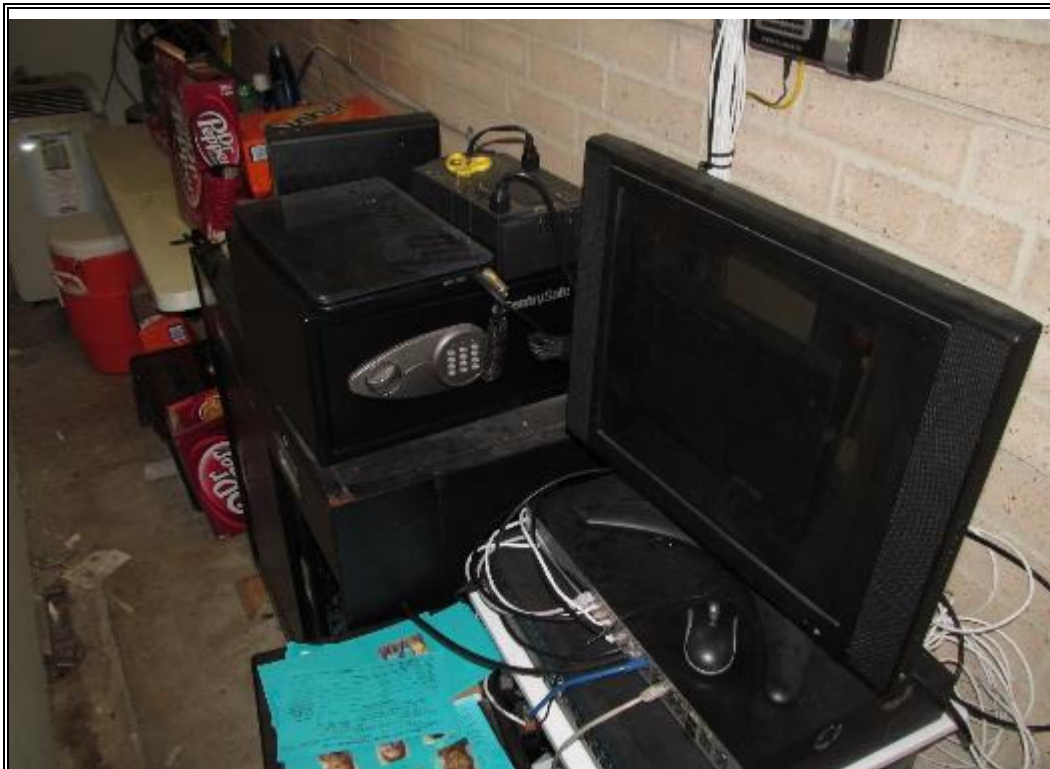
Photo Number
22

The community security and control system appears to be in good condition.

Description:
Security camera
and DVR

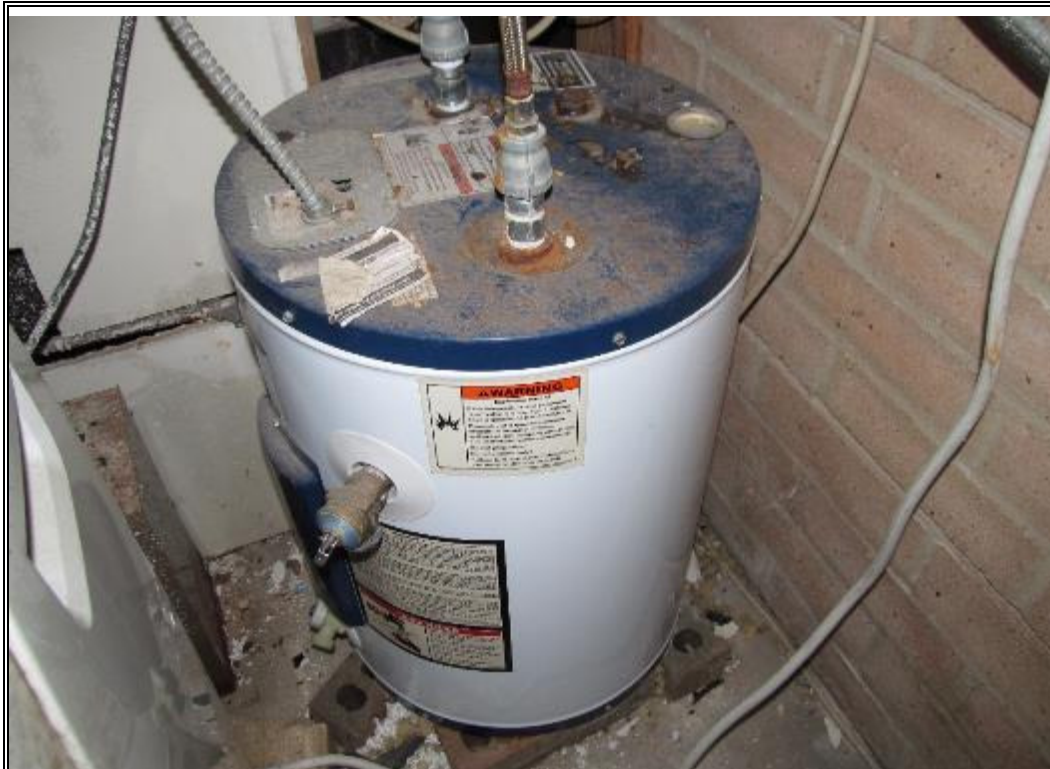
Photo Number
23

The clubhouse hot water heater is approximately 7 years old and is in generally good condition.

Description:
Domestic hot
water heater
located in security
room

- We anticipate the replacement of the clubhouse hot water heater over the term and have added an amount to the spreadsheet for this project.
- We anticipate replacement of the clubhouse air conditioning equipment over the term and have added amounts to the spreadsheet for this project.
- We do not anticipate replacement of the water fountain over the term.
- We anticipate replacement of the exterior shower fixtures over the term and have added an amount to the spreadsheet for this activity.
- We anticipate replacement of the large and wading pool water filtration systems over the term and have added amounts to the spreadsheet for these projects.
- We anticipate replacement/upgrades to the security equipment and have included funds for this activity.

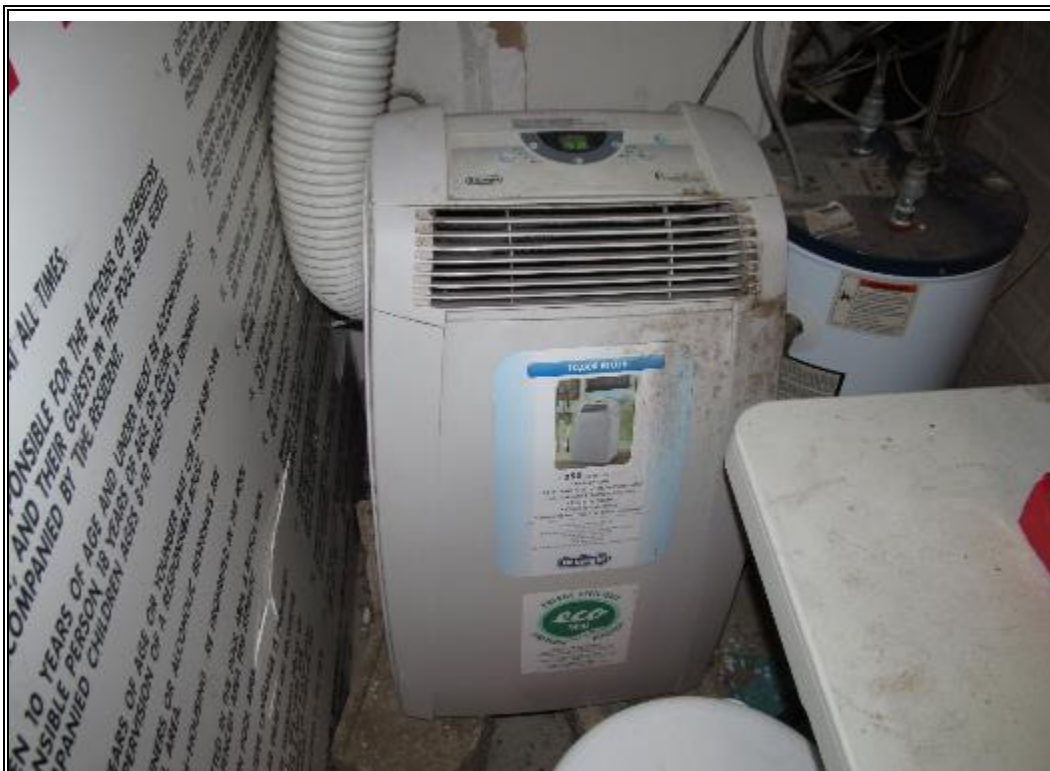
Photo Number
24

The kitchen/gathering room window air conditioner and security room air conditioner appear to be in good condition.

Description:
Small air
conditioner serving
security equipment
room

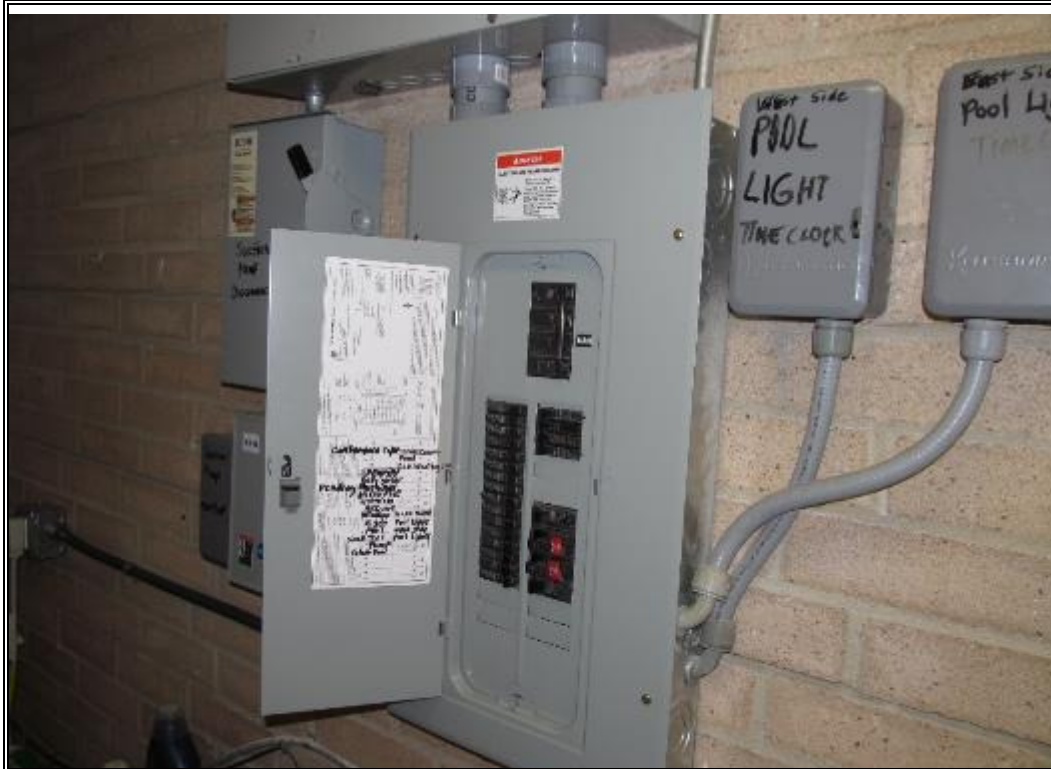
Photo Number
25

The clubhouse electrical panel appears to be in good condition.

Description:
Main electrical
panel

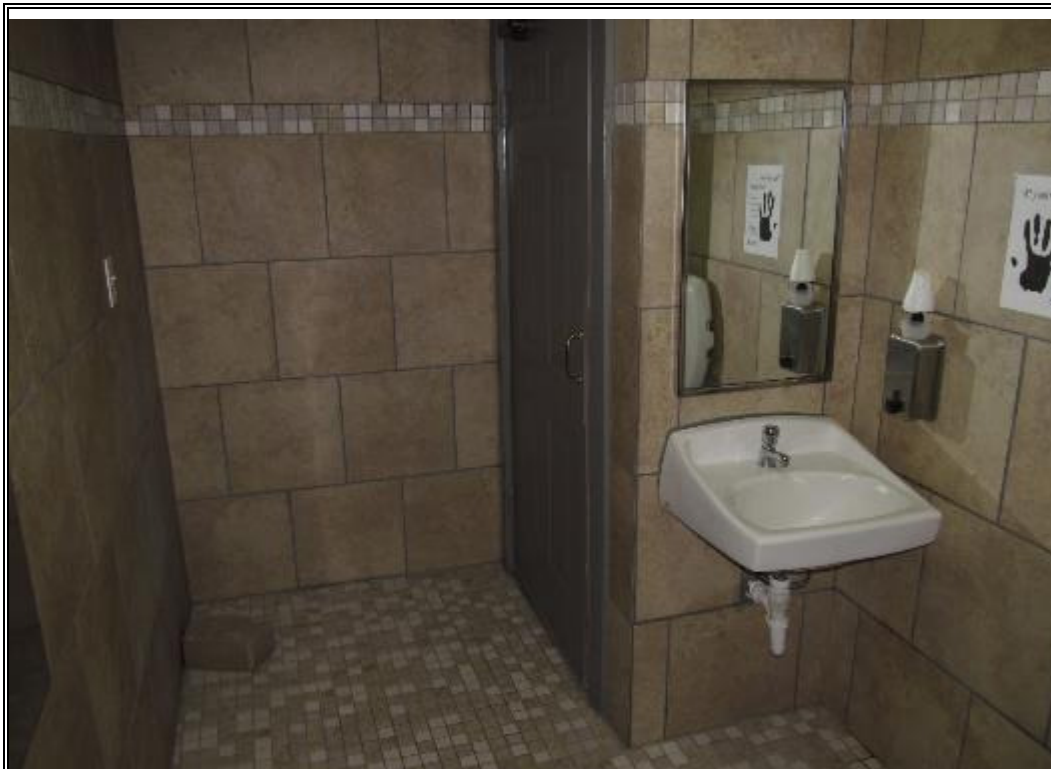
Photo Number
26

Description:
Clubhouse
restroom
