RESERVE FUND STUDY

**Meadowlake Village
7410 Breda Dr.
Baytown, TX 77521**

Final Report

December 20, 2015

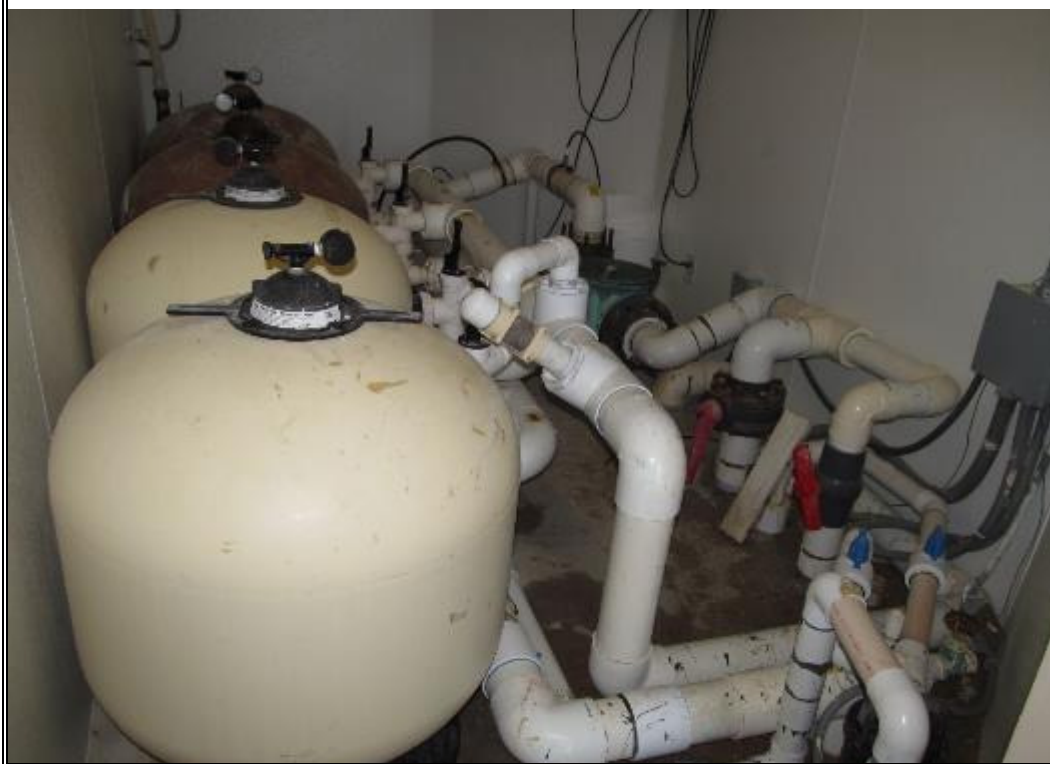
Photo Number
27

Ventilation of the pool filtration room and chemical storage appeared to be good to fair. We observed a buildup of crystallized chlorine on the pool pump and motor.

The large pool and wading pool water filtration equipment appears to be in generally good condition.

Description:
Pool filtration
equipment

- We recommend installation of additional ventilation equipment in the pool equipment and pool storage spaces and have added an amount to the spreadsheet for this activity.

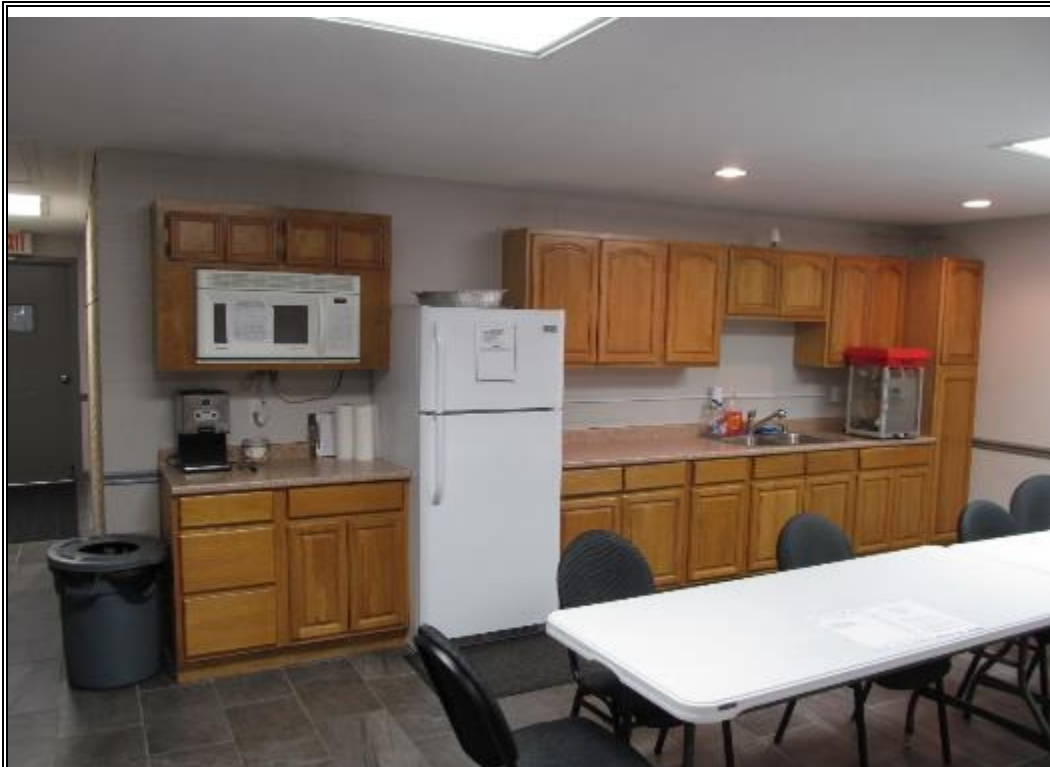
Photo Number
28

The clubhouse kitchen cabinets and appliances are in generally good condition.

Description:
Clubhouse kitchen

- The clubhouse kitchen appliances and cabinets will require replacement over the term. We have added amounts to the spreadsheet for these projects.

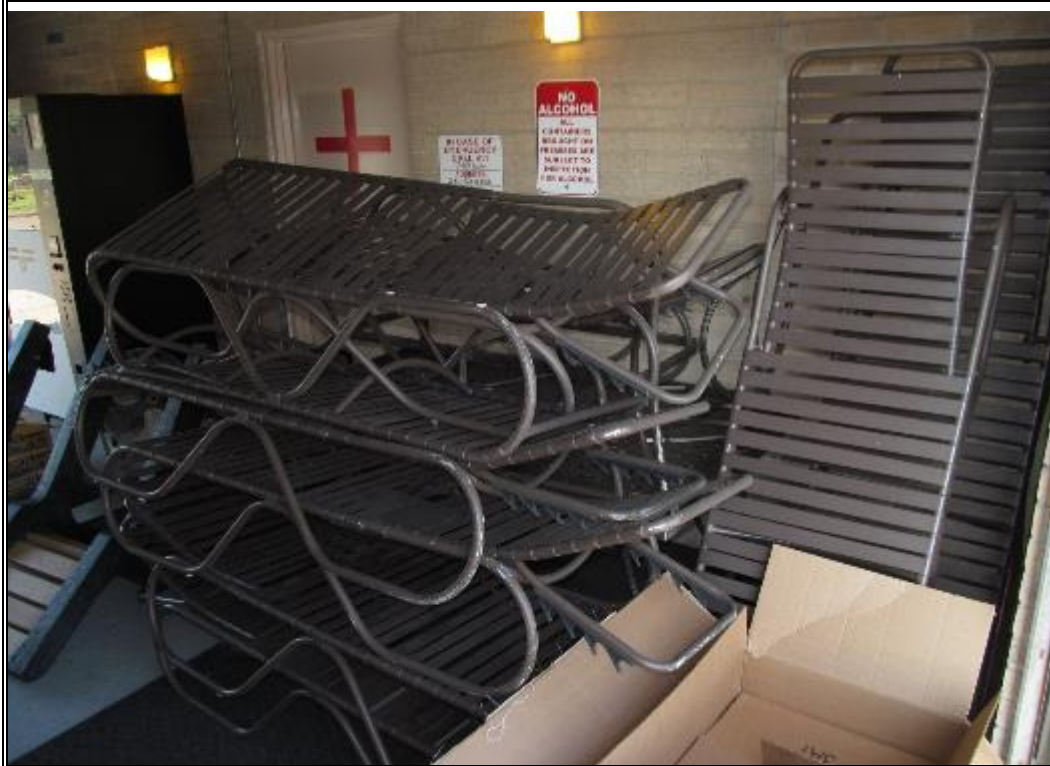
Photo Number
29

The pool furniture appears to be in good condition.

Description:
Pool furniture

- The pool furniture appears to be in good condition. We anticipate replacement of the pool furniture over the term and have added an amount to the spreadsheet for this activity.

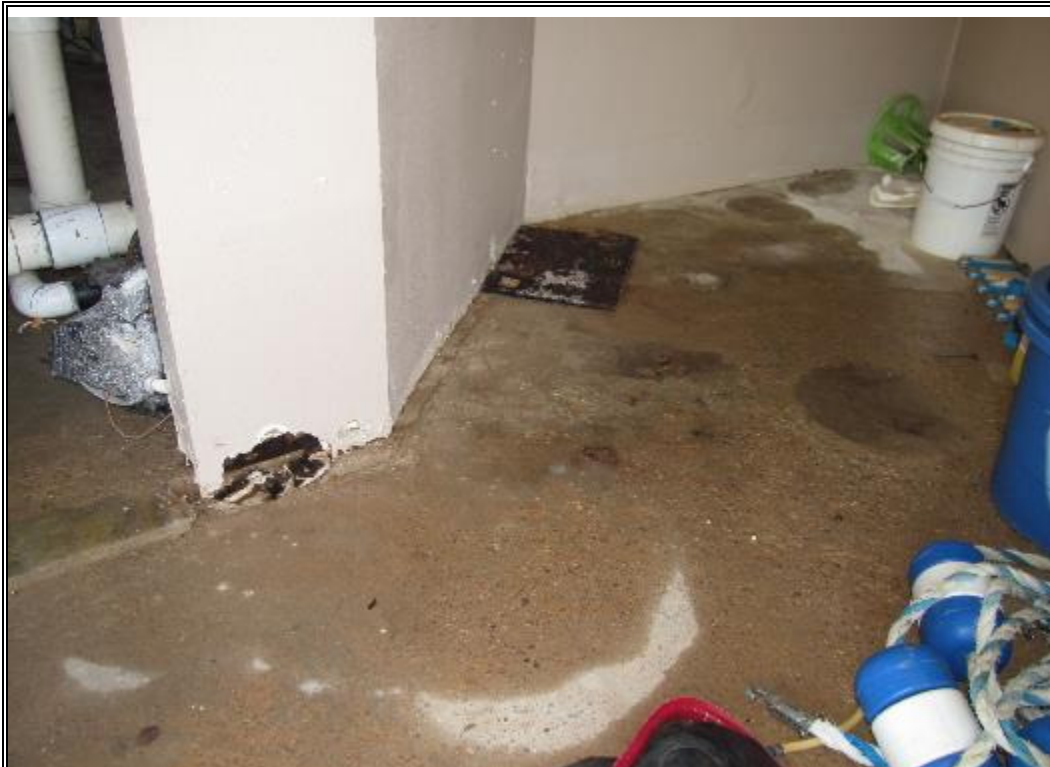
Photo Number
30

Description:
Minor amount of
drywall
deterioration in
pool filtration
room.
