General Information

Property Address 1234 E. 1st. St.
City Shawnee State Okla. Zip 74804
Contact Name Jane Doe

Inspector Name Deveral Bridges
Company Name Advanced Home Inspections
Company Address 200 Wright Lane
City Chandler State OK Zip 74834
Phone 405-240-0216 Fax 405-258-2062
E-Mail deveral@sbcglobal.net
File Number 594-0502
Amount Received \$245.00 Check #1234

Advanced Home Inspections

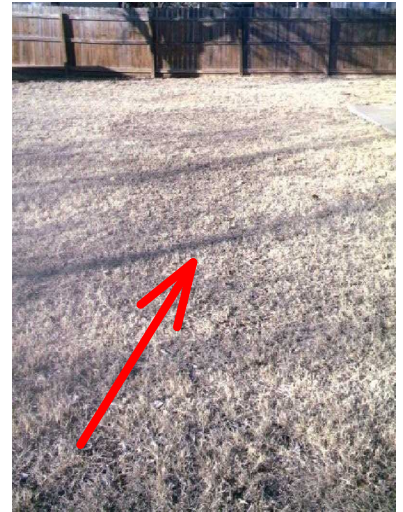
| 15. | <input type="checkbox"/> | <input type="checkbox"/> | <input type="checkbox"/> | <input type="checkbox"/> | <input checked="" type="checkbox"/> | Swale: Pooling due to improper drainage Swale does not have adequate depth or slope for proper drainage |

<u>Low</u>	<u>High</u>
<u>Grounds</u>		
Swale: The negative grading in the back yard is channeling the water towards the back of the house. Because of the lack of swale to channel the water around the house, the water is pooling in the yard just west of the patio concrete slab.	\$ 250	\$ 300
<u>Exterior Surface and Components</u>		
Type: Stress cracks present above the garage door and at the northeast corner of the garage. The broken bricks could be replaced and the mortar patched.	\$ 200	\$ 250
Trim: Wood rot is present in the garage door jamb on the south side of the door.	\$ 50	\$ 75
Fascia: Wood rot is present in the fascia at the lower end of the front gable.	\$ 50	\$ 75
Patio Door: The deadbolt of the patio door needs to be oiled to operate properly.		
<u>Garage</u>		
Ceiling: A crack is present in the center of the garage ceiling. It is not representing any structural problems and I would simply recommend that it be patched and painted.	\$ 40	\$ 50

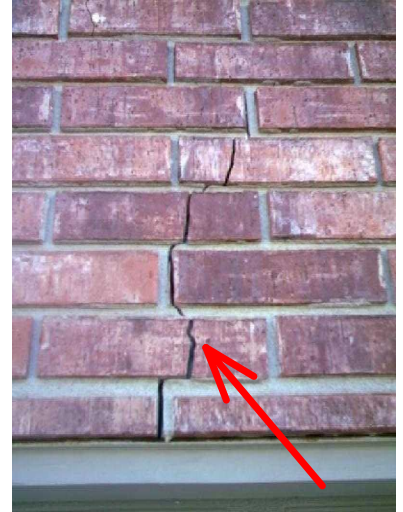
1. Type: Brick veneer **Stress cracks.**

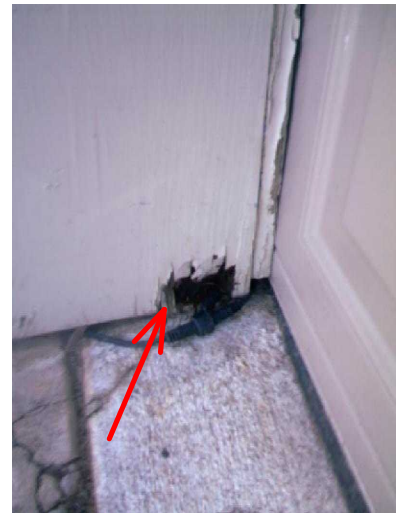
2. Trim: Wood **Wood rot**

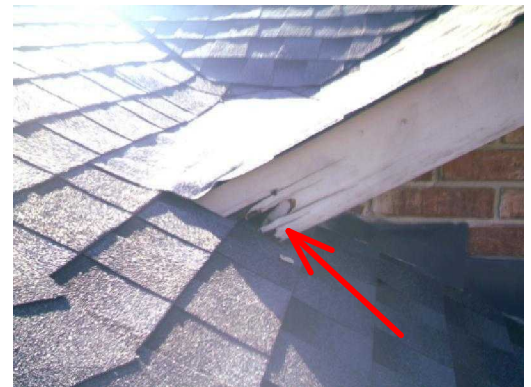
3. Fascia: Wood **Wood rot**

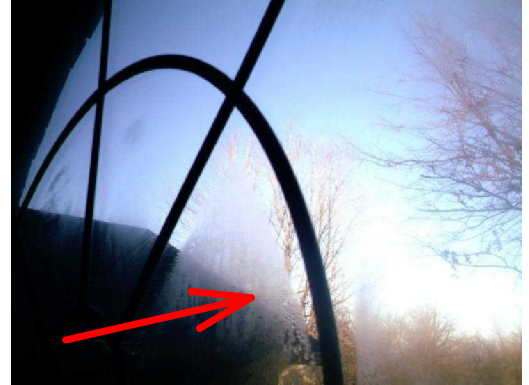
8. Windows: Aluminum single hung **Lost seal.**
Fogged window.

<u>Low</u>	<u>High</u>
<u>Exterior Surface and Components</u>		
Windows: The arched window in the dining room has lost its seal and fogged.	\$ 400	\$ 500
Window Screens: Missing screen at the south end of the house.	\$ 20	\$ 30
Replacement Total	\$ 420	\$ 530
Cost Estimate Total	\$ 1125	\$ 1435

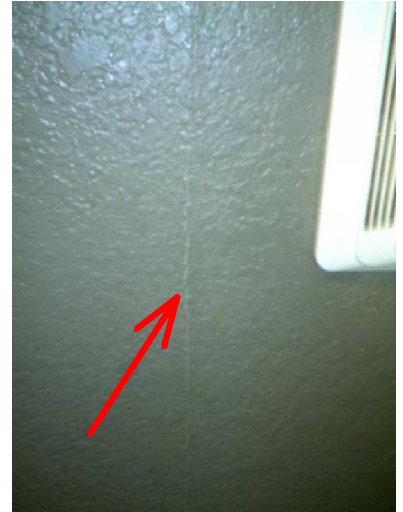
- 1. Closets: Small & Walk-in
- 2. Ceilings: Drywall Cracks present

<u>Interior</u>		
Ceilings: Crack present in the ceiling of the master bathroom. Recommend patching and painting.	\$ 40	\$ 50
Floors: Loose flooring between the dining room and the kitchen. The transition strip needs to be installed to prevent the trip hazard.	\$ 20	\$ 30
<u>Electrical</u>		
Manufacturer: Open space in box needs to be covered.	\$ 10	\$ 15
GFCI: The breaker does not trip when tested with an external tester. It also shows that the Hot and Neutral wires are switched.	\$ 20	\$ 30
Exterior Electric Outlets: The outlet on the back patio was not operating.	\$ 25	\$ 30
<u>Structure</u>		
Differential Movement: There is a crack in the brickwork in the center of the garage door. The crack appears to have been caused by settlement in the angle iron which was installed above the opening to support the brick in the gable. It doesn't appear that the crack was caused by any type of footing failure. If you are concerned about the crack and what caused it, you may want to get the opinion of a Structural Engineer.

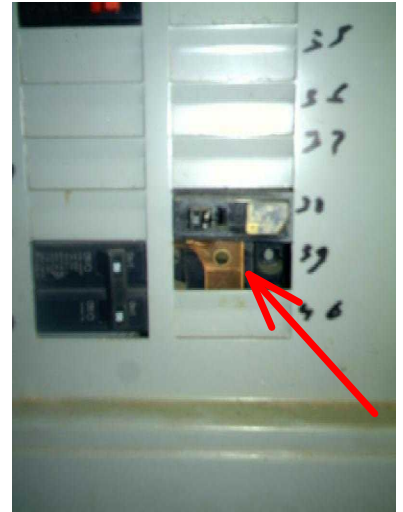
- 1. Service Entrance: Under ground utilities
 - 2. Service Size Amps: 200 Volts: 220-240 VAC
 - 3. Service: Copper
 - 4. Ground: Rod in ground only
 - 5. 120 VAC Branch Circuits: Copper
 - 6. 240 VAC Branch Circuits: Copper
 - 7. Aluminum Wiring:
 - 8. Conductor Type: Romex
 - 9. Interior Lighting: 110 VAC
 - 10. 120 VAC Outlets: Grounded
 - 11. 240 VAC Outlets: 3-pole 3-wire grounded
- Garage Electric Panel
- 12. Manufacturer: General Switch Open "knock-out" hole- insert "blank-out" cap to close off opening

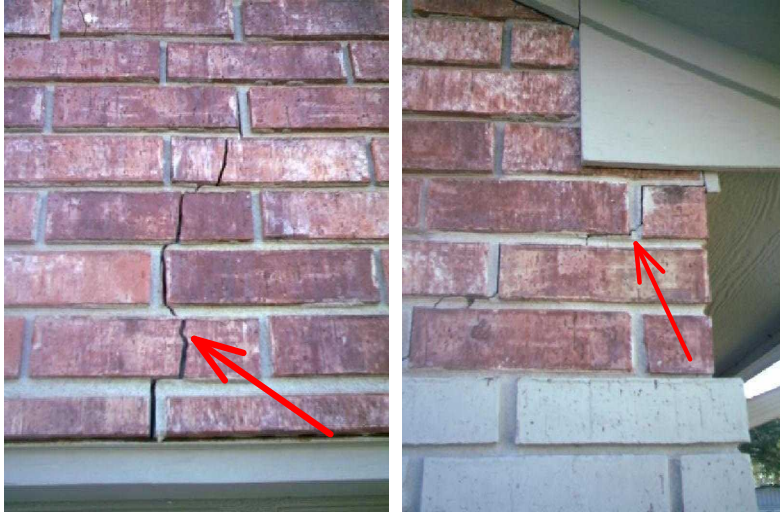
| 3. | <input type="checkbox"/> | <input type="checkbox"/> | <input type="checkbox"/> | <input type="checkbox"/> | <input checked="" type="checkbox"/> | Differential Movement: Crack with displacement Vertical crack in brick above the garage door. |

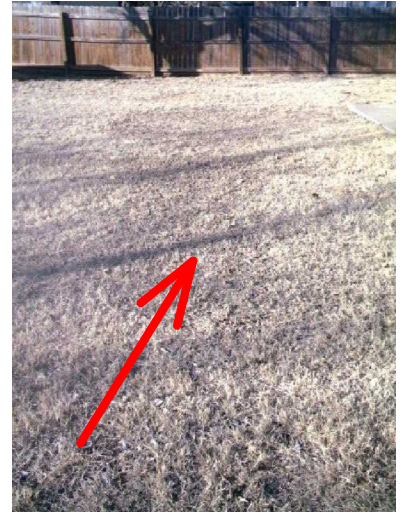
1. **Swale:** Pooling due to improper drainage Swale does not have adequate depth or slope for proper drainage

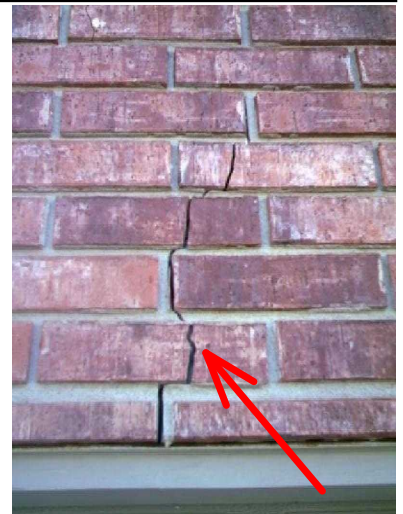
2. Whole house Exterior Surface Type: Brick veneer Stress cracks.

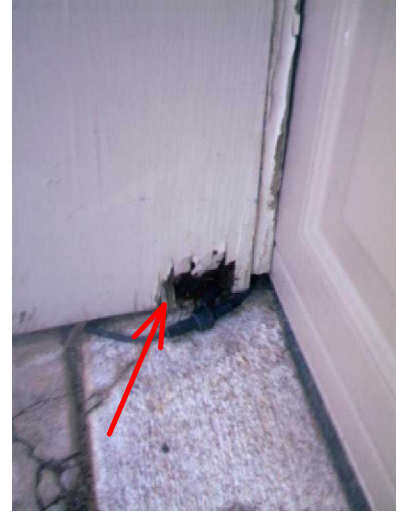
3. Trim: Wood Wood rot

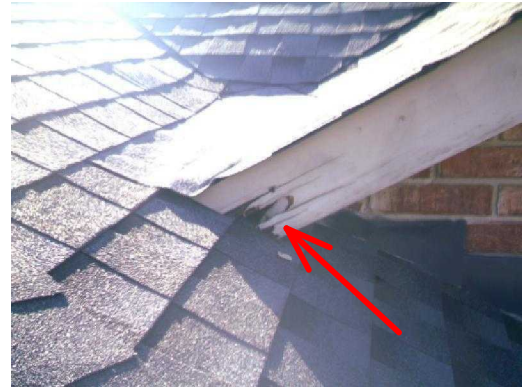
4. Fascia: Wood Wood rot

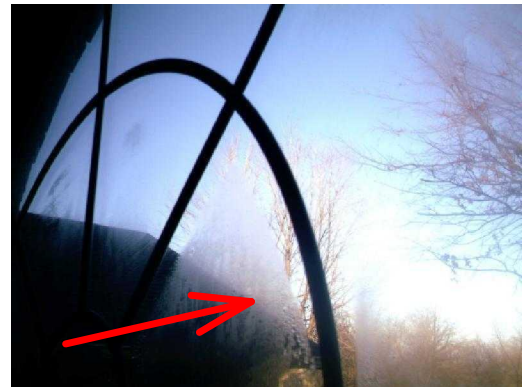
6. Windows: Aluminum single hung Lost seal. Fogged window.

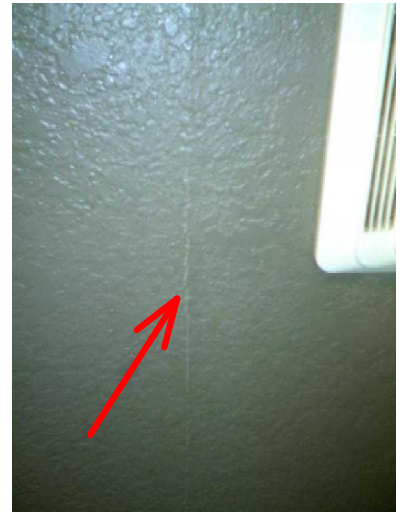
9. Ceilings: Drywall Cracks present

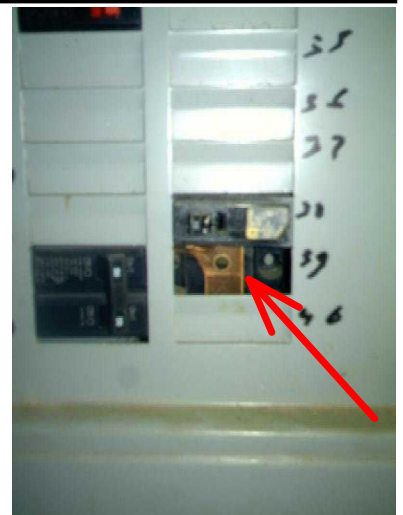
11. Garage Electric Panel Manufacturer: General Switch Open "knock-out" hole- insert "blank-out" cap to close off opening

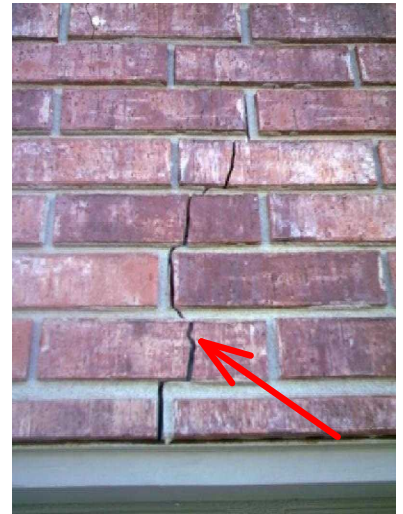
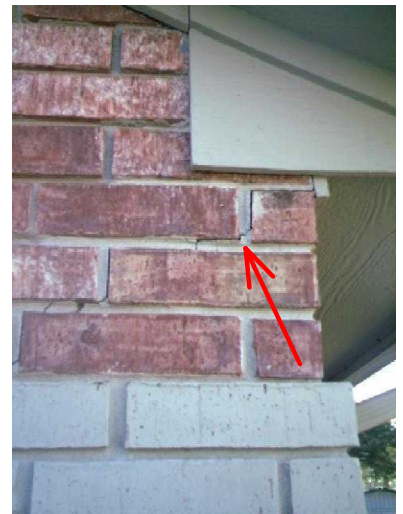
14. Differential Movement: Crack with displacement Vertical crack in brick above the garage door.
