CONEJOS RIVER

DIVERSION INFRASTRUCTURE INVENTORY

Structure Name: WILLIAM STEWART CO IRR D

Date: April 16, 2019

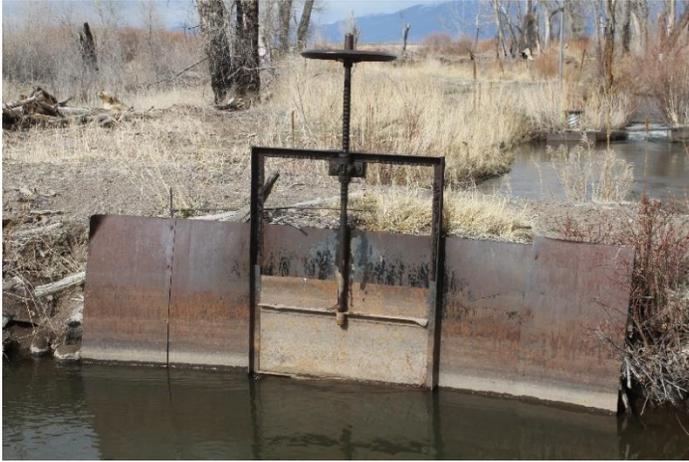
Headgate looking downstream

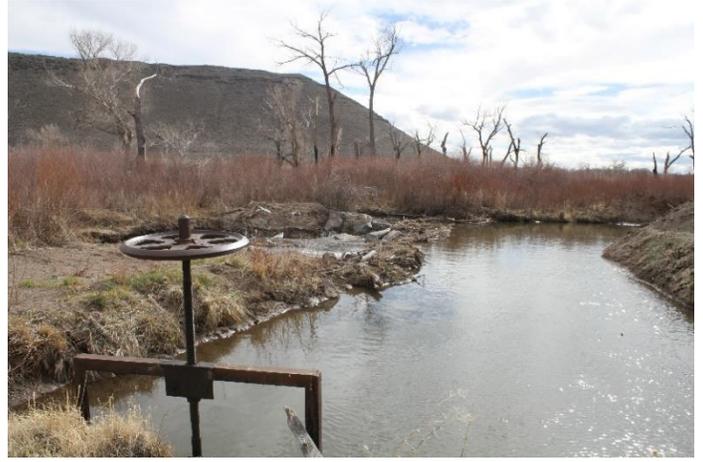
Headgate and diversion dam (on feeder ditch)

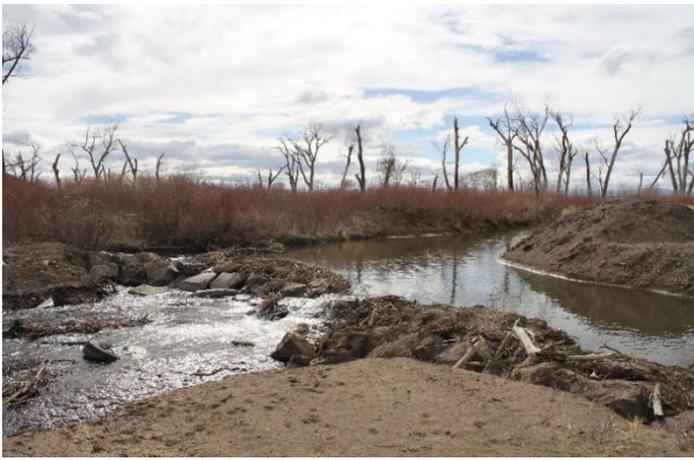
Diversion dam on feeder ditch

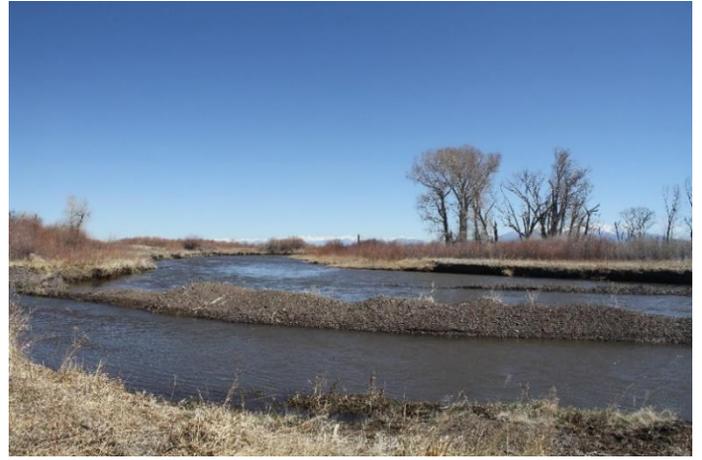
Diversion dam looking downstream

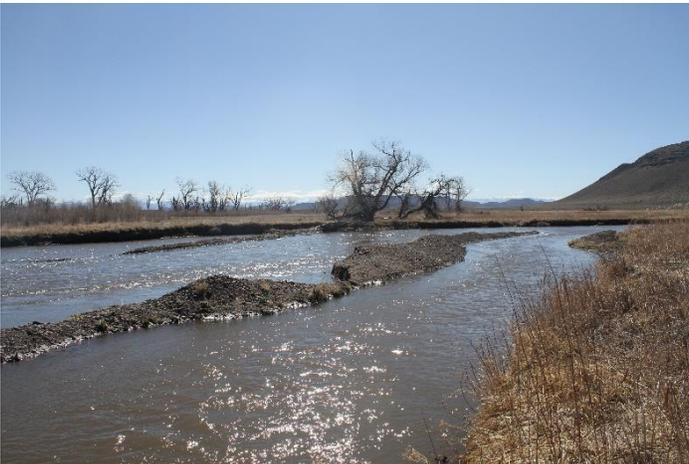
Diversion dam looking upstream

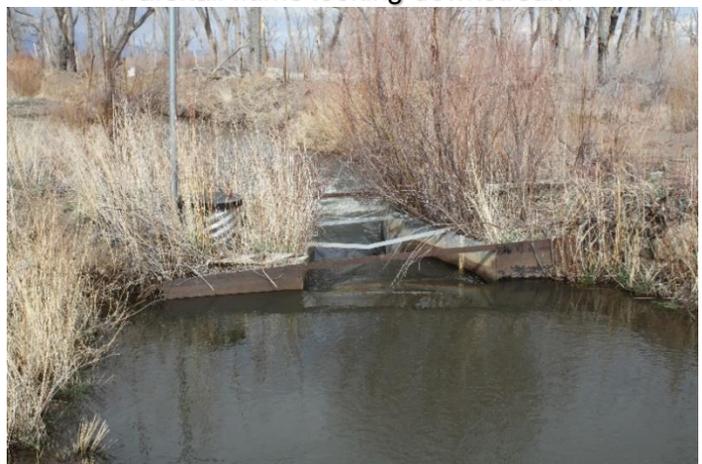
Parshall flume looking downstream

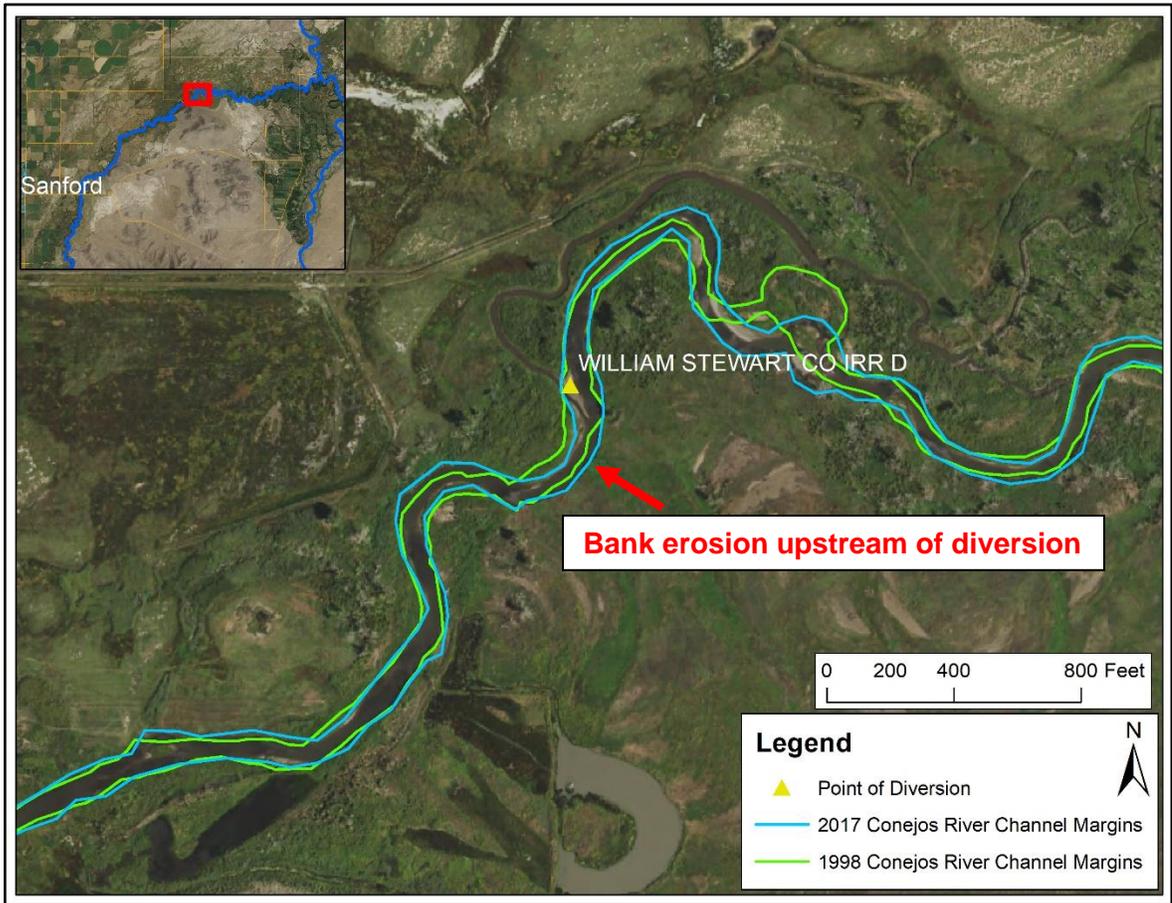
Headgate location with 1998 and 2015 channel margins overlaid.

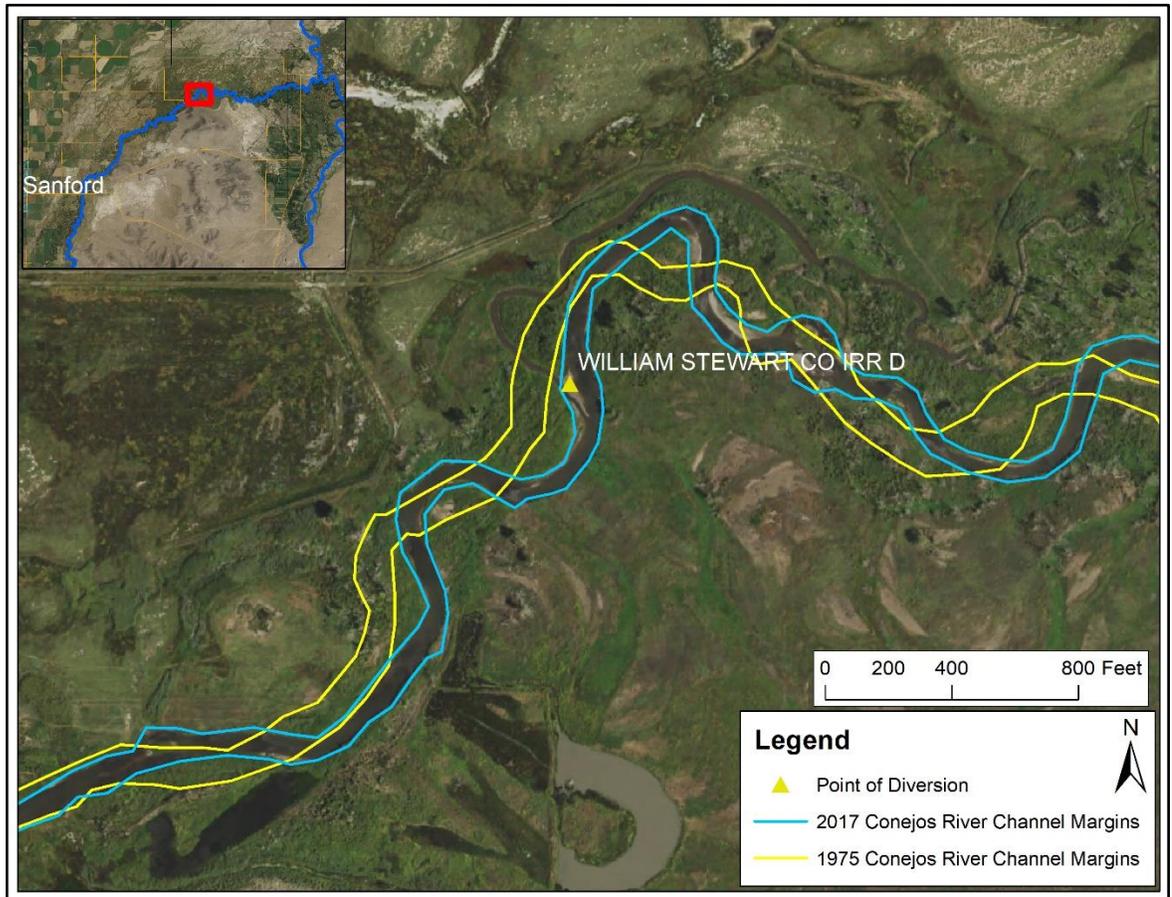
Headgate location with 1975 and 2015 channel margins overlaid.
