Sample Inspection Report

1234 School House Road
Yourtown, US 12345

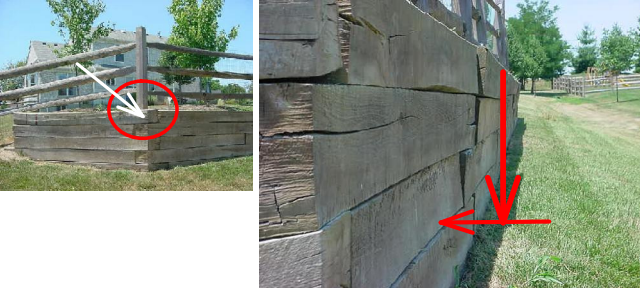
1. Vegetation: Shrubs with some weeds
2. Retaining Walls: Railroad ties - **The wall is showing signs of movement, but appears to be stable at this time. A qualified contractor is recommended to evaluate and estimate repairs to maintain the wall.**

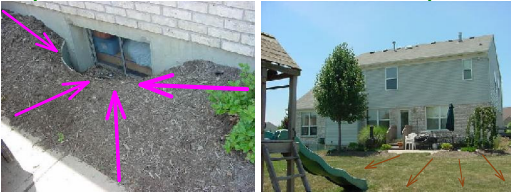
1. Deck: Treated wood - **The deck has been built below acceptable building standards and is not safe in its current state. Recommend further evaluation and estimate to bring deck up to an acceptable building standard.**
2. Grading: Moderate slope - **The grade and landscaping materials are too high and extend above the window well at the Northeast rear of the home. Recommend that the grade be reduced or the metal window well soil retainer be replaced with a taller unit to keep the mulch and soil beds from washing into the well.**

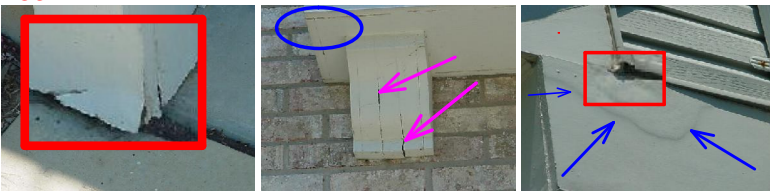
4. Trim: Composite material - **Note: Damaged wood areas should be checked while doing the repair and replaced if wood rot is present.**

1. **Water damage to trim wood at either side of garage door from moisture wicking into the finished particle board. The surface is starting to delaminate. Recommend repair/replacement of the trim boards and silicone seal wood that is in contact with concrete to prevent wicking.**

2. **The wood window boxes have water damage and will require repair/replacement. The wood has started to separate at the supports and at the corners of the window boxes.**

3. **The trim board at the southwest corner of the porch has water damage due to water penetration. The trim board extends out creating a ledge allowing water to collect on the top edge of the board and cause the wood to rot.**

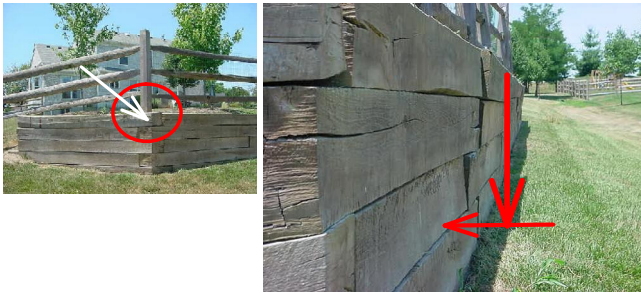
- 1. Acceptable Walks: Concrete
- 2. Acceptable Steps/Stoops: Concrete
- 3. Acceptable Patio: Pebble top
- 4. Defective Deck: Treated wood - **The deck has been built below acceptable building standards and is not safe in its current state. Recommend further evaluation and estimate to bring deck up to an acceptable building standard.**
- 5. Acceptable Balcony: Concrete
- 6. Acceptable Porch: Concrete
- 7. Marginal Vegetation: Shrubs with some weeds
- 8. Marginal Retaining Walls: Railroad ties - **The wall is showing signs of movement, but appears to be stable at this time. A qualified contractor is recommended to evaluate and estimate repairs to maintain the wall.**

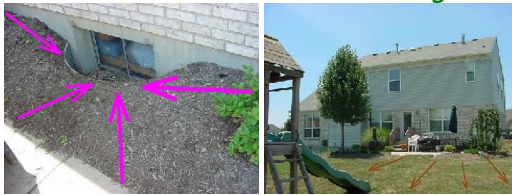
- 9. Acceptable Basement Stairwell: Concrete
- 10. Acceptable, Defective Grading: Moderate slope - **The grade and landscaping materials are too high and extend above the window well at the Northeast rear of the home. Recommend that the grade be reduced or the metal window well soil retainer be replaced with a taller unit to keep the mulch and soil beds from washing into the well.**

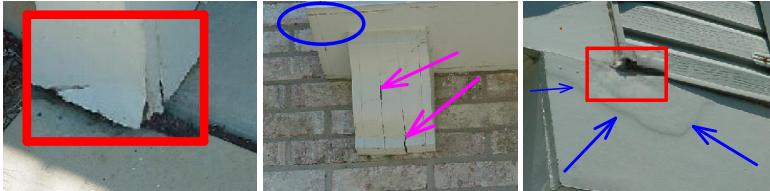
2. Acceptable Type: Vinyl siding
3. Defective Trim: Composite material - **Note: Damaged wood areas should be checked while doing the repair and replaced if wood rot is present.**

1. **Water damage to trim wood at either side of garage door from moisture wicking into the finished particle board. The surface is starting to delaminate. Recommend repair/replacement of the trim boards and silicone seal wood that is in contact with concrete to prevent wicking.**

2. **The wood window boxes have water damage and will require repair/replacement. The wood has started to separate at the supports and at the corners of the window boxes.**

3. **The trim board at the southwest corner of the porch has water damage due to water penetration. The trim board extends out creating a ledge allowing water to collect on the top edge of the board and cause the wood to rot.**

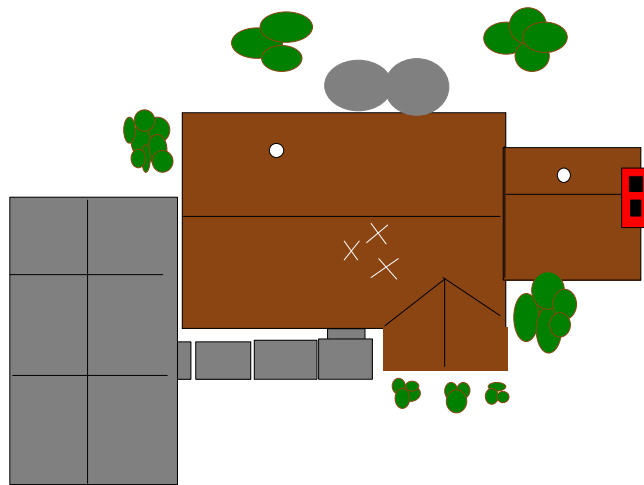
1. Method of Inspection: On the roof
2. Not Inspected Unable to Inspect: 30% - Height of the roof
3. Defective Material: Fiberglass shingle - Missing roof shingles from wind damage as marked "x" in diagram. Repairs are required.
4. Type: Gable
