Home Inspection Report

1234 New Street
Better City, North Carolina 27215

Date of Inspection: Saturday, February 28, 2015

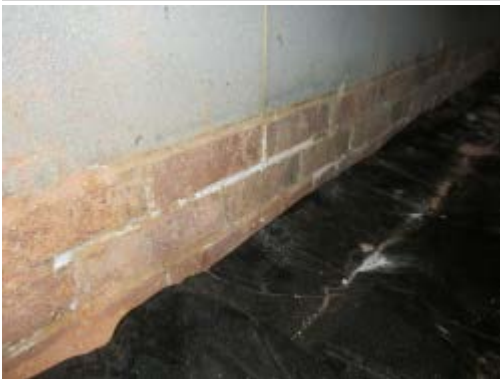
(A1 - 1.1) Main House

Efflorescence (salt stains) was noted on the foundation walls. The stains indicate that the foundation was been cyclically wet and dry. Water penetration into the foundation area can result in structural damage and undesirable environmental conditions. Water in the foundation area indicates an absent or damaged waterproofing and foundation drain systems. Repairs are needed to prevent water penetration. A general contractor should be consulted for further evaluation to determine the source of the moisture and to make necessary repairs. Refer to the exterior section of the report concerning the lot grading.

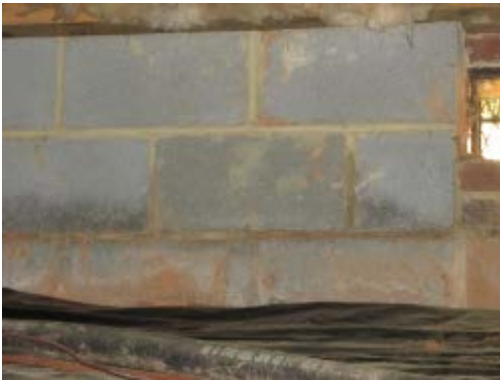
(A1 - 1.2) Main House

Stains and water lines indicate a history of standing water in the crawl space around the perimeter of the foundation and under the porches. Direct water penetration damages the foundation, the wood structure, and creates an undesirable environment in the crawl space areas that encourages insect, fungal growth such as mold/mildew. Repairs are needed to prevent water penetration. Water in the crawl space indicates an absent or damaged waterproofing and foundation drain system. Repairs are needed to prevent water penetration. A general contractor should be consulted for further evaluation to determine the source of the moisture and to make necessary repairs.

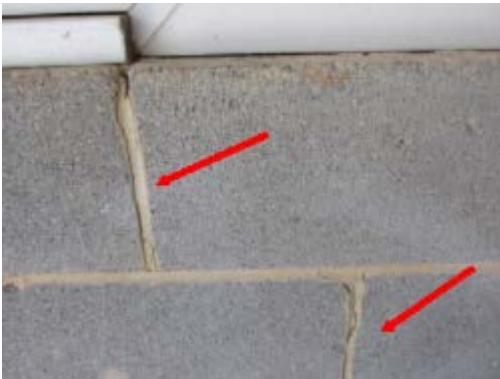
(A1 - 2.1) Garage

Closed cracks were noted in the foundation of the garage at locations where the foundation steps related to elevation change. Cracks in the foundation indicate a deficiency in the foundation, footing, or supporting soil that can change and worsen if it progresses over the life of the home. An engineer should be consulted to determine the significance /cause of the cracks and outline any necessary repairs.

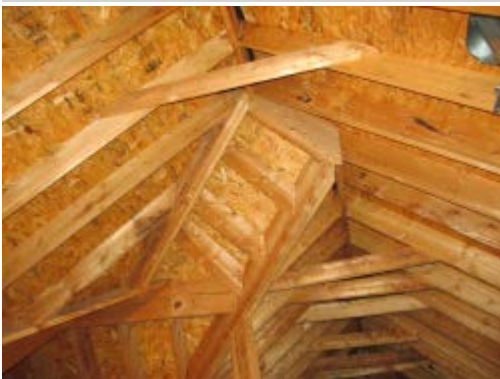
(A6 - 1.1) Main House

From the attic, it was noted that the Valley/Hip rafter located between the main home and first floor room was not posted for end support. End post supports are typically installed to supplement nailed joints and ensure the stability of the roof system. An engineer should be consulted for further evaluation to determine the significance and cause of the concern and outline necessary repairs to ensure the stability of the structure.

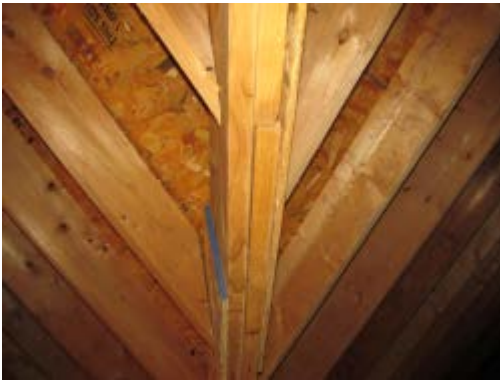
(A6 - 1.2) Main House

From the attic, it was noted that the valley rafter located over the main living room was constructed of multiple members and was not posted for support. Post supports are typically installed to supplement nailed joints and ensure the stability of the roof system. An engineer should be consulted for further evaluation to determine the significance and cause of the concern and outline necessary repairs to ensure the stability of the structure.

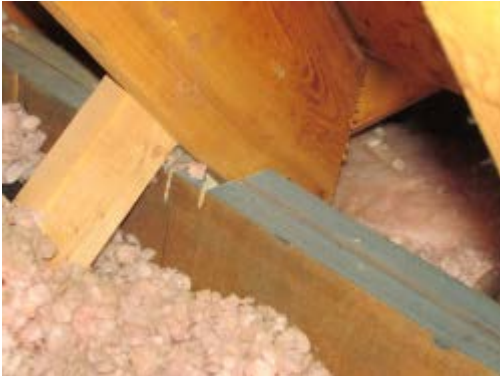
(A6 - 1.3) Main House

The LVL girder located under the main rafters on the front side of the home has been notched for rafter installation. Engineered lumber beams have specific installation specifications that rarely allow notching. If a notch is beyond what would be typically expected and could result in cracking or failure of the beam. A girder is a main structural component that provides support of the framing structure and transfers loads to the foundation. An engineer should be consulted for further evaluation to determine the significance of the concern and outline necessary repairs to ensure the stability of the structure.

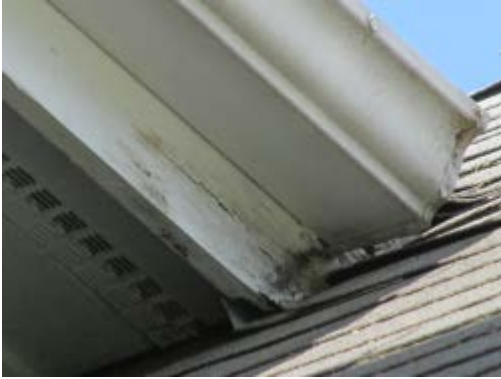
(B1 - 1.1) Main House Front

The exterior boxing of the home need repairs and painting to prevent further damage and water penetration. The following items were noted during the inspection all areas should be evaluated as a repair plan is prepared:

1. Peeling paint, swollen edges behind the gutter trays;
2. Boxing and trim areas were found to have area of decay at roof line intersections

A licensed general contractor should be consulted for a complete evaluation of the trim and boxing to determine the scope of the damage and make necessary repairs.

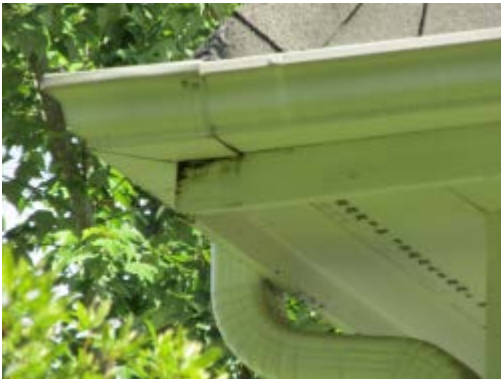
(B1 - 1.2) Main House Front

Additional Photograph: This a photograph of decayed boxing at the left front corner of the main home. All corner trims areas were noted to have some level of decay.

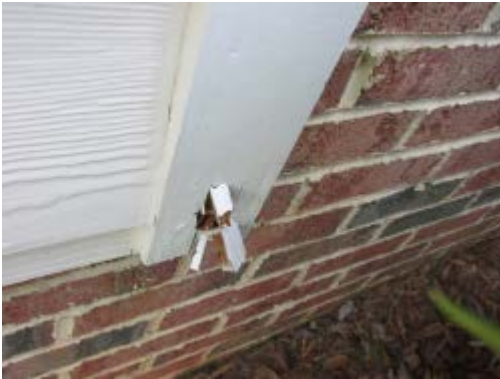
(B1 - 2.1) Main House Rear and Sides

The exterior trim of the home need repairs and painting to prevent further damage and water penetration. The following items were noted during the inspection all areas should be evaluated as a repair plan is prepared:

1. Corner trim moldings have visible areas decay.
2. Vertical wood trim boards at corner and brick intersections have visible areas of decay.

A licensed general contractor should be consulted for a complete evaluation of the exterior trim to determine the scope of the damage and make necessary repairs.

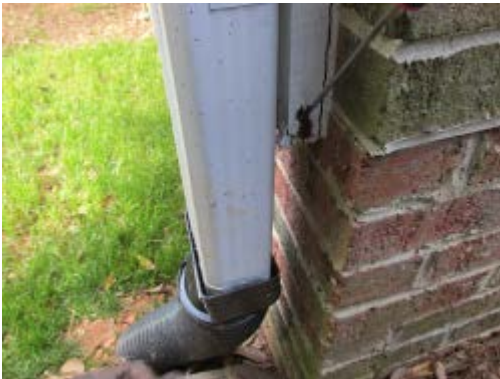
(B1 - 2.2) Main House Rear and Sides

Additional Photograph: This a photograph of a decayed vertical trim molding behind the back left gutter.

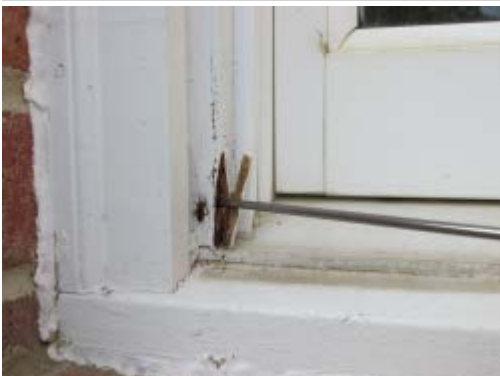
(B2 - 1.1) All Windows

The all windows have soft and decayed wood in the sill, trim, sash areas. Decay in the windows can result in leaking and water penetration and should be repaired as soon as possible. All windows should be inspected for similar damage as repairs are made. A licensed general contractor should be consulted to evaluate the extent of the damage and make necessary repairs.

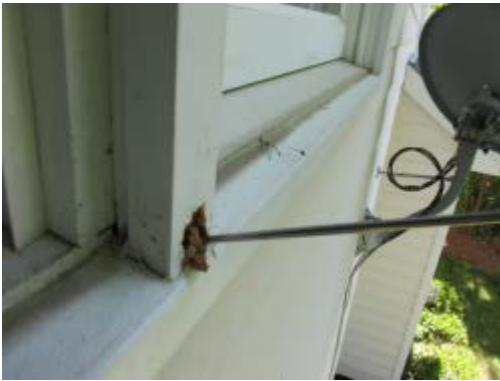
(B2 - 1.2) All Windows

Additional Photograph: This a photograph of the living room window, the trim between the windows is decayed.

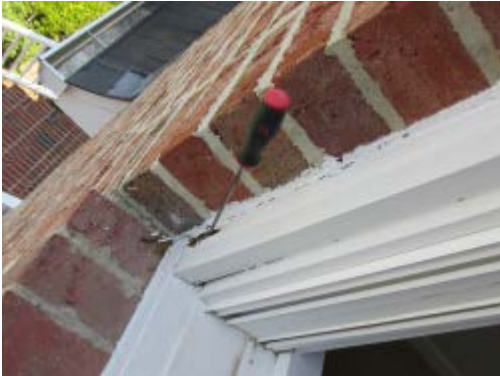
(B2 - 1.3) All Windows

Additional Photograph: This a photograph of a second floor window, decay was noted in all accessible windows.

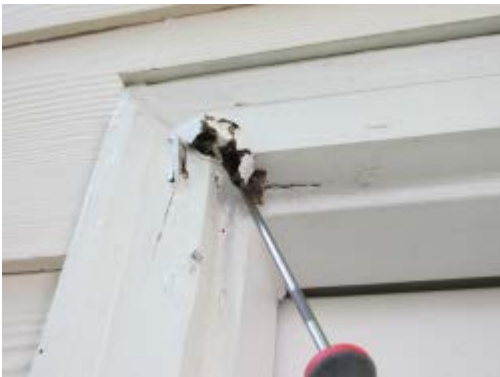
(B2 - 2.1) Door

The door has extensive soft and decayed wood in the frame area . Decay in the door frames can result in leaking and water penetration and should be repaired as soon as possible. A general repair specialist or licensed general contractor should be consulted for evaluation and repair.

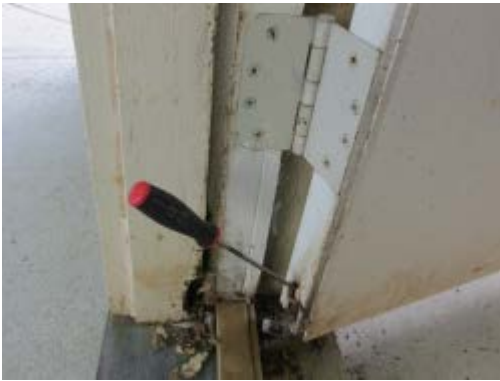
(B2 - 2.2) Door

Additional Photograph: The door also has soft and decayed wood in the door panel area. Decay in the door panel can result in leaking and water penetration and should be repaired as soon as possible. A general repair specialist or licensed general contractor should be consulted for evaluation and repair.

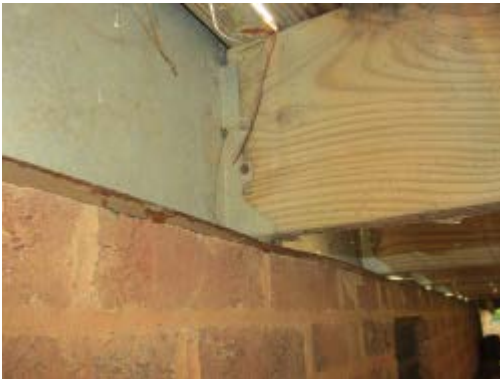
(B3 - 1.1) Deck Sample 1

The metal hangers used to support the floor framing of the deck were installed without the proper number and sized nails. The nail installation is crucial to the function of the hanger, without proper installation the hanger could fail allowing the deck to move or collapse. A licensed general contractor should be consulted for complete evaluation of the deck and to make necessary repairs.

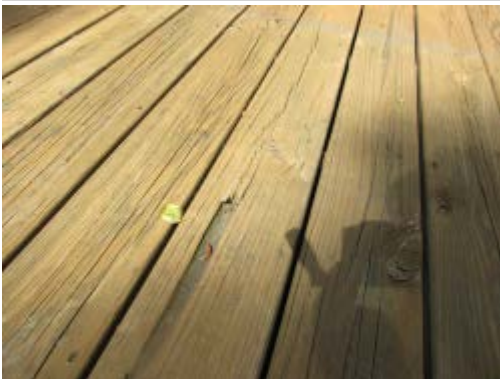
(B3 - 1.2) Deck Sample 1

The wood deck was found to be severely weathered. Decking boards were splintering and cupped. The deck should be considered hazardous. A licensed general contractor should be consulted for complete evaluation of the deck and to make necessary repairs.

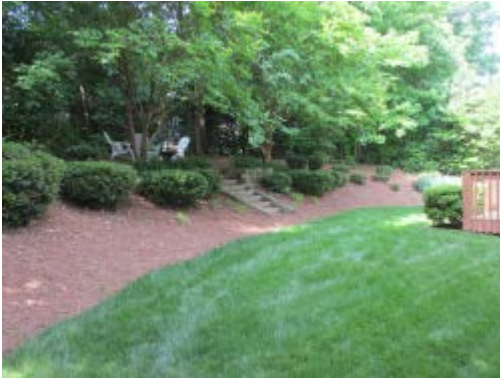
(B5 - 1.1) Grading

The rear yard slopes toward the home and there is evidence of erosion of soil along the sides of the yard that is directing drainage against the perimeter of the home. Corrections are needed to control drainage and prevent water penetration, a licensed general contractor should be consulted for a complete evaluation and to make necessary repairs.

The rear yard slopes toward the home and there is evidence of erosion of soil along the sides yards that is directing drainage against the perimeter of the home. Corrections are needed to control drainage and prevent water penetration, a licensed general contractor should be consulted for a complete evaluation and to make necessary repairs.

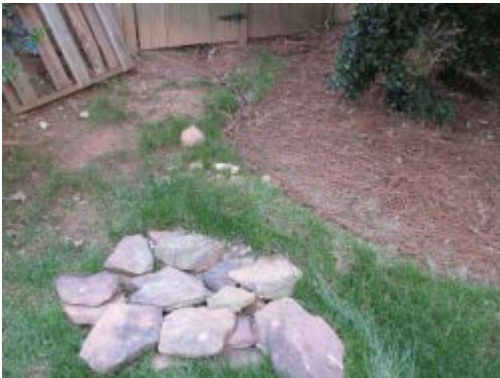
(B5 - 1.2) Grading

Additional Photograph: Evidence suggests that the drainage from the rear section of the lot accumulates along the fence and left foundation wall.

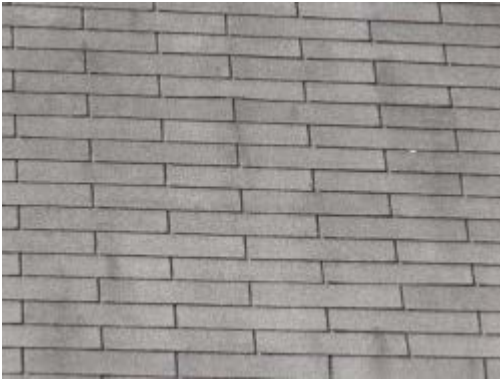
(C1 - 1.1) All Accessible Areas

The roof shingles were noted to be lifting or curling at the corners of the tabs. Since shingles are designed to lay flat to shed water and debris, the curling can result in trapped moisture and leaks. Shingle curl for several reasons including: end of the service life, improper installation and or limited ventilation. A licensed roofing contractor should be consulted for a complete evaluation of the roof covering and flashings system to make necessary repairs to ensure the weathertightness of the roof covering system. At the time of the repair, the roofer may be able to answer questions related to the life expectancy of the roof covering system.

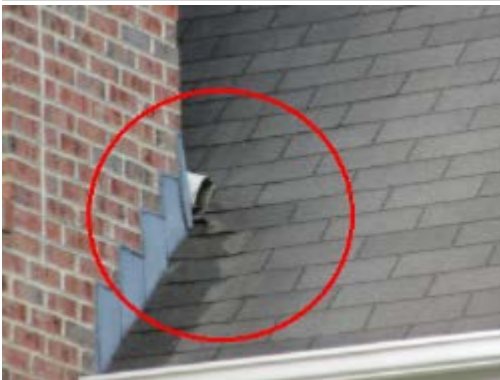
(C2 - 1.1) All Accessible Areas

The gutter downspout at the right dormer is not extended or piped out to direct roof drainage away from the side wall of the main home. Direct drainage from the gutter system can result in direct water penetration into the attic areas of the home. A licensed general contractor should be consulted for a complete evaluation and to make necessary repairs.

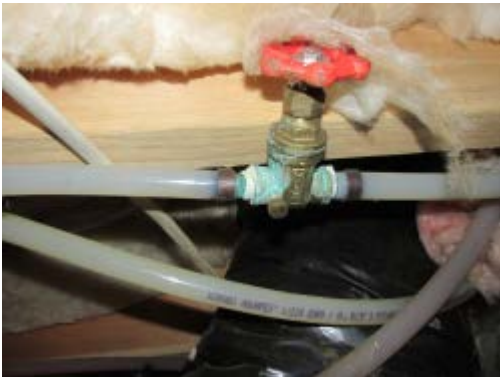
(D1 - 1.1) All Accessible Areas

The main water supply line located in the crawl space at the back door is corroded. Corrosion on the main water lines should be addressed as soon as possible to prevent major leaks and property damage. A licensed plumbing contractor should be consulted for a complete evaluation and repair of the main water supply line.

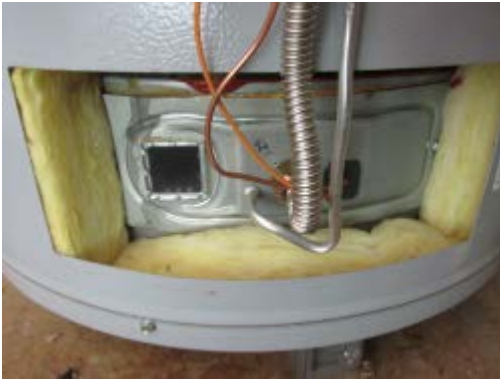
(D3 - 1.1) Unit #1

There was no hot water available for the main home during the inspection. The gas service to the unit was off. The inspector did not have permission or knowledge of the circumstances that required the unit to be turned off and therefore did not turn the unit on. The inspection of the hot water heating unit, fixtures, and appliances was limited and not completed. It is recommended that the hot water be restored and the inspection completed prior to the purchase of the home.

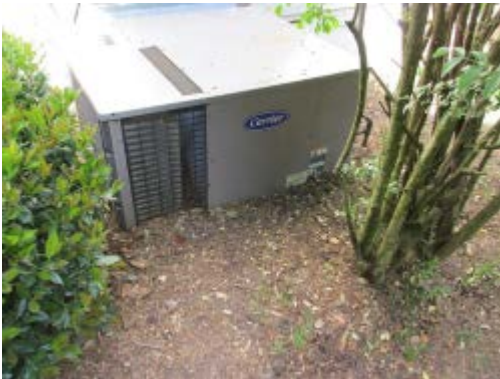
(F1 - 1.1) Heating Unit #1

The grading around the package HVAC unit is directing drainage toward the unit. Evidence suggests that water from lot drainage has been entering the unit., see next photograph. Drainage needs to be corrected to prevent damage to the unit. A licensed general contractor should be consulted for further evaluation and repair.

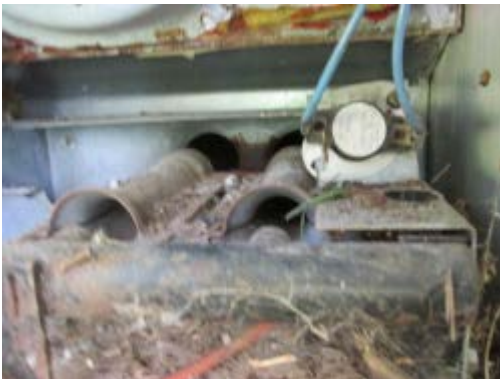
(F1 - 1.2) Heating Unit #1

The gas burner section of the package unit has visible rust and debris in the burner chamber area. The rust indicates deterioration of the exchanger. Deterioration of the heat exchanger is a serious concern that can result in improper combustion and carbon monoxide poisoning. The furnace needs a complete evaluation which should include a heat exchanger inspection to ensure safe, reliable, and proper operation of the HVAC system. A licensed HVAC contractor should be consulted for repair.

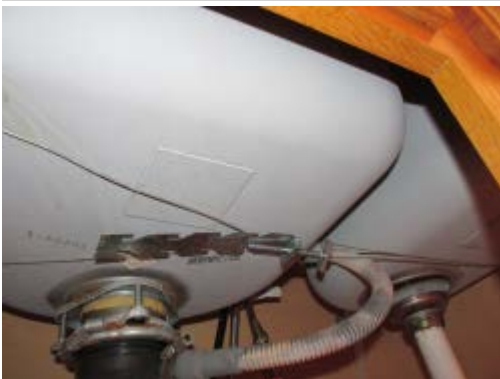
(H2 - 1.1) Kitchen

The sink is in need of further evaluation and repair. The following concerns were noted at the time of the inspection:
1. The sink is supported by a wire and bracket was not secure.
A general repair specialist or licensed general contractor should be consulted for evaluation and repair.

The sink is in need of further evaluation and repair. The following concerns were noted at the time of the inspection:

1. The sink is supported by a wire and bracket was not secure.
2. Fasteners to hold the sink were secure to the cabinet walls and they are not secure.

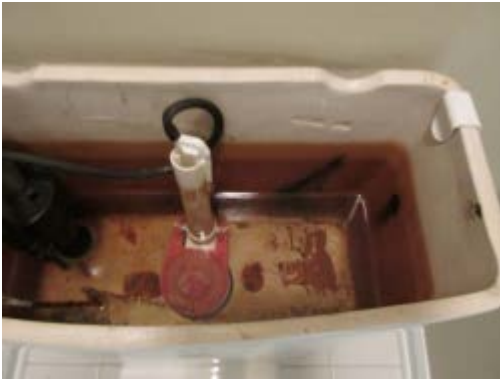
(H3 - 1.1) Bathroom #1 Master

The toilet flush valve is not operating properly. This could result in improper functioning, flooding and waste of water. A licensed plumbing contractor should be consulted for evaluation and repair.

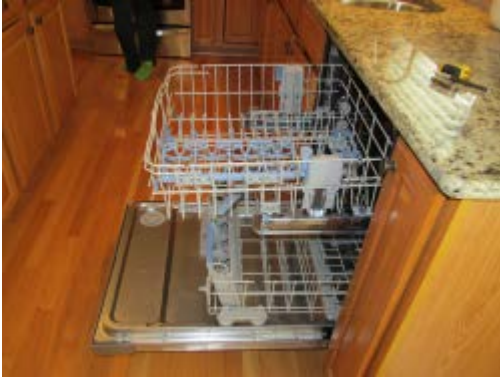
(J1 - 1.1) Dishwasher

The dishwasher is not secure to the cabinet and it moves forward when the door is opened. The appliance needs to be secured to the cabinet to prevent damage to the unit or personal injury. An appliance repair person or general contractor should be consulted for repair.
