Home Inspection Report

Produced by: Kyle Pfeifer

John Doe
123 Main Street
Greenwood, Indiana 46131

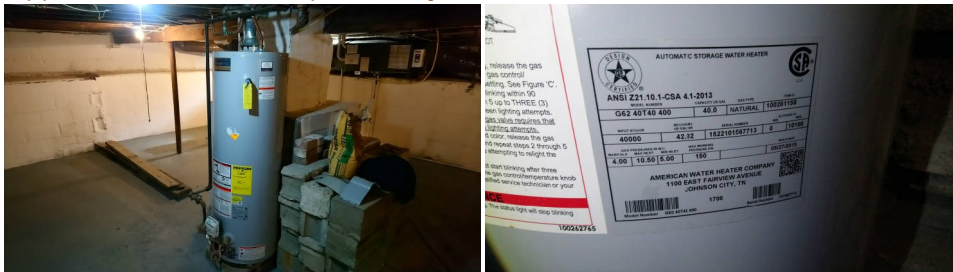
1. Basement Water Heater Water Heater Operation: The hot water heater was not turned on during our inspection. As such, we were unable to ensure hot water was being delivered to all areas of the home. The unit is newer and appears to be hooked up correctly.

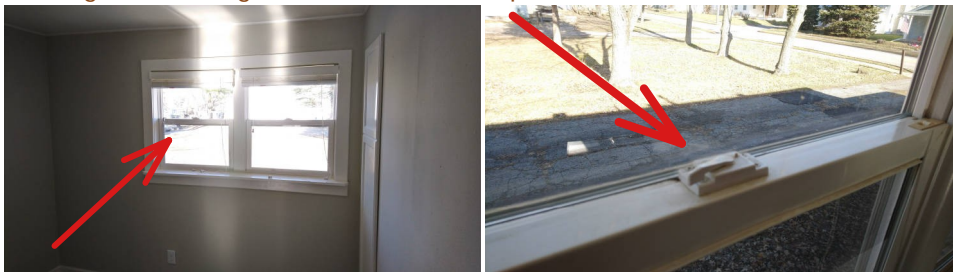
2. 1st Floor - Master Bedroom Windows: Vinyl single hung - The window on the left in this room had a difficult time closing and locking. After several attempts we were able to lock the window but it appears the frame is slightly off.

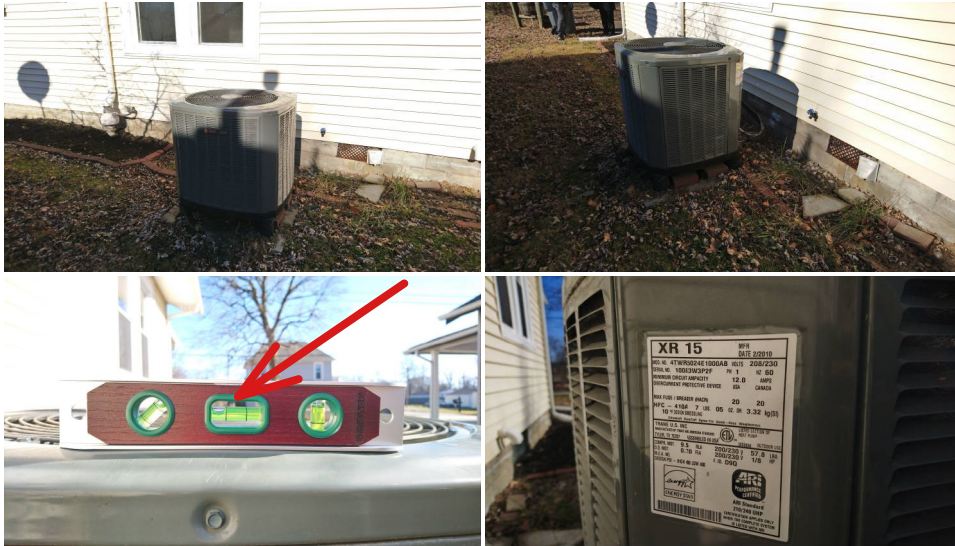
1. Main AC System A/C System Operation: Not inspected - Due to the temperature outside the AC unit was not tested, however were able to review the exterior of the unit. The suction line was correctly insulated from the home to the unit. We did notice the machine was not level and most condensing units need to be completely level. The reason is refrigerant travels with the lubricating oil through an a/c system. When the condenser is out-of-level, the oil can separate and the compressor may operate without adequate lubrication. A qualified contractor will need to level the unit out.

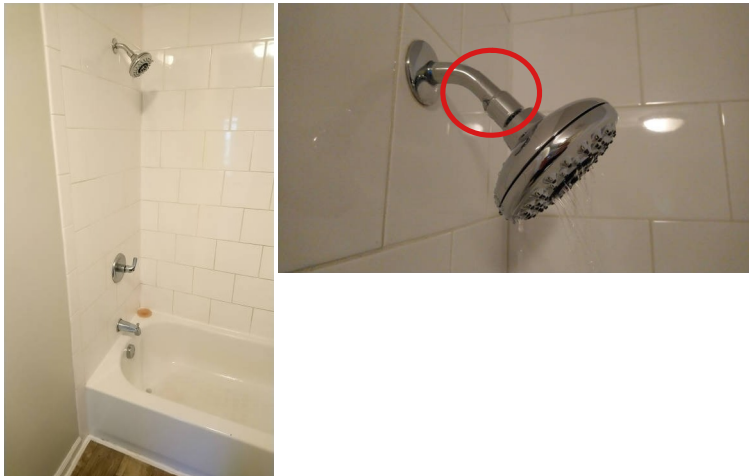
2. 1st Floor - Main Bathroom Bathroom Shower/Surround: Fiberglass pan and ceramic tile surround - This shower head is leaking when the water is engaged. A qualified contractor will need to tighten the shower head so it's not leaking.

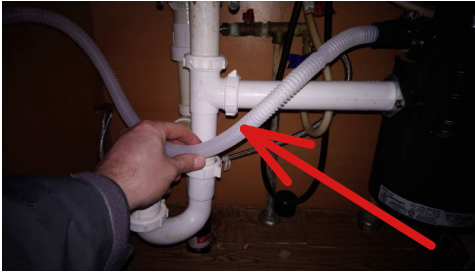
3. 1st Floor Kitchen Dishwasher: A "high loop" needs to be installed under the kitchen sink. The "high loop" prevents any backflow of water into the dishwasher or water siphoning out during operation. A qualified contractor will need to evaluate for repairs.

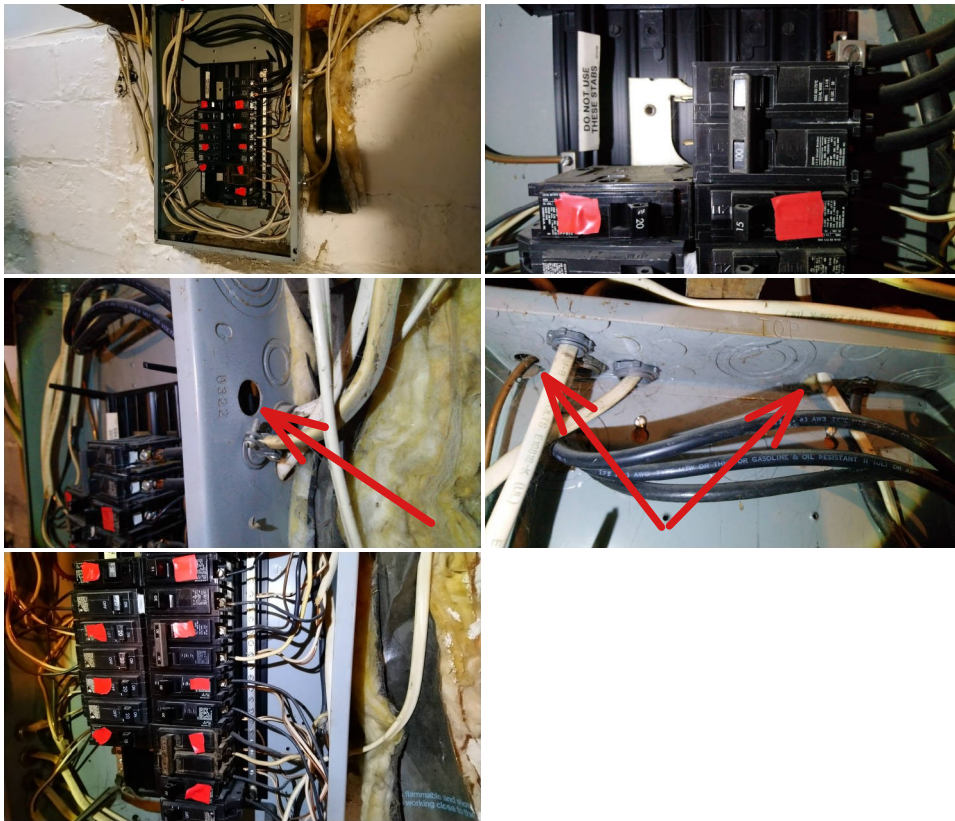
1. Basement Electric Panel Manufacturer: Per code, all knockouts need to be properly covered if removed from the panel. If not, it presents a shock hazard as someone could accidentally stick a finger in the panel. We several open knockouts in the panel needing addressed. The rest of the panel is up to code. All neutral wires were isolated on both bus bars. All wiring is the right size for the attached breaker. A qualified contractor will need to evaluate for the correct repairs.

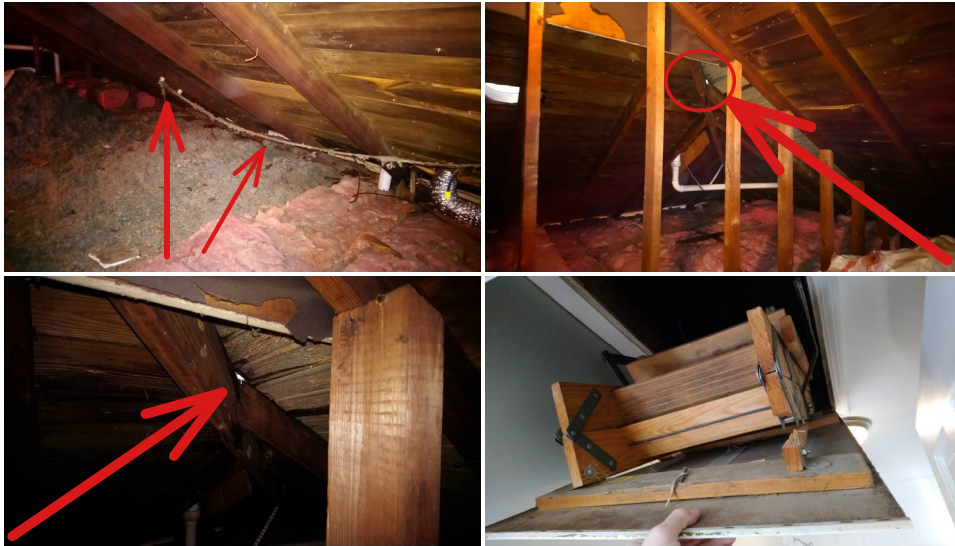
2. Main Attic Roof Framing: 2x6 Rafter - Overall, the structure in this attic is in good condition with no signs of any active leaks. The house is a "stick built" house, meaning each rafter was individually cut to fit together. No water stains or wood rot were found on any of the rafters. The attic appears to be venting properly with no issues as well. We did find old knob and tube wiring in the attic. It does appear the lines are not active, however code dictates all knob and tube wiring needs to be removed from the home. Furthermore, in pictures 2 & 3 we observed a small amount of sunlight entering the attic. Outside on the West elevation we found a small hole on the bottom left corner of the vinyl siding. A qualified contractor will need to address these issues immediately.

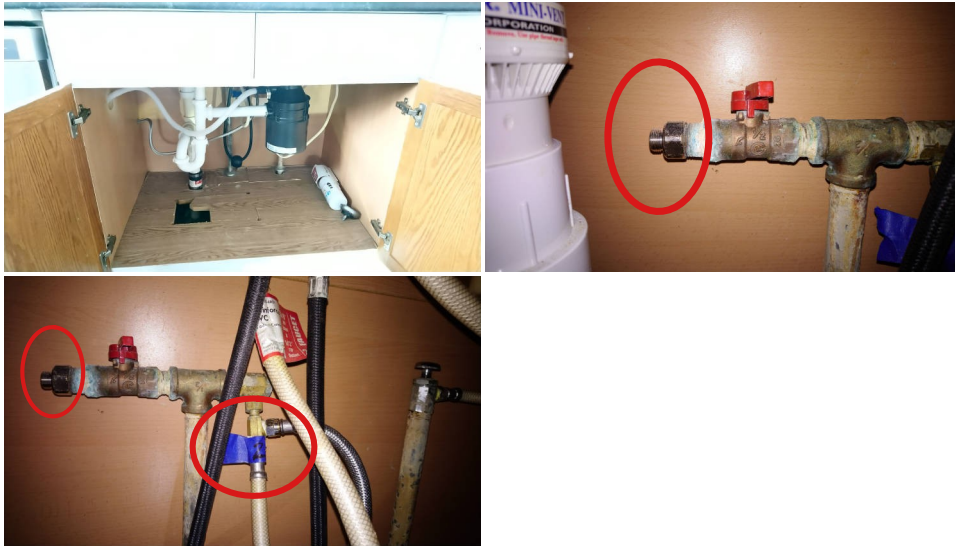
6. 1st Floor Kitchen Sink: Under the kitchen sink we found a few issues needing addressed. The hot water line will need reviewed as no shut off valve is currently installed on this line. In picture three we found an uncapped section of the hot water line needing reviewed. Furthermore, the cold water shut off valve was open however no water was coming out. A qualified contractor will need to review all supply lines under the sink to ensure all are working as expected.

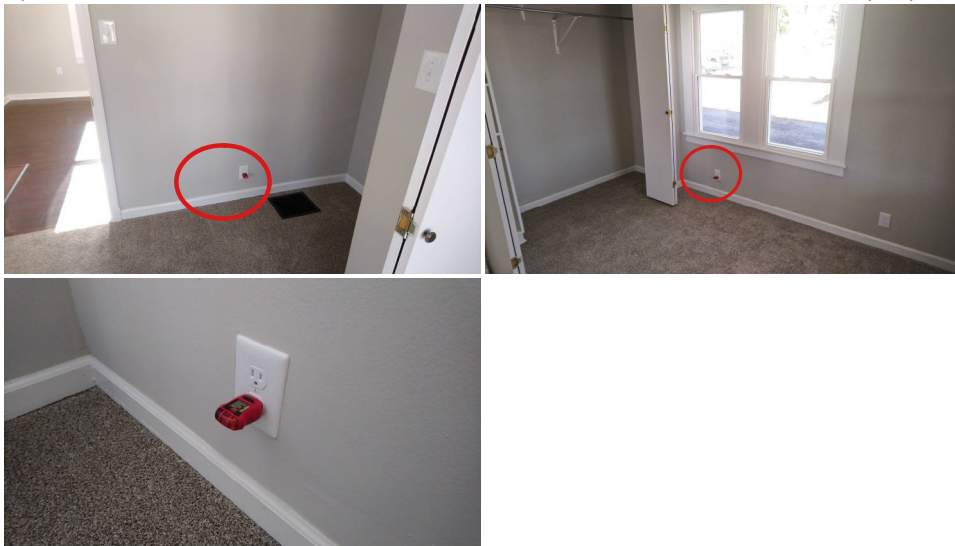
7. 1st Floor - Right Bedroom Electrical: The outlet in picture one is indicating "reverse polarity." Reverse polarity is when the hot and neutral wires are reversed. Additionally, we found an outlet not working at all in pictures 2 & 3. A qualified contractor will need to review both of these outlets for the proper repair.

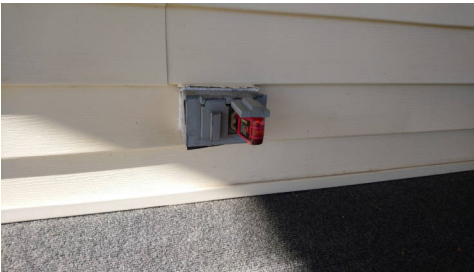
1. Acceptable Exterior Electric Outlets: 110 VAC - The exterior outlets are working properly around the outside of the home.

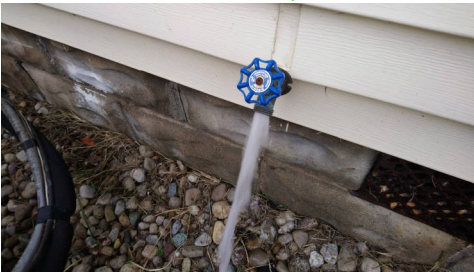
2. Acceptable Hose Bibs: The hose bibb on the south elevation of the home was functioning properly when tested. No leaks or obvious imperfections were observed.

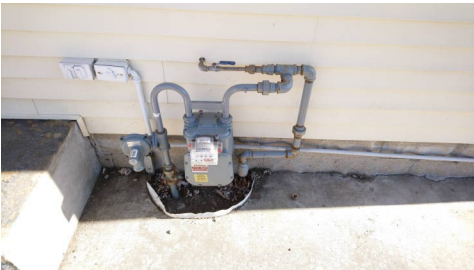
3. Acceptable Gas Meter: Exterior surface mount at side of home - The exterior gas meter was inspected with no visible sign of any leaks. No code violations were noticed as well.

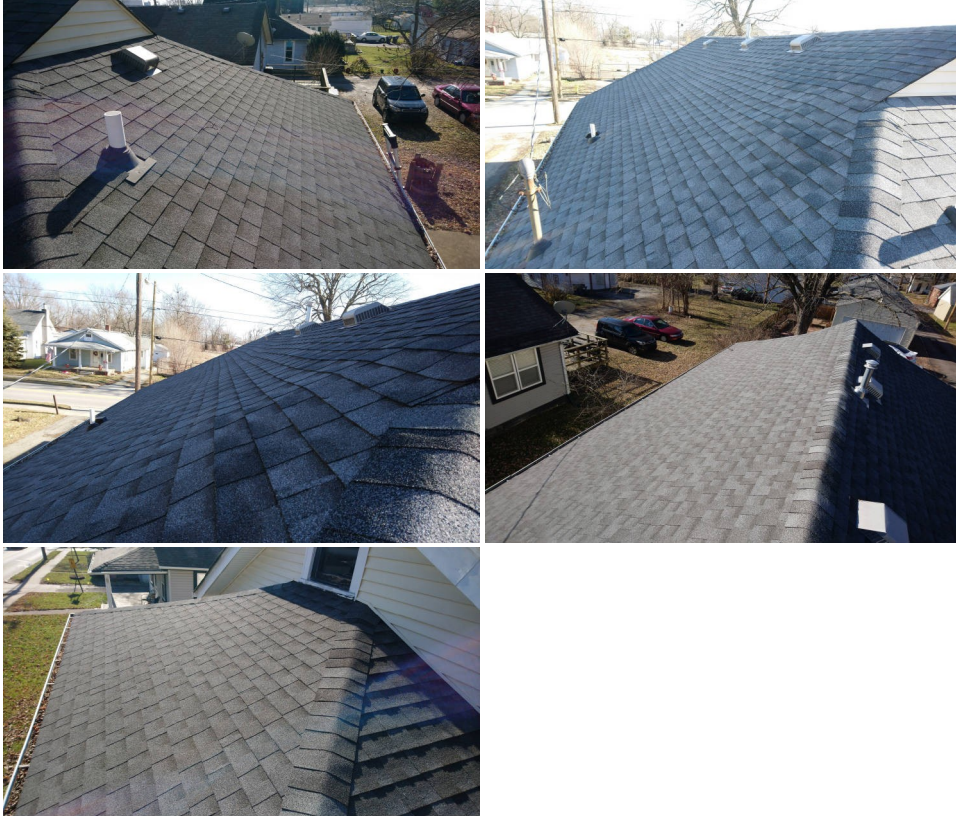
1. Method of Inspection: On roof
2. Acceptable Material: Asphalt shingle - We did not notice any major issues or imperfections with the roof. The shingles seem to be brand new and will have several years of life left. Water is properly being shed down to the gutters and away from the foundation. All of the roofing vents were replaced at the same time the roof was replaced.

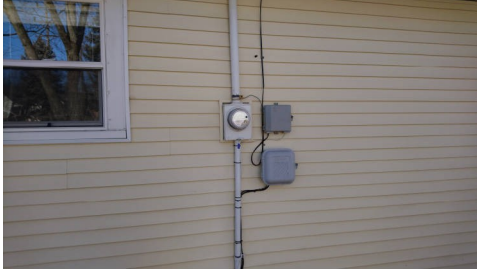
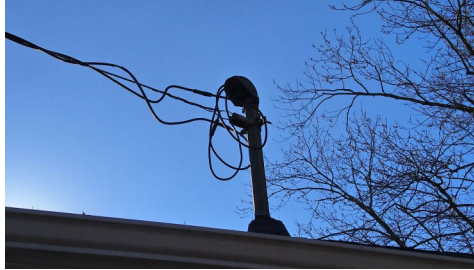
1. Service Size Amps: 100 Volts: 110-240 VAC
2. Acceptable Service: Copper - The service entrance is up to code with no imperfections. No water appears to be entering any of the equipment.

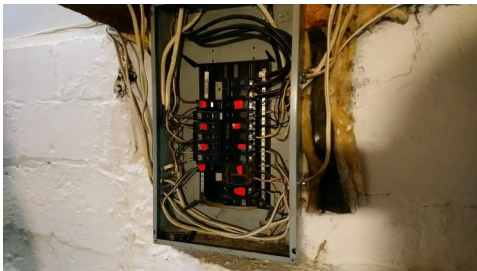
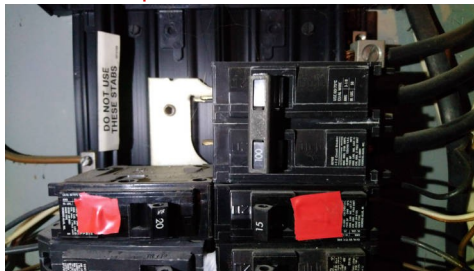
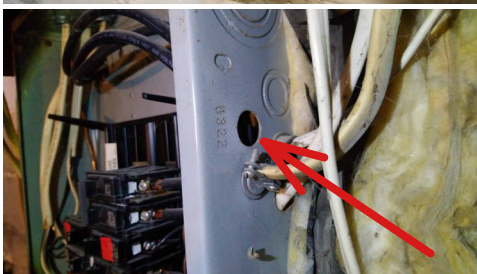
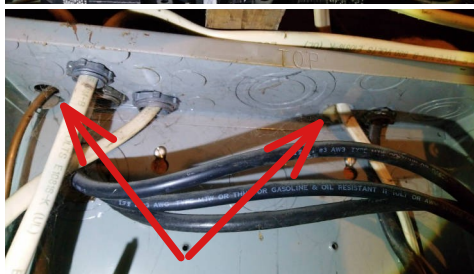
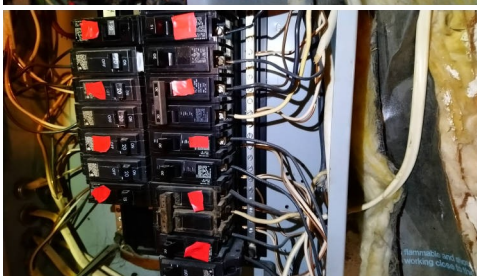
3. Defective Manufacturer: Per code, all knockouts need to be properly covered if removed from the panel. If not, it presents a shock hazard as someone could accidentally stick a finger in the panel. We several open knockouts in the panel needing addressed. The rest of the panel is up to code. All neutral wires were isolated on both bus bars. All wiring is the right size for the attached breaker. A qualified contractor will need to evaluate for the correct repairs.

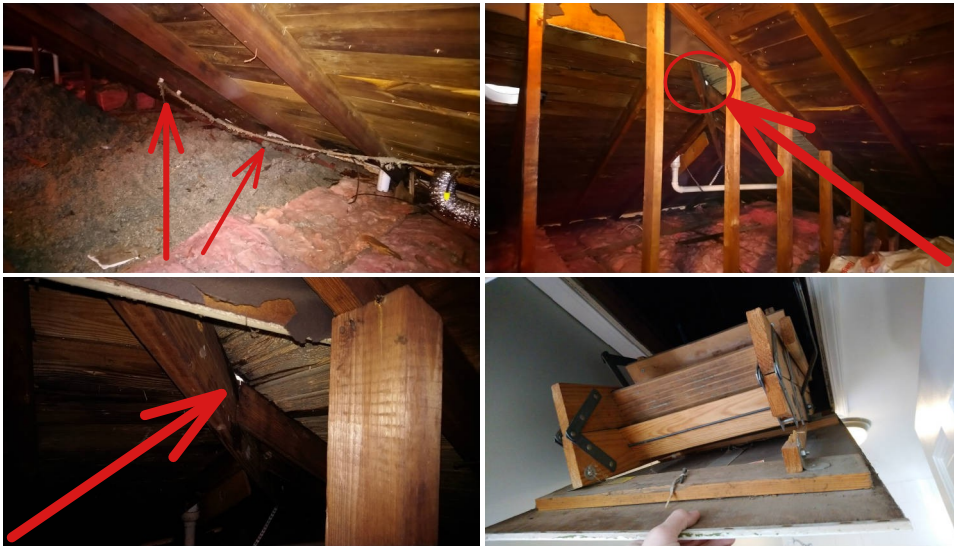
1. Method of Inspection: In the attic
2. Defective Roof Framing: 2x6 Rafter - Overall, the structure in this attic is in good condition with no signs of any active leaks. The house is a "stick built" house, meaning each rafter was individually cut to fit together. No water stains or wood rot were found on any of the rafters. The attic appears to be venting properly with no issues as well. We did find old knob and tube wiring in the attic. It does appear the lines are not active, however code dictates all knob and tube wiring needs to be removed from the home. Furthermore, in pictures 2 & 3 we observed a small amount of sunlight entering the attic. Outside on the West elevation we found a small hole on the bottom left corner of the vinyl siding. A qualified contractor will need to address these issues immediately.

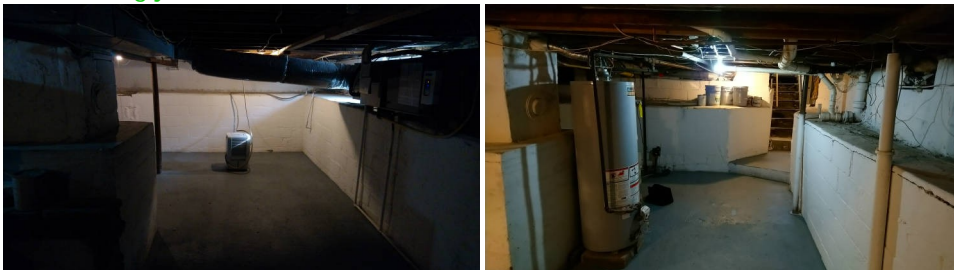
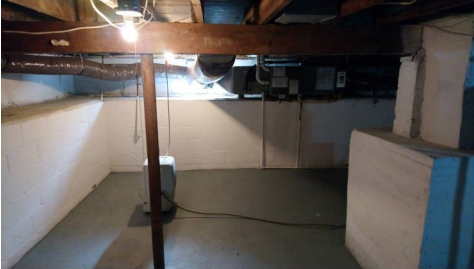
1. Acceptable Walls: Cement Block - Inside the basement we did not observe any major issues. The basement is extremely dry as no water is entering around the foundation. The cement block foundation is in great shape as no cracks or shifting was observed. We tested the sump pump already installed and the pump extracted the water as expected. All electrical and plumbing line were adequately attached to the flooring joists above.

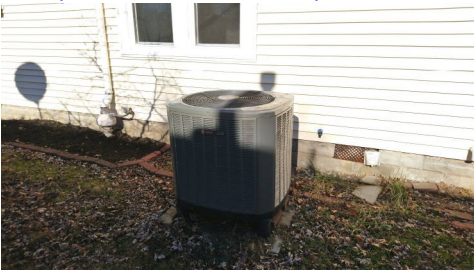
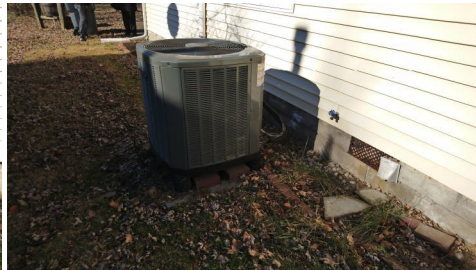
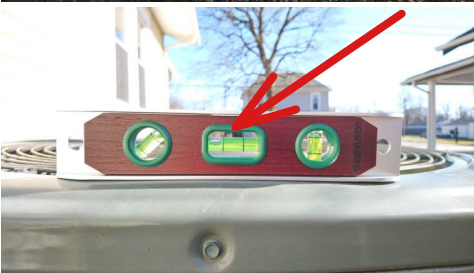
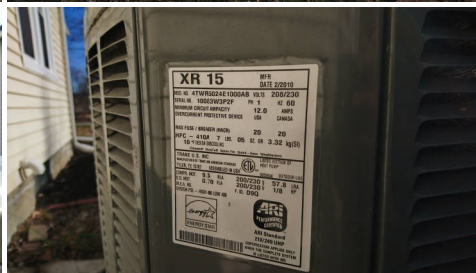
1. Marginal

A/C System Operation: Not inspected - Due to the temperature outside the AC unit was not tested, however were able to review the exterior of the unit. The suction line was correctly insulated from the home to the unit. We did notice the machine was not level and most condensing units need to be completely level. The reason is refrigerant travels with the lubricating oil through an a/c system. When the condenser is out-of-level, the oil can separate and the compressor may operate without adequate lubrication. A qualified contractor will need to level the unit out.

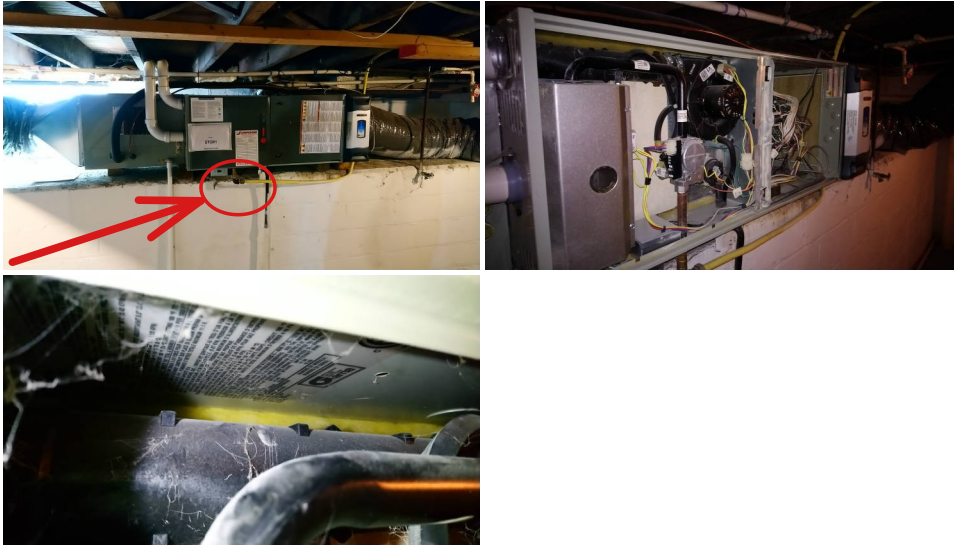
1. Acceptable Heating System Operation: Adequate - We tested the furnace and everything was functioning normally. The covers were removed to view the inner components and the unit was slightly dirty. Outside of a cleaning the unit is up to code. We always recommend cleaning the inside of any furnace when buying a new home.

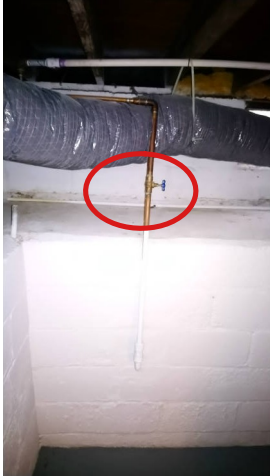
1. Acceptable Main Water Shutoff: Front of house - The main water shut off valve is located on the East side of the basement.

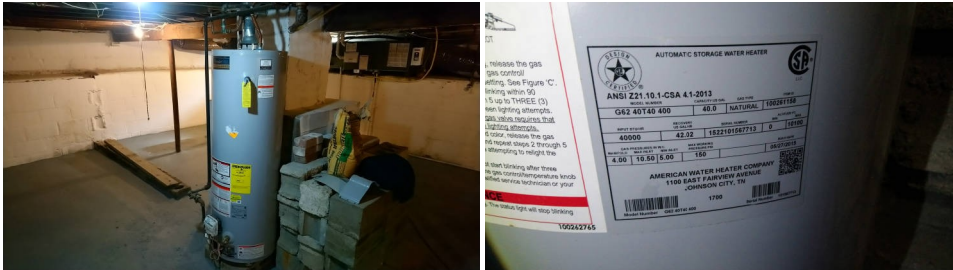
2. Maintenance Water Heater Operation: The hot water heater was not turned on during our inspection. As such, we were unable to ensure hot water was being delivered to all areas of the home. The unit is newer and appears to be hooked up correctly.

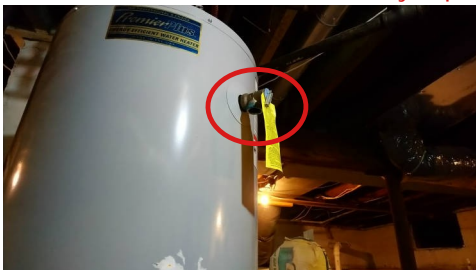
8. Defective TPRV and Drain Tube: Missing - Per code, all hot water heaters are required to have a copper/CPVC drainage line piped between 6-24 inches of the floor. Here the pipe is missing. A qualified contractor will need to make the necessary repairs.

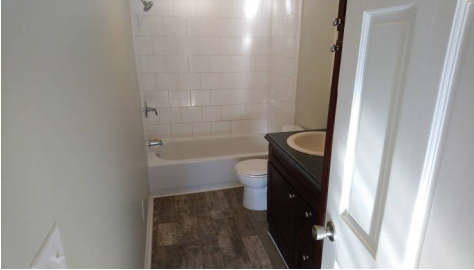
1. Acceptable Walls: Paint - We inspected all of the walls in this room and did not see any major holes or imperfections in the drywall.

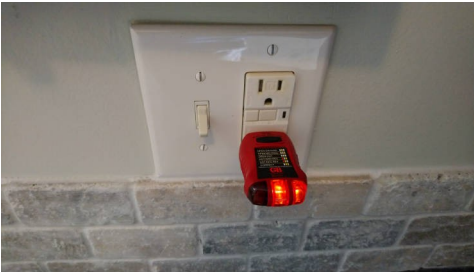
2. Acceptable Electrical: 110 VAC - All outlets were tested in this room and in working condition. The outlets were tight to the wall and not moving.

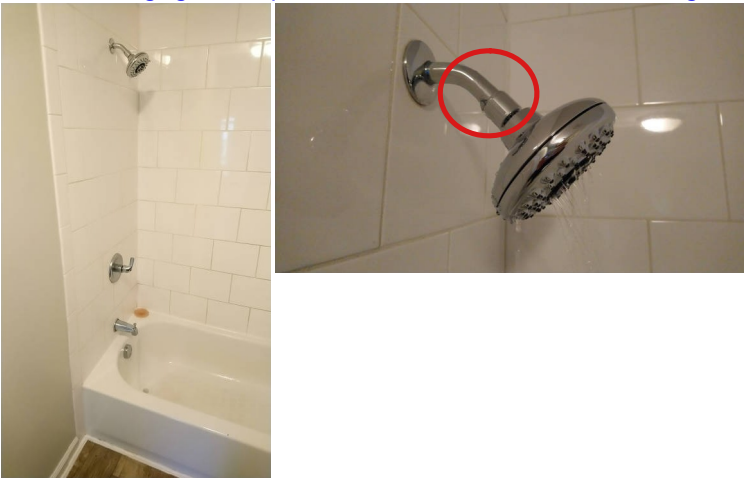
3. Marginal Shower/Surround: Fiberglass pan and ceramic tile surround - This shower head is leaking when the water is engaged. A qualified contractor will need to tighten the shower head so it's not leaking.

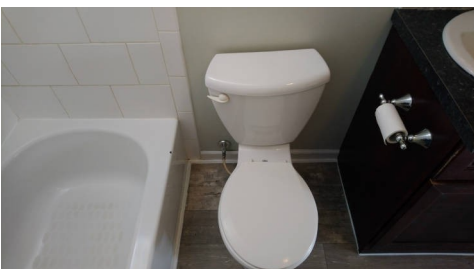
4. Acceptable Toilets: 1 1/2 Gallon Tank - The toilet was functioning correctly during the inspection. We inspected the supply lines to the toilet and did not find any leaks at all. Additionally, we felt around the bottom of the toilet and no leaks were discovered.

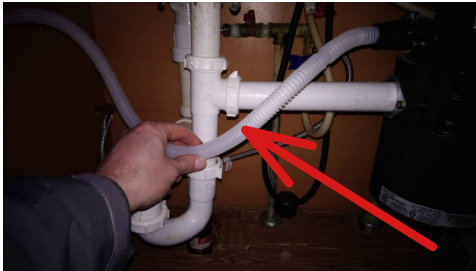
1. Marginal

Dishwasher: A "high loop" needs to be installed under the kitchen sink. The "high loop" prevents any backflow of water into the dishwasher or water siphoning out during operation. A qualified contractor will need to evaluate for repairs.

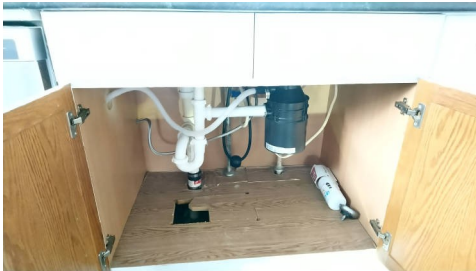
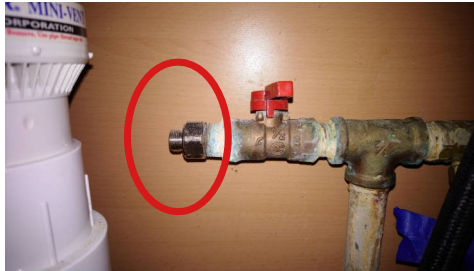
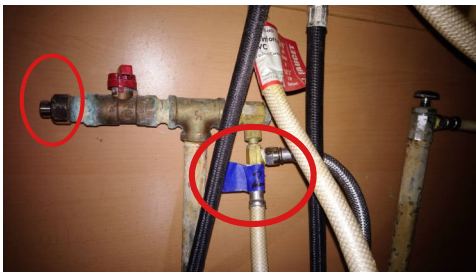
2. Defective

Sink: Under the kitchen sink we found a few issues needing addressed. The hot water line will need reviewed as no shut off valve is currently installed on this line. In picture three we found an uncapped section of the hot water line needing reviewed. Furthermore, the cold water shut off valve was open however no water was coming out. A qualified contractor will need to review all supply lines under the sink to ensure all are working as expected.

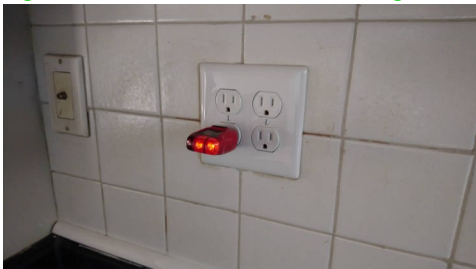
3. Acceptable

Electrical: 110 VAC - All outlets were tested in this room and in working condition. The outlets were tight to the wall and not moving.

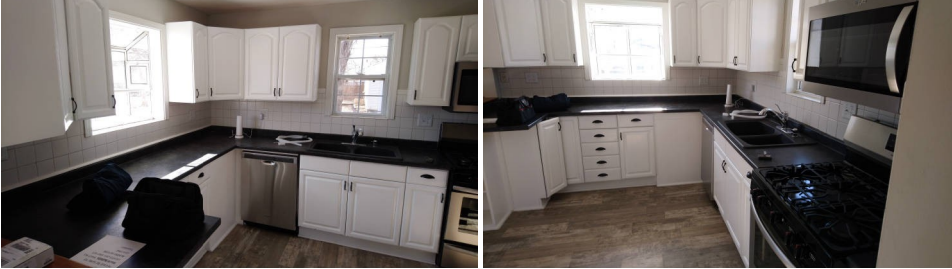
4. Acceptable Walls: Paint - All of the walls are in good condition in this room. No large holes or imperfections were noticed.

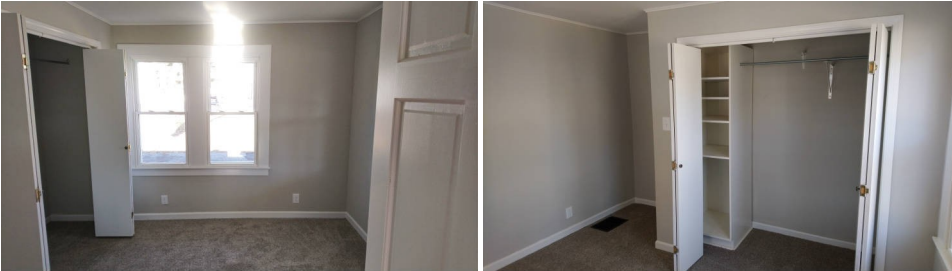
1. Acceptable Walls: Paint - All of the walls are in good condition in this room. No large holes or imperfections were noticed.

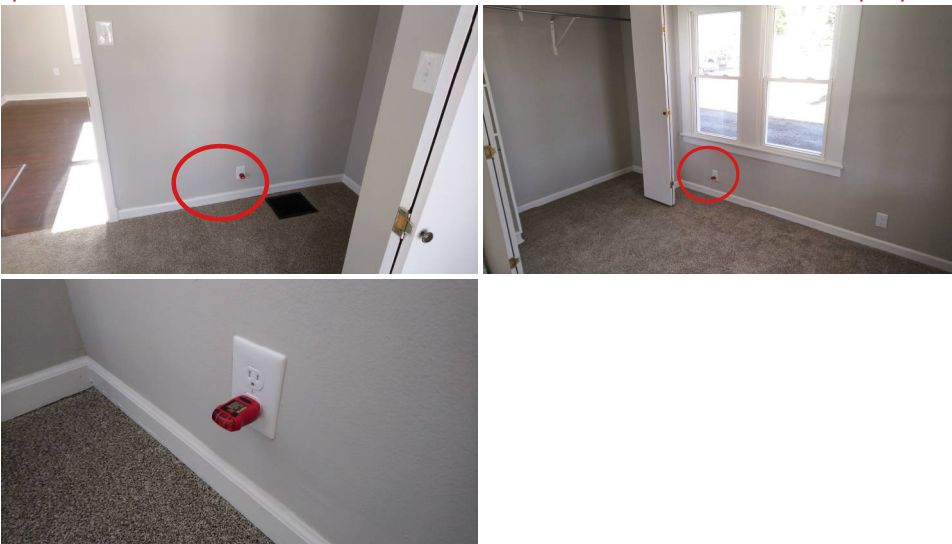
2. Defective Electrical: The outlet in picture one is indicating "reverse polarity." Reverse polarity is when the hot and neutral wires are reversed. Additionally, we found an outlet not working at all in pictures 2 & 3. A qualified contractor will need to review both of these outlets for the proper repair.

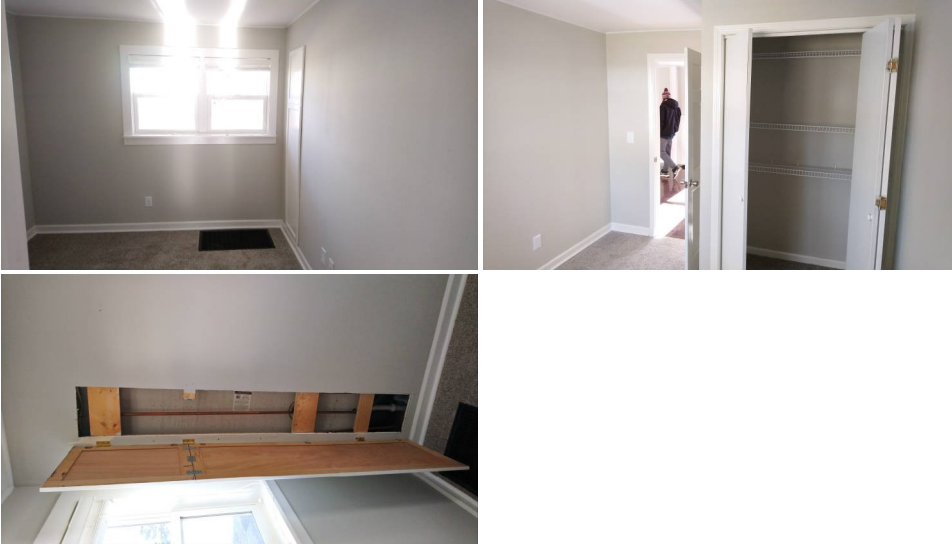
3. Acceptable Walls: Paint - All of the walls are in good condition in this room. No large holes or imperfections were noticed.

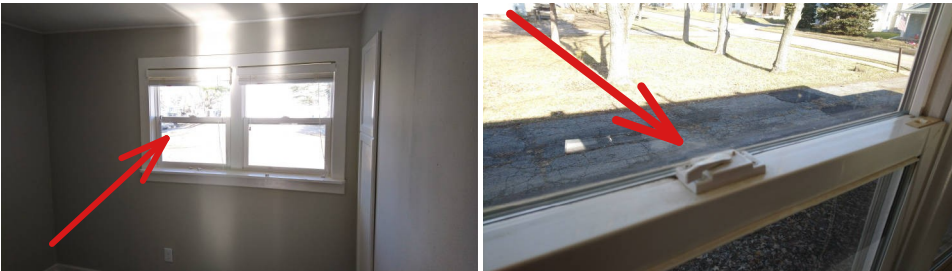
4. Maintenance Windows: Vinyl single hung - The window on the left in this room had a difficult time closing and locking. After several attempts we were able to lock the window but it appears the frame is slightly off.

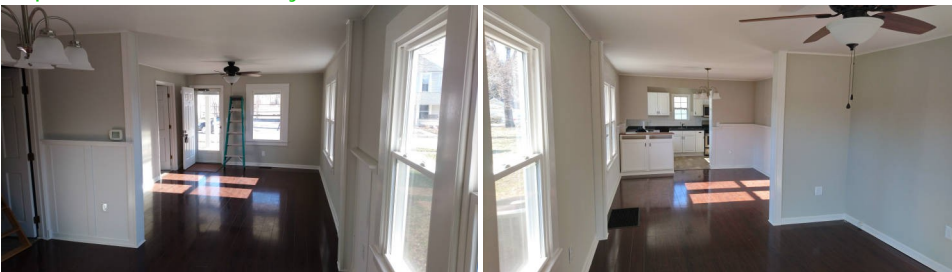
1. Acceptable Walls: Paint - We inspected all of the walls in this room and did not see any major holes or imperfections in the drywall.
