Property Inspection Report

Property Address:
503 First Street
Inspectionville NJ 07000

Terra Home Inspections LLC

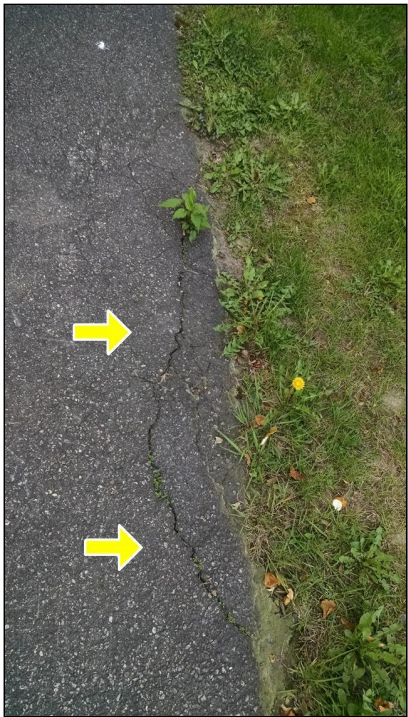
1.0 (1) The driveway has numerous areas that are cracked and depressed. Deterioration could occurred if not repaired. Recommend further evaluation for repairs by a qualified, licensed contractor.

1.0 Item 1(Picture) Cracks

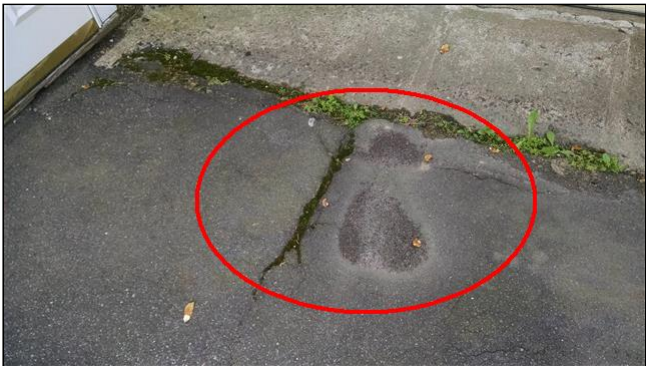
1.0 Item 2(Picture) Depression

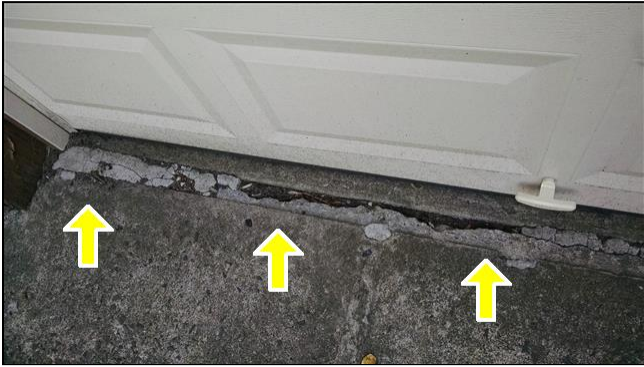
1.0 Item 3(Picture)

1.0 (2) The gap between the concrete garage floor and the concrete driveway apron needs to be sealed up. The masonry is cracked and missing. Recommend further evaluation for repairs by a qualified, licensed contractor.

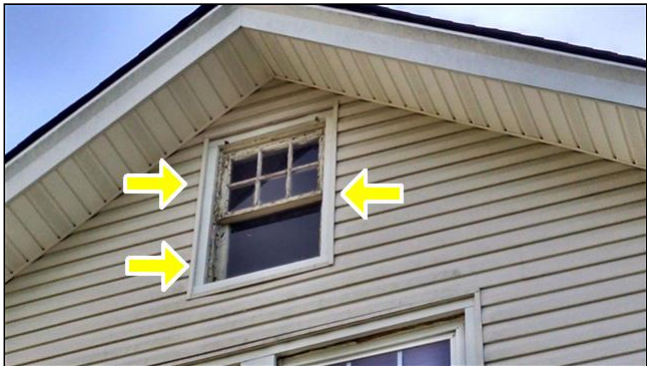
2.3 (1) The paint is peeling off of the wood trim around the old attic wood windows. If the trim is not caulked and painted, the trim could deteriorate. Also it appears there were new vinyl windows installed in the rear bedroom and they were not flashed properly on the exterior. There are some flashing pieces missing. Recommend further evaluation for repairs by a qualified, licensed contractor.

2.3 Item 1(Picture) Attic windows

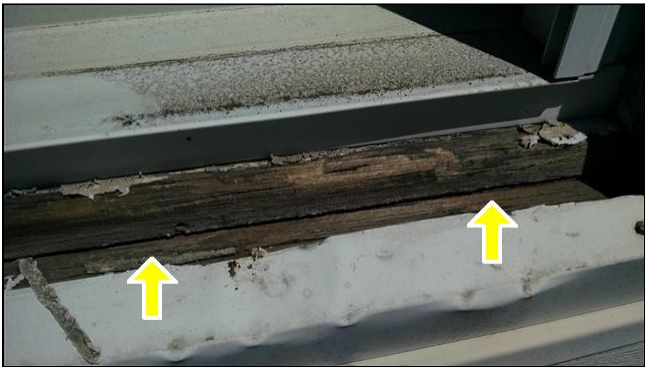
2.3 Item 3(Picture) Rear bedroom window

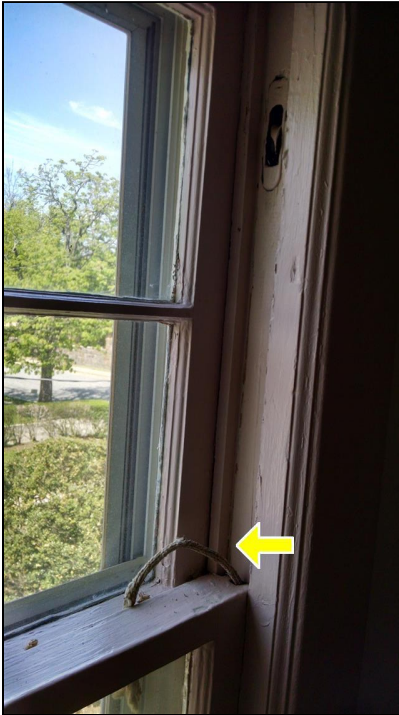
2.3 Item 4(Picture)

2.3 (2) The exterior window in the staircase leading to the 2nd floor has a broken window sash pulley cord. The window would not open. Recommend further evaluation for repairs by a qualified, licensed contractor.

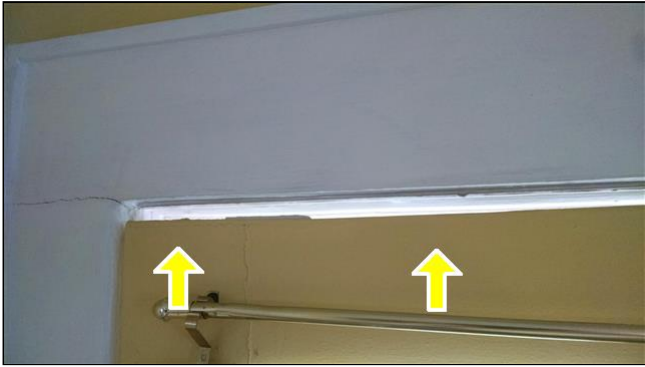
2.4 Item 2(Picture)

2.4 (2) The rear exterior wood door is not closing properly. There is a big gap on the top and the door is not fitting properly in the door frame. Recommend further evaluation for repairs by a qualified, licensed contractor.

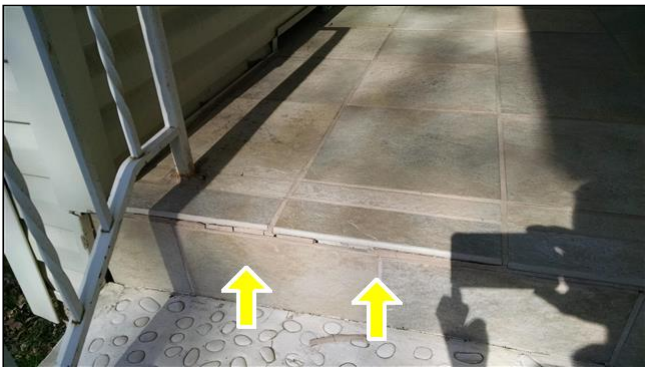
2.9 The rear porch is covered with what appears to be ceramic tile with large grout joints. The grout at the riser joint (at the top of the steps) is cracking and coming apart. There are also several loose tiles in this area. It appears whomever installed these tiles just installed them over what might have been the original wood porch boards. Also the client stated there was water damage to the ceiling in the shower area of the basement bathroom that is located below this porch. Grout joints are porous and this configuration (tile with grout joints installed outdoors exposed to the weather) without an appropriate water proofing membrane underneath may lead to moisture intrusion into the interior. The water damage to the ceiling was repaired and there was no visible water damage at the time of the inspection. Recommend further evaluation for repairs by a qualified, licensed contractor.

2.9 Item 2(Picture) Grout joints cracked and tiles loose

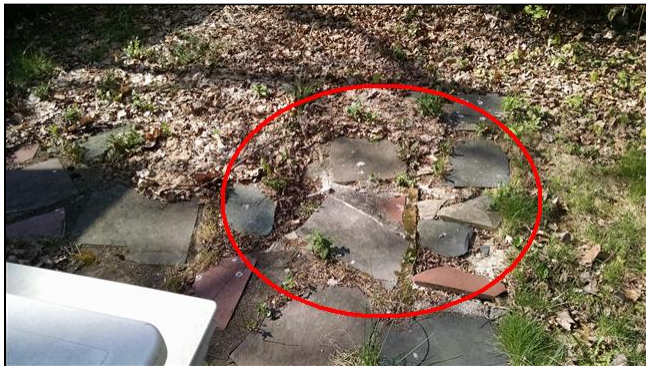
2.10 Item 1(Picture)

2.10 The masonry portion of patio located in the rear yard is deteriorated and cracked in several areas. This could be a trip hazard. Recommend further evaluation for repairs by a qualified, licensed masonry contractor.

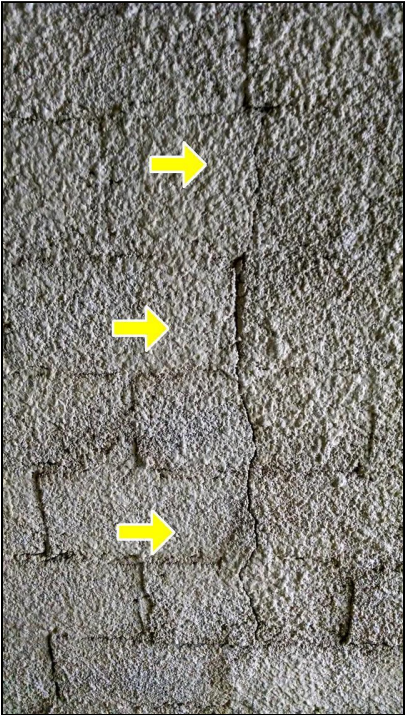
3.8 Item 1(Picture)

3.8 The right side masonry block interior wall of the garage has a vertical crack visible. This crack should be sealed up and monitored. Recommend further evaluation for repairs by a qualified, licensed contractor.

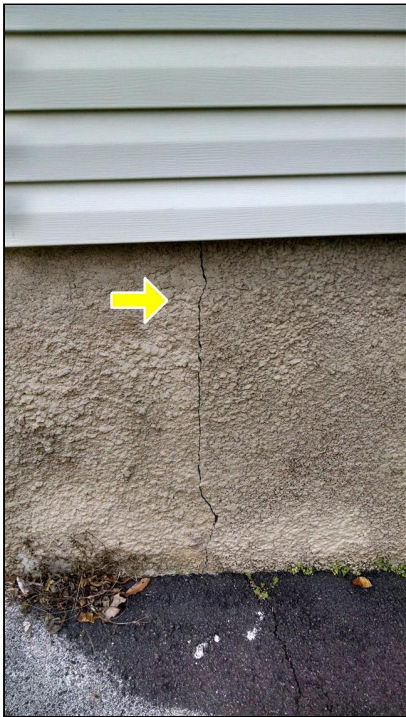
5.0 (1) There were numerous vertical cracks visible in the exterior wall surface of the foundation. These cracks could let water into the foundation walls and which may deteriorate the walls and the interior of the dwelling. The locations are noted on the corresponding pictures. Recommend further evaluation for repairs by a qualified, licensed contractor.

5.0 Item 1(Picture) Right side near driveway

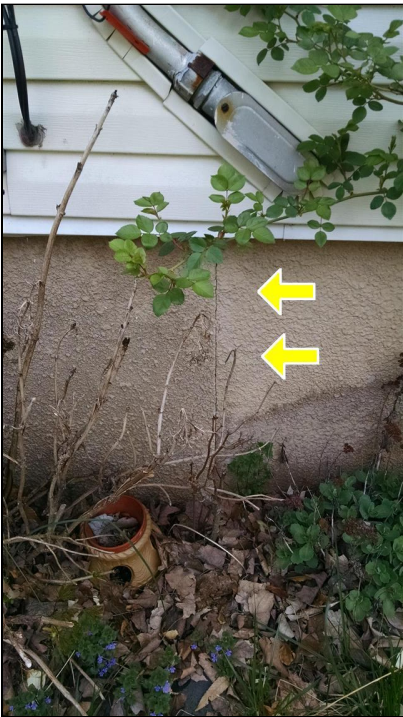
5.0 Item 4(Picture) Left side

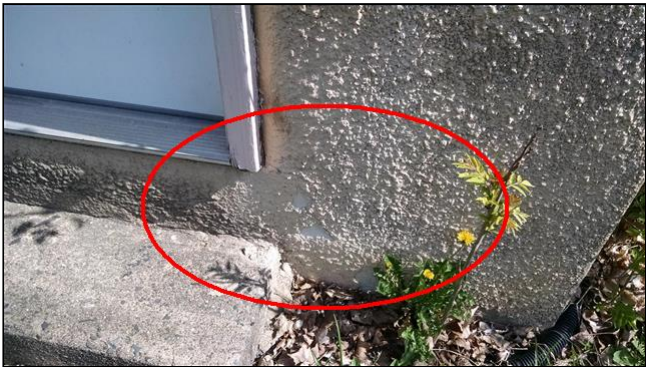
5.0 (2) The parging on the rear exterior foundation wall in several areas is flaking off. If not repaired, this could lead to deterioration of the foundation walls. Recommend further evaluation for repairs by a qualified, licensed contractor.

5.0 Item 6(Picture) Rear wall behind garage

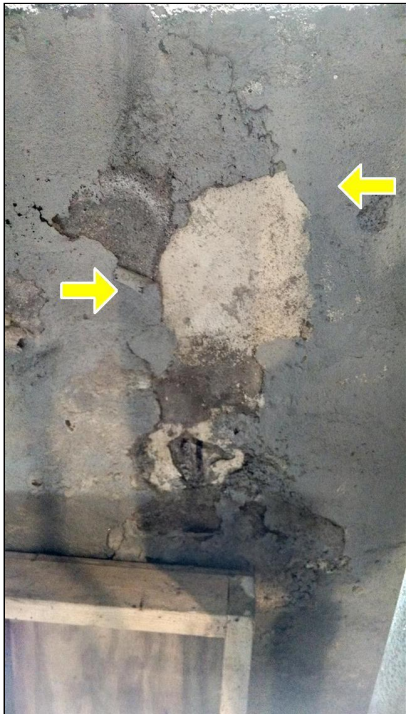
5.2 (1) The paint and parging on the interior foundation wall in the boiler area in the basement is flaking off in some areas along with small fragments of the masonry block. This is usually caused by water/moisture coming through the masonry block walls. Further deterioration of the block could occur if this isn't addressed. Recommend further evaluation for repairs by a qualified, licensed contractor.

5.2 Item 1(Picture) Paint/parging flaking off

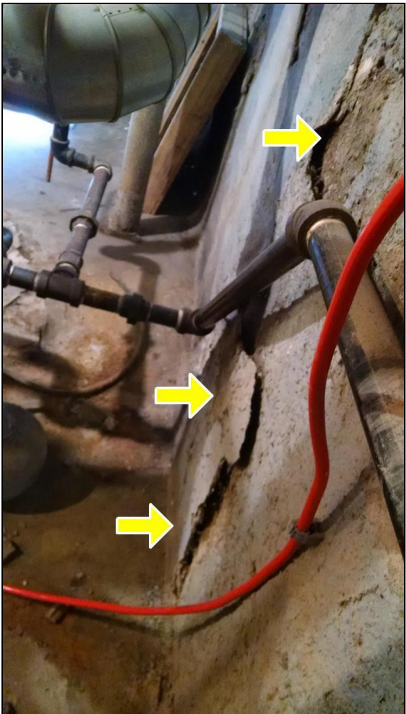
5.2 Item 2(Picture) Parging flaking off

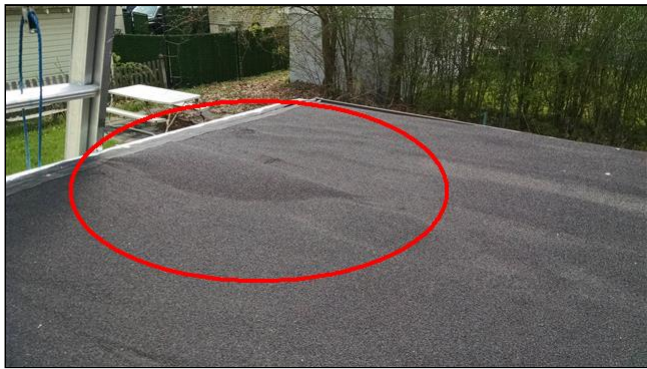
6.0 Item 1(Picture)

6.0 (1) The flat rolled roof over the rear portion of the garage has several areas that are lifting up. If the covering in these areas where compromised, it could lead to moisture intrusion into the interior. It doesn't appear the roof was leaking into the interior at the time of the inspection. Recommend further evaluation for repairs by a qualified, licensed roofing contractor.

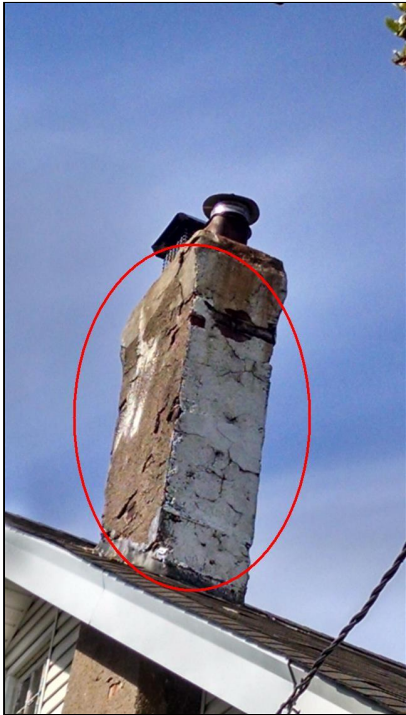
6.5 Item 1(Picture)

6.5 (1) The chimney above the roofline is severely deteriorated. The parging is cracked and peeling, there are several cracked bricks visible, the crown has numerous cracks and there are several bricks that are spalling. This condition could lead to moisture intrusion into the interior walls, ceilings, fireplace and the hot water heater and heating system boiler vent pipes. Recommend further evaluation for repairs by a qualified, licensed chimney professional.

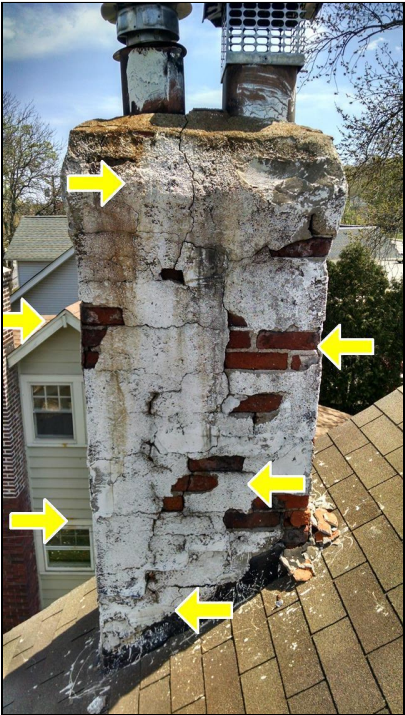
6.5 Item 2(Picture) Parging missing/cracked

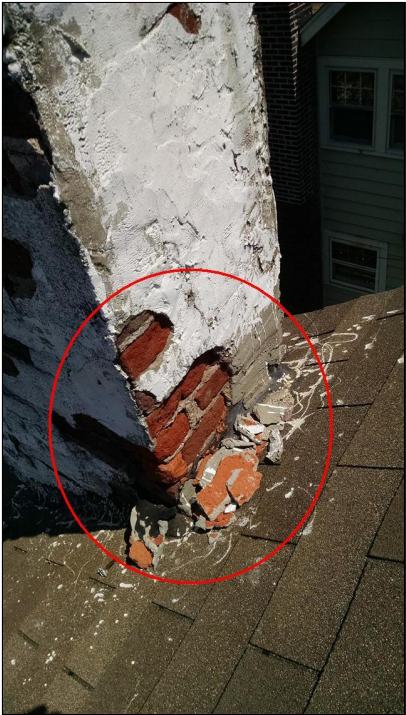
6.5 Item 3(Picture) Bricks spalling

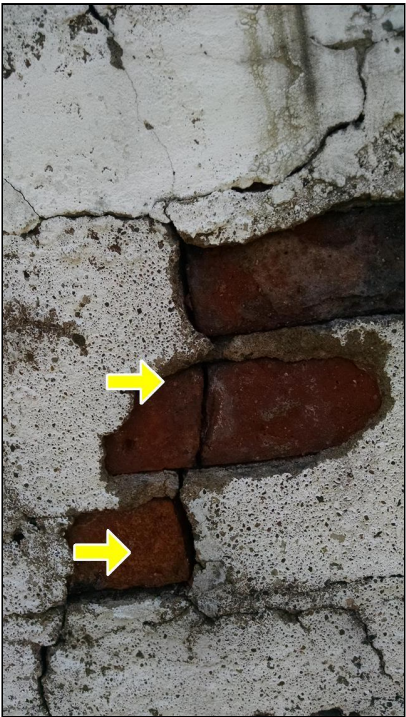
6.5 Item 5(Picture) Bricks cracked

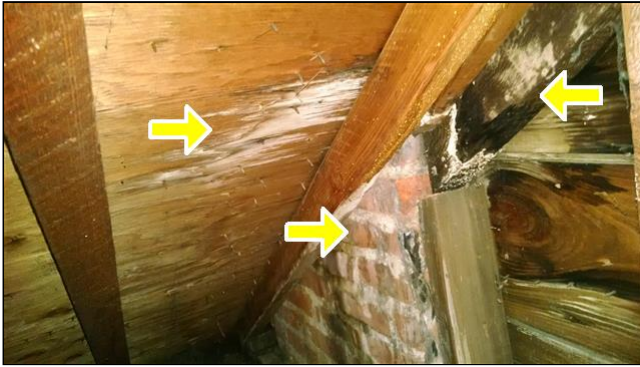
6.5 (2) There appears to be water damage to the roof structure and decking in the area below the chimney. Recommend further evaluation for repairs by a qualified, licensed contractor.

6.5 Item 6(Picture) View from attic

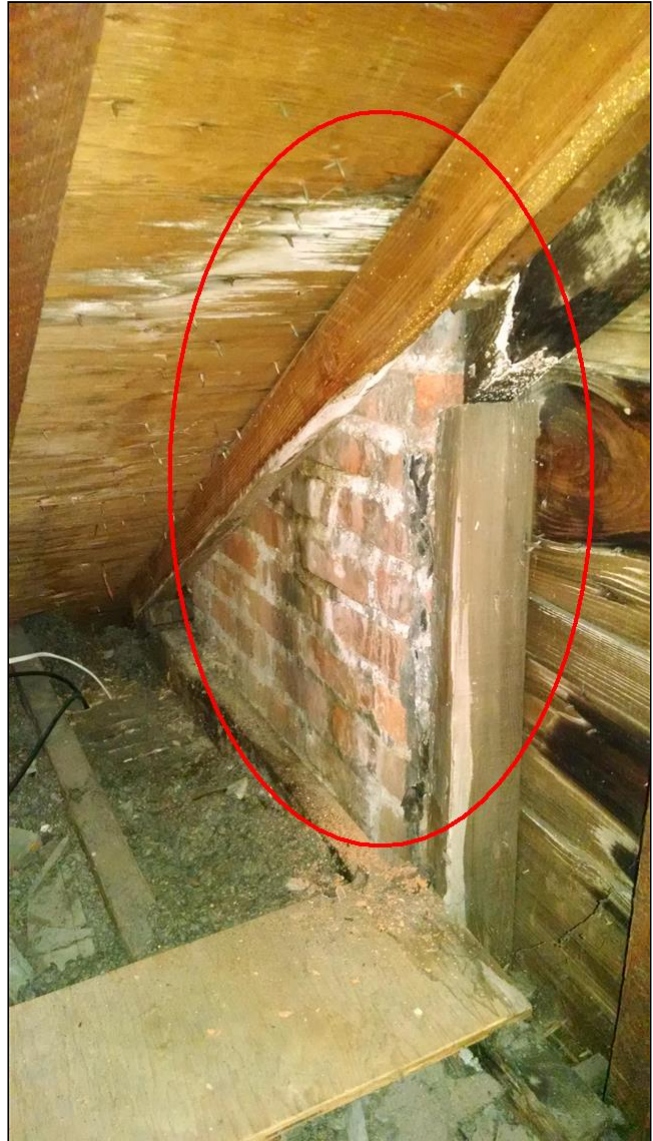
6.5 Item 7(Picture) View from attic

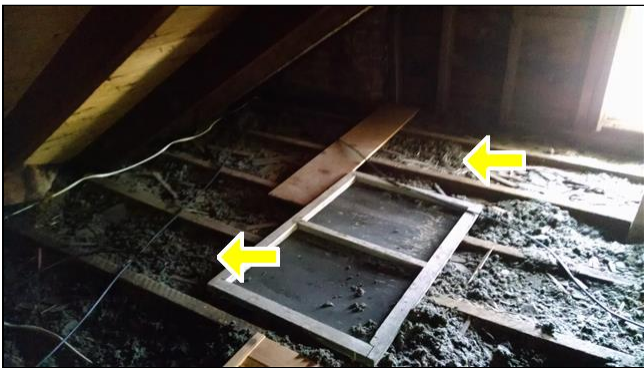
7.2 Item 1(Picture)

7.2 The blown in insulation installed in the floor joist bays is inadequate in some areas. Recommend adding some additional insulation to reduce energy expenses and prevent condensation/mold in the attic space by reducing the heat loss from the living space to the attic space. Recommend further evaluation for repairs by a qualified, licensed contractor.

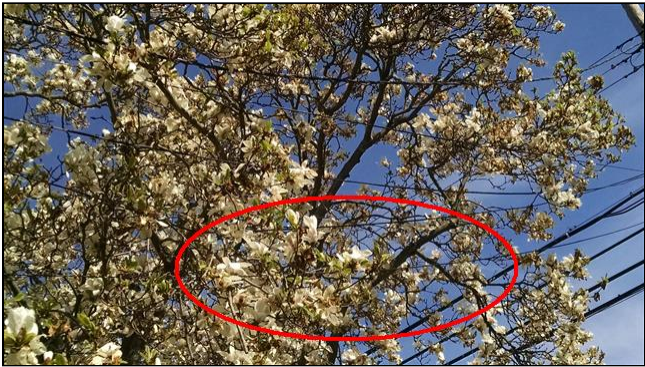
8.0 Item 1(Picture)

8.0 The branches on the tree in the front of the house are growing into the overhead electric service entrance wires. These branches should be trimmed away from the wires. PSE&G should be called because these wires are their responsibility. There should be no charge for this service.

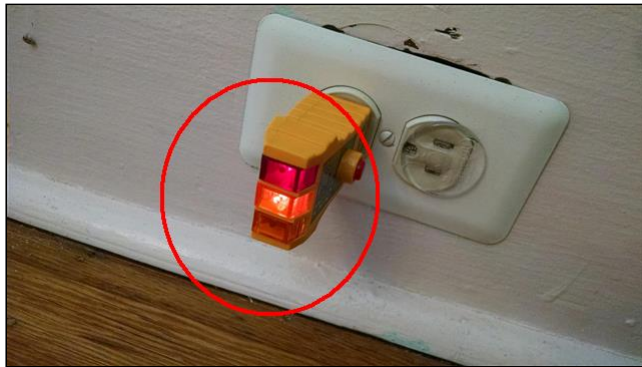
8.8 (5) There were numerous electrical outlets located in the dining room and 1st floor bathroom that had a reversed polarity condition. This happens when the hot and neutral wires get flipped around at an outlet or upstream from an outlet. Reversed polarity creates a potential shock hazard. Locations are marked on the corresponding pictures. Recommend further evaluation of the entire electrical system for repairs by a qualified, licensed electrician.

8.8 Item 8(Picture) Dining room outlet

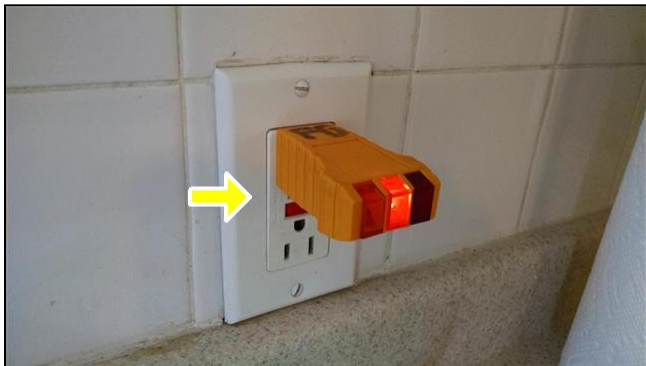
8.12 Item 1(Picture)

8.12 The GFCI outlet in the kitchen countertop area was not functioning properly. Also, the 2 other outlets in the countertop area should be GFCI protected. They may or may not be connected to the GFCI outlet that is not functioning properly. So they couldn't be tested for GFCI protection. Recommend further evaluation for repairs by a qualified, licensed electrician

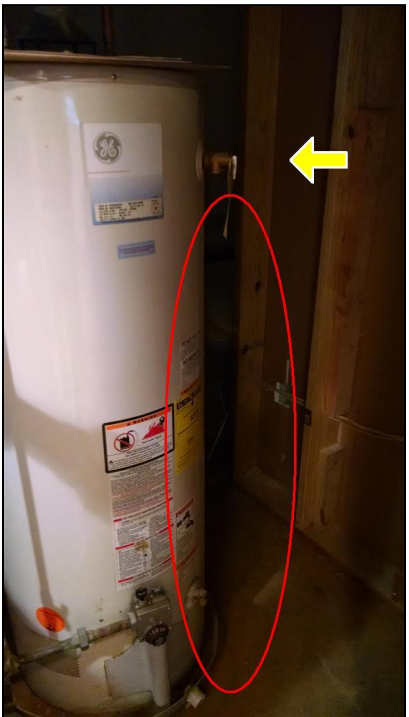
10.2 Item 1(Picture)

10.2 The TPRV discharge tube is missing from the hot water heater. This tube is needed and should be present incase the TPRV discharges hot water that could scald someone if they were in the area of the heater. Recommend further evaluation for repairs by a qualified, licensed plumber.

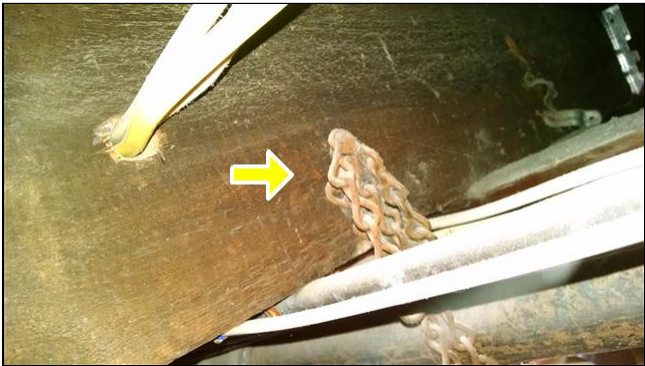
11.1 Item 1(Picture)

11.1 The heating distribution pipes located above the boiler were being supported by a chain hanging on a nail. The required strapping should be used. Recommend further evaluation for repairs by a qualified, licensed HVAC professional.

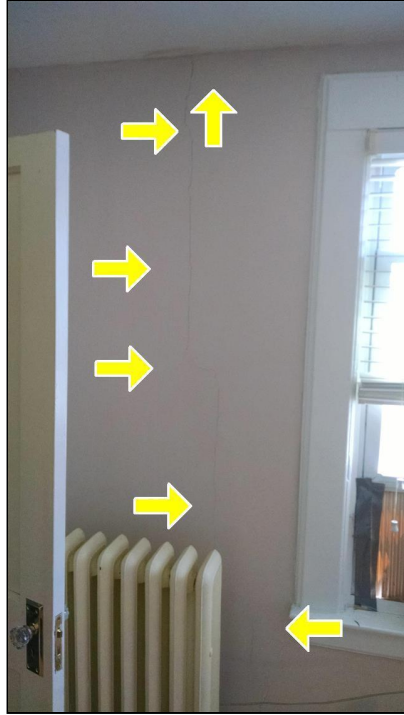
13.2 There was a vertical crack visible in the wall surface of the interior wall next to the chimney in the middle bedroom. The closet also had a vertical crack in the same area. There was also some what appeared to be some water damage to a small portion of the ceiling in the same area. These cracks should be repaired and monitored. Recommend further evaluation for repairs by a qualified, licensed contractor.

13.2 Item 1(Picture) Middle bedroom wall

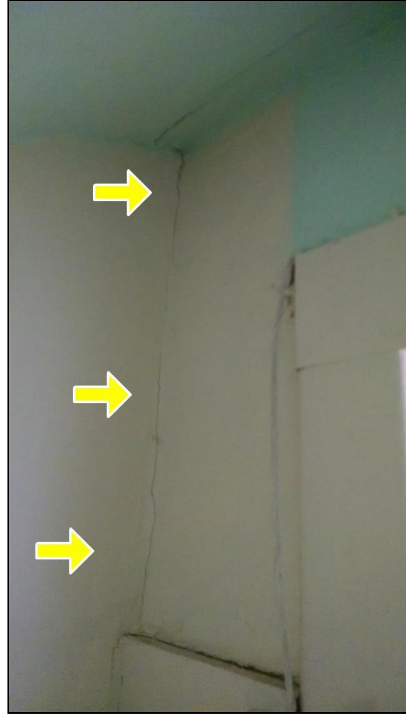
13.2 Item 2(Picture) Middle bedroom closet

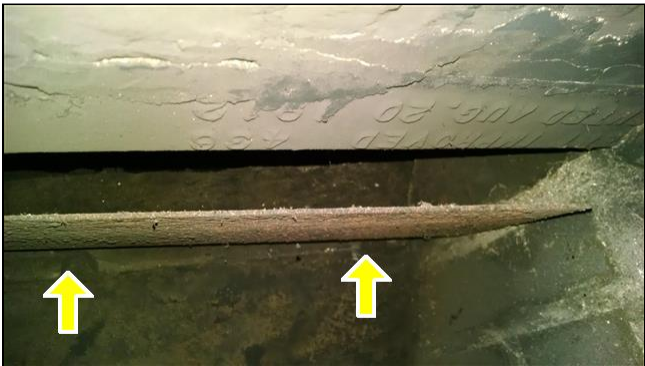
13.8 Item 2(Picture)

13.8 (2) The fireplace damper was not functioning properly. It appears to not be sitting in the pivot slots in the back of the fireplace damper frame. This is a safety issue and should be repaired before the fireplace is used. Recommend further evaluation for repairs by a qualified, licensed chimney professional.

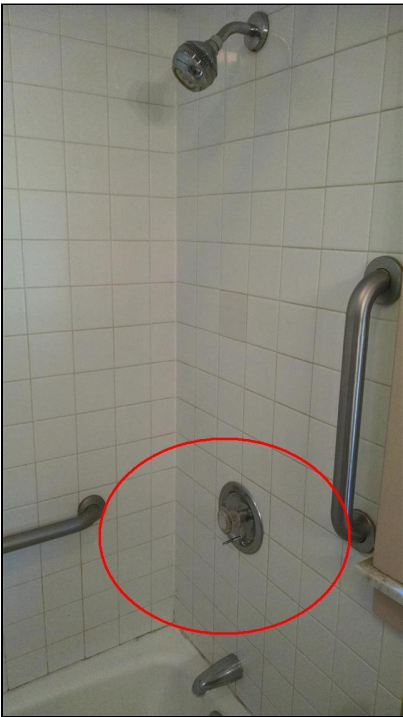
14.5 Item 1(Picture)

14.5 The shower water diverter in the 2nd floor bathroom was not functioning. I couldn't get any water to come out of the showerhead when the tub water was running and the diverter was activated. The diverter diverts the water from the tub spout to the showerhead when activated. Recommend further evaluation for repairs by a qualified, licensed plumber.

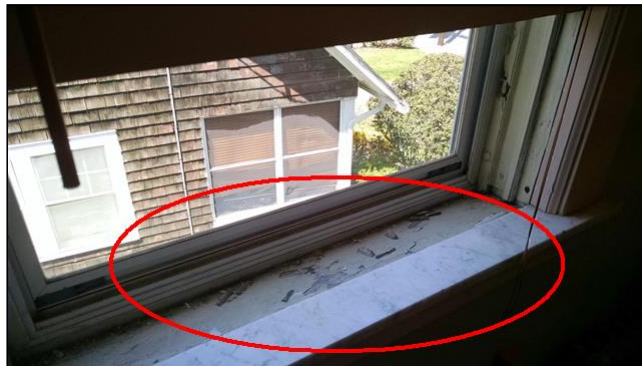
2.3 Item 5(Picture)

(3) The glazing is chipping off of the old wood framed window in the 2nd floor bathroom. Recommend further evaluation for repairs by a qualified, licensed contractor.

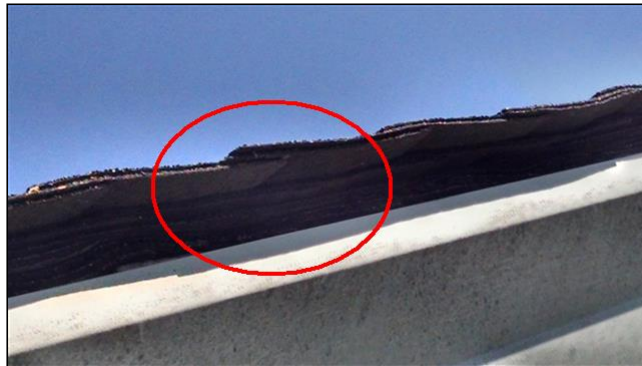
(2) It appears there are 4-5 layers of roof shingles on the rear half of the main roof including the original wood shake roof covering. The total measurement of these coverings together was close to 1 1/2". This portion of the roof didn't appear to be leaking but the weight of these coverings along with a deep snow/ice load could compromise the roof structure which is undersized by today's standards. Recommend further evaluation by a qualified, licensed roofing contractor.

6.0 Item 3(Picture) 3-4 layers of shingles

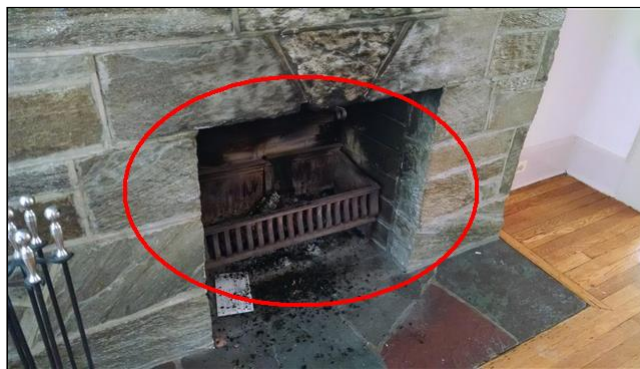
(1) The NFPA (National Fire Protection Agency- www.nfpa.org) highly recommends an annual inspection of all fireplaces and chimneys. They also recommend that an inspection take place upon the transfer of a property, the replacement of a solid fuel burning appliance, or following an external event likely to have caused damage. Our inspection of the fireplace and chimney pipe is limited to the readily visible areas and components. This visual inspection is not adequate to discover hidden deficiencies or damage should they exist. A NFPA 211 Standard, Level II inspection, which includes cleaning the interior of the chimney pipe and the use of specialized tools and testing procedures, such as video cameras, etc., is needed to thoroughly evaluate the fireplace system. If one has not been performed over the past 12 months, such an inspection is recommended at this time for your safety. Additional information pertaining to fireplace/chimney inspections can be found in Chapter 14 of the NFPA 211 standard. <http://www.nfpa.org/codes-and-standards/document-information-pages?mode=code&code=211>

13.8 Item 1(Picture) Fireplace should be cleaned and inspected
