Home Inspection Report

7 Anytown, USA, NY 12866

Inspection Date:

Sunday, February 4, 2018

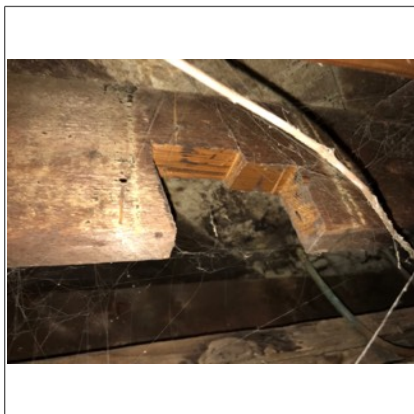
- Foundations**
 - Cracks and minor settling was observed on the foundation of this home. The crack on the rear wall of this home, that allows moisture to pass through, should ideally be filled by a mason as discussed.
- Floors**
 - The right rear floor joist is notched in the basement of this home. Notched joists are repaired by replacement, "sister" joists along side, or additional support as discussed. Where one or very few damaged joists are found, this work is not high priority and can be combined with other structural or carpentry repairs at the property.

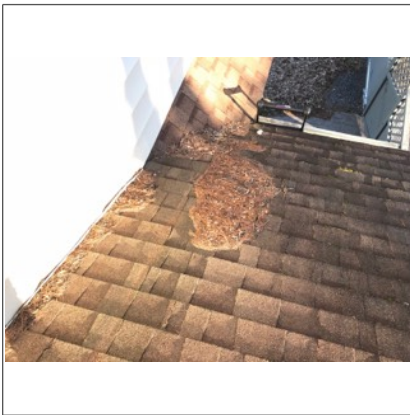
Sloped •Debris should be removed from the roofing to reduce risk of leaks and early roof wear as discussed.

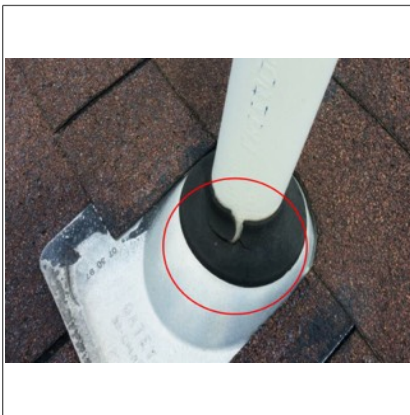
Flashings •The pipe boot flashing around the plumbing (vent) roof penetration has become cracked and broken and is in need of replacement. Repairs to the flashings around this roof are needed, especially around the chimney and annual inspections are encouraged as discussed.

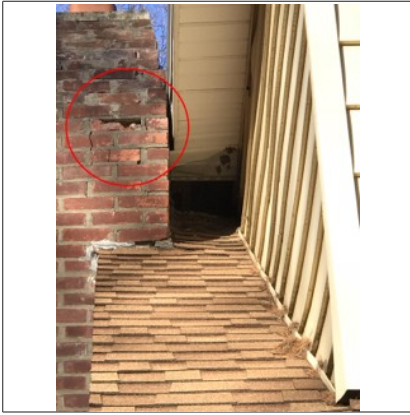
Chimney •The masonry chimney needs re-pointing (replacing the mortar between the bricks) and brick repairs to avoid water damage as discussed.
•The installation of rain caps and vermin screens on chimneys is a logical improvement also as discussed.

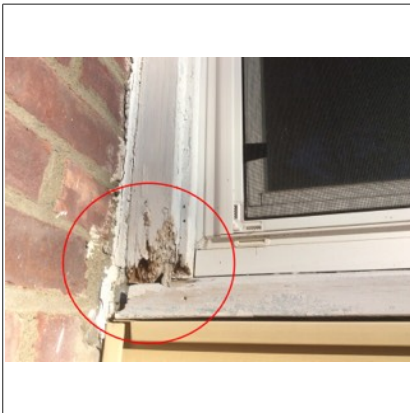
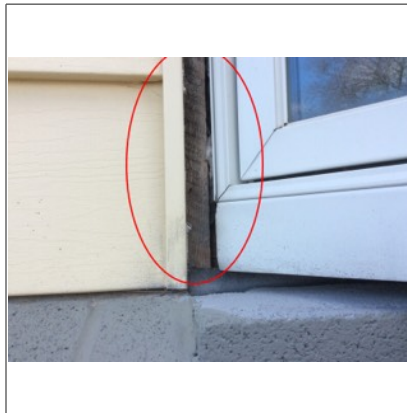
- Ext. walls**
- The openings in the siding around the front bay window of this home should be sealed and re-secured to avoid moisture and wind-damage as discussed.
 - The wood trim around this home should be painted to preserve the building.
 - Localized rot was observed in the wood trim on the right wall of this home as discussed. Following repair of the damaged areas (which should be combined with exterior painting/maintenance) proper maintenance of the wood trim and control of water from roof or surface runoff can avoid further damage.
 - Sliding glass doors are often vulnerable to splash back from the deck, patio or steps immediately outside of them. Localized rot may be present under these types of doors. Proper maintenance of the siding and control of water from roof or surface runoff can avoid damage.
