GENERAL INSPECTION REPORT (Non-NPDES)

Name and Location of Facility or Pollution Incident LMT Greenhouse, LLC	County Bucks	Municipality Lower Makefield Township
---	------------------------	---

Today I conducted a complaint inspection regarding the Bright Farms, LMT Greenhouse, LLC and the discharge of tinted red water to the ground in the adjacent field. I was accompanied by Mr. Jason Jackson, Head Grower, with LMT Greenhouse, LLC. I made the following observations:

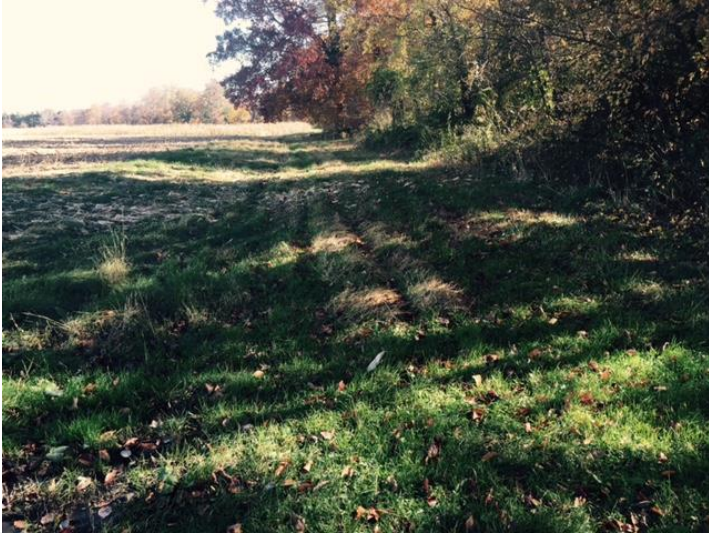
- #1 - The video provided by the complainant showed an unpermitted discharge of red tinted water to the ground along the side of the driveway that flowed down gradient along the path adjacent to the tree line. I inspected the area of the discharge identified in the complaint. The ground alongside the entrance did not have any residual red liquid but was slightly wet and had evidence of runoff. The evidence of run-off followed the same path described by the complainant's video and flowed down gradient adjacent to the tree line towards a small pond on the adjacent property. The grass in the path adjacent to the tree line was slightly wet. There was evidence of run-off and an erosion ditch on the grass along the path in the direction of the small pond. The discharge of red tinted pond water to the ground is an unpermitted discharge of Industrial Waste and a violation of Section 301 and 307 of the Clean Streams Law.** I inspected the small pond. The pond water was not red in color but brown due to sediment discharge into it. The pond has a discharge pipe that discharges to the ground and field adjacent to it. The pond does not discharge to a stormwater collection system or stream. The slope between the pond's discharge and the surrounding area was minimal and the distance to the nearest stream was significant.

1. The path adjacent to the tree line with evidence of erosion, 11/08/16.

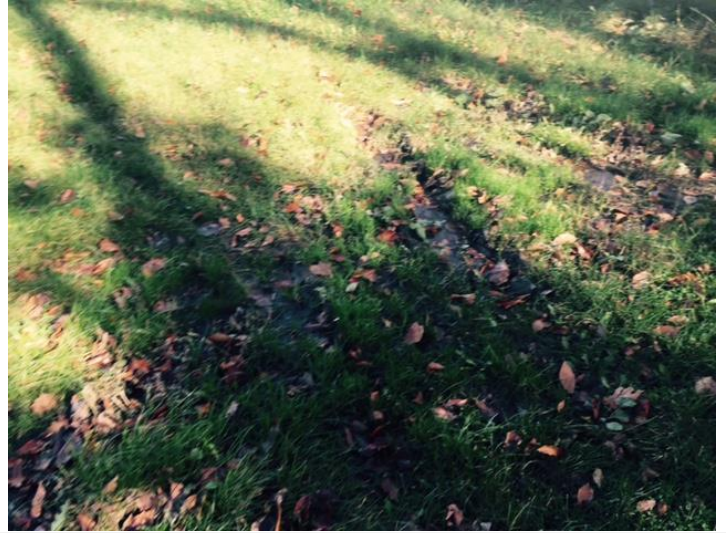
2. The ground adjacent to the driveway.

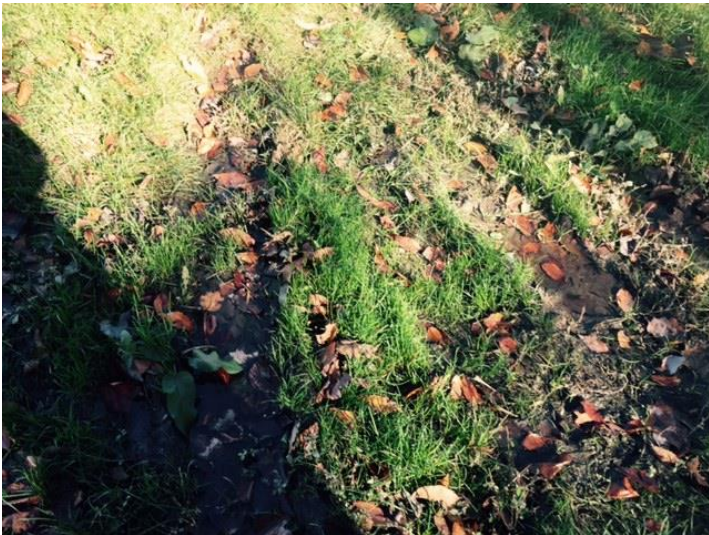
3. Evidence of flow and some wet grass adjacent to the driveway, 11/08/16.

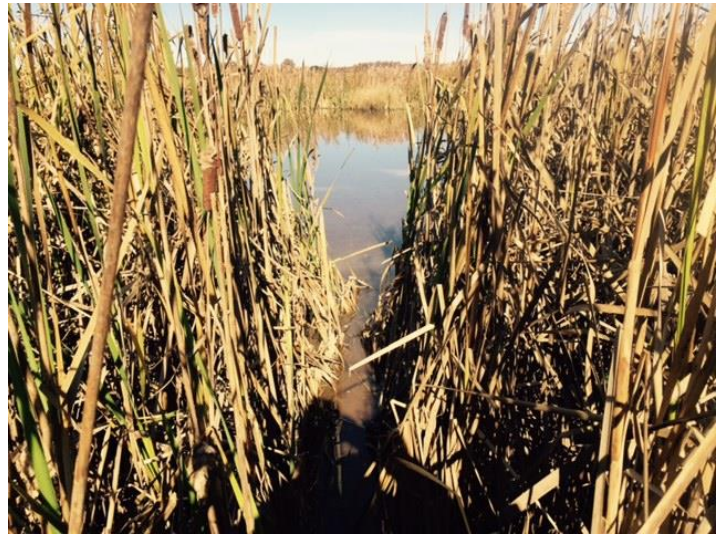
4. The pond in the field approximately 100 yds from the driveway.

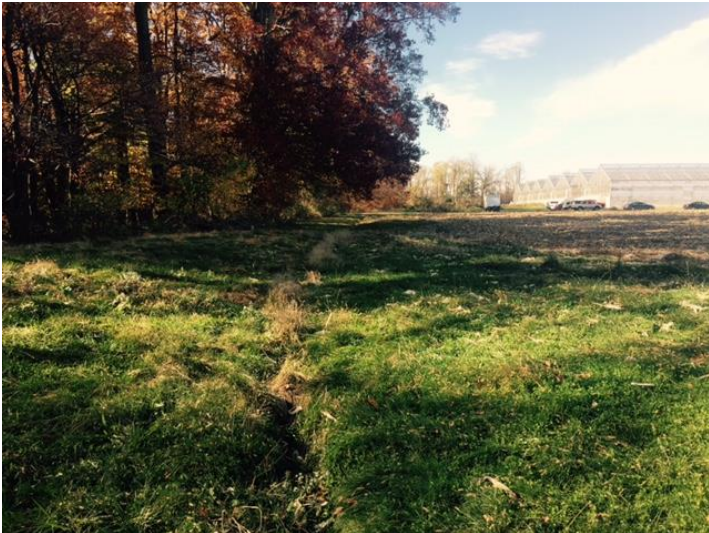
5. Evidence of erosion along the path adjacent to the treeline towards the pond.

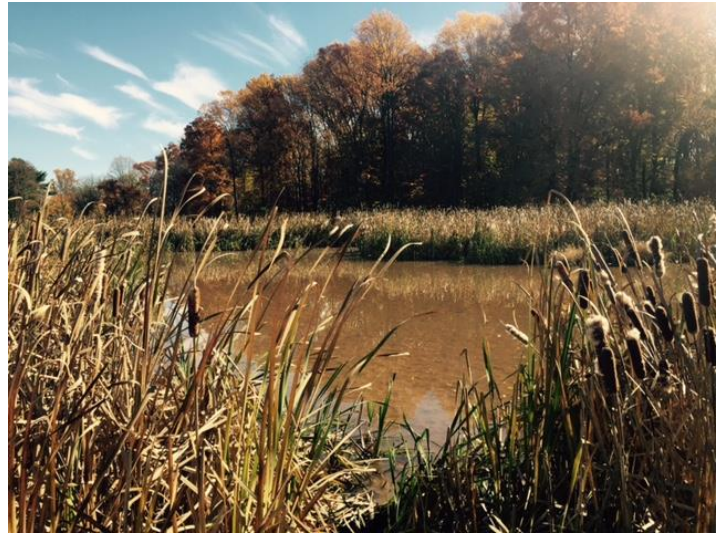
6. The pond.

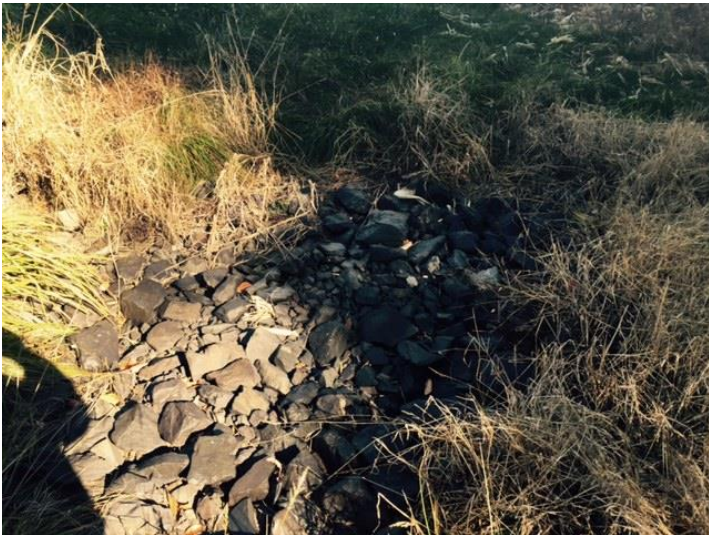
7. The pond's discharge was dry and goes to a field.

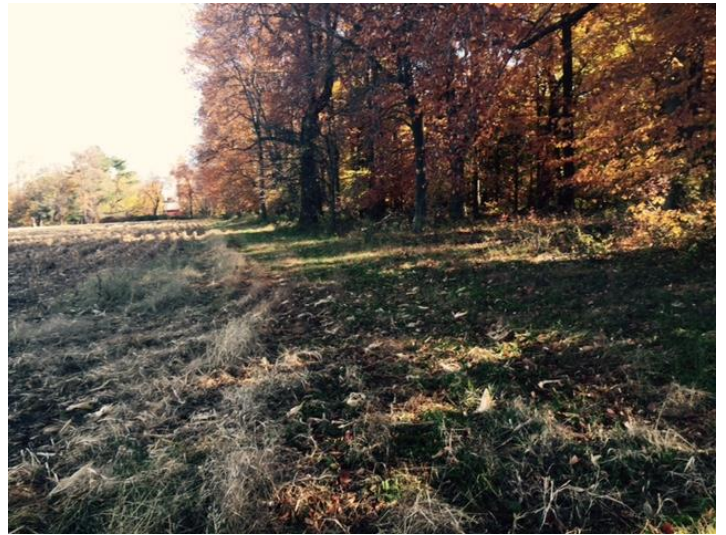
8. The edge of the field the location of the pond's discharge.

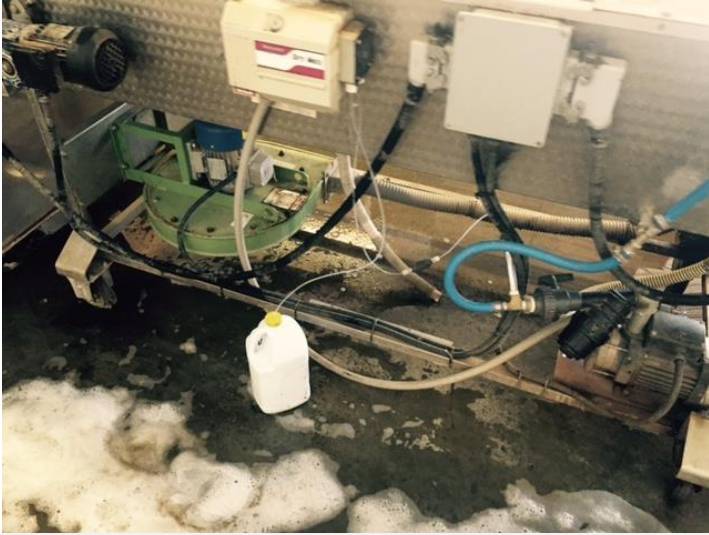
5. There are 4 or 5 drains located inside the facility that discharge to the sanitary sewer system and are pumped by the Environmental Ejector Pump to the Lower Makefield Township Sanitary Sewer Collection System. The Greenhouse system was previously an NFT System which used lower volumes of water. There is a board washer and harvest machine that both discharge small volumes to the sanitary sewer system. The board washer uses a quaternary ammonia solution to clean the boards. The water is recirculated to a tank where it is reused. Some of the wash water is discharged to the sanitary sewer system via a drain under the board washer.

9. The board washer, soap and associated sanitary sewer drain.

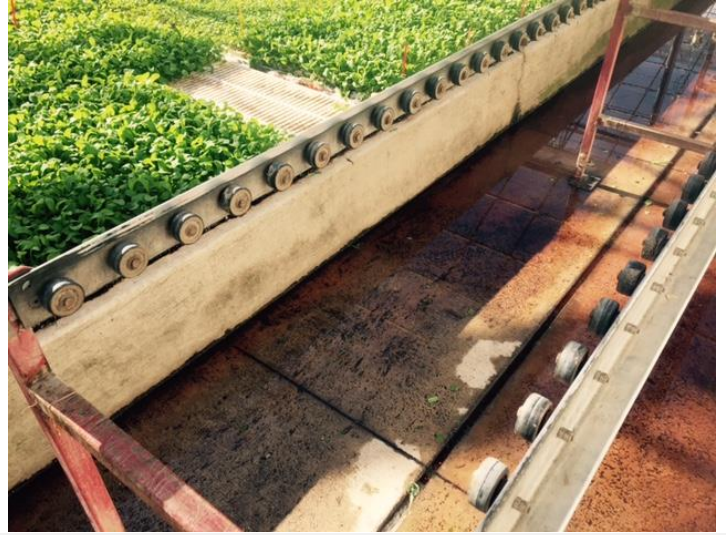
- The Bright Farms LMT Greenhouse has 7 48,000 gallon ponds that are used to grow multiple types of plants for consumption such as arugula, kale, spinach, basil and Lettuce. The ponds are initially filled with well water. Fertilizers are added to the well water such as potassium nitrate and calcium nitrate. The red color of the water comes from iron. Every Monday samples of the pond water are collected and sent to a laboratory for analysis especially for the Total Iron concentration which is required to be below 5.0 mg/L or ppm. Samples of the well water are also taken weekly. The seeds are placed on trays with groves for the vermiculite and peat moss media. The trays float on the surface of the ponds. As the chlorides build up in the pond approximately 1-2 inches of the

10. The hydroponic greenhouse ponds.

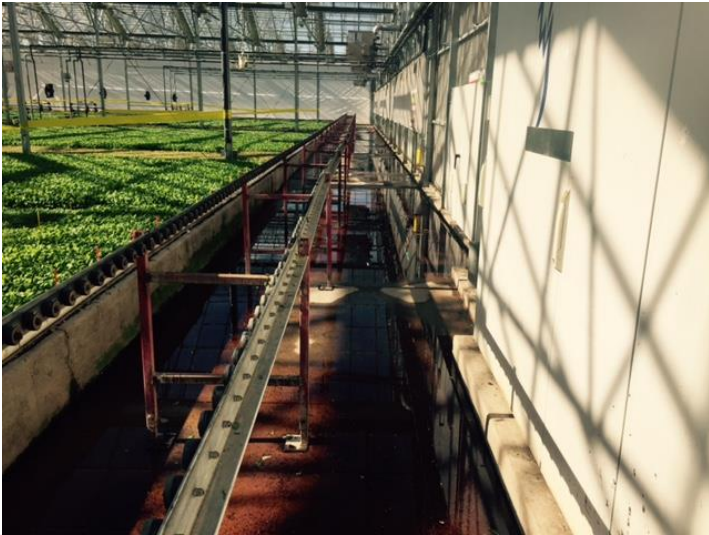
11. The greenhouse interior, 11/08/16.

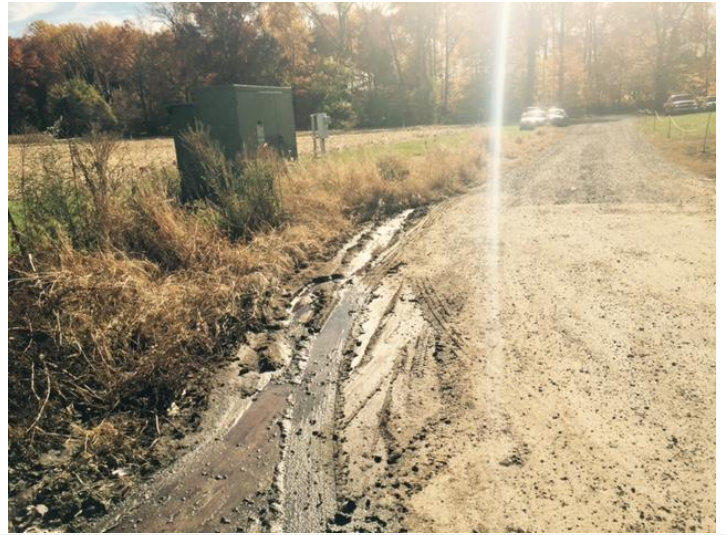
- I inspected the Bright Farms hydroponic greenhouse operation. **#2 - Outside near the entrance to the facility there were bins of cut plants waiting to be hauled offsite. There was small volume of red tinted water flowing out of the door near the entrance onto the pavement and ground, and some red tinted water leaking from the bins. This is also an unpermitted discharge of Industrial Waste.** The bins with plant material should be drained inside the facility and red tinted water should not be discharged outside.

12. Some red material on the ground from the water flowing under the door and the bins.

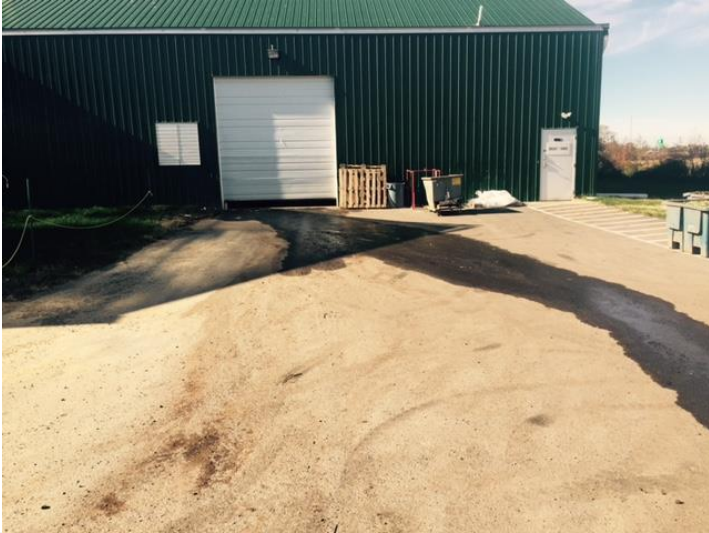
13. Water flowing under the door.

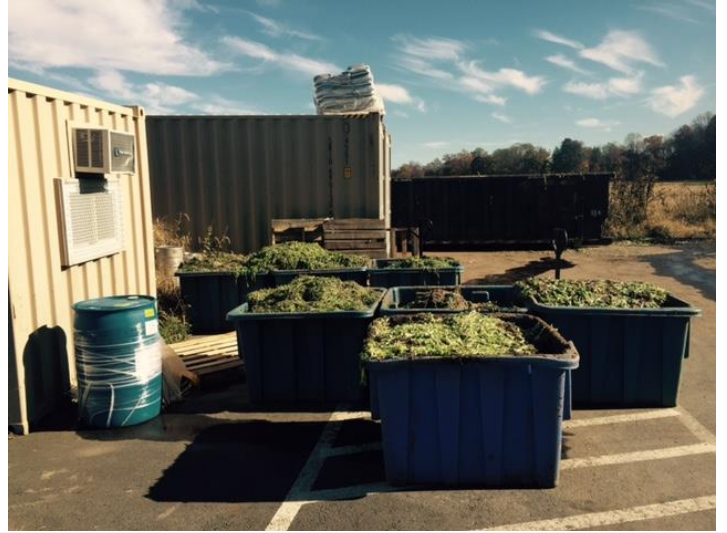
14. Bins of plant material that will be composted.

6. The Harvest Machine separates the leafy front part of the plants from the back parts using a saw. The leafy finished product is packaged and moved into refrigeration. **The back parts of the plants are placed into the bins that were observed outside. I recommend draining these bins inside the facility and ensuring they do not leak before moving them outside.**

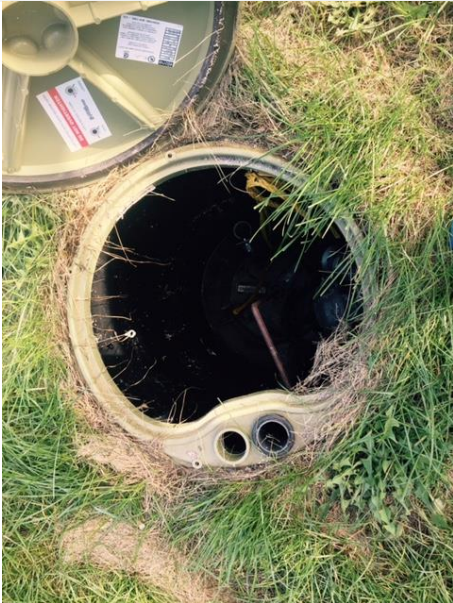
15. The sewer ejector pump.

8. I requested that LMT Greenhouse, LLC determine the maximum amount of flow that can be discharged via their ejector pump. I contacted Lower Makefield Sewer Administrator and asked for them to follow up with LMT Greenhouse and determine if your wastewater can be discharged to the sanitary sewer system. Until approval is obtained to discharge to the sanitary sewer any pond water that needs to be removed should not be discharged onto the ground but disposed of in another manor such as hauling offsite. I also requested LMT Greenhouse, LLC provide the most recent sample results of the pond water and well water going back 6 months if possible.
