PROPERTY INSPECTION REPORT

Concerning: XXXX Cimarron Road, McKinney, Texas 75070

By: Jen K Chen (Jake) TREC #20333

XX/XX/2018

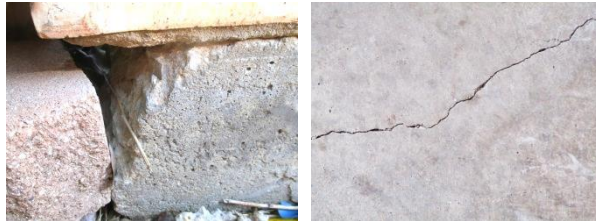
A. Foundations

Comments: Foundation shows evidence of movement; cracks in concrete corner need to be repaired. Several settlement cracks are located on the garage floor; shows evidence of foundation movement that needs to be repaired. Monitor these cracks for further separation. It is recommended for a licensed foundation company to check.

The tree needs to be at least 15 to 20 feet away from the foundation wall; the roots may damage the foundation.

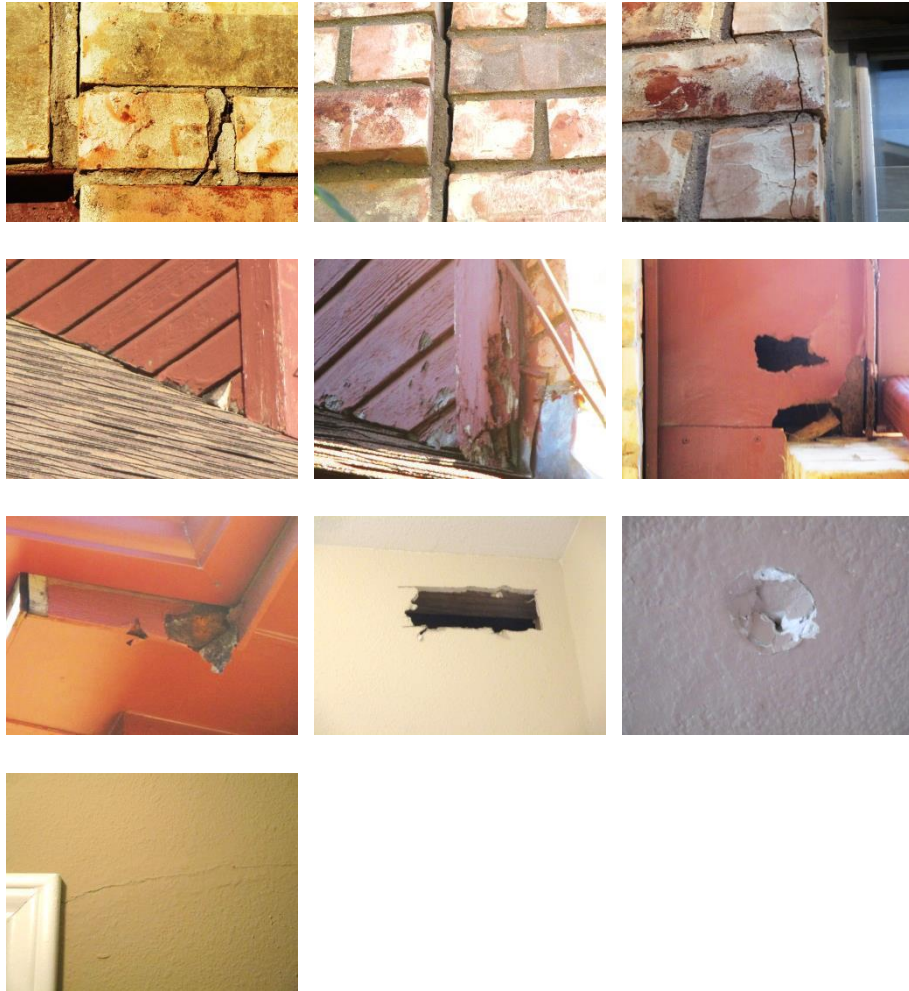
E. Walls (Interior & Exterior)

Comments: There are some exterior brick wall cracks on the east, south and north side; shows evidence of foundation movement which needs to be repaired. On the west and south side of the wooden exterior wall, there is wood damage; needs to be repaired. At the front of the house, the soffit underneath the roof on the east side has hole damage that needs to be repaired. At the front of the house, the fascia underneath the roof on the east side has wood damage that needs to be repaired. The following places have some interior wall cracks and holes damage in the sheetrock that needs to be repaired: closet in the downstairs study room, upstairs west bedroom and closet in the upstairs south bedroom.

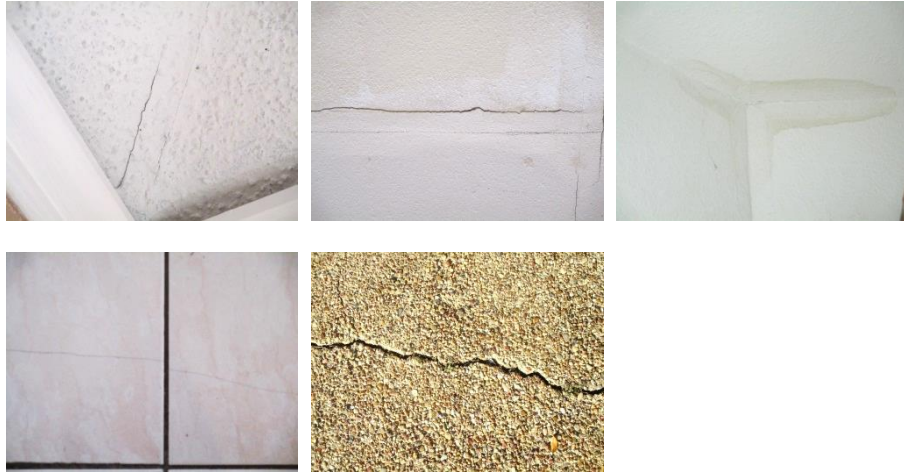
F. Ceilings & Floors

Comments: The following places have some ceiling cracks in the sheetrock that need to be repaired: upstairs east bedroom, upstairs south bedroom, upstairs west bedroom and upstairs master bedroom. The ceiling above the water heater of the upstairs bedroom hallway closet has water stains; shows evidence of water penetration from the roof; needs to be repaired. The floor tile in the front entryway shows evidence of cracks; needs to be repaired. Settlement cracks on the concrete floor are located in the driveway and in the garage; show evidence of foundation movement that needs to be fixed.

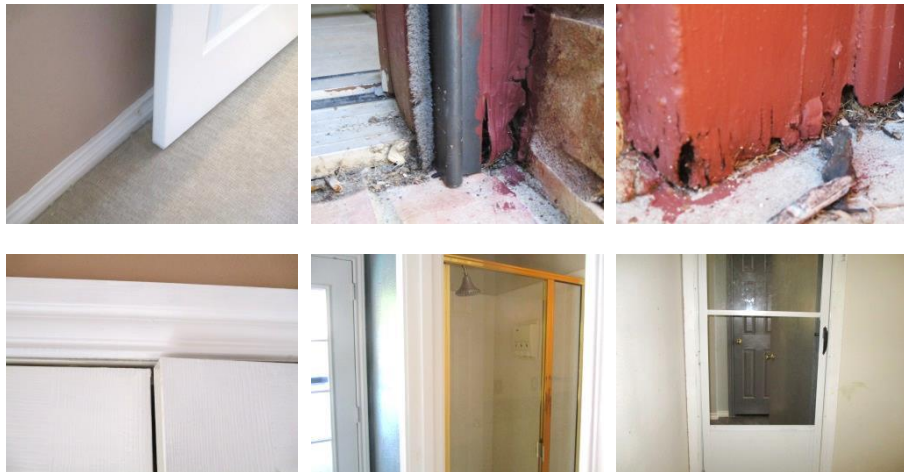
G. Doors (Interior & Exterior)

Comments: Opened and closed all doors and checked outside locks. All the exterior and interior doors need to have door stoppers. The bottom of the door frame at the backyard door and garage door shows evidence of damage; needs to be repaired. The following places have double doors with the top locks that are inoperable; needs to be repaired: upstairs east bedroom and closet in the upstairs bedroom hallway. The shower door in the downstairs bathroom is inoperable; needs to be repaired. The screen of the interior garage door is damaged; needs to be repaired.

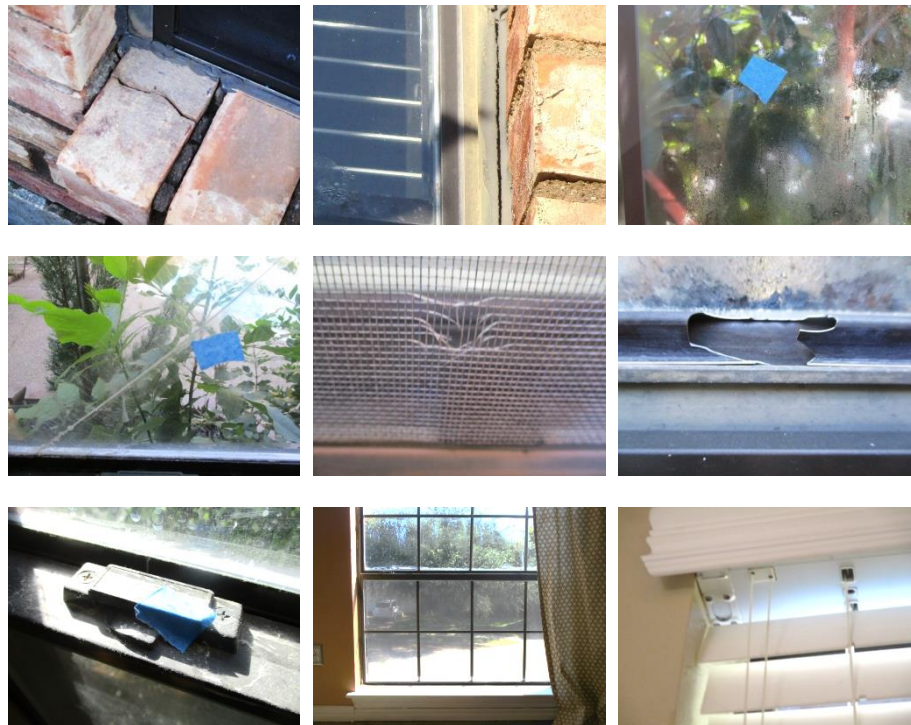
H. Windows

Comments: Opened and closed all windows and checked locks. The exterior window sills are cracked; shows evidence of movement which needs to be repaired. The exterior window needs to be caulked to the brick wall. There are 21 windows marked with blue tape showing evidence of moisture in between the glass; need to be repaired. The following places have windows that are broken and need to be repaired: the upper right window on the west wall of the breakfast room, the upper two windows on the east wall of the upstairs east bedroom, the right window on the west wall of the upstairs west bedroom and the upper window on the east wall of the walk-in-closet in the upstairs master bathroom. The following places have window screens that are damaged and need to be repaired: the left window on the east wall of the living room and the three windows on the east wall of the dining room. On the east wall of the walk-in-closet in the upstairs master bathroom, the window screen is missing; needs to be restored. Along the east, west and north side, the exterior window's glazing bead shows evidence of damage; needs to be repaired. The following places have window locks that are inoperable; needs to be repaired: the three windows on the west wall of the family room, the right window on the west wall of the breakfast room, the two windows on the south wall of the downstairs study room and the four windows on the west wall of the upstairs master bedroom. In the upstairs east bedroom, the left window on the east wall does not stay up when opened; needs to be repaired. The window miniblind tilt wands are inoperable and need to be repaired in the following places: the window on the east wall of the living room, the right window on the west wall of the family room and the left window on the west wall of the upstairs master bedroom.

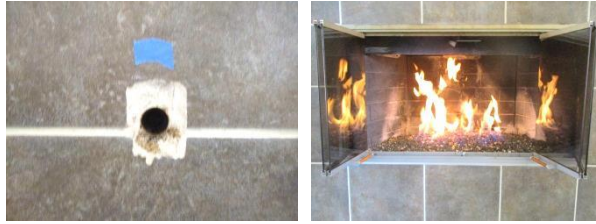
J. Fireplace/Chimney

Comments: The fireplace's key lock cover is missing; needs to be restored.

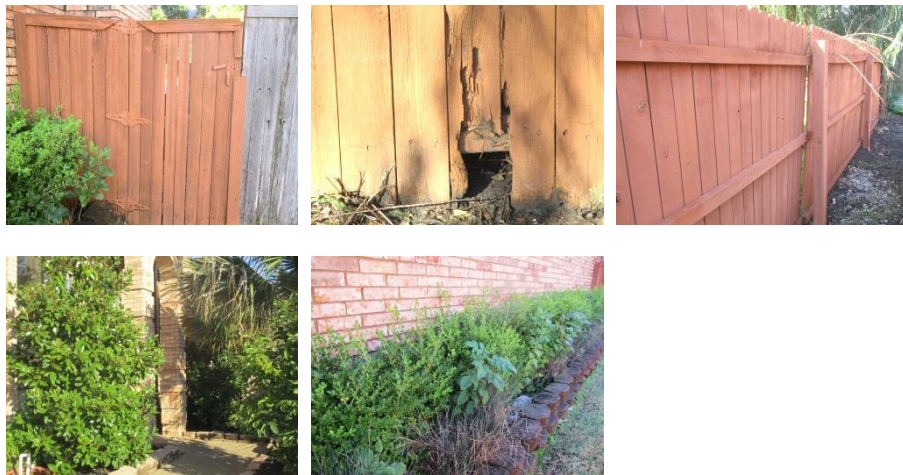
L. Other

Comments: The east side of the door fence is inoperable; needs to be repaired. Part of the backyard fence has some wood damage on the west side; needs to be repaired. Along the west and south side of the wood fence, the wood post shows evidence of instability; may possibly fall in the future and needs to be repaired.

The bushes and trees are touching the house.

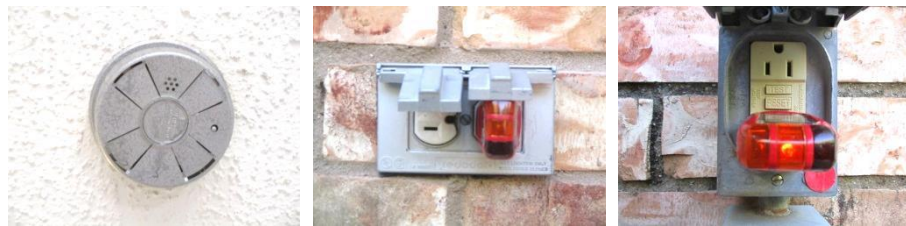
B. Branch Circuits, Connected Devices, and Fixtures

Comments: All the outlets around the kitchen countertop, garage, and bathroom need to be GFCI (ground fault circuit interrupter) protected. The smoke detector is missing in all the bedrooms; needs to be restored. The following places have smoke detectors that are inoperable and need to be repaired: kitchen and upstairs bedroom hallway. On the west side of the backyard patio, the exterior outlet is inoperable and needs to be repaired. On the north wall of the side yard, the GFCI reset button outlet is inoperable; needs to be repaired. On the west wall of the bar room, the light switch cover is damaged; needs to be repaired. On the west wall of the family room, the outlet cover is damaged; needs to be repaired. On the south wall of the walk-in-closet in the upstairs master bathroom, the cover of the electrical junction box is missing; needs to be restored. The following places which have ceiling fans are inoperable and need to be repaired: family room, downstairs study room, upstairs south bedroom and upstairs west bedroom. The following places have light fixtures that are inoperable and need to be repaired: backyard, downstairs bathroom, upstairs east bedroom and upstairs south bedroom.

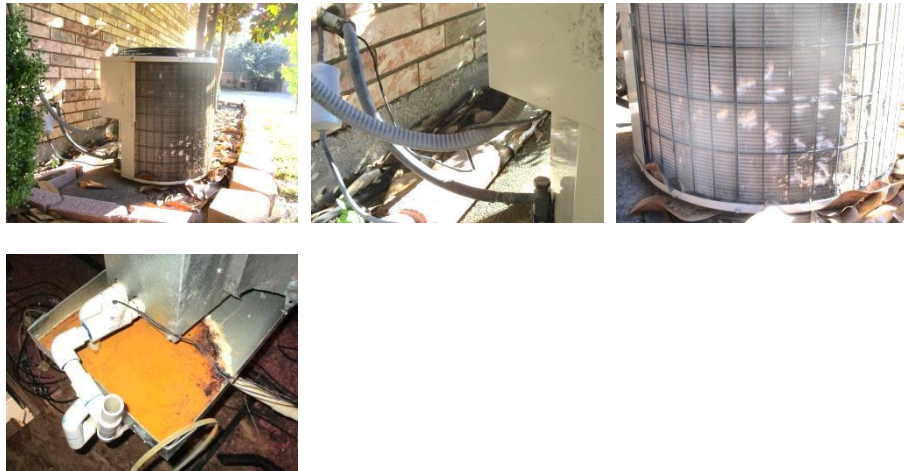
B. Cooling Equipment

Comments: Air conditioner to determine if the differences in temperatures of the supply and return air are between 15 degrees and 22 degrees which indicate that the unit is cooling as intended. The supply air temperature on your system reads 53 degrees, and the return air temperature was 70 degrees downstairs. This indicates the range in the temperature drop is normal. The supply air temperature on your system reads 55 degrees, and the return air temperature was 70 degrees upstairs. This indicates the range in the temperature drop is normal. Condenser unit out of level and could cause premature wear on the compressor and components. Damaged insulation on condensate lines should be repaired. Condenser unit fins are damaged and should be repaired. The secondary drain pan in the attic needs to be cleaned or repaired, due to rusting. This indicates that a primary drain line is clogged.

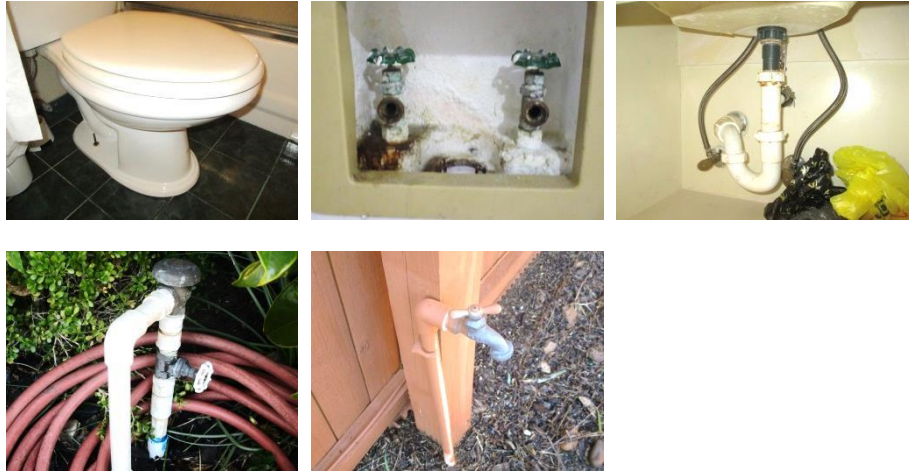
A. Water Supply System and Fixtures

Comments: The static water pressure of the supply plumbing system exceeded 80 PSI. The Texas Real Estate Commission requires home inspectors to report this as deficient. It would be wise to install a pressure regulator. Otherwise, the plumbing system may be prone to leaks in piping, fittings or other equipment. The drain stopper of the right lavatory in the upstairs bathroom is inoperable; needs to be repaired. Both drain stoppers of the lavatory in the upstairs master bathroom is inoperable; needs to be repaired. The bathtub's drain stopper in the upstairs bathroom is inoperable; needs to be repaired. When bathtub's diverter is pulled, and the shower head is running in the upstairs bathroom, the faucet below leaks water; needs to be repaired. When the right bathtub's faucet in the upstairs master bathroom is turned on, there is evidence of water leaking; needs to be repaired. In the downstairs bathroom, the shower handheld connection leaks when turned on; needs to be repaired. In the upstairs master bathroom, the shower head connection leaks when turned on; needs to be repaired. The regROUT is needed between the bathtub, the tile and the corner in the upstairs bathroom and upstairs master bathroom. The backsplash on the countertop of upstairs bathroom needs to be caulked. The commode in the upstairs bathroom and upstairs master bathroom is loose on the floor; needs to be repaired. The laundry room's hot faucet on the left side of the washer shows evidence of water leaking which needs to be repaired. In the upstairs bathroom, underneath the left lavatory, the drainage pipe leaks when water is turned on; needs to be repaired. When the exterior faucet on the east wall of the front yard is turned off, there is evidence of water leaking; needs to be fixed. The exterior faucet in the backyard is inoperable; needs to be repaired.

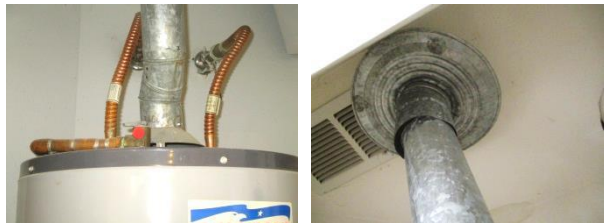
C. Water Heating Equipment

Comments: The cold water and hot water pipe need to be covered in insulation. The pipe is exposed and needs to be wrapped all the way. The water heater's gas vent pipe collar is loose; needs to be repaired. The water heater in the upstairs closet has a strong gas odor and needs to be further investigated by a licensed plumber.
