January 25, 2021

Mark Kuhn, Property Manager  
St. Davids Park Condominium Association  
P.O. Box 1605  
West Chester, PA 19380

Re: St. Davids Park Condominium Association – Structural Evaluation Report

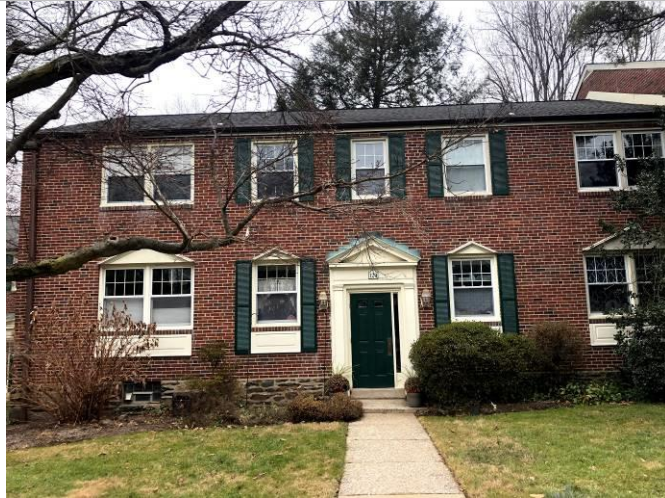
Buildings with gable roofs are of wooden A-frame construction which are supported by the front and rear exterior walls. Wood ceiling joists span approximately halfway across the short-dimension (front to rear) of the building and are supported by a central load-bearing wall.

1. Front view of typical gable roof building.

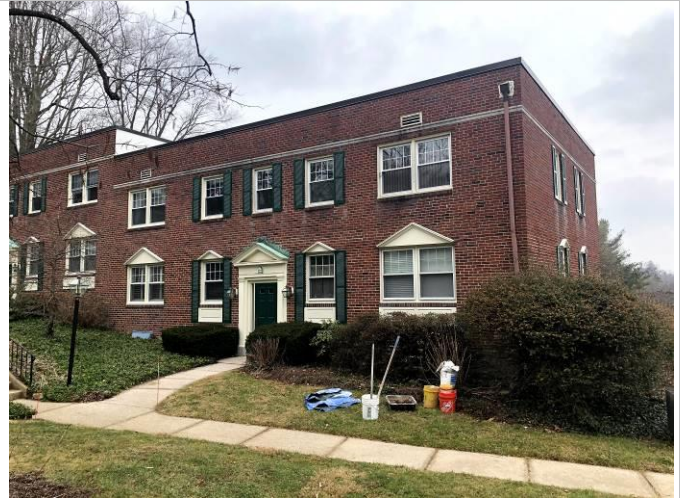
Flat roofs are supported by wood roof/ceiling joists which span approximately halfway across the short dimension of the building and are supported by the central load-bearing wall.

2. Front view of typical flat roof building.

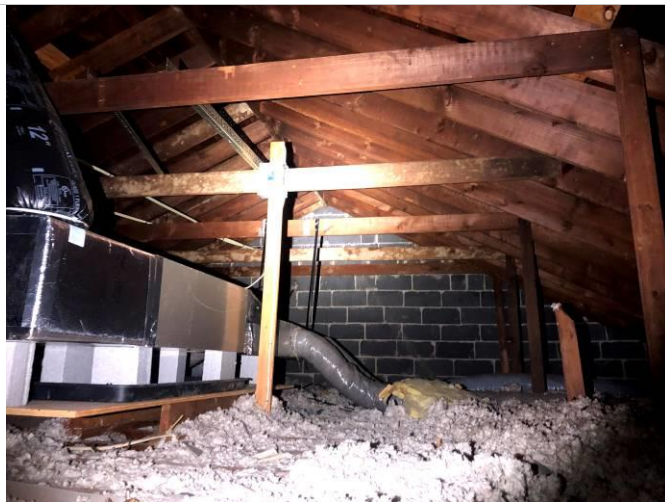
3. Roof rafters in attic of Gable-framed building

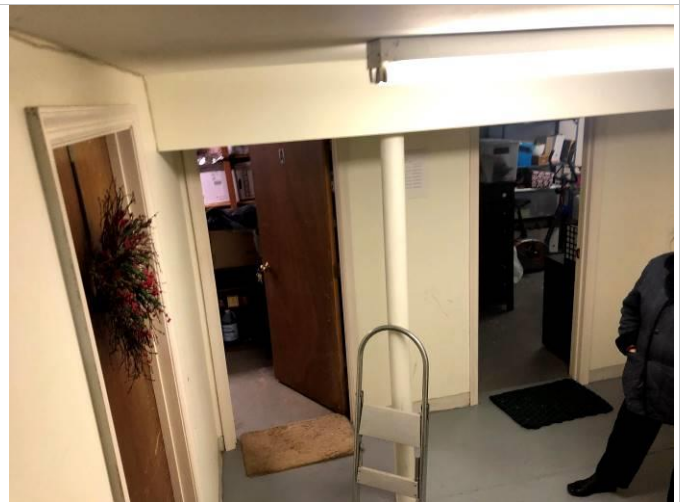
The central load bearing wall runs the entire length of the building parallel to the long-dimension exterior wall. In the basement, a steel column is used to support a beam of unknown construction which carries the load bearing wall above.

4. Steel column in basement supports load bearing wall above.

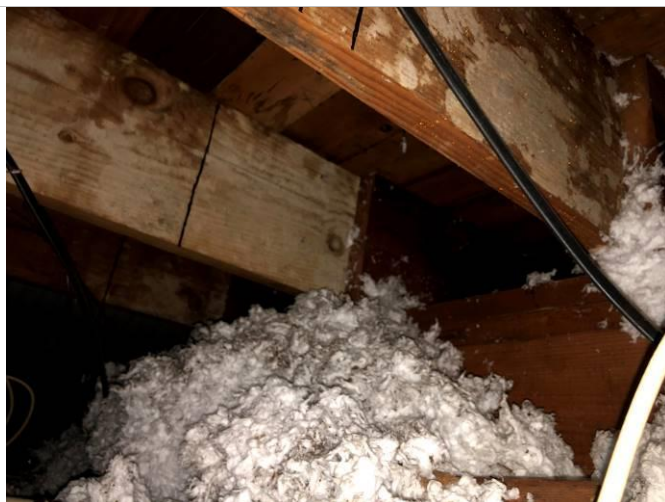
5. Photograph taken looking into attic shows roof/ceiling joists bearing on center load-bearing wall.

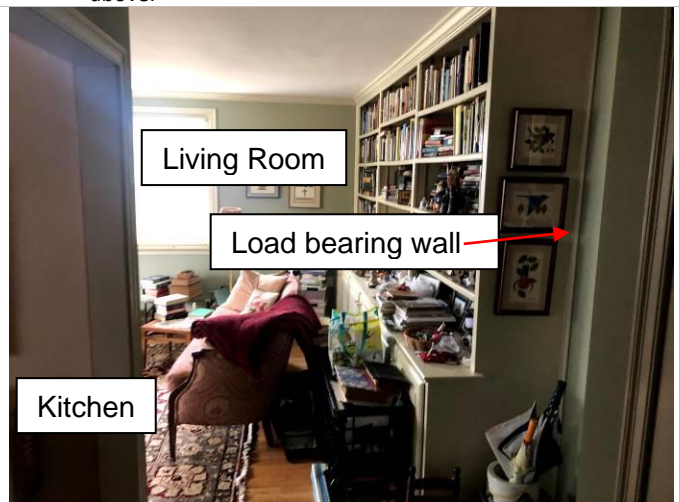
6. View inside two-bedroom unit showing load-bearing wall and wall separating kitchen and living room.

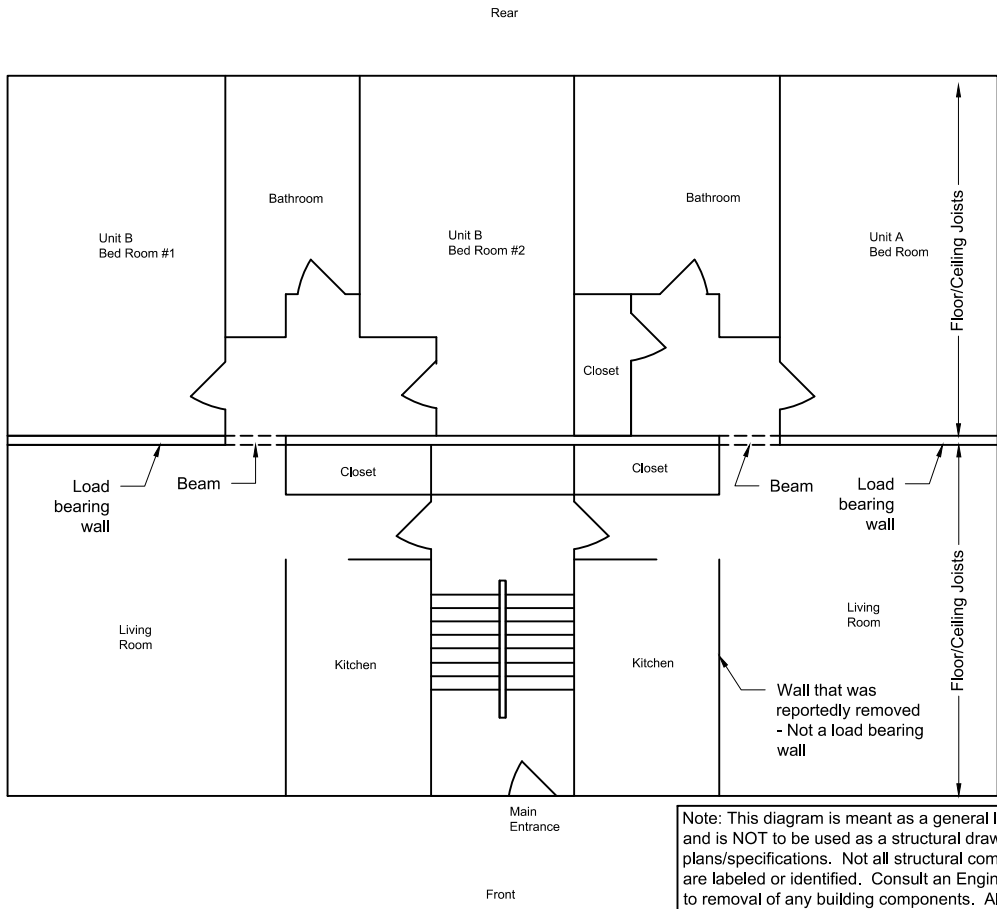
# First Floor Layout Diagram

In conclusion, based on visible evidence readily accessible during our inspection, the wall that separates the kitchen and living room in the typical one-bedroom layout on the first floor, as shown in the attached diagram, is not a load bearing wall and can be removed. This report is not intended to list all load-bearing components of the structure as should not be construed as such. As a precaution, an engineer should be contacted prior to the removal of any wall.
