**CASE STUDY  
ANALYSIS OF CENTRIFUGAL FAN HIGH AMPLITUDE VIBRATION**

**Abstract:** A request was received to determine the root cause of very high amplitude vibration of a spray dryer fan. The fan was an AMCA Arrangement 8, 500 Hp. The fan's vibration amplitudes had reportedly been trending up. Balancing the fan had not reduced vibration to acceptable levels. The analysis used visual inspection, vibration data, operating deflection shape analysis (ODS) and experimental modal analysis to determine the root causes. Problems identified included operation at the 1<sup>st</sup> critical speed of the fan rotor, anchor bolt failures, loose bolting, improperly sized bolting, improperly installed anchor bolts, lack of grouting during installation, extensive corrosion and erosion of the fan housing. Recommendations were provided to properly install anchor bolts and steel reinforcement to anchor the fan to the foundation. This article discusses the findings of the inspection and vibration analysis process. The client decided not to install the recommended base stiffening but rather to replace the fan.

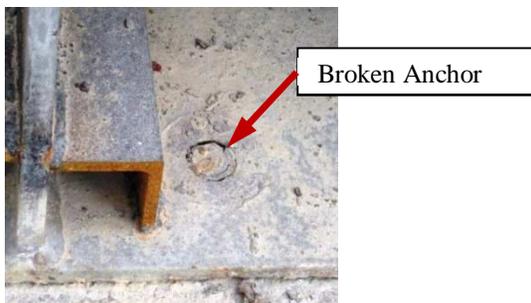
**Figure 2. Broken Anchor Bolts on Fan Base.**

**Visual Inspection:** With the fan shutdown and locked out, a visual inspection of the duct work, fan housing and wheel were made. One of the broken anchor bolts is shown in **Figure 2**. Bolt fatigue failure often occurs when there is inadequate stretch length of the

- Several bolts had broken and others were loose causing excessive flexure of the fabricated base.
  - The anchor bolt washers were too thin. This resulted in deformation of the washers and the inability of the bolted assembly to stay properly tensioned. The use of double spherical washers would prevent bending loads on the bolts.

1. The concrete anchor bolts must have a minimum free stretch length of 10-12 times the bolt length for optimal tensioning and resulting clamping force. Double spherical washers should be used to prevent side loads on the bolts.

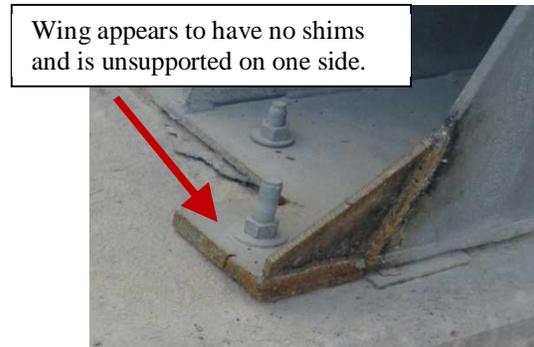
**Figure 3. Unsupported Wing for Anchor Bolts.**

6. Drawings are provided showing the installation of a 3/4" thick X 4" wide steel plate welded to the existing frame and providing for new anchor bolt locations. This may provide an immediate solution to reduce vibration also coupled with replacement of the fan wheel and housing.

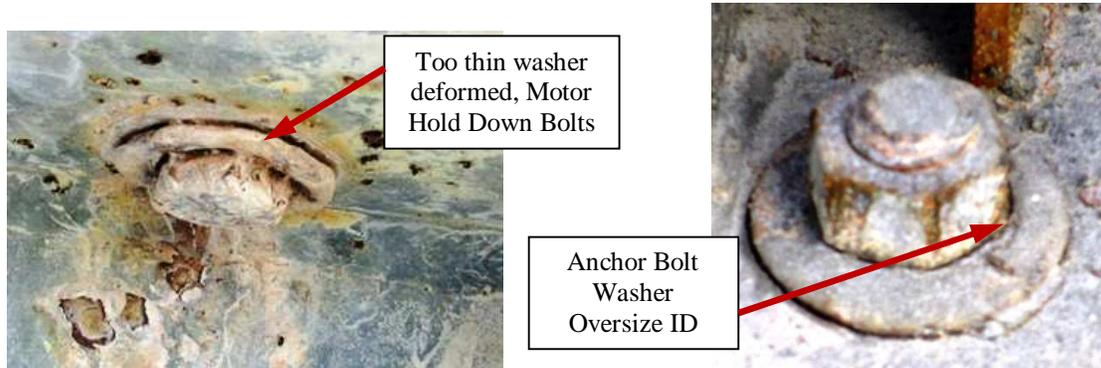
**Figure 4. Washers Were Too Thin and the Washer ID Too Large (Corners Of Nuts Contacting the Washers)**

3. The fan base to concrete foundation should be fully grouted to provide vibration free service.
4. All attachment bolts for bearings and the electric motor should be grade 8, with thick washers under both the bolt head and the nut. Washer clearance to bolt should be no more than 1/32nd inch.

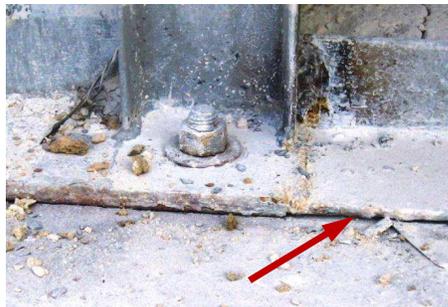
bolts. For this fan installation, only about ½” of stretch length was provided for the anchor bolts, see **Figure 5**. The rule of thumb is a stretch length of 10 to 12 bolt diameters. An effort had been made to reduce vibration of one corner of the fan base by welding a stiffener and installing an anchor bolt, see **Figure 3**. Motor and bearing housing hold down bolts had washers that were too thin and the washer ID too large, see **Figure 4**. The fan bearings were unshielded, see **Figure 8**. During the original installation of the fan, no grout was used between the fan base and the concrete, see **Figure 5**.

During original installation of the fan, no grout was used between the fan base and the concrete, see **Figure 5**.

**Figure 5. No Grout Under Fan Base. Pronounced Movement Between Base and Foundation.**

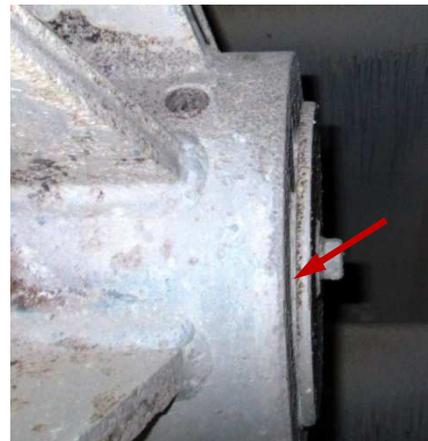
Fan hub had a straight fit and keeper washer to prevent the hub moving off the fit. However, there was about 1/8” gap between the retainer washer and the hub, see **Figure 6**.

**Figure 6. Wheel Hub and Retaining Bolt & Washer Gap.**

2. Fan hub to shaft fit is optimally a taper fit with advance calculated to allow for centripetal and thermal coefficient of expansion to maintain an interference fit.

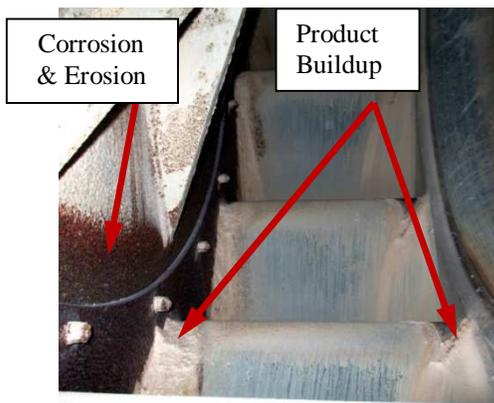
**Figure 7. Material Buildup on Fan Wheel.**

The fan wheel had some product buildup on the fan blades, see **Figure 7**. The fan wheel and fan housing exhibited corrosion and erosion. The housing had been patched in several locations by welding thin material to the inside of the housing to cover holes. The fan bearings were unshielded, see **Figure 8**.

5. The primary forcing function causing vibration is unbalance forces generated by the fan wheel assembly. Cleaning the particulate build-up might help. However, the condition of the wheel itself, as a result of corrosion and erosion, plus operating on a 1<sup>st</sup> critical speed may make further balance improvement improbable.

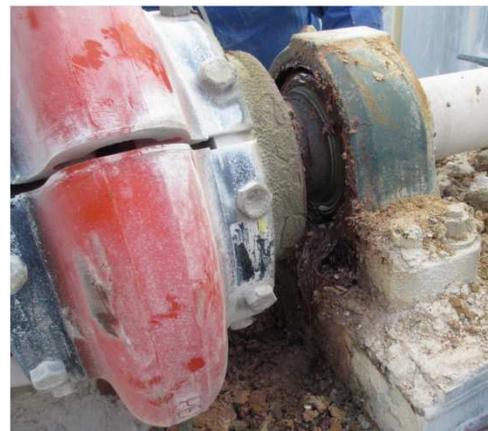
**Figure 8. Bearings Were Unshielded.**

7. The fan bearings should be replaced in the near future with sealed or at minimum, shielded bearings assemblies. The current open bearing arrangement allows contamination from weather related elements as well as air borne particulates.

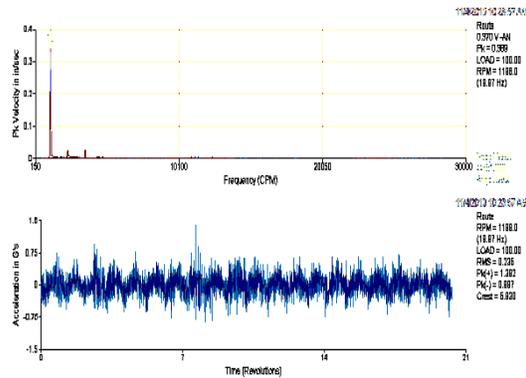
**Vibration Analysis:** Vibration data were measured using a portable spectrum analyzer. The frequency spectrum showed most vibration at 1X run speed frequency. Highest amplitude at the bearing housings was in the horizontal direction. Spectra and time domain data measured at the fan end bearing housing are shown in **Figures 9 & 10**. Multiples of the run speed frequency was in the frequency spectrum in the vertical direction.

**Figure 9. Frequency & Time Domain Data Measured on the Fan End Bearing Housing Horizontal.**

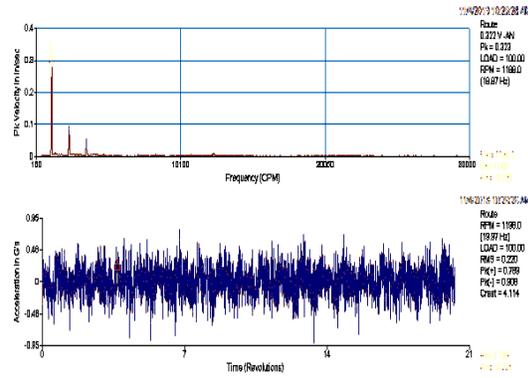
**Figure 10. Frequency & Time Domain Data Measured on the Fan End Bearing Housing and Vertical.**

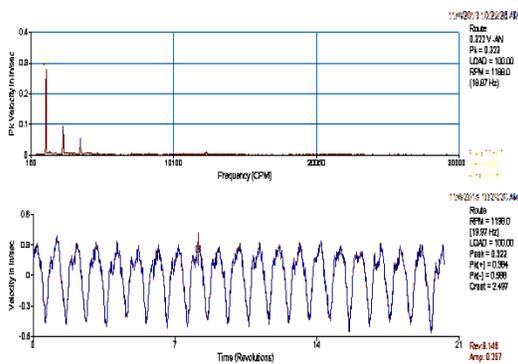
**Figure 11. The Data on the Fan End Bearing Housing Vertical Direction, Time Data in Velocity in/sec.**

Plotting the bearing housing vertical vibration time domain data in velocity clearly showed non-sinusoidal vibration due to the loose bearing housing hold down bolts, see **Figure 11**.

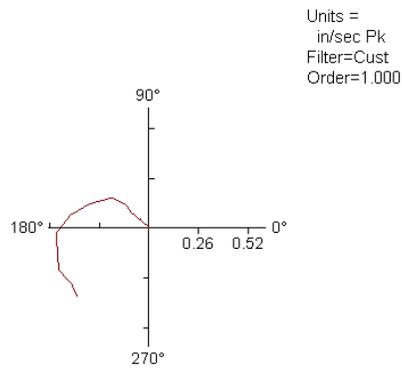
**Figure 12. Polar Plot 1X Amplitude & Phase Lag During Coastdown.**

Coast down data was measured at the fan coupling end bearing. Reflective tape on the shaft and a laser tachometer provided the once per revolution signal. The coast down data in polar format, shown in **Figure 12**, showed that the fan was operating at a natural frequency.

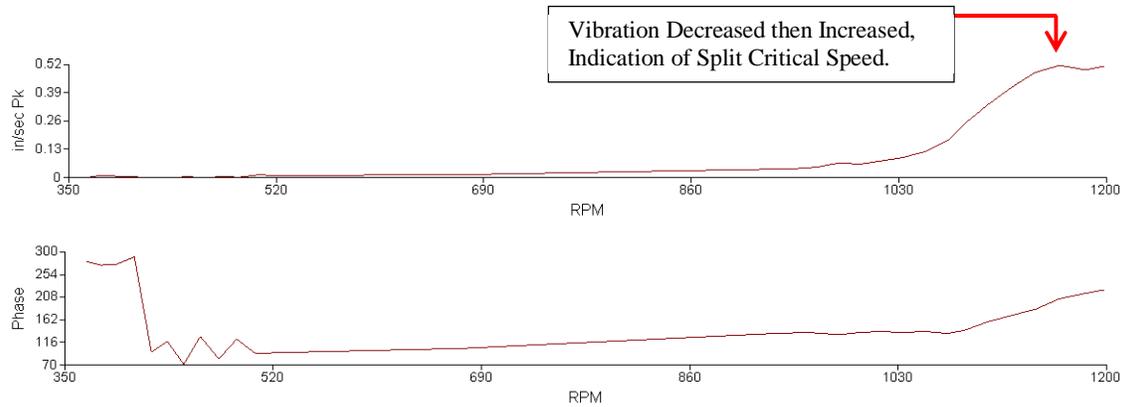
The coast down data is also plotted in bode format in **Figure 13**. Close inspection of the data shows that the vibration amplitude decreases then increases before dropping dramatically. The data clearly indicated the fan was operating at the 1<sup>st</sup> critical and that the critical was split or bifurcated due to asymmetric support stiffness.

**Figure 13. Bode Plot During Coastdown, Fan Coupling End Bearing Horizontal Direction.**

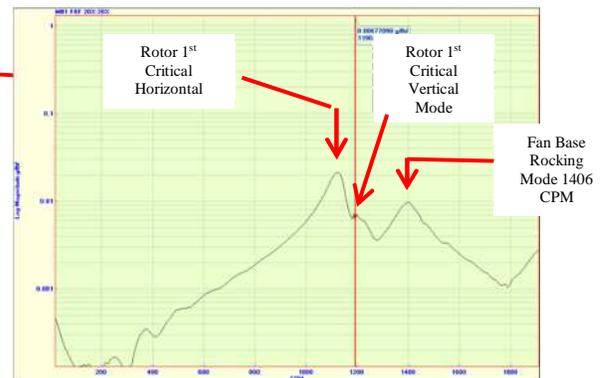
**Modal Analysis:** As additional confirmation of a critical speed near the fan running speed frequency, modal driving point measurements were made on the fan bearing housings and the fan wheel. A medium sledge modal hammer and accelerometer were used. The frequency response function (FRF) measured on the fan wheel in the axial direction at the rim is shown in **Figure 15**. Two natural frequencies were measured at 1069 and 1200 CPM as indicated by the cursors. A rigid body rocking mode of the fan was at 1406 CPM.

**Figure 15. Modal Data Fan Wheel Axial Direction Shows Rotor 1<sup>st</sup> Critical Near Run Speed.**

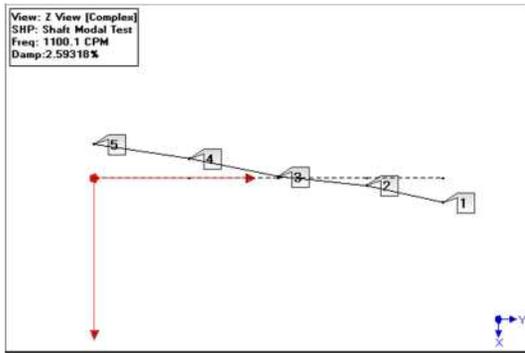
FRF were also measured at five locations along the fan shaft, see **Figure 14**. The FRF were curve to determine the mode shape of the rotor natural frequencies near run speed. The shaft natural frequency mode shape is shown in **Figure 16**. The mode shape showed little flexure of the shaft was occurring. This indicated that the rotor mode (1<sup>st</sup> critical) was primarily controlled by the low stiffness of the bearings & pedestal due to loose anchor bolting.

**Figure 16. Modal Test of Exposed Fan Shaft Between Bearings.**

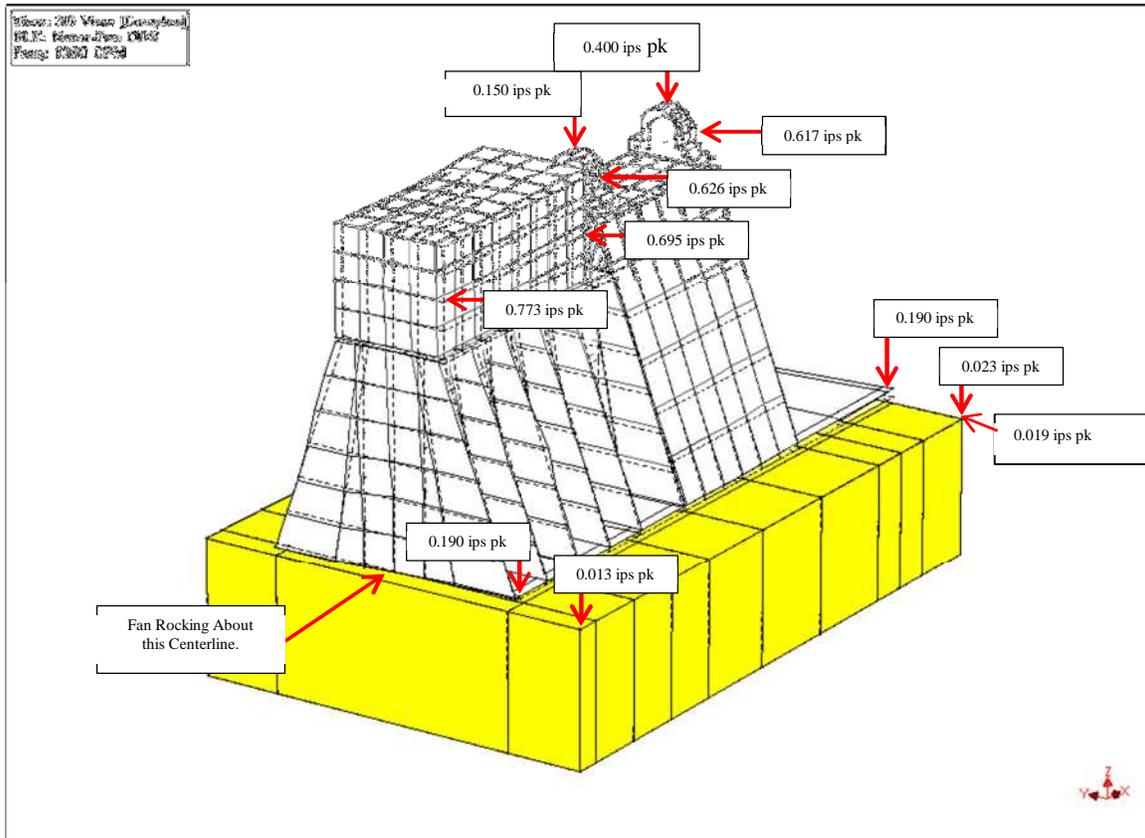
The vibration shape or pattern was rocking side-to-side, pivoting about a centerline just above the surface of the concrete base. The motor and wheel end bearing exhibited movement relative to the bearing support plate confirming loose attachment.

There was very low amplitude vibration of the concrete pad indicating it had very little participation in the fan vibration.

**Figure 20. Animated ODS at Fan Run Speed Frequency.**

- The severe rocking motion of the entire fan assembly was a result of wheel unbalance amplified by the natural frequency near running speed and the loose mounting of the fan assembly to the concrete foundation. The ODS animation showed the rocking motion to be approximately about the center of the base parallel to the drive centerline.
