RICS  
**HomeBuyer** Report

1 Acacia Avenue,  
WOLVERHAMPTON  
West Midlands  
WV1 1WV

29 August 2014

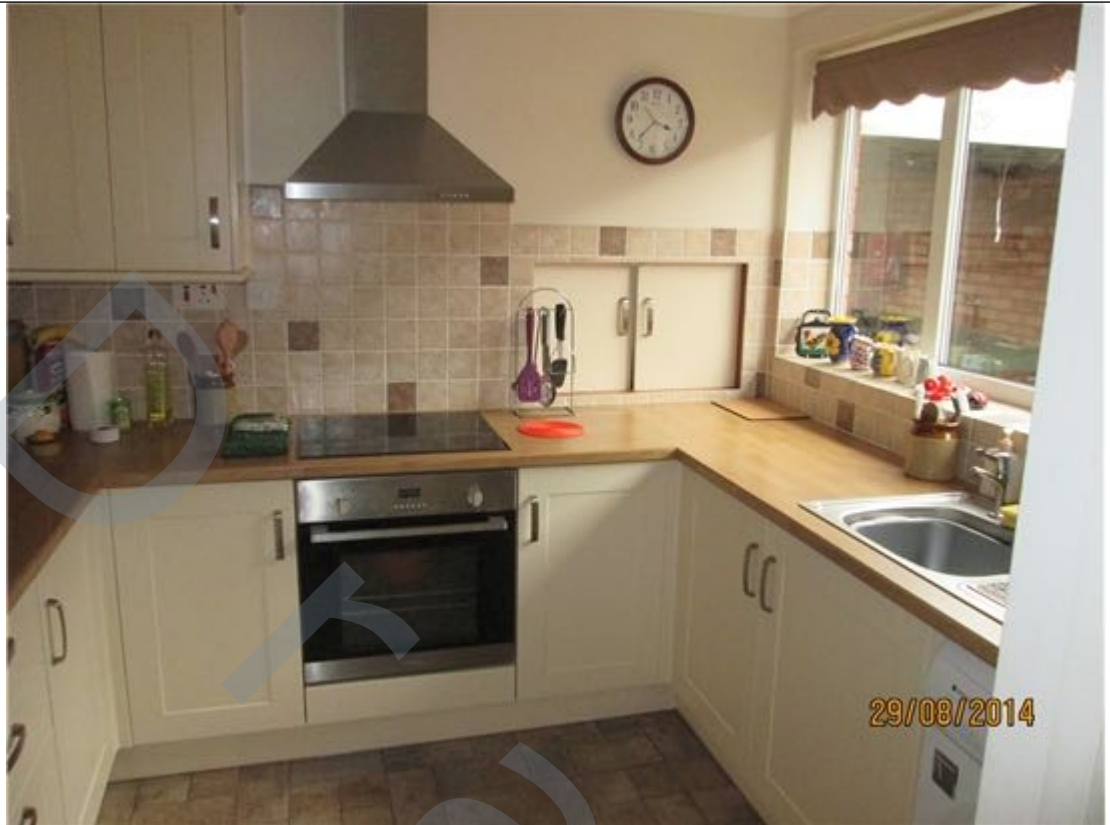
Kitchen

The kitchen is fitted with a range of modern units and appliances which appear in acceptable condition. 1

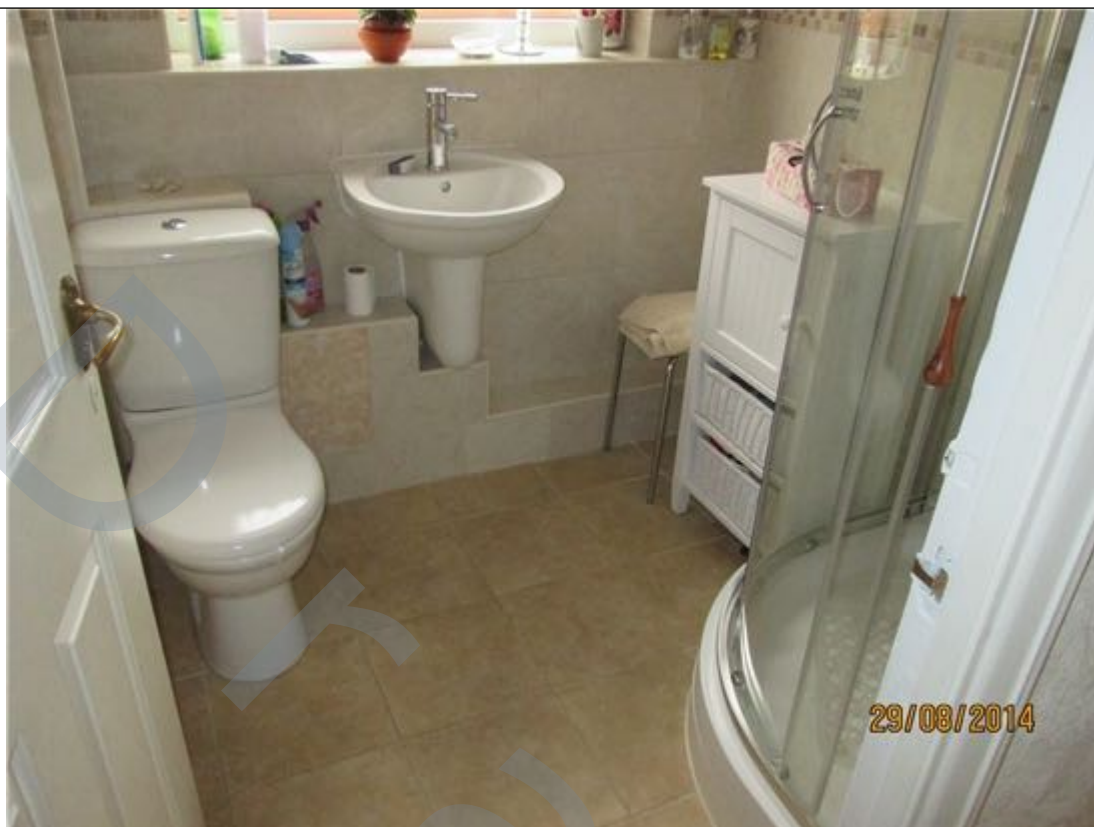
Bathroom

The fittings are in acceptable condition.
