SURVEY REPORT

PURPOSE OF SURVEY: Evaluate Condition & Value for insurance underwriting
FOR: Concerned Underwriters
OWNER: Rosemary Hathaway
#40 Quarry Road
Bolton, CT 06043
DATE: May 16, 2009
LOCATION: Owner's home
VESSEL STATUS: Hauled, blocked, systems winterized
PARTIES PRESENT: Mr. & Mrs. Hathaway

NAME: NIGHT WIND
STYLE: Diesel auxiliary ketch
MODEL YEAR: 1977
BUILDER: Ta Chiao Bros. Yacht Builders Taiwan
LOA: 34' 6" BEAM: 11' DRAFT: 5'
DISPLACEMENT: Approximately 18,000 lbs.
HULL ID#: TAC350320177
REGISTRATION: RI 584401 08
DOCUMENTATION: 584401
INTENDED USE: Near coastal cruising, recreational.

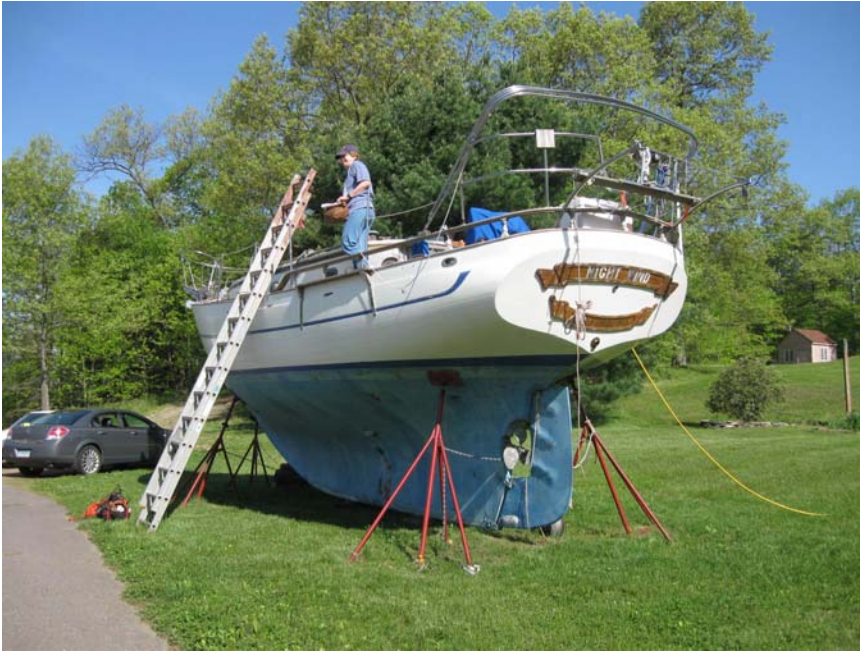
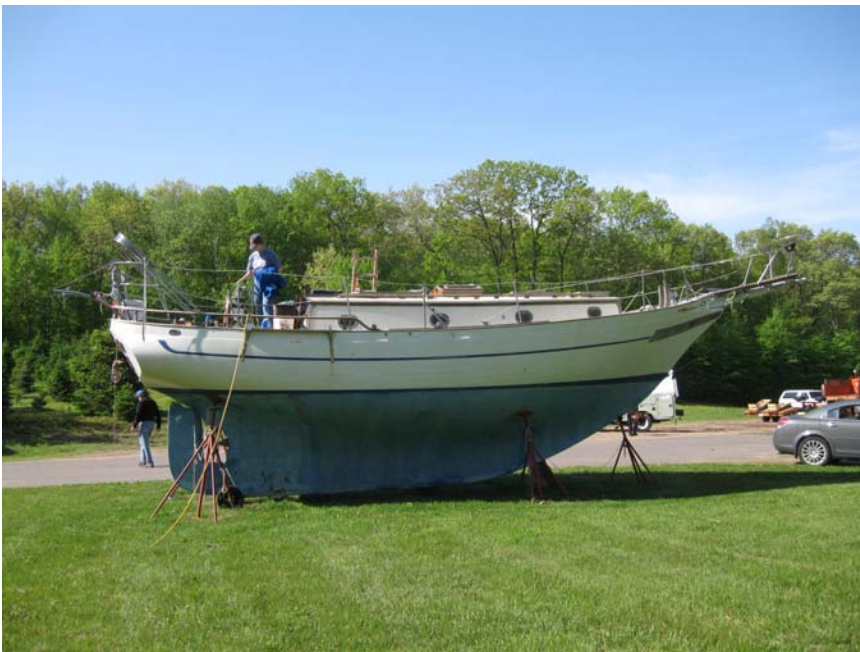
Subject vessel as found at owner's home.
