Home Inspection Report

**Delk
Home
Inspections**

151 Tower Point Lane, Kilmarnock, Va.

Client: Harlan Seymour Date: 7/20/16
Report Number: 3299 Temperature: 80's Conditions: dry
Year constructed: 1999
Present during Inspection: client / agent State of Occupancy: occupied

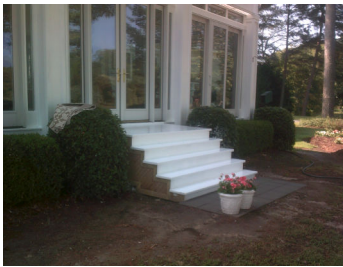
This stairway lack railings.

The exterior stairway from the addition lacks railings. Installation of railings is highly recommended.

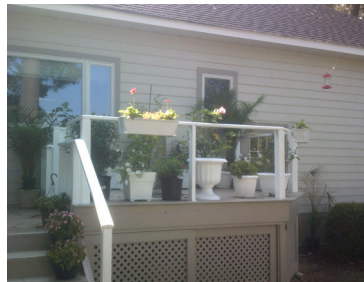
This porch lacks balusters.

The small porch lacks balusters. Baluster placement not exceeding 4" apart is recommended.

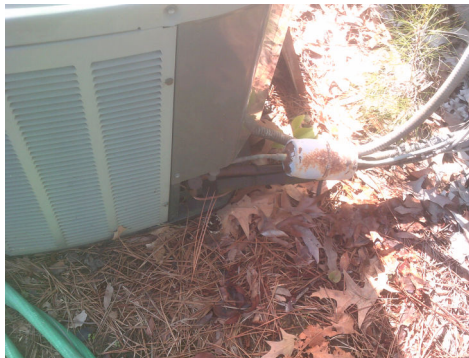
Heat pump sitting directly on the ground.

The small heat pump located at the side of the house is sitting directly on the ground. Placement on top of a pad is recommended.

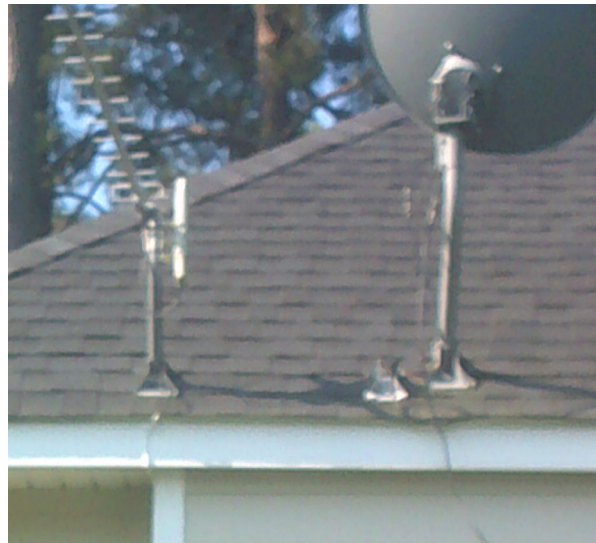
Antennas improperly mounted to roof.

Antennas are mounted directly to the asphalt roof. Placement of the antennas elsewhere and replacing the damaged shingles is recommended.

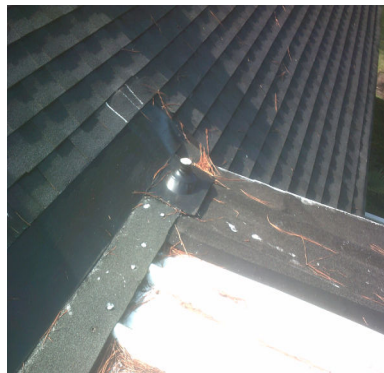
The roof on the addition is not a typical installation. Although **no leakage was observed**, the tie-in to the main roof was incorrectly accomplished by sliding the flashing underneath the lower row of shingles and caulking the seam between the individual shingles. Additionally, The use of torched down membrane roofing for flashing on a metal roof is not typical. Caulking on the nail heads holding down the addition roof has failed in areas. Evaluation by a roofing contractor should be considered.

Flashing to addition slid underneath existing asphalt roof and caulked.

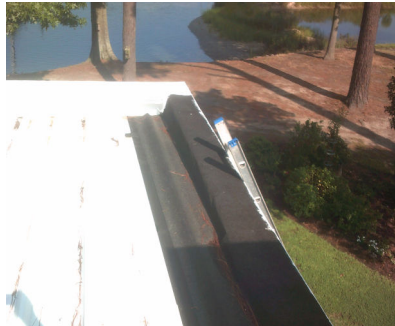
Torched down roofing covering parapet wall used as flashing on metal roo

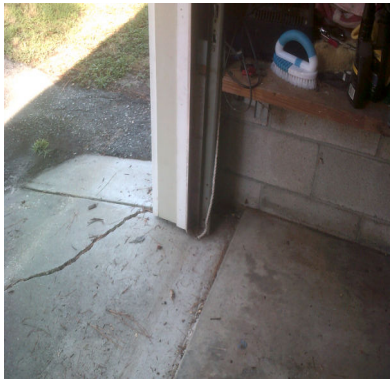
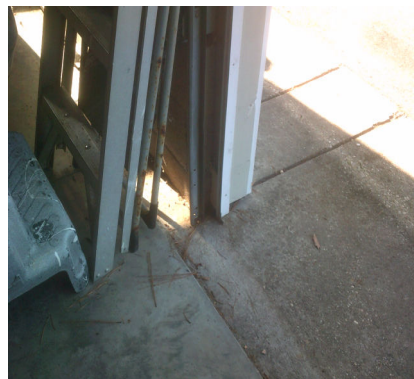
Both garage door openers lack the auto reverse safety feature.

Both of the automatic door openers lack the safety reverse feature. Installation of this feature is highly recommended.

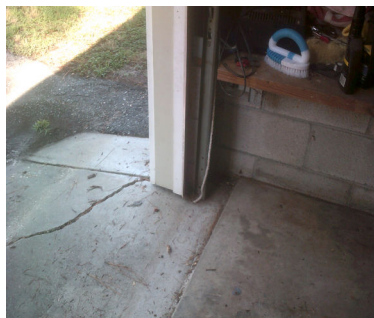
Typical cracking.

The crack in the corner of the garage entrance should be filled with concrete or caulking.

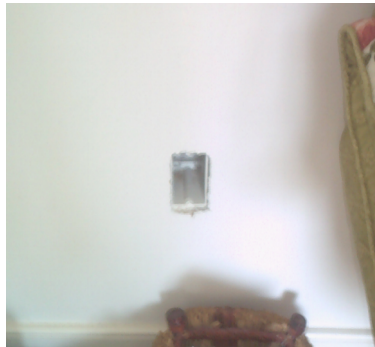
Bedroom

The house has adequate GFCI protection in the kitchen and bathrooms. The service panel is not well labeled. Several receptacles around the house, especially the attic area, lack completion or covers.

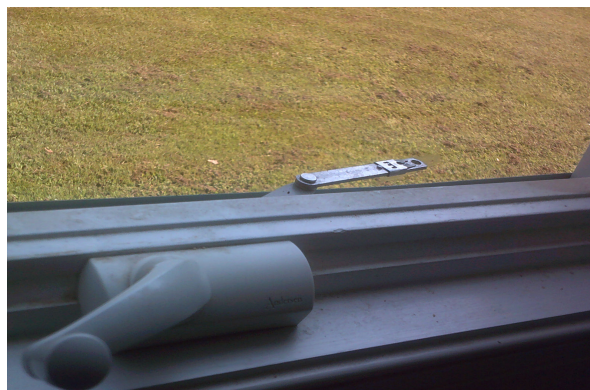
The master bathroom window needs repair.

The window in the master bathroom needs the opening mechanism reattached to perform properly.

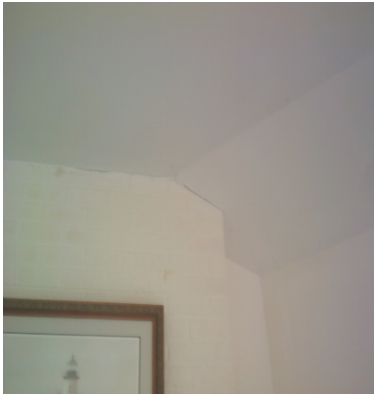
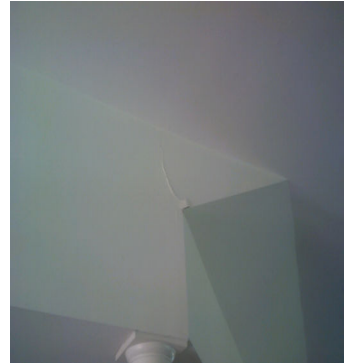
Settling was observed in the ceiling of the living room. Vertical supports in the attic area were not installed in accordance with standard construction practices. Evaluation by a structural engineer is recommended.

Settling has occurred in the living room.

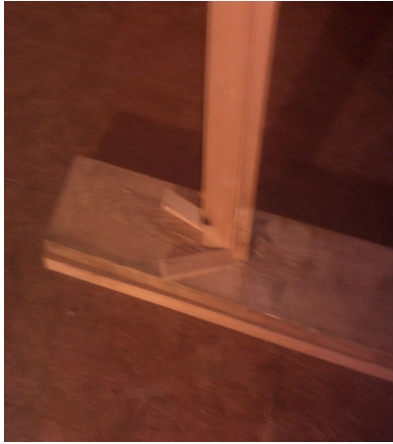
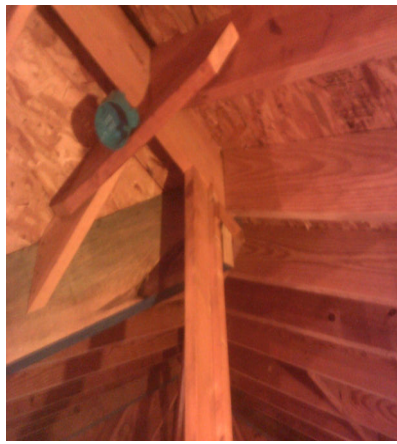
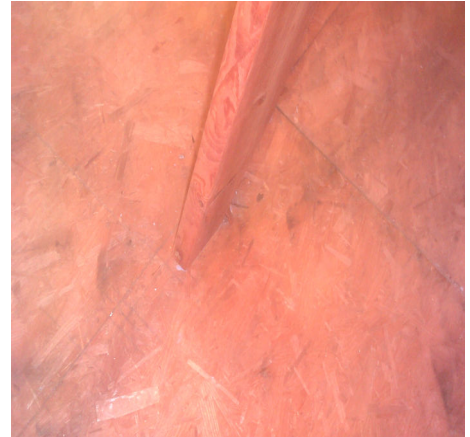
Vertical roof supports are not typical construction.

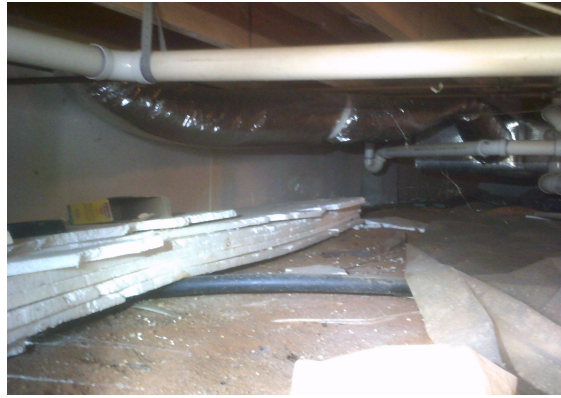
The poly that lays on the flooring and covers the block walls was never completed and has been damaged in areas.

The conditioned crawl space was never completed and lacks the polyethylene properly sealing the foundation walls. Completion of the conditioned crawl space is recommended.
