2004 Sea Ray 480 Sedan Bridge

"BIG BREEZE"

Report of Marine Survey

April 27, 2017

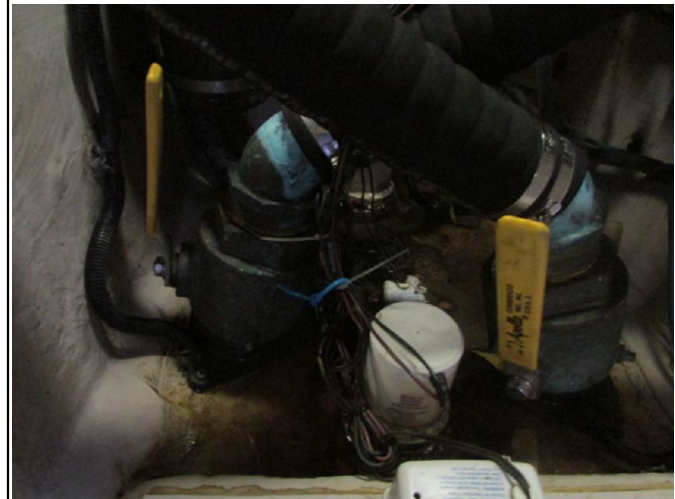
Forward Engine Space Bilge

* **BILGE: [C3]** Deep (below deck) amidships and lazarette aft bilge areas provides for most boat mechanical, electrical systems and tankage. The forward shallow bilge area provides good access to the forward sump pump and float switch. The bilge areas were finished in smooth white gelcoat and were found mostly clean, the forward engine space bilge pump area and the aft-most bilge pump area against the transom in the lazarette were dirty.

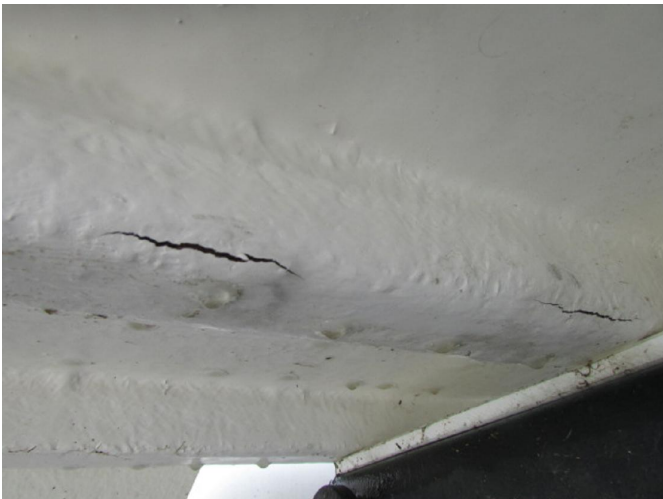
* **TRANSOM: [C2]** Reinforced, FRP (Fiberglass reinforced plastic) cored transom. The FRP swim platform is remote operated Hydraulic with attached metal mechanism through-bolted to the transom with stainless steel fasteners and backing plates. The platform also serves as a docking point for the tender. (tender was not onboard). There is a 36" stainless steel telescoping ladder under a hatch positioned to the center of the platform. The transom locker above the swim platform gives access to connection points for TV, phone and city water. The transom locker also provides stowage for, fenders and lines. The transom door is positioned to port. There is a built in hand shower wand here too. The swim platform attachment points appear securely fixed. All fit for intended use. Note: There were five cracks sighted under the swim platform in the gelcoat, they appear superficial in nature (see attached photos). The parameter plastic finishing strip has three loose screws. The affected area's were sounded and checked for moisture without negative report at this time.

Gelcoat Crack Under Swim Platform

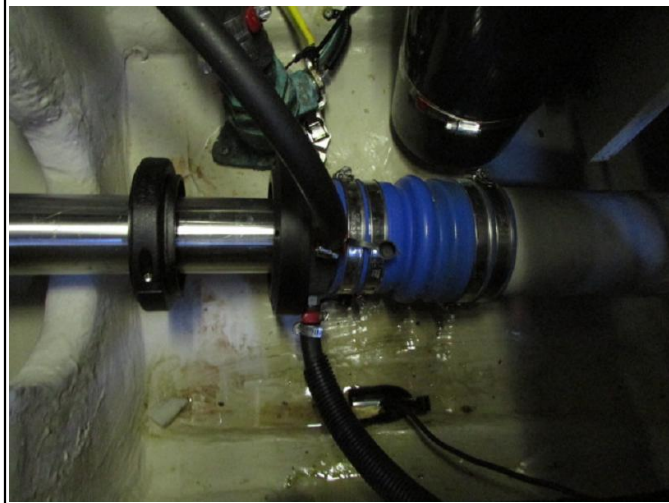
DISCHARGE HOSES AND CLAMPS: *Discharge thru-hull at engine space aft of starboard main engine, approved type hoses double clamped. Hoses and clamps serviceable. Note: The discharge thru-hull is leaking/weeping water where connected to the hull. (See findings B.1 Thru-Hulls List).

Leak At MSD Seacock

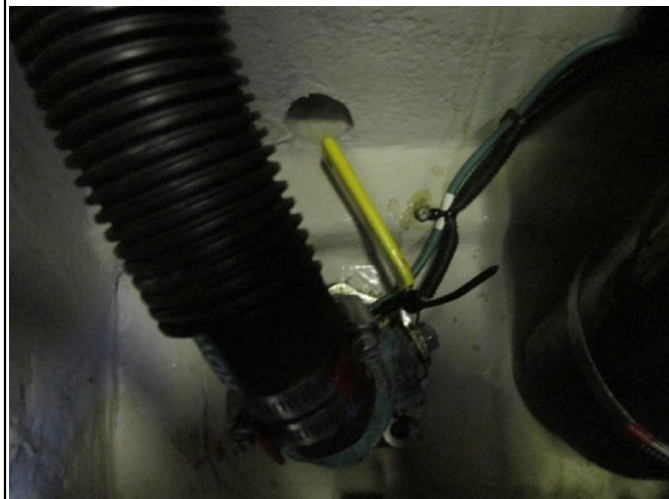
- * **THRU-HULLS LIST: [B1, B2]** Located in the engine space. Two (2) Main engine, raw water up take forward center engine space. One (1) generator, raw water up in lazarette bilge aft. One (1) Black water sanitation, raw water discharge behind the starboard main engine. Note: The blackwater sanitation discharge thru-hull is weeping/leaking where fastened to the hull, location behind the starboard main engine. One (1) AC, raw water up take forward center engine space. One (1) AC raw water up take behind port engine, aft engine space. Note: The raw water sea strainer up take for the generator, the incoming hose to the stainer and the out going hose to the generator are cracked/fatigued, location lazarette aft bilge.

MSD Seacock Fixed Closed

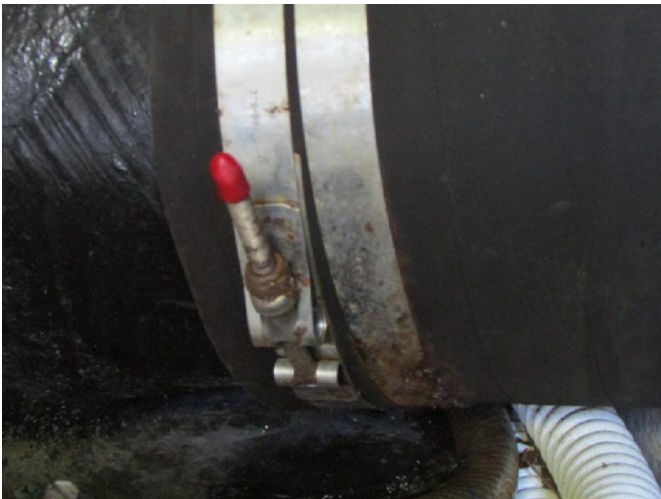
- * **EXHAUST SYSTEM: [A1]** Hose to pipe joints double clamped and hose found to be serviceable from external visual examination. System installation from Stainless engine mounted pipes, USCG approved flexible hose aft to FRP (fiber reinforced plastic) power pac/lift system silencers located under the cockpit sole. Then exiting through stainless fittings at hull sides port and starboard aft near transom. Hose to pipe connections are double clamped where sighted. Note: The port exhaust connection flex hose to silencer, where the exhaust enters the silencer is leaking and clamps are corroded. (See findings A.1 Exhaust System). All but where noted the exhaust system appears to be in serviceable condition.

Port Exhaust Hose Clamp

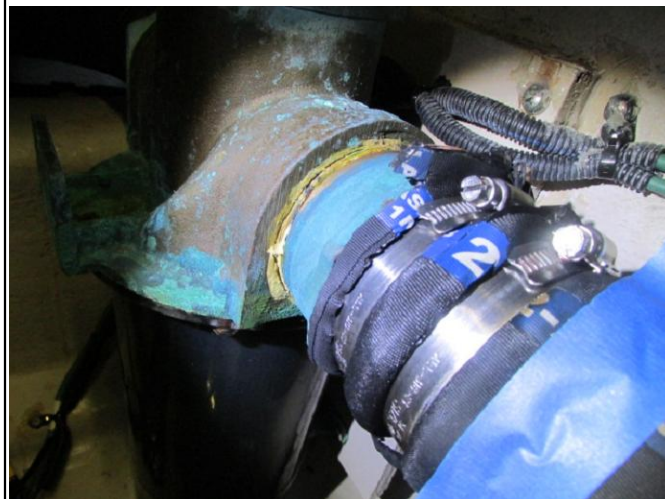
- * **HOSES AND CLAMPS: [A2]** Re-enforced rubber hoses double clamped and well routed and supported, where sighted. * Note: The starboard raw water inlet hose from the strainer to the main engine is showing signs of fatigue and is leaking at the clamp.

Starboard Main Engine Raw Water Strainer Hose Leak

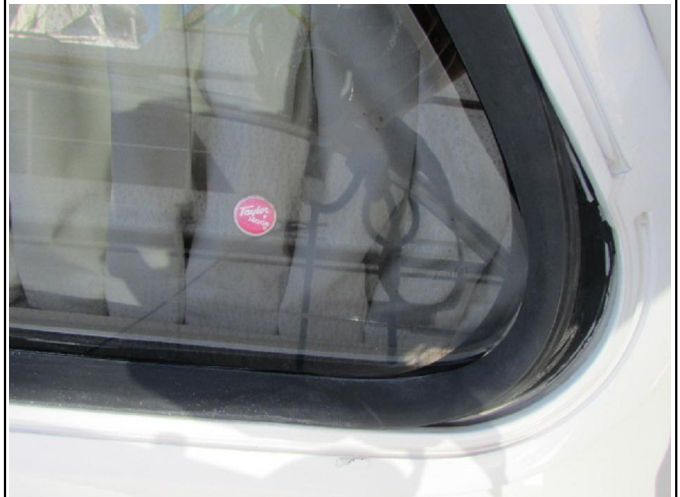
* **WINDOWS/PORTS/DOORS: [C4]** Large fixed windows flank the salon cabin. The port fixed window gasket has come loose from the frame and is deformed at the aft lower corner. It does not appear to be leaking at this time. (See photo).

Window Gasket Port.
