(Final Report, Revised November 9, 2016)

Condition Assessment & Reserve Fund Plan Update 2016

Hiddenbrook HOA

Herndon, Virginia

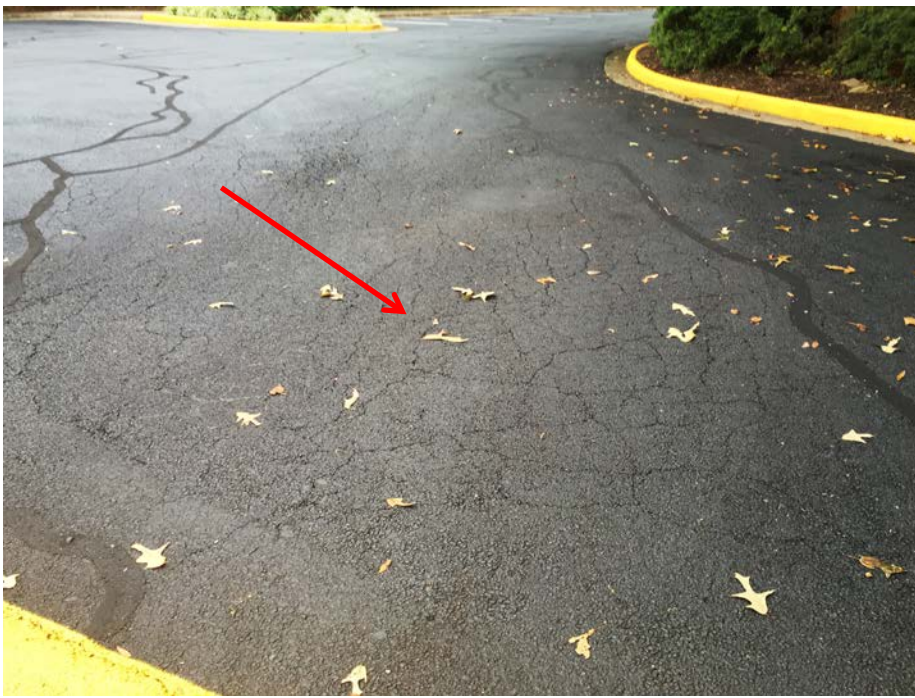
PHOTO #1

The asphalt parking lot is in overall good condition for its age, and was recently seal coated and crack filled. However, adjacent to the dumpster location we observed deflection, indicative of sub base failure. We have scheduled a full depth repair near-term to help ensure a full service life of the pavement is achieved.

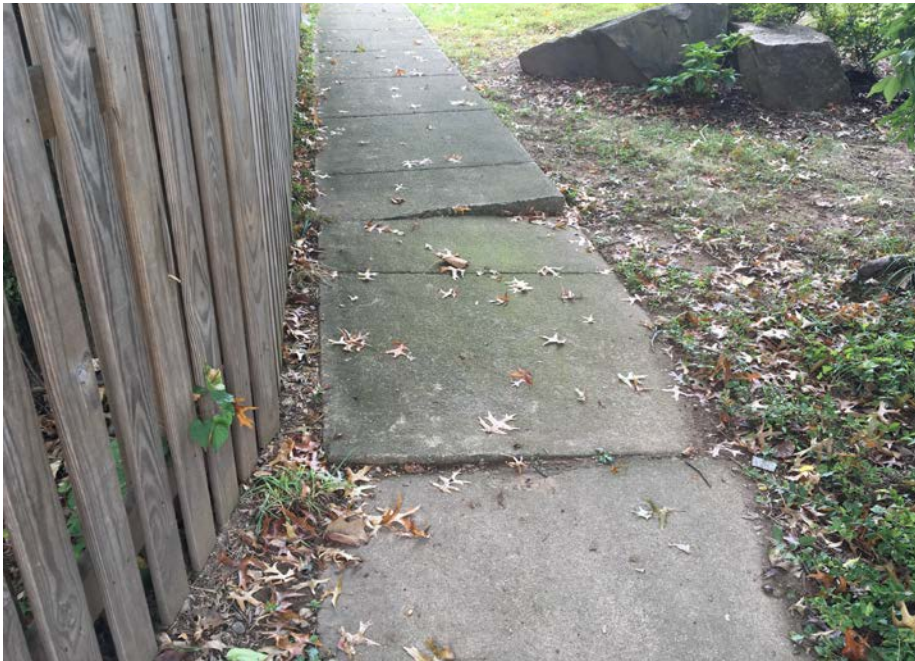
PHOTO #2

The pedestrian surface leading to the pool facility exhibits significant tripping hazards, which appear to be caused by the adjacent mature tree's root system. We have scheduled a remediation project near-term to prevent personal injury.

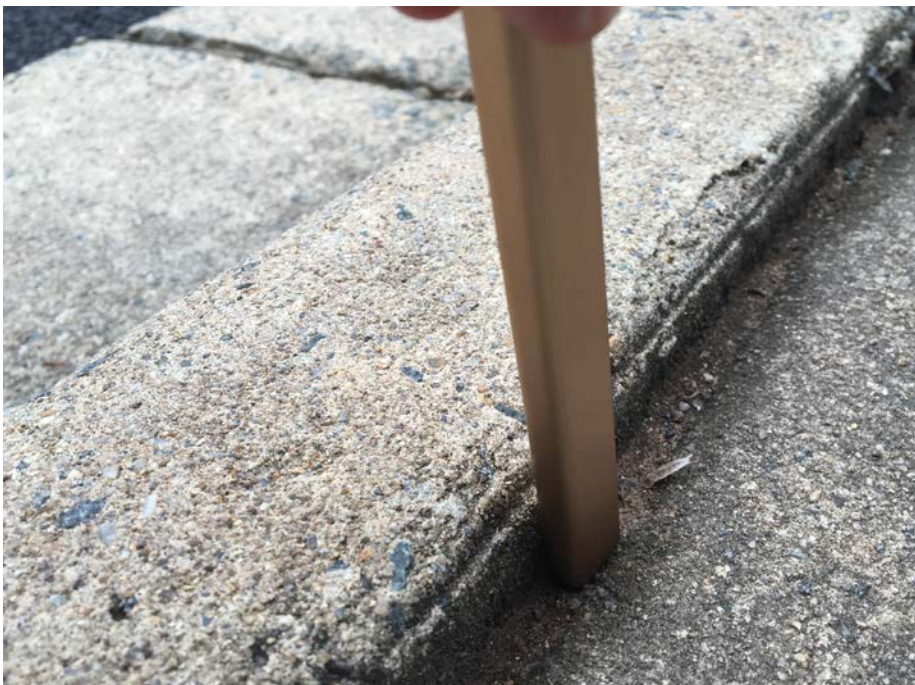
PHOTO #3

Approximately 102 linear feet of the sidewalk panels have settled adjacent to the curb profile creating tripping hazards. We have scheduled a repair project to potentially use precision concrete cutting or replace the curbs, near-term.

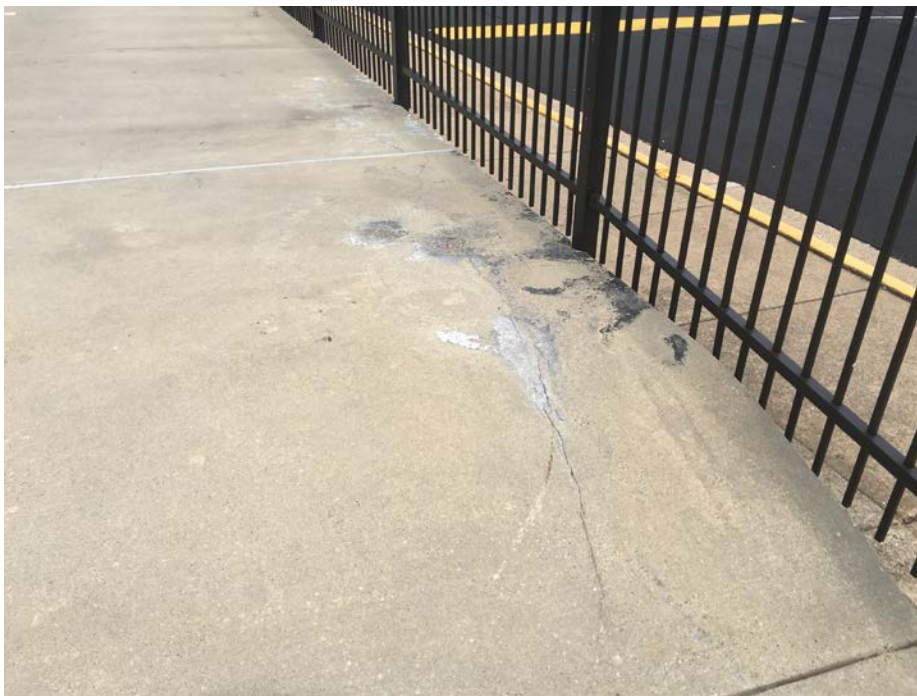
PHOTO #4

The concrete pool deck is in overall continuing good condition. Minor unsealed cracking and deterioration was observed and should be repaired coinciding other concrete projects near-term. Cracking along the east side of the deck may be the result of deflection, and should be monitored.

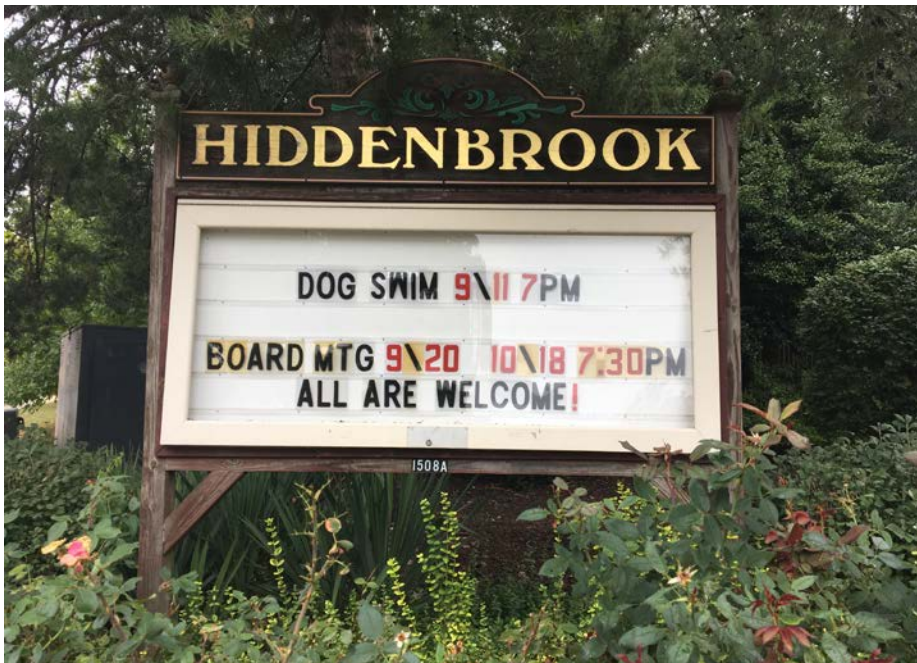
PHOTO #5

We understand the painted wood message board at the entrance of the community center parking lot is problematic. We have scheduled a partial expenditure to replace or repair the sign near-term.

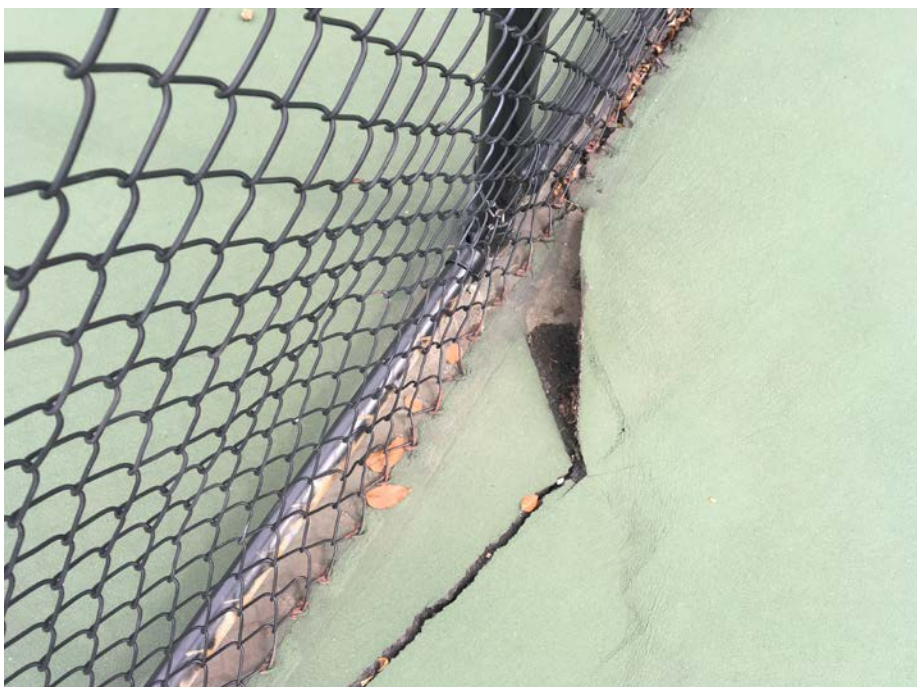
PHOTO #6

The tennis courts are in good condition with minor unfilled cracks and localized delamination of the color coat observed. We have scheduled a remediation project near-term. The cost was provided by Management based on an accepted contractor's proposal.

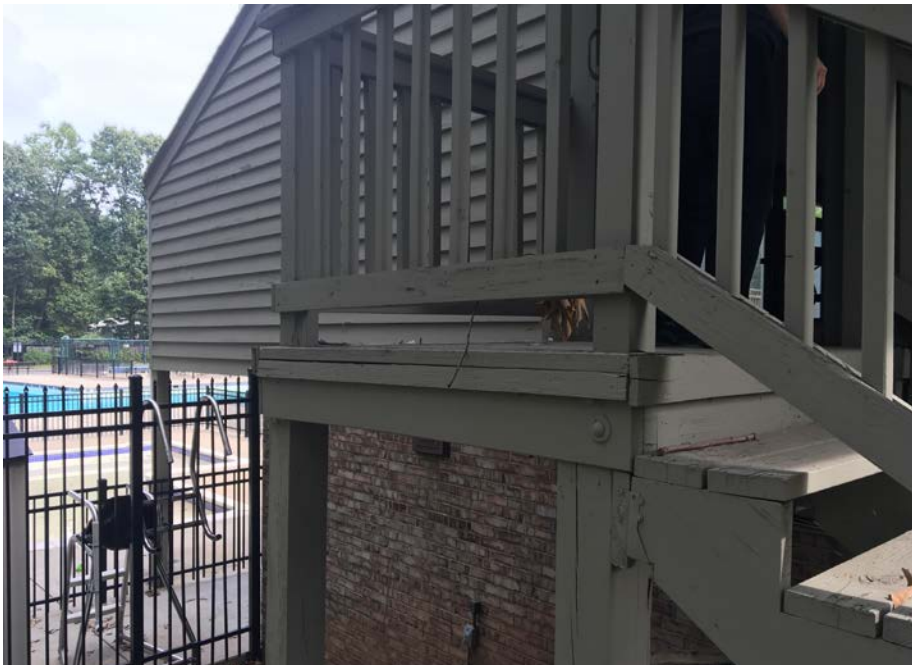
PHOTO #7

The exterior components of the community center building are in overall fair condition. We have scheduled several significant projects near-term that include re-roofing, replacement of deteriorated trim, and replacement of the remaining wood decks and railings with Trex decking.

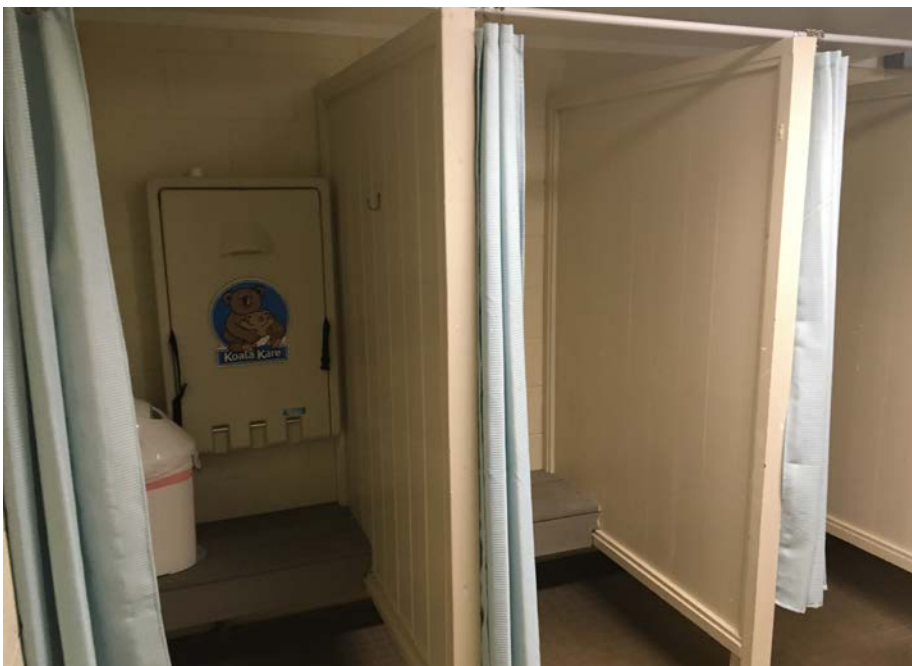
PHOTO #8

We understand many partitions were replaced with composite material recently and the remaining wood partitions may be replaced during the shower room renovation project.

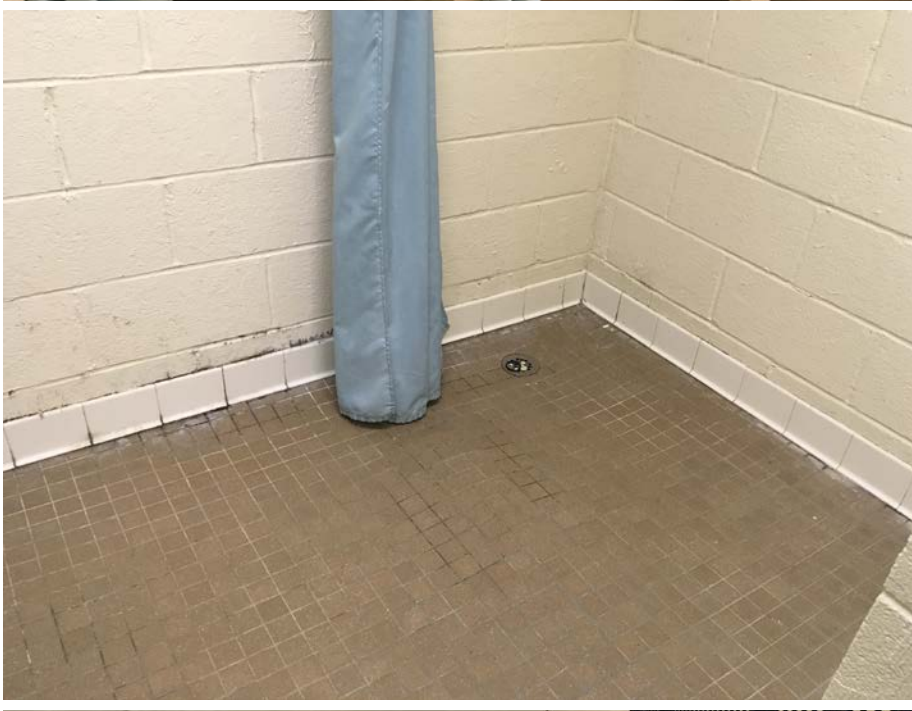
PHOTO #9

The shower room finishes appear outdated and at the end of their service lives. We have included a replacement project to coincide with the plumbing fixtures refurbishment project scheduled near-term. Once a budget and scope of the project is established the report should be revised.

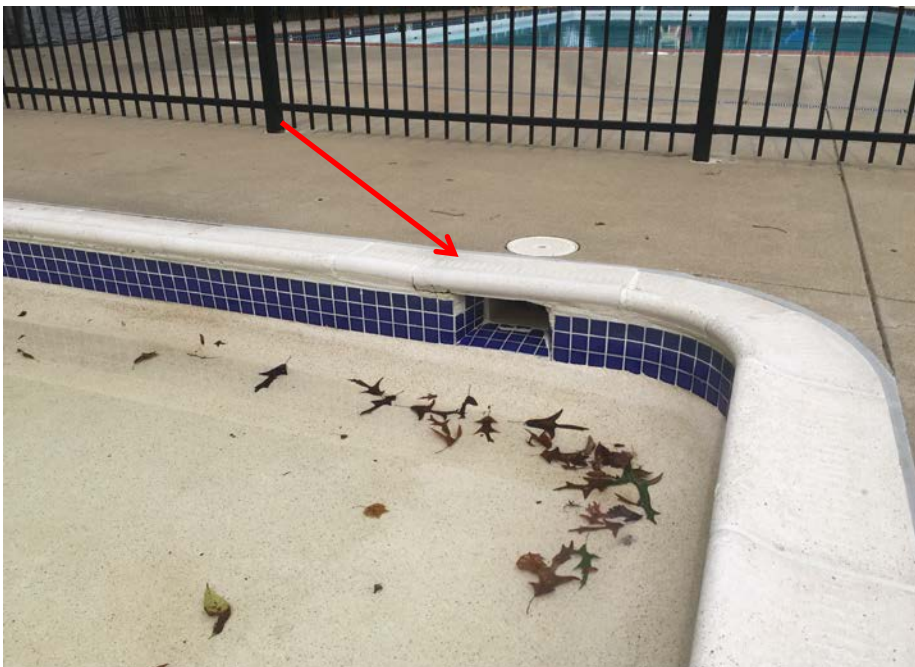
PHOTO #10

We observed 18 linear feet of loose or hollow coping stones associated with the wading and main pool. The majority of the deficiencies are located over the skimmer bays.

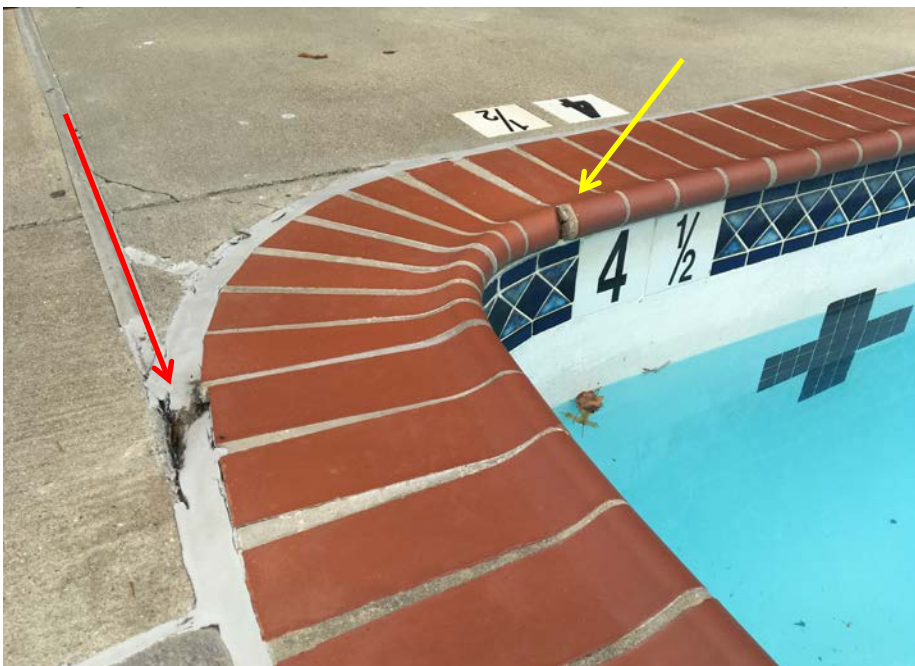
PHOTO #11

Pictured is an example of soft sealant (red) and deteriorated grout (yellow). This should be repaired during the coping stone replacement project near-term.

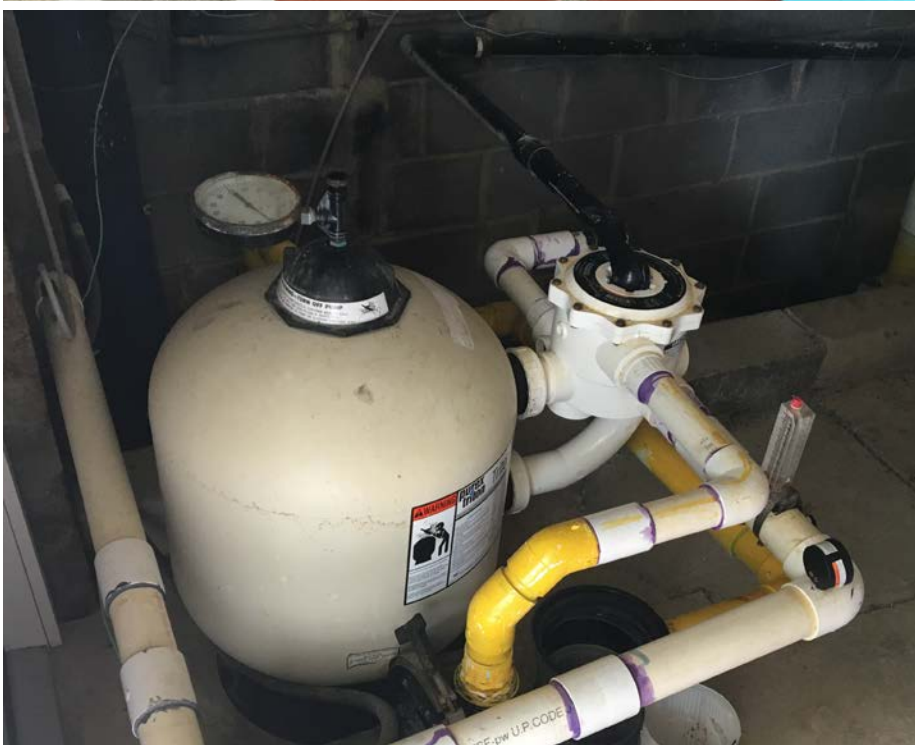
PHOTO #12

The wading pool pump is statistically at the end of its service life. We have scheduled its replacement near-term.
