**DESCRIPTION OF SERVICE
UNITED STATES PEACE CORPS RESPONSE
PHILIPPINES**

Assessment of Groundwater Resources: Field Survey Results in
Guiuan, Eastern Samar, Philippines

William Thurman Nutt, Jr.

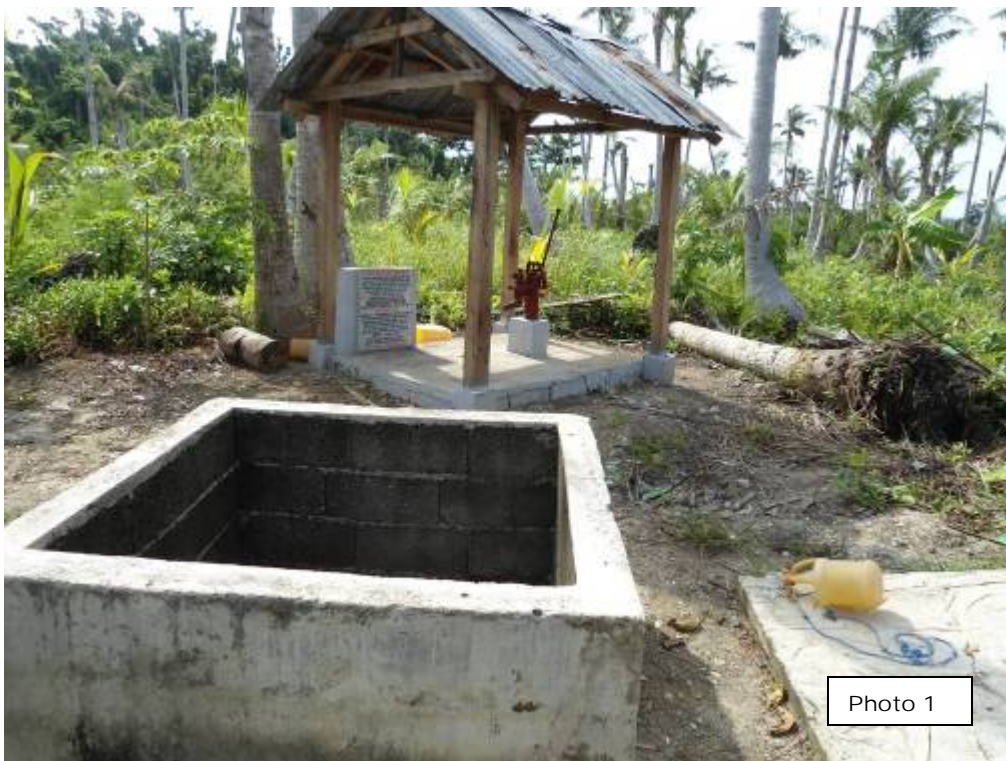
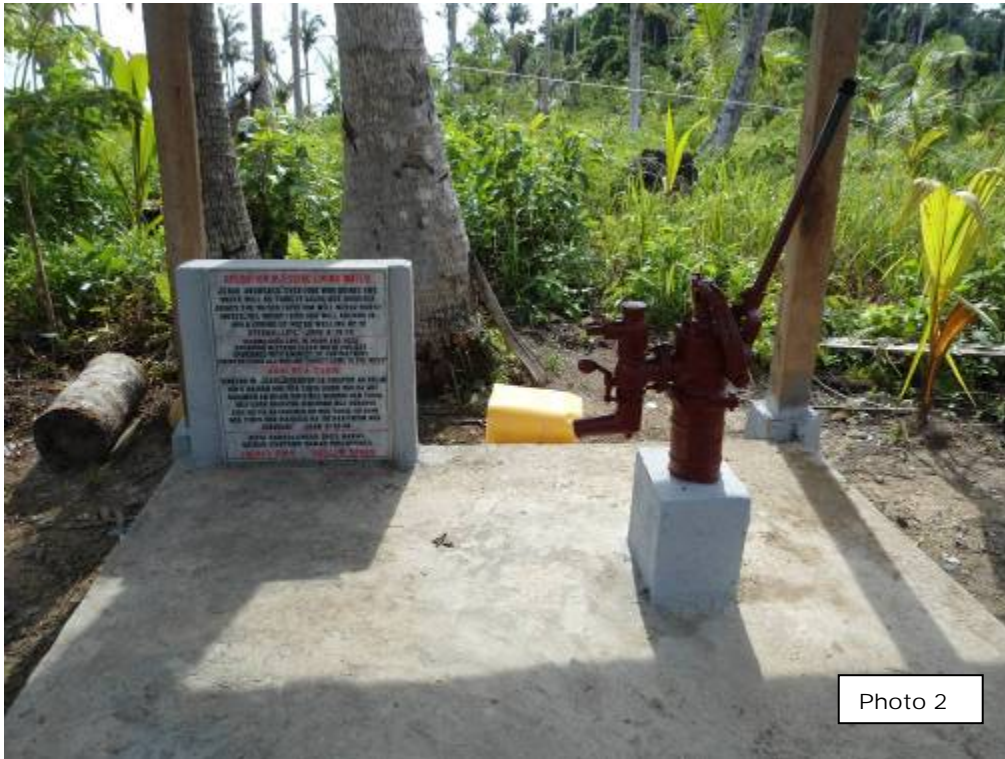
Photo 2

Examples of contaminated and neglected wells are found throughout Guiuan. One of the most glaring illustrations of this is found in a pair of neighboring wells in Baras (Photo 1). In Kabadlungan, a fishing village to the south of the main population center of Baras, there is a new well that provides drinking water to the residents. Easily recognizable as a recent Operation Blessing installation, it is appropriately adorned with Biblical verses concerning the vital and spiritual force that water gives us (Photo 2). The angelic benefactors were apparently unaware that the devil has set up shop about 10 feet away. The previous well abandoned for some reason and pump in disrepair, is left unsecured and is collecting garbage (Photo 3). If left to fill up with debris the newly installed well will be threatened with contamination also.

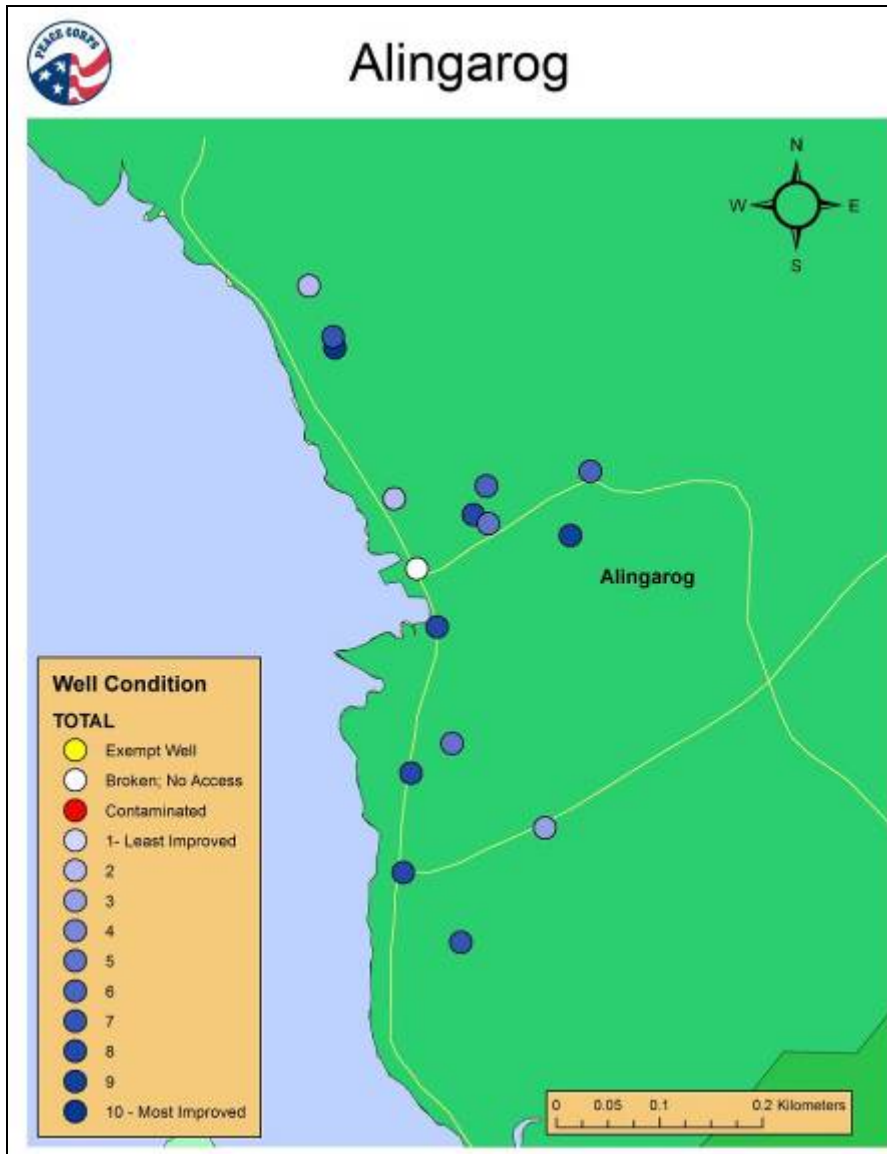
Number of Wells Sampled: 15

Average Improvement Score: 6.2

Alangarog is in the Northwest corner of the Peninsula along the Leyte Gulf coast. The water table is less than a meter from the surface. The inaccessible well at the plaza is the BWS. Even though the solar pump and tank are destroyed, the residents should still be able to access water at the manual pump

Priorities: Replacement of Barangay Water System; Repair Well-07 at Plaza.

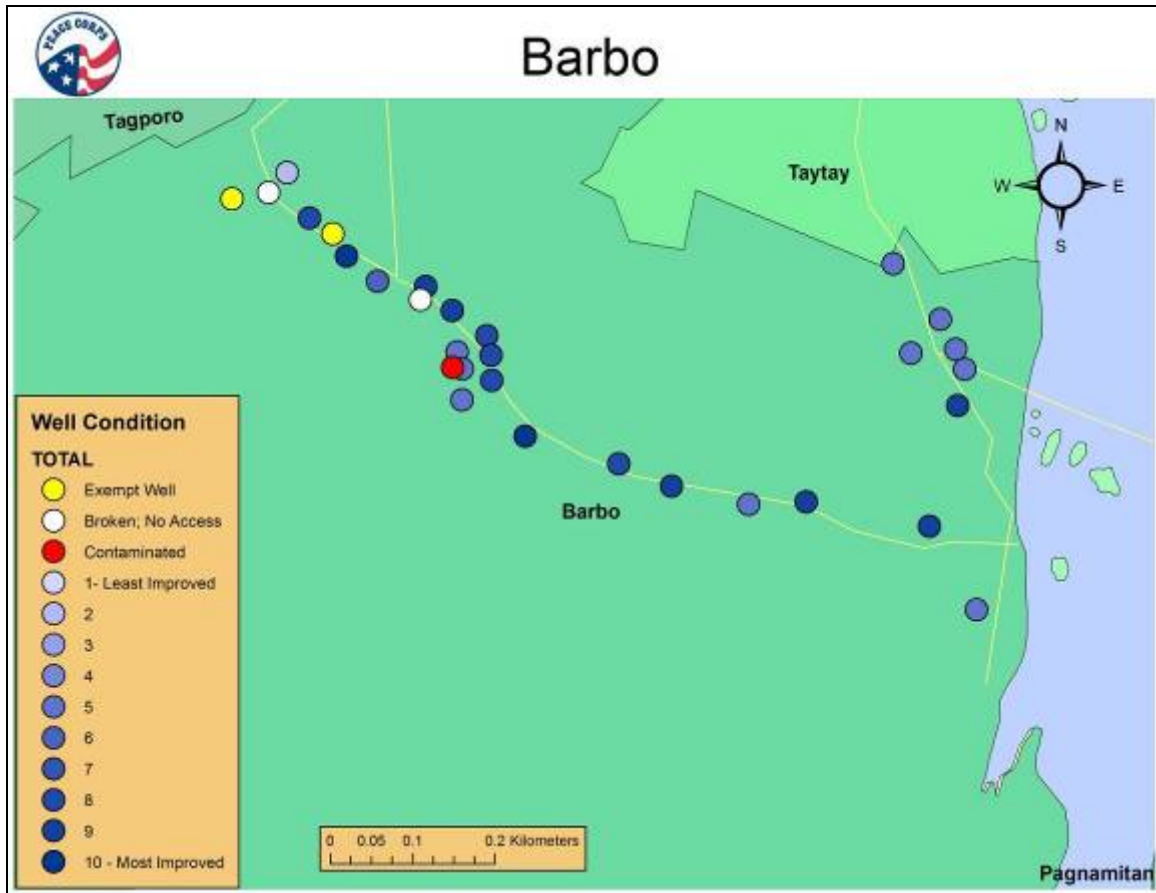
Number of Wells Sampled: 26

Average Improvement Score: 6.6

Issues: Broken pumps in common areas, No BWS, Contaminated Well.

Barbo is at the southern tip of the Peninsula and contains the connecting bridge to Calicoan Island. Wells are mainly of open with "jetmatic" pumps. There are MWS connections along the national road as well as the coastal road to the south. Well-03 (natural setting) and Well-05 (superior construction) are possible candidates for preservation in their current state. Well-18 is remarkable due to its superior designed cover. The barangay captain was instrumental in its improvement.

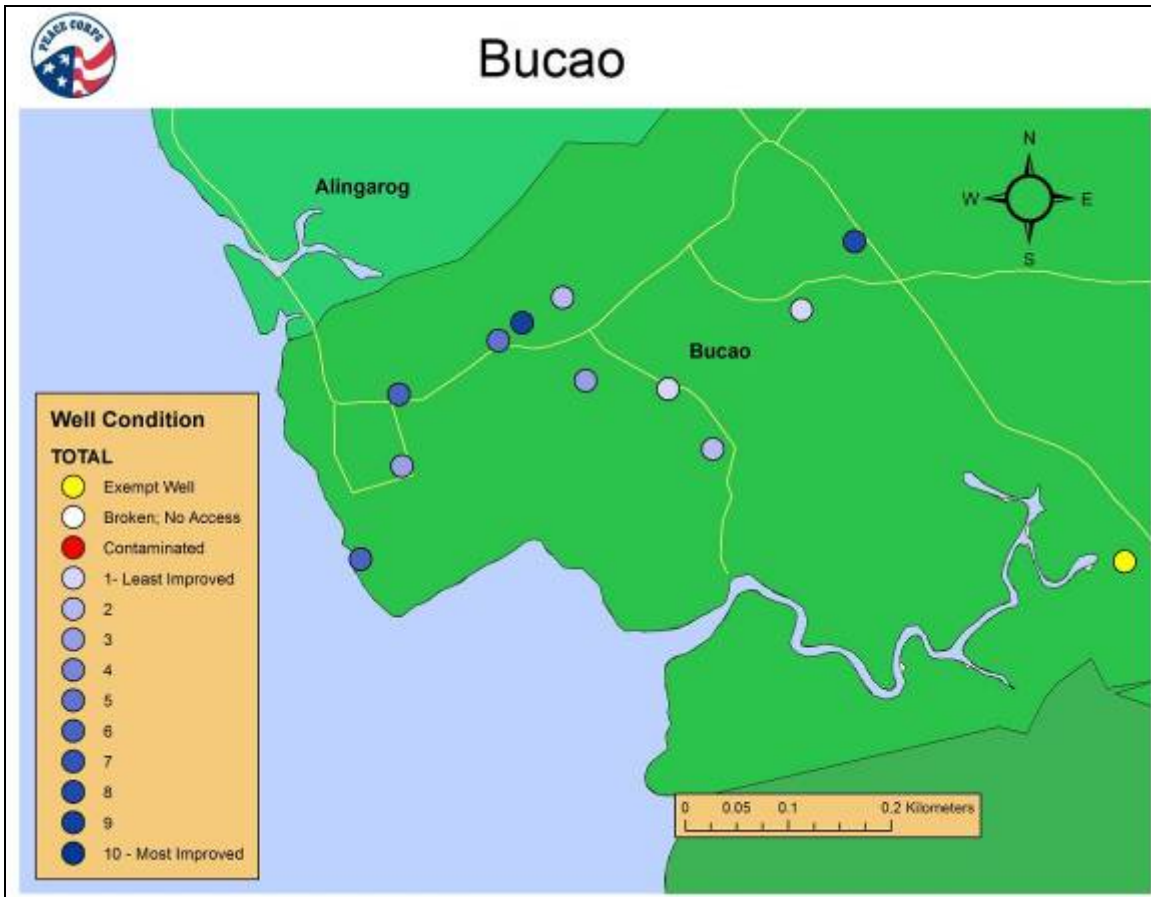
Number of Wells Sampled: 11

Average Improvement Score: 4.2

Bucao is located on the Leyte Gulf side, northwest on the Peninsula. The BWS was destroyed by the Typhoon and has not been replaced. There is one well with a pump that is centrally located that residents rely upon for water for utility purposes. There is a spring on the way to Cagdara-o with some improvements; however it is only useable at low tide. It is generally trashed.

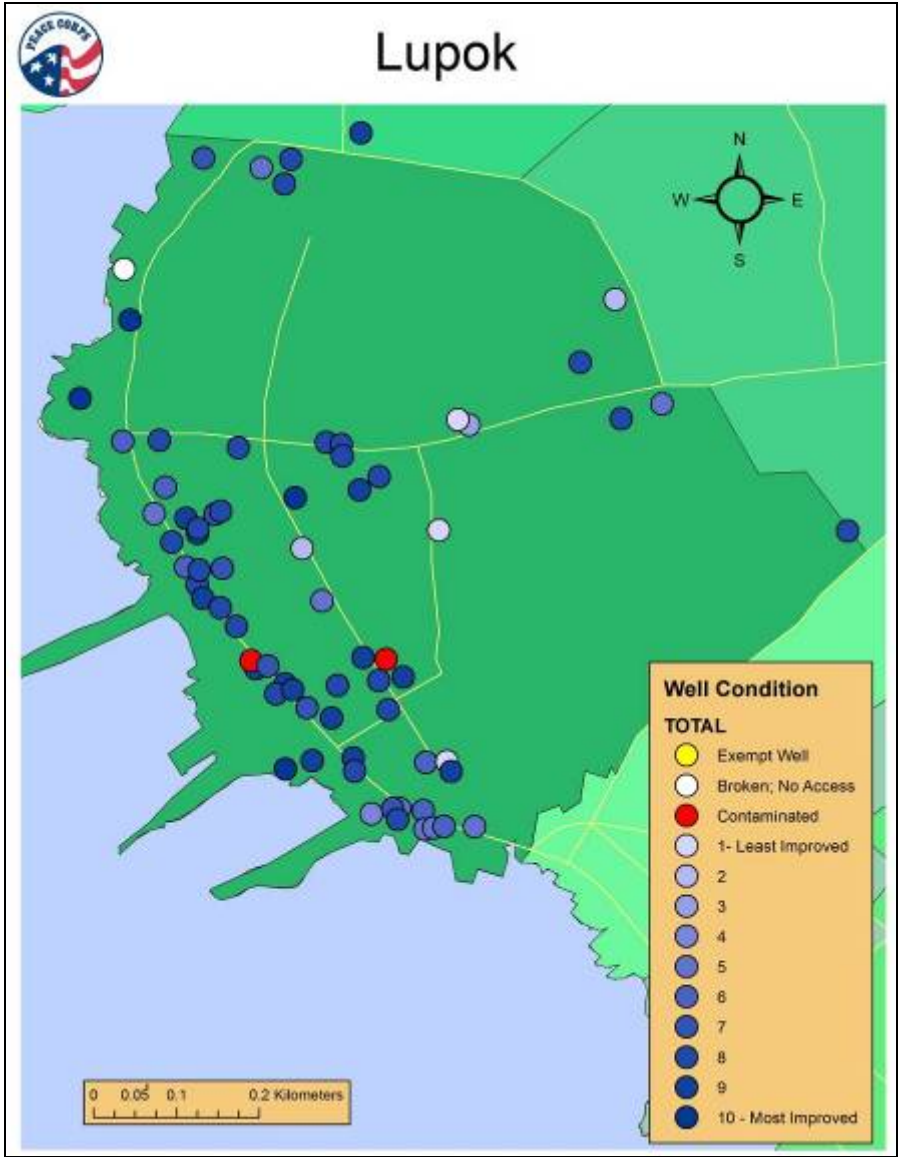
Number of Wells Sampled: 70
 Average Improvement Score: 6.8
 Issues: Contaminated and Uncovered wells.
 Priorities:

There is a contaminated well along the main road that is evidently a remaining cleanup task from the Typhoon (Well-34). What appears to be a contaminated well (Well-15) near the elementary school may be a overgrown planter box. The surveyor may be erroneous in counting this as a well. Lupok has one of the best designed wells (Well-20) the surveyor has found on the survey trail.

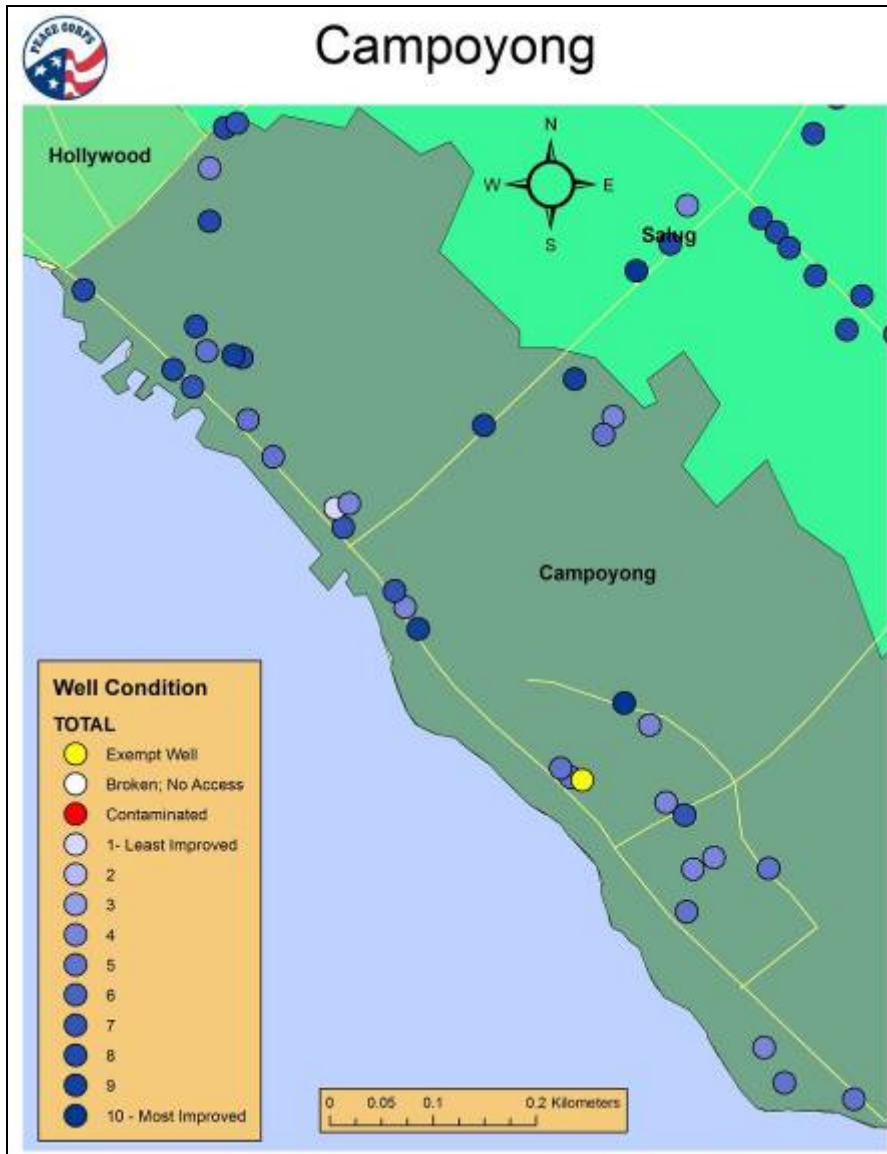
Number of Wells Sampled: 36

Issues: Large number of damaged, or deteriorating wells.

Among the wells in Campoyong, are two wells that apparently have been properly closed and decommissioned; something not found elsewhere along the survey trail in Guiuan.

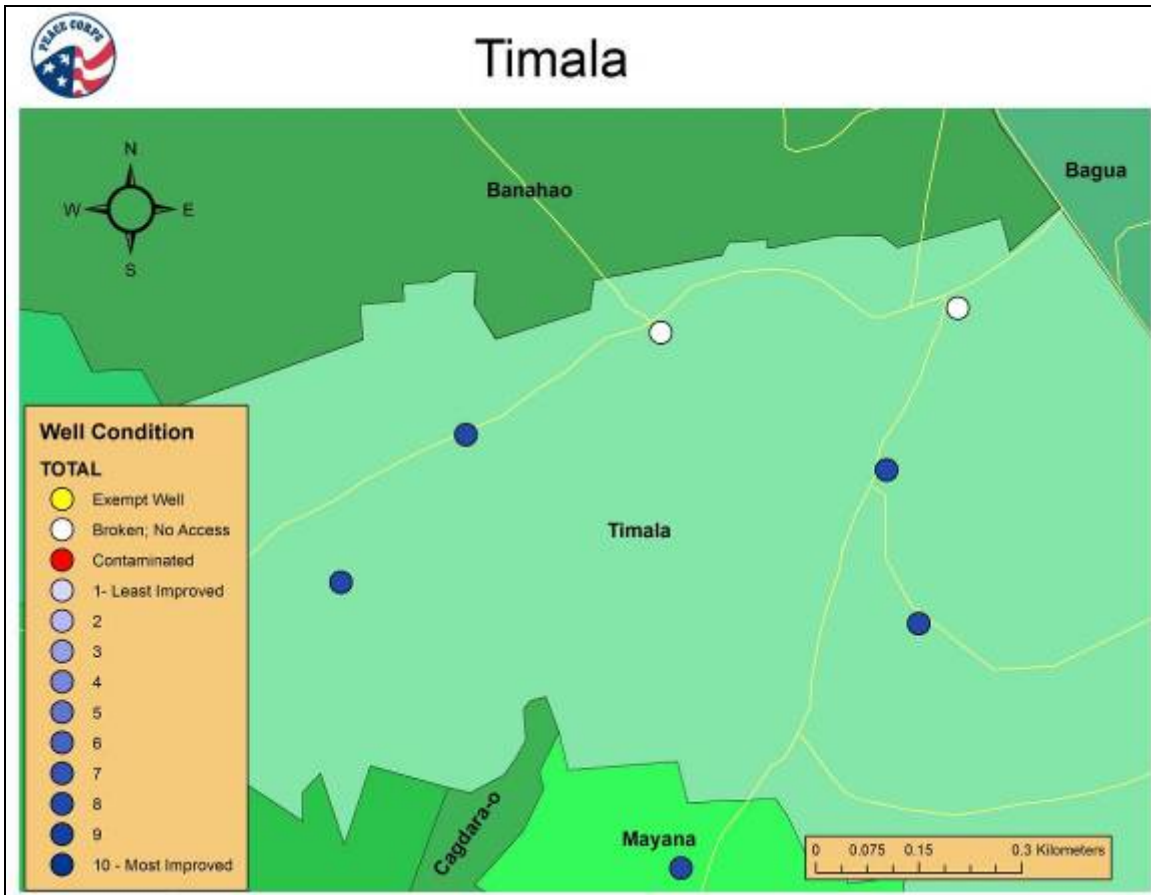
Number of Wells Sampled: 4

Issues: Few wells, un-repaired wells

Timala is an inland barangay found at the higher elevations. It boasts a cave locally famous for it's access to the water table. Technically this cave is a contingent source of water but is not included in the survey. The high elevation makes residents dependant on downhole positive displacement pumps to bring the water to the surface. Two of the six wells being off-line is significant. The BWS has been restored with a new tank on the damaged "solar" tower. It was not determined if the MWS extends to the National Road border of Timala. At the Timala - Mayana Border is located also has a MWS tank that is currently off line.

Priorities: Return to service "artesian" wells that are broken

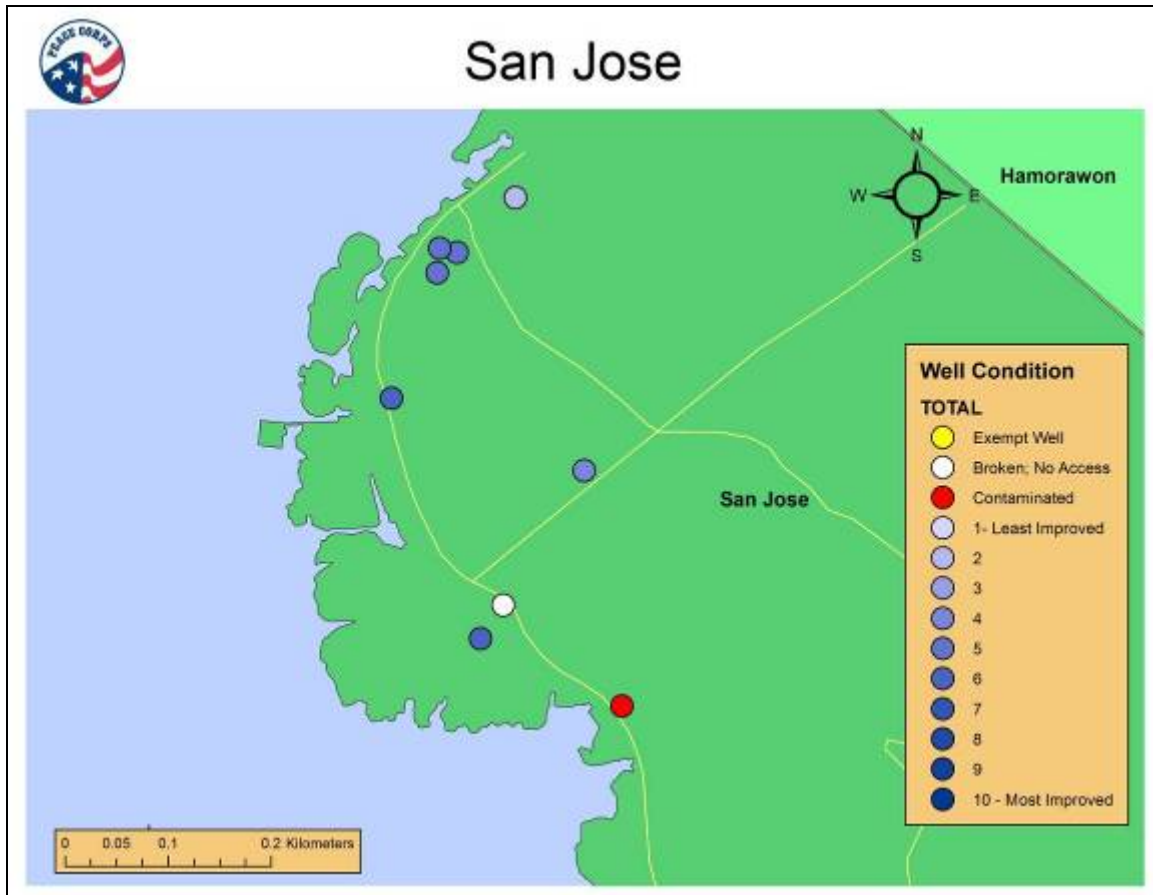
Number of Wells Sampled: 8

Issues: Deterioration in BWS water piping.

Priorities: Fix leaks

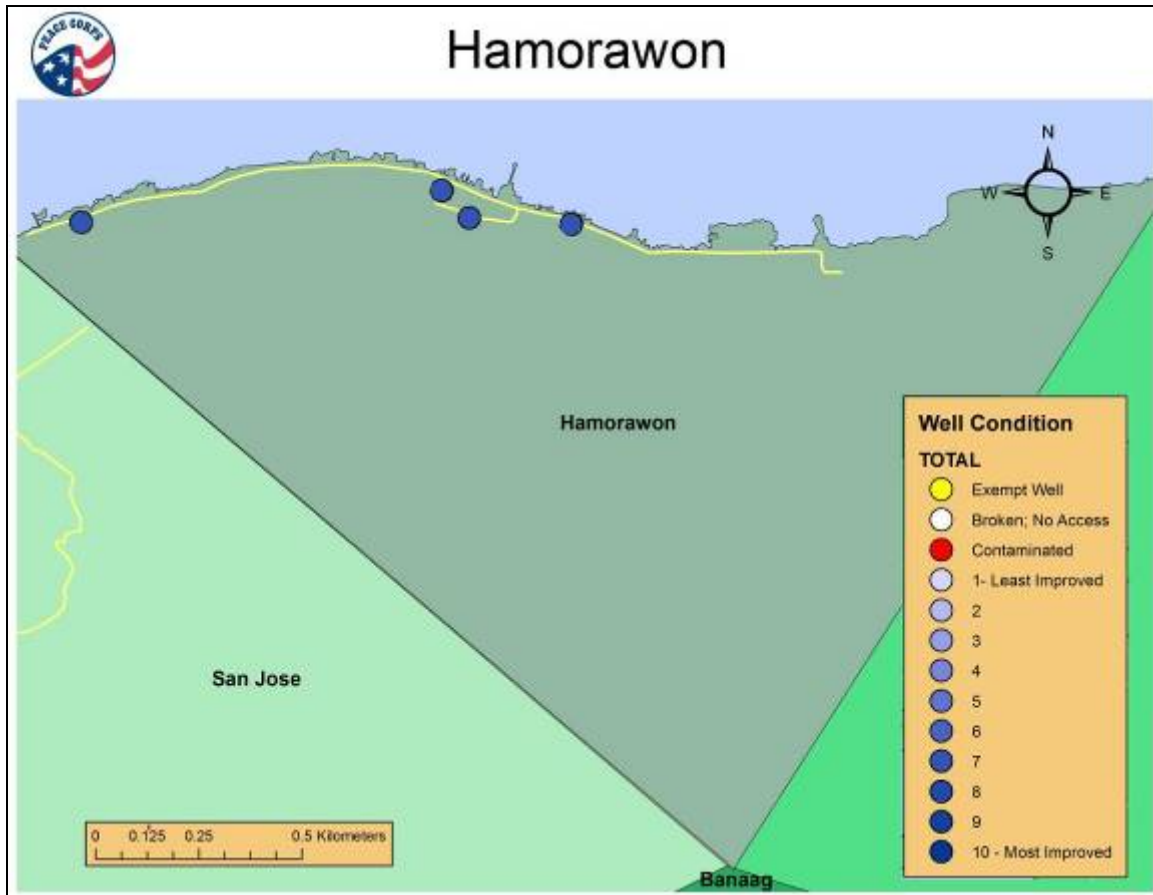
Number of Wells Sampled: 4

Issues: leaking pipes

Homorawon has a two contaminated wells observed among the few wells surveyed, but since the eastern half of the barangay was not surveyed due to time constraints, averages or scores were not calculated and they are not indicated on the map.
