HOME INSPECTION

1234 Main Street
Beaverton, OR 97005

Buyer Name
07/14/2024 9:00AM

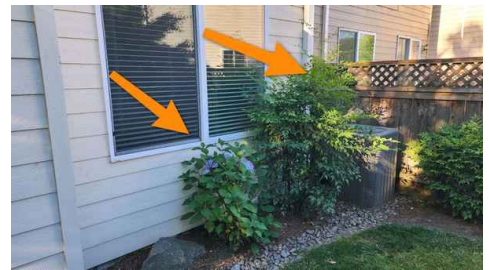
Maintain a clearance between shrubs/trees and the siding. 1-2 feet would be ideal. This will protect the siding from moisture and branches scraping over the surface.

Trim back

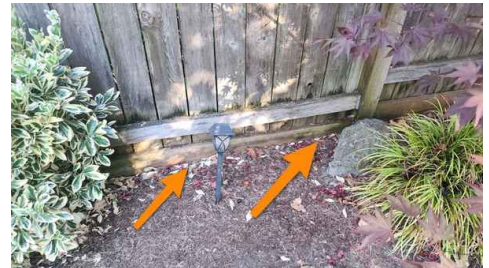
Wooden fences require continuous maintenance. The posts in the ground will eventually start to rot. Make repairs as needed. Maintain a clearance between the fence boards and the ground to prevent moisture from wicking up, causing rot over time.

Create a clearance

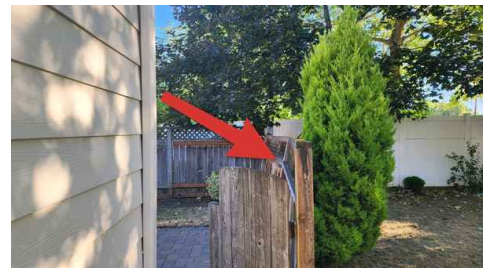
EAST SIDE

The fence is falling and needs to be replaced. It is leaning heavily towards the neighbor.

Replace

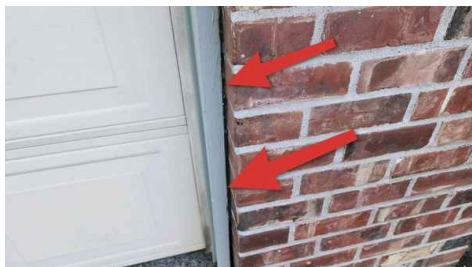
The stone veneer is improperly installed. It doesn't end at a weep screed 2" above the driveway surface and 4" above the soil, and it doesn't have backer rod/sealant joints where it abuts wood trim. This can cause the stones to loosen and the wood trim to rot. So far, I see no evidence of either. At this point, proper repairs would be costly and provide questionable benefit. My best advice is to keep an eye on the stones and make repairs if anything goes wrong. Any gaps should be caulked. If you're interested, proper installation details are here:

Missing backer rod and sealant

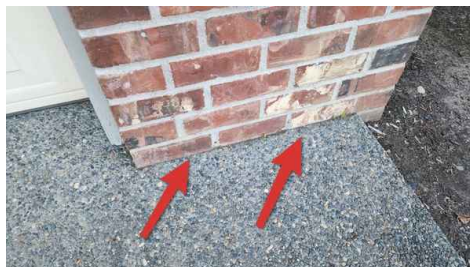
Inadequate clearance

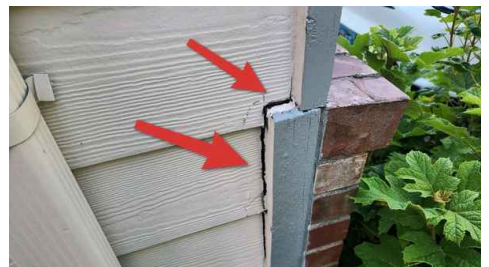
Flash and caulk

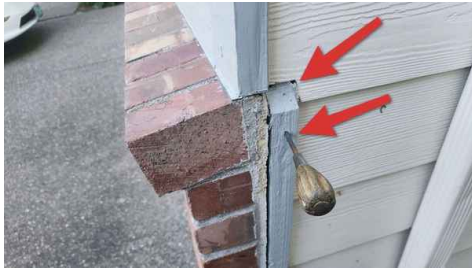
There is no flashing on top of the wooden trim next to the stone veneer which has led to moisture intrusion and rot. This needs to be repaired. All horizontal transitions need to have proper flashing.

Missing flashing and rot

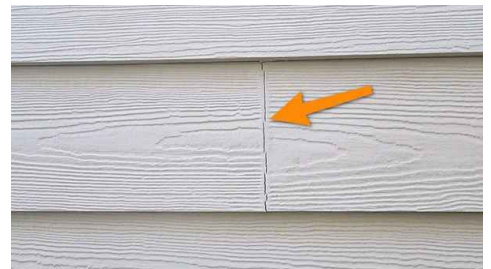
Maintain the caulking on all siding butt joints to prevent water intrusion.

Maintain caulking

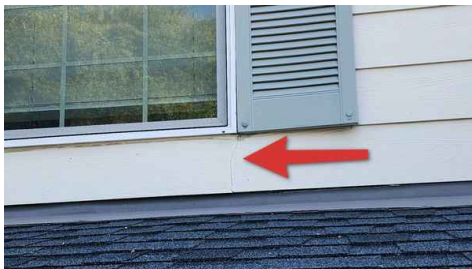
I observed a couple cracked siding boards, mainly on the upper level in front of the house. These need to be properly sealed or replaced to prevent water intrusion.

Cracked

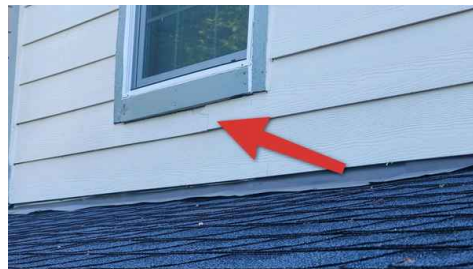
Another crack

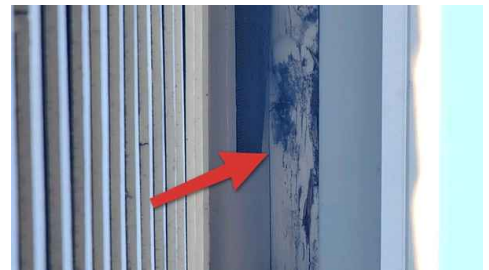
EAST SIDE

Water stains were observed under the roof eaves. This is hopefully from before the roof was replaced but should be monitored to detect potential issues early. Make sure you also get the warranty information from the roof install.

Water damage

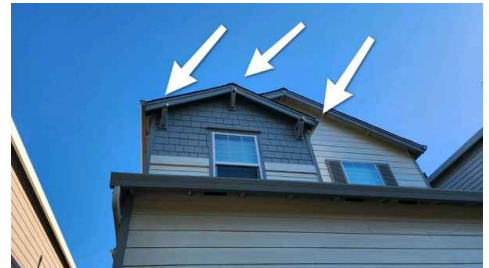
I suggest installing a metal flashing on top of the exposed beams/rafters to prevent deterioration over time.

Consider adding flashing

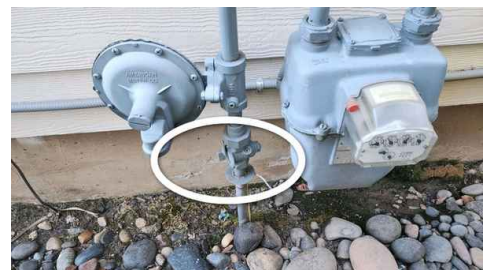
I recommend having a wrench readily available at the gas meter in case you need to turn it off quickly during an emergency. An even better protection would be provided by installing an automatic shutoff.

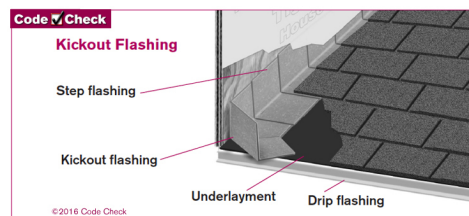
Adequate kick out flashing should be installed where the roof meets the house so water is less likely to run down between the gutter and the wall, eventually causing damage to the structure. It is supposed to be 4" long and 4" high. You have it installed above the front entrance but it is too small.

Kick out Flashing

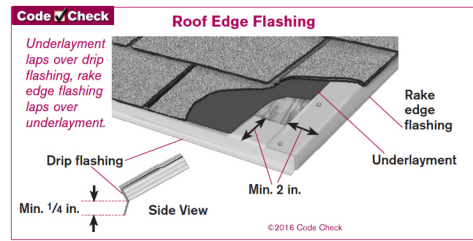
The roofing membrane underlayment is supposed to be installed on top of the drip edge flashing and not below. This may cause moisture intrusion and potential damage to the sheathing. A repair would be difficult and it is best to monitor those areas and have it done correctly when the roof is being replaced.

Flashing Placement

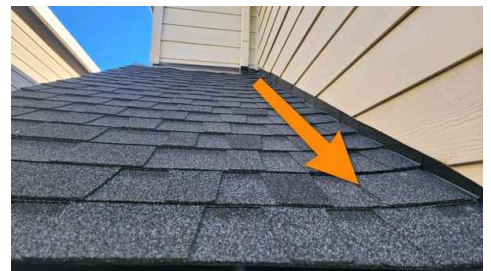
The downspouts from the upper roof should be extended all the way into the lower gutters to protect the shingles from premature deterioration.

I suggest extending downspouts into lower gutters

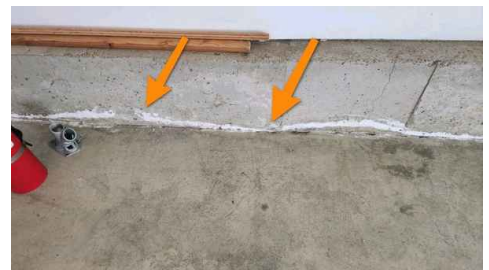
Efflorescence is visible in areas of the exposed foundation wall. It is a salty deposit that is separated from the concrete and is a sign that moisture pushes through.

Efflorescence

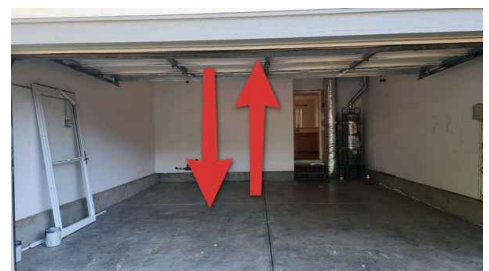
The door does not reverse with resistance and the force needs to be adjusted for safety. This can usually be done directly on the opener unit.

Adjust reversing

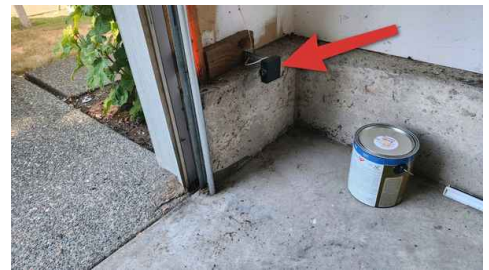
The sensors are installed fairly high. I recommend lowering them to within 4-6" off the ground to avoid potential injury. That way small children and pets are better protected.

Lower sensors

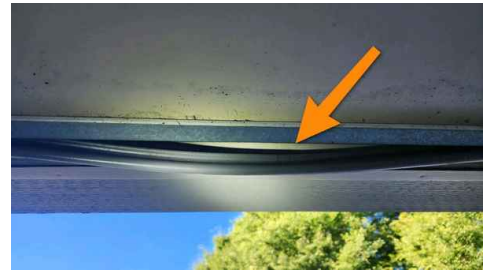
Attach seal

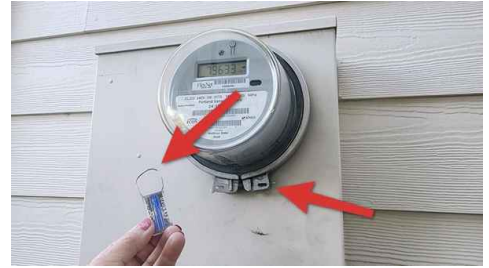
The PGE lock was cut and is now hanging on the telephone box. This might be an indication that the meter has been tampered with as the local utility company will always lock the meter. Bring this to their attention and have it inspected (to make sure nobody tapped into your electrical) and properly locked again.

Tempered with

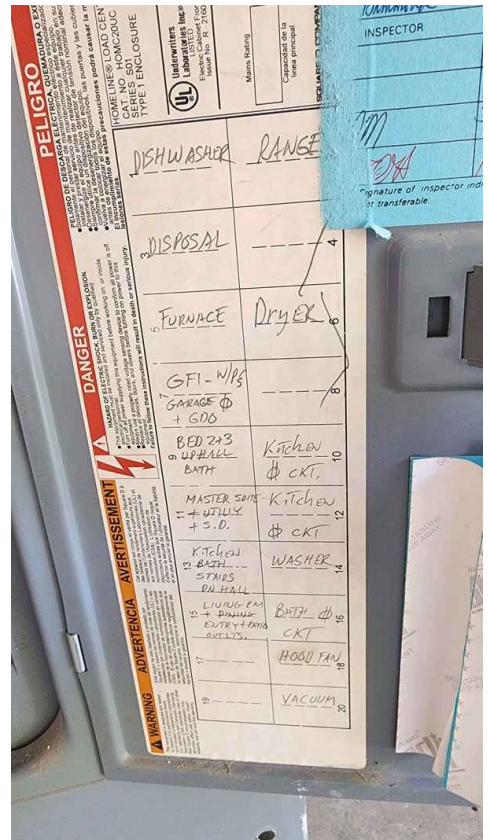
Some breakers are either not labeled or improperly labeled. Make sure all labeling is correct so you can quickly turn off any breaker in question during an emergency. You can check proper labeling by turning off one breaker at a time and verify that there is no power in the home on those circuits.

There is for example no label for the air conditioner breaker.

Missing AC label

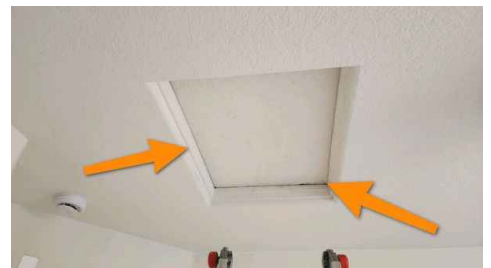
I recommend adding weather stripping to seal the attic access better, prevent heat loss and condensation related issues such as mold growth.

Add weather stripping

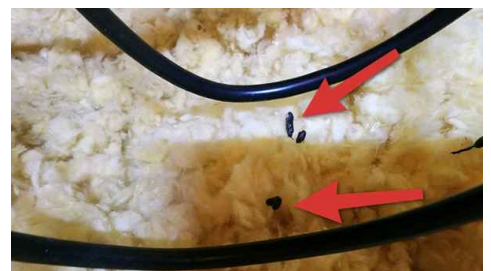
I found evidence of rodent activity in the attic. You can see holes and trenches through which they travel. The attic should be evaluated by a licensed pest control company to make sure there is no ongoing infestation. Since rodents carry diseases, any severely contaminated insulation should be replaced.

Rodent droppings

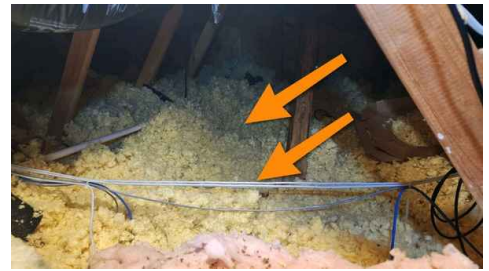
Some of the insulation was moved around/compressed and should be evenly distributed to prevent condensation issues.

Refluff

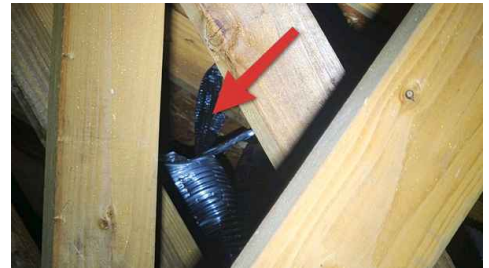
One of 3 bathroom ducts improperly vents into the attic which needs to be corrected to prevent mold growth. Ideally, a dedicated bathroom vent should be installed on the roof.

Vents into attic

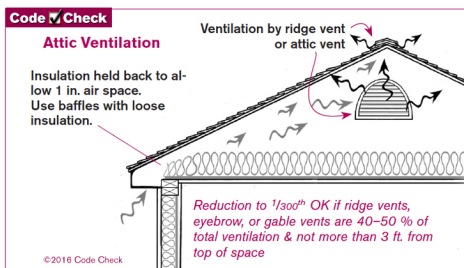
The soffit vents are covered or blocked which limits airflow and is conducive to mold growth. I suggest adding baffles and/or moving the insulation to provide better insulation in the attic. A baffle is missing on at least one of them near the entry.

Clear Soffit Vents

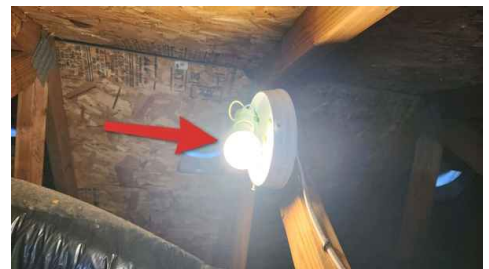
These light bulbs can pose a fire hazard when they are left on or something is stored too close. I recommend replacing them with LED lights and installing a cover around the fixture.

Upgrade fixture

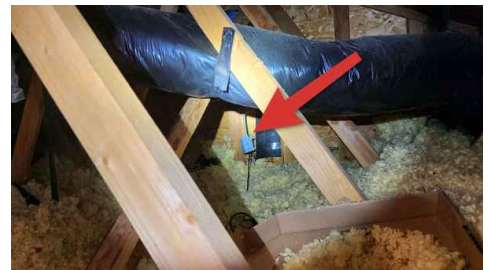
The junction box for the thermostatically controlled fan is just hanging down and needs to be properly attached to the framing members.

Hanging down

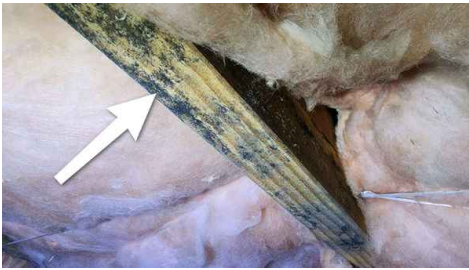
Lumber yard mold

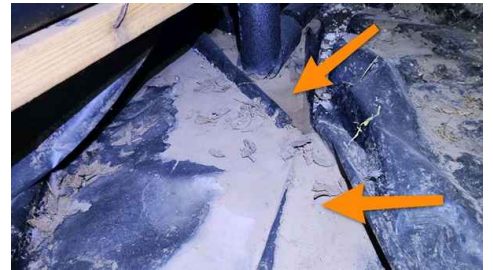
Since there are old water stains, I recommend checking the crawlspace again after we have more rain to make sure there is no standing water. If you find any, consult with a licensed drainage specialist about options of keeping the crawlspace reliably dry.

Previous standing water

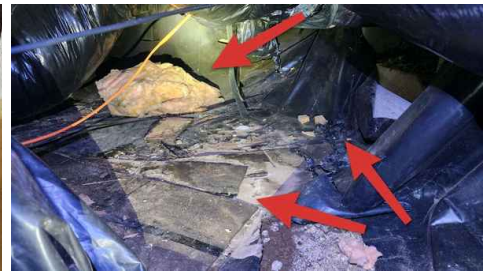
I recommend cleaning out all left over building material from the crawlspace.

Clear out

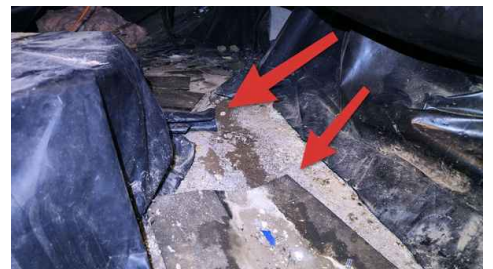
I found a few areas in the crawlspace where the vapor barrier is missing and/or damaged. This should be corrected as moisture from the ground will enter the crawlspace, eventually causing damage like mildew and mold to the structure. All seams need to overlap 12".

Exposed soil

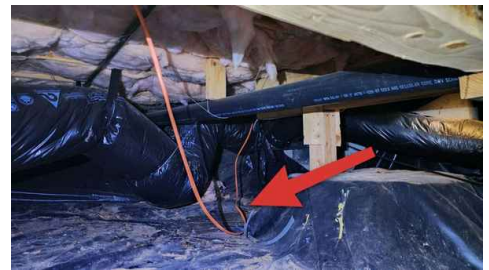
Wiring is lying on the ground. It should be raised off the floor and attached to the floor joist so it will not come in contact with water, should there ever be any in the crawlspace.

Secure to Subfloor

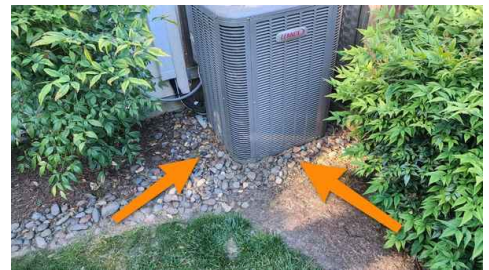
Keep the pad free from debris, rocks and weeds to protect the fins from potential damage.

Keep clean

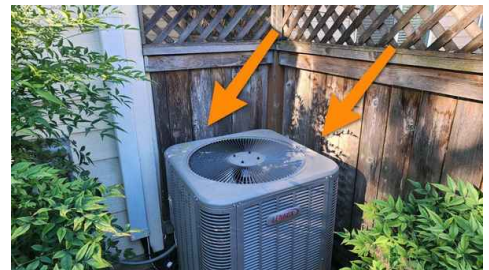
The minimum clearance around the condenser is 1 ft, ideally two to three foot to provide maximum air flow and allow the unit to run efficiently. Consider having the air conditioner moved so it's not as close to the corner.

Minimal air flow

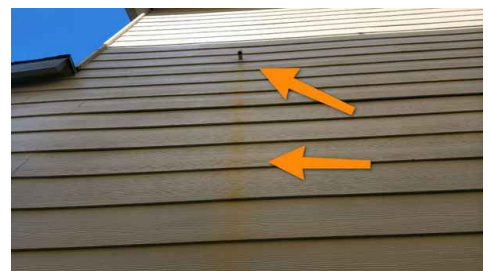
The condensate termination may be tied into the overflow drain. After running the air conditioner, water was dripping out of the pipe on the east side. It should be extended further down so the acidic water does not drip down along the siding, causing damage over time.

Water dripping down when running the AC

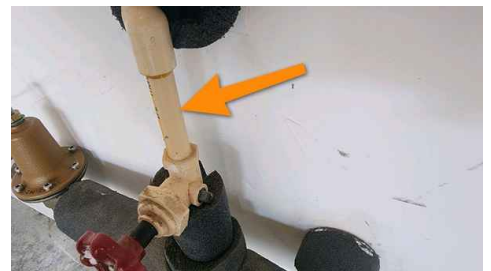
While CPVC has never been recalled, it does have a higher tendency for cracks than other materials. Monitor for leaks on a regular basis. I am aware of several incidents where the entire plumbing needed to be replaced.

CPVC

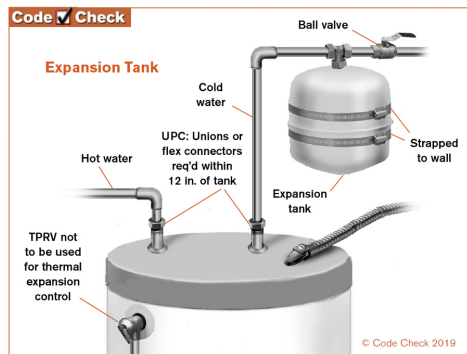
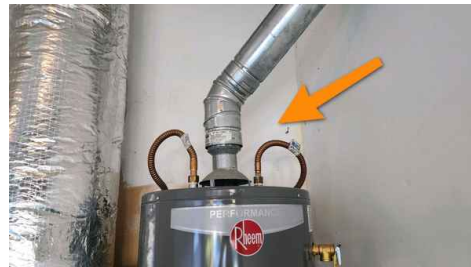
Since the home has a pressure reducing valve installed, there should be an expansion tank on the water heater to protect the unit. Have this evaluated by a plumber and a tank added as needed. When you install a PRV (Pressure Reducing Valve), the water pressure steps the water pressure down on the homeowners side but does not allow water to flow backwards, offsetting thermal expansion. In the event there is no thermal expansion tank on a water system that is protected by a PRV and produces hot water, the water pressure will spike to a point higher than before there was a PRV. The PRV works like a check valve not allowing the water to push back into the City main when the water heater is heating. When installed correctly, a thermal expansion tank will accept the higher-pressure spikes and contain the excess pressure in the tank until the water cools back down, or somebody uses the water allowing the pressure out.

Add expansion tank

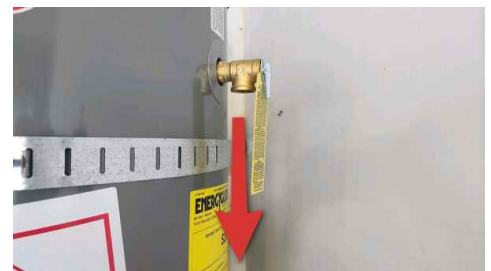
The drain tube is missing. Install to within 6" -24" of the floor. A missing drain tube can lead to scalding within seconds if somebody happens to be in front of the unit when the valve releases.

Missing drain tube

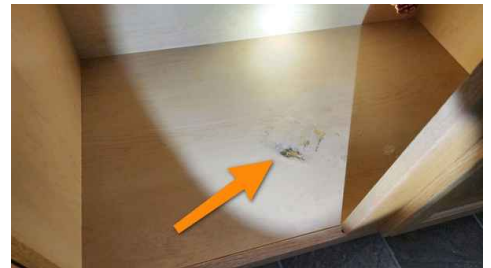
I observed evidence of a prior leak. It was dry at this time but should be monitored to detect potential issues early.

Old damage

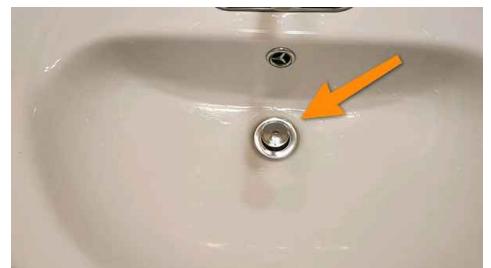
The stopper does not work, repair as needed.

Repair stopper

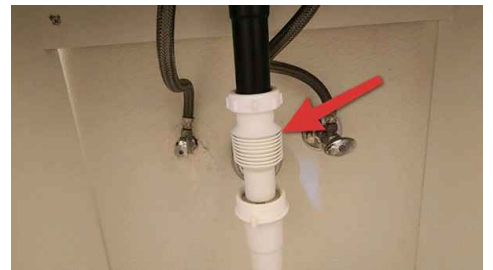
Flexible drain pipe is neither allowed nor recommended. It will clog over time. Install a rigid drain instead.

Replace flexible drain

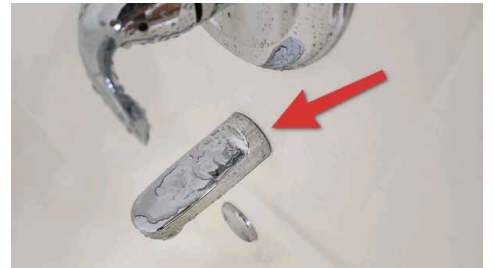
The water spout needs to be adequately fastened and caulked to the wall so water cannot get behind and potentially damage the structure.

Needs caulking

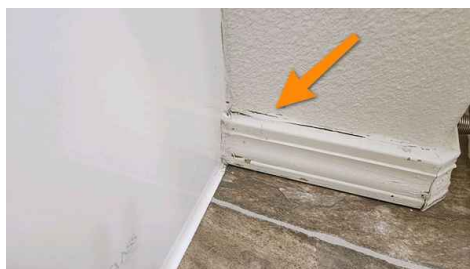
Consider installing a glass door if you find that too much water is splashing out while showering. Minor damage is already noted on the trim in front of the tub.

Minor damage

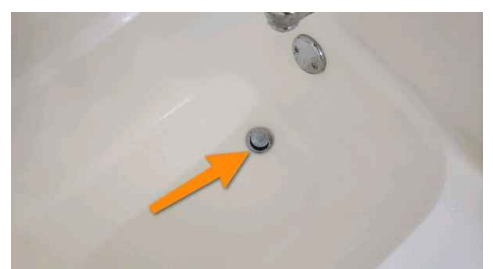
Does not work

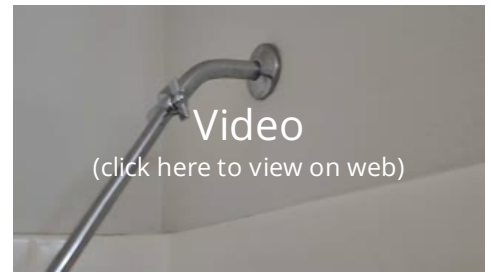
The shower head pipe is very loose and needs to be better secured to prevent potential leaks inside the wall.

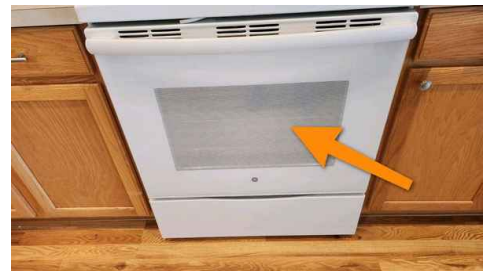
The oven light doesn't work and should be repaired.

Repair oven light

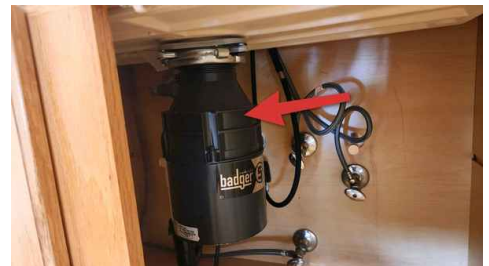
The garbage disposal was inoperable at the time of inspection. It needs to be repaired or the unit replaced.

Not working

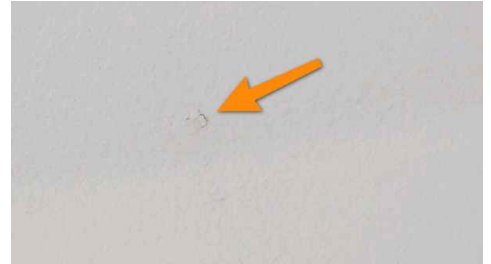
Nail pops are visible in one or more locations in the ceiling. These are cosmetic only and do not have any structural impact. You can opt to have them repaired by a drywall contractor or try removing the nails and using drywall screws instead.

Nail pops

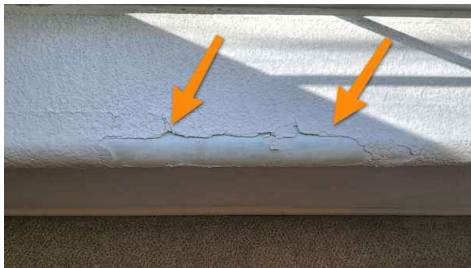
The windowsill is damaged and should be repaired. There may have been water damage at some point.

Damaged sill
