Kennedy Inspections  
115 Gable Rd  
Paoli PA 19301  
610-833-8220  
RossDKennedy@gmail.com

Report: 2676

# Confidential Inspection Report

September 3, 2020

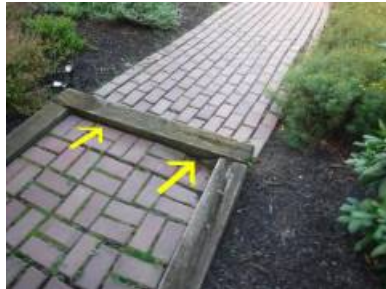
- Brick. Sunken walk at front door has created a trip step with the railroad tie beams. Recommend repair for safety.

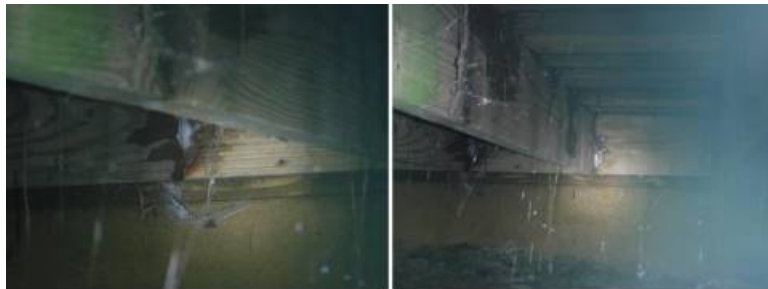
Wood. Deck brackets are rusted and subject to failure. Recommend repair by a qualified deck contractor for safety.

- Wood. Deck brackets are rusted and subject to failure. Recommend repair by a qualified deck contractor for safety.

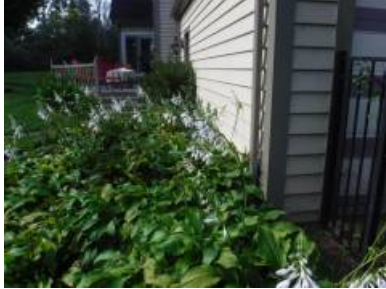
- Trees/foliage noted touching the walls or roof. Recommend trimming vegetation as needed to protect structure.

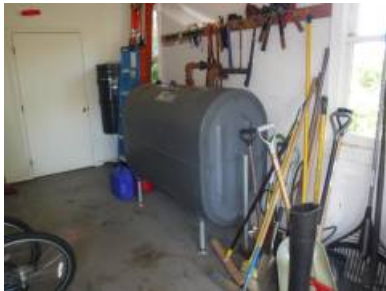
- Oil tank located in garage. Some municipalities require protective caging or barriers be built around the tank to avoid this hazard. Consult with local authorities for determination of requirements.

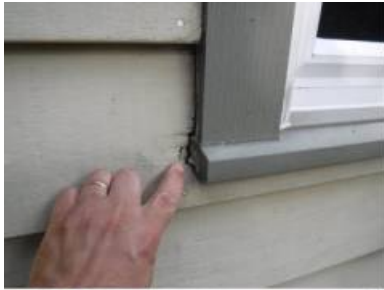
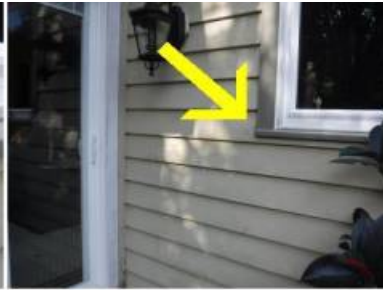
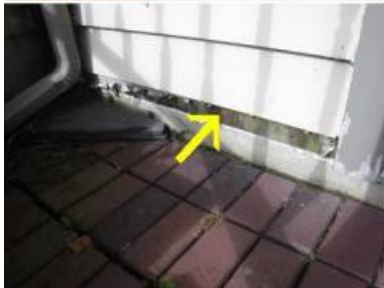
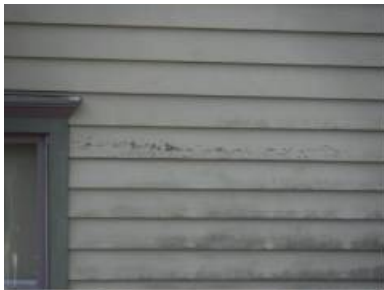
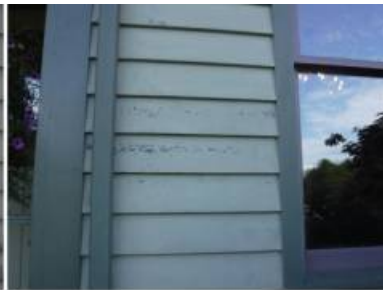
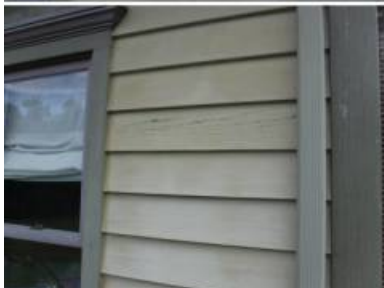
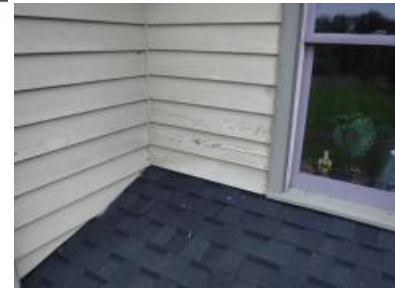
- Wood siding. Exterior wood requires maintenance. Re-stain or paint as needed in course of maintenance. Some wood rot noted at siding near rear door slider and exposed wood near rear door to entry vestibule leading to the garage. Recommend repair by a qualified contractor to prevent worsening conditions and moisture entry.
- Peeling stain or paint is noted throughout the property as this last coat appears to be aging. Recommend updating the stain by a qualified painter to maintain cedar siding integrity.

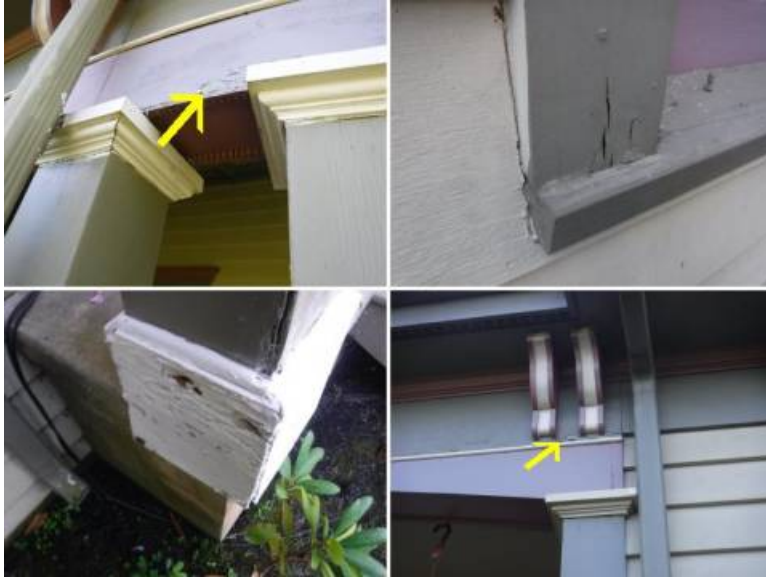
- Wood trim. Maintain caulk and paint as needed. At wood trim, soft areas noted in several locations. Wood trim requires maintenance, and occasional putty repairs or trim replacement while painting is part of maintenance. Recommend repairs as needed to prevent further damage and weather entry. Repaint as needed in course of maintenance.

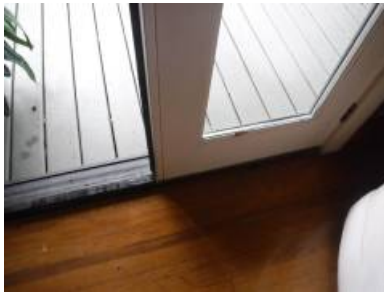
- Wood, Metal, Hinged. Vinyl, Sliding. Right passive door at front most french doors in living room was jammed shut and could not be opened. Recommend repair as needed for use.

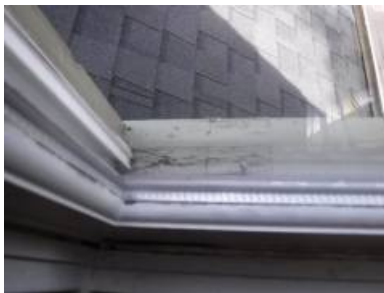
- Wood frame, Double glazed insulated.
- Peeling paint noted at exterior windows. Recommend scrape and paint as needed to encapsulate and protect.
- Wood. Some wood sills have some minor rot due to water penetration. Recommend repairs as needed.

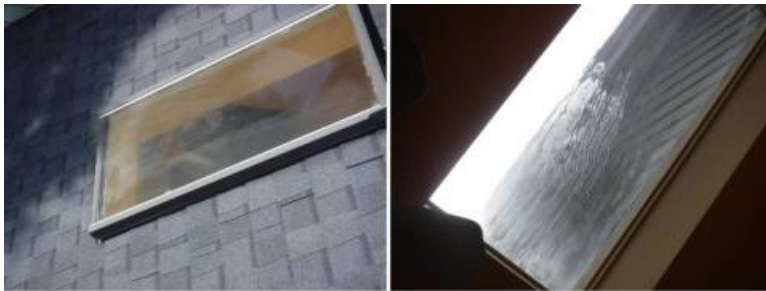
- Raised curb type skylight noted. Monitor for future leakage. Fogged window, blown thermal seal noted at skylight in rear dining area off of kitchen. Seal at double pane insulated window has failed, allowing moisture between the panes. Not all blown seals are visible in all seasons and visibility can vary with other factors such as temperature. This inspection can only mention those that are clearly visible at time of inspection. Repair typically is the replacement of the glass unit. Recommend evaluation for repair as needed by qualified window contractor.

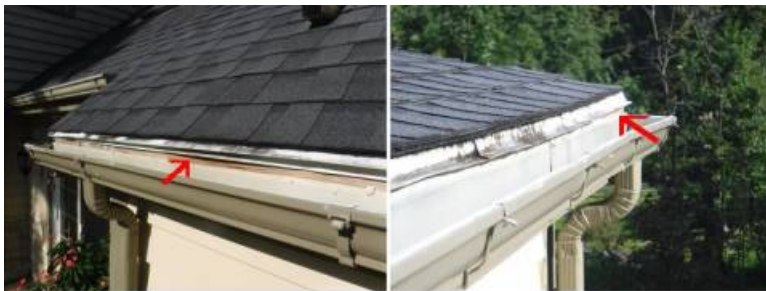
- Soffits and overhang materials are a combination of wood and aluminum. Missing capping is noted at the fascia boards at rear of garage 2nd floor. This exposes the wood to the elements and will lead to wood rot. Recommend capping or painting for protection of the wood surfaces.

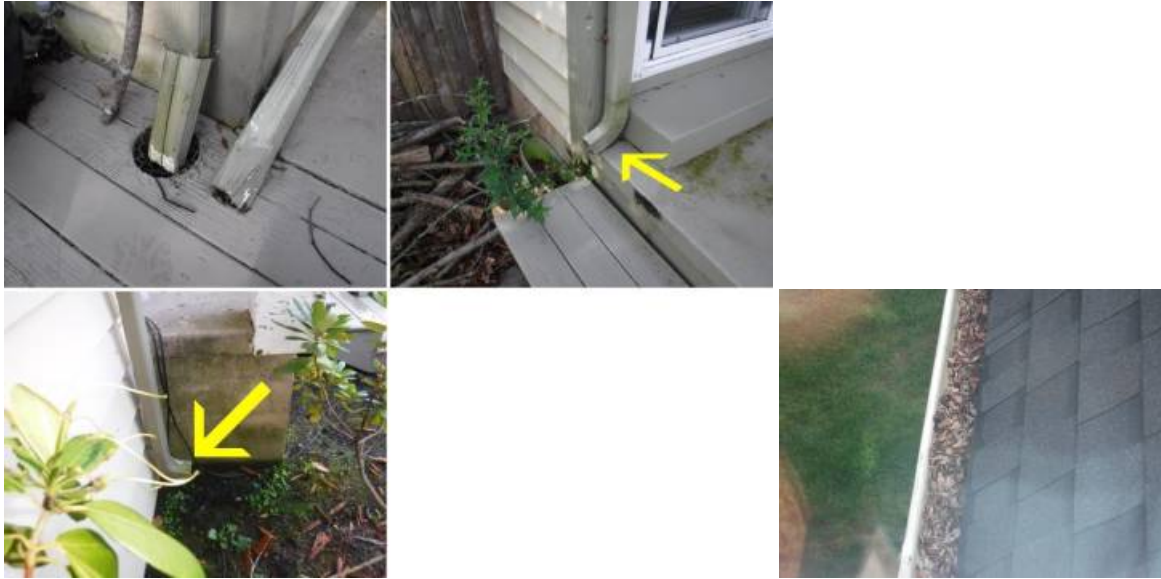
- Aluminum, Extend downspouts to route rainwater away from the building.
- Clogged gutters noted. Recommend clearing gutters as needed.

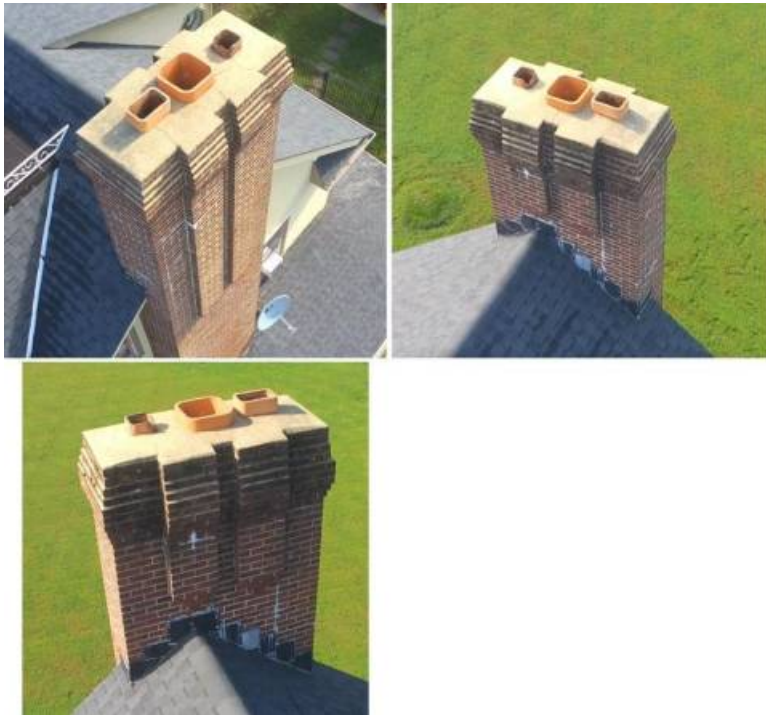
- Flue:* ○ Fireplace flue. Terra Cotta clay, There is no chimney rain cap installed. Installation of a chimney rain cap is recommended to prevent water from entering the chimney flue and causing damage. Also will prevent bird and critter entry.
- Flue #2:* ○ Fireplace flue. Terra Cotta clay, There is no chimney rain cap installed. Installation of a chimney rain cap is recommended to prevent water from entering the chimney flue and causing damage. Also will prevent bird and critter entry.
- Flue #3:* ○ Heating appliance flue. i.e. furnace or boiler, Terra Cotta clay, There is no chimney rain cap installed. Installation of a chimney rain cap is recommended to prevent water from entering the chimney flue and causing damage. Also will prevent bird and critter entry.
- Chimney Cap/Crown:* ○ Cement.

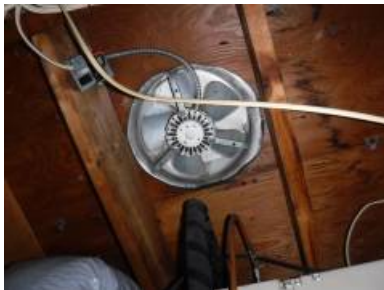
- Attic Ventilation:*  There are ridge vents installed. There are soffit vents installed.
- Attic Power Vent:*  A power vent fan is installed.  
Improper wiring noted at attic power vent fan. Recommend re-wiring as needed for safety by qualified electrician. Fan thermostat setting was dialed to the lowest setting in an attempt to test the fan. Fan did not function when tested. Power may be turned off to the fan at another location or the fan is broken. Recommend repair as needed. Consult with a qualified roofer to determine the need for the fan.

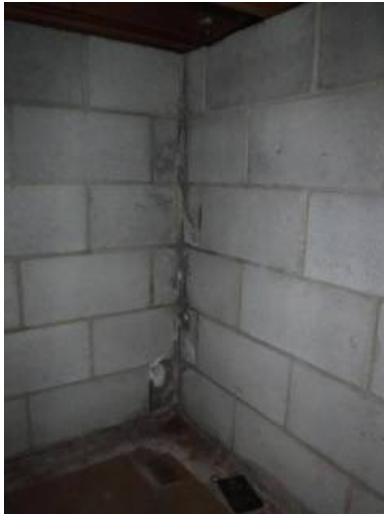
- Concrete block. Efflorescence noted at foundation walls. White powdery substance noted on foundation walls is efflorescence; minerals residue left behind from moisture evaporation. Some efflorescence is common and normal. Excessive amounts can indicate a water issue. Recommend extending downspouts, and improving exterior drainage away from the foundation.

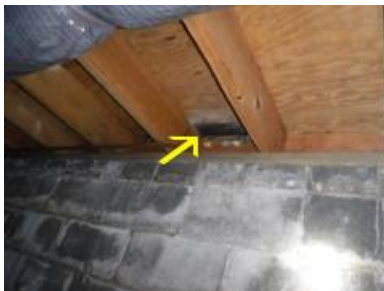
- Plywood. Small area of moisture noted above the rear rim joist at the secondary crawlspace room nearer to the garage. This could be moisture coming in through a door threshold or otherwise. Recommend further evaluation by a qualified contractor to prevent worsening conditions.

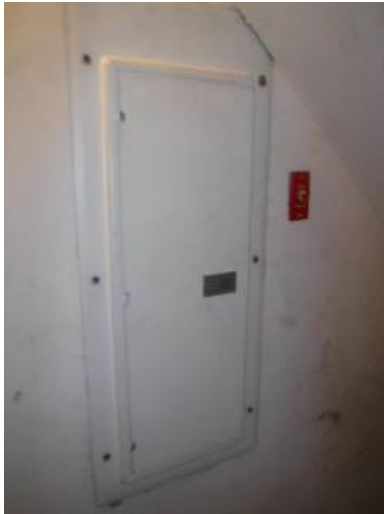
- Main Panel Location:*  Top of the crawlspace stairs.
- Main Circuit Breaker Rating:*  200 amps.
- Entrance Cable Size:*  4/0 Aluminum: 200 amps.
- Main Panel Rating:*  200 amps.
- Main Panel Observations:*  Circuit breaker rating and wire sizing appears correct for present usage. Missing panel cover screws noted. Install blunt panel screws as needed for safety.

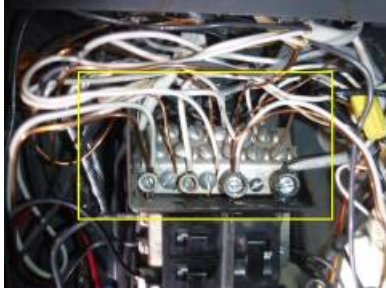
Improper bonding noted at sub-panel. Ground and neutral wires not properly isolated or wired. Recommend evaluation for repair as needed by qualified electrician to prevent fire and shock risk.

- Sub Panel Location:*  Crawlspace.
- Sub Panel Breaker Rating:*  100 amps.
- Sub Panel Supply Cable Size:*  #2 Aluminum: 100 amps.
- Sub Panel Bonding:*  Improper bonding noted at sub-panel. Ground and neutral wires not properly isolated or wired. Recommend evaluation for repair as needed by qualified electrician to prevent fire and shock risk.

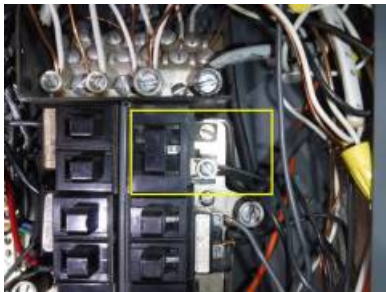
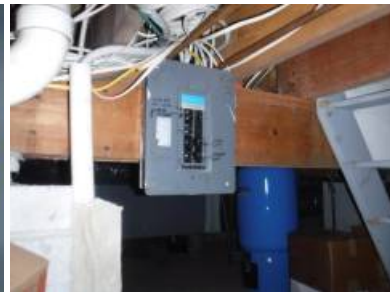
Double tap(s) noted. Multiple circuit wires noted at breaker(s) rated for a single circuit wire. This can cause an overload or burned wire. Recommend evaluation by qualified electrician to separate double taps for safety.

- ⊙ Double tap(s) noted. Multiple circuit wires noted at breaker(s) rated for a single circuit wire. This can cause an overload or burned wire. Recommend evaluation by qualified electrician to separate double taps for safety.
- Pushmatic panels were used primarily from the 1960s to the 1980s. It is unclear why this panel would have been used on a home built in 1990. Pushmatics are not considered unsafe in general but parts are expensive and difficult to replace.

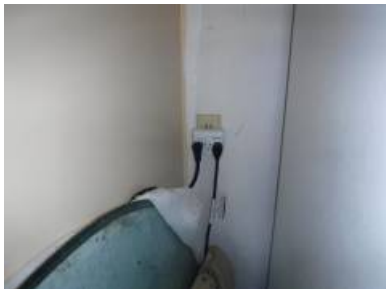
Ground Fault Circuit Interrupter (GFCI) protection is required at all garage outlets. Recommend evaluation for installation or repair as needed by qualified electrician for safety. Outlet at rear wall requires upgrade.

- ⊙ Ground Fault Circuit Interrupter (GFCI) protection is required at all garage outlets. Recommend evaluation for installation or repair as needed by qualified electrician for safety. Outlet at rear wall requires upgrade.

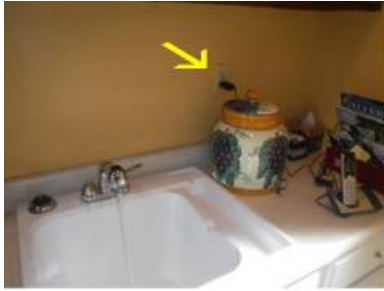
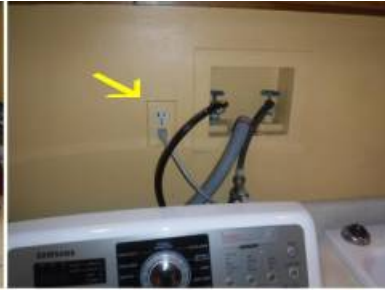
Ground Fault Circuit Interrupter (GFCI) protection is required laundry sink and at washer. Recommend evaluation for installation or repair as needed by qualified electrician for safety.

- ⊙ Ground Fault Circuit Interrupter (GFCI) protection is required laundry sink and at washer. Recommend evaluation for installation or repair as needed by qualified electrician for safety.

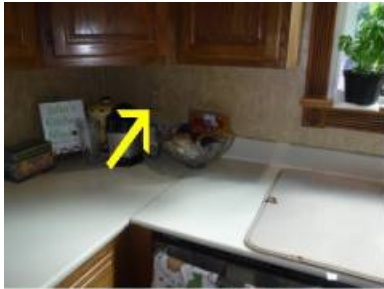
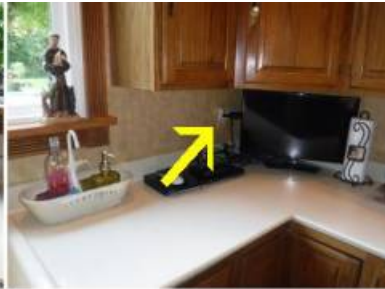
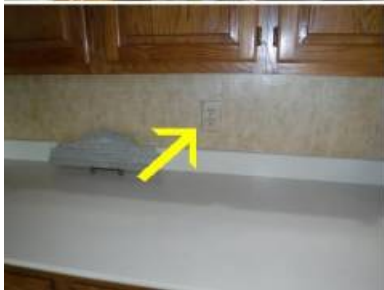
Missing GFCI protection noted at kitchen at all countertop outlets.. Ground Fault Circuit Interrupter (GFCI) protection is required at all outlets above kitchen counters and outlets for use related to kitchen counters. Recommend evaluation for installation or repair as needed by qualified electrician for safety.

- ⊙ Missing GFCI protection noted at kitchen at all countertop outlets.. Ground Fault Circuit Interrupter (GFCI) protection is required at all outlets above kitchen counters and outlets for use related to kitchen counters. Recommend evaluation for installation or repair as needed by qualified electrician for safety.

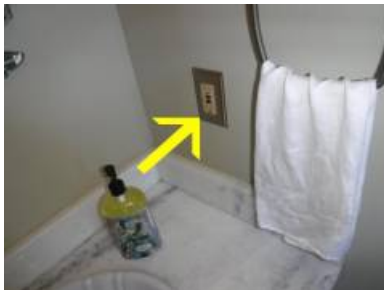
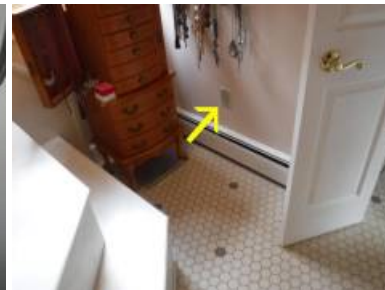
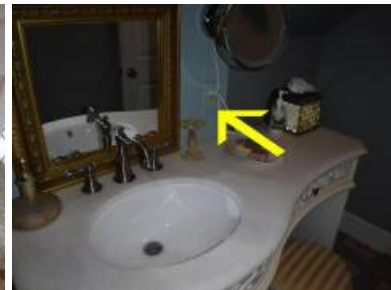
GFCI outlet at bath off of laundry room did not trip when tested with a wall trip tester. Recommend replacement as needed for safety by qualified electrician.

Outlet without power noted near master bath whirlpool. Inquire with seller for more info. Repair if needed.

Ground Fault Circuit Interrupter (GFCI) protection is required at all bathroom outlets. Outlet at bathroom over the garage requires upgrade to GFCI. Recommend evaluation for installation or repair as needed by qualified electrician for safety.

- ⊙ GFCI outlet at bath off of laundry room did not trip when tested with a wall trip tester. Recommend replacement as needed for safety by qualified electrician.
- ⊙ Outlet without power noted near master bath whirlpool. Inquire with seller for more info. Repair if needed.
- ⊙ Ground Fault Circuit Interrupter (GFCI) protection is required at all bathroom outlets. Outlet at bathroom over the garage requires upgrade to GFCI. Recommend evaluation for installation or repair as needed by qualified electrician for safety.

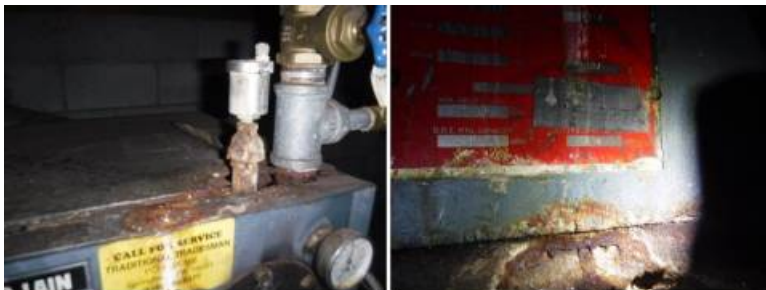
- Furnace Efficiency:*  Conventional efficiency system. The expected life of a conventional efficiency system in this area is 15 to 25 years. Yearly routine maintenance and cleaning by a qualified technician is suggested.
- General Operation & Cabinet:*  Heating system showed proper response to controls and appears to be functional as designed however with concerns. Heavy corrosion is noted at the cabinet exterior. Recommend evaluation by a qualified HVAC technician to determine repairs as needed.

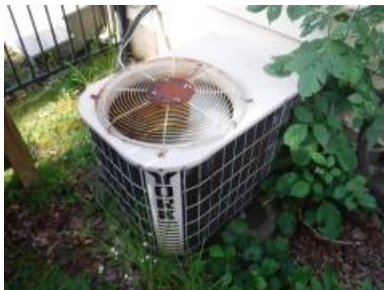
*System Condition:* ○ General condition appears serviceable but with concern. The expected life of an A/C system in this area is 15 to 25 years. This unit is very old and beyond the end of its design life. Upgrade to current technology and efficiency will save energy and possibly begin to pay for itself in savings quickly. Recommend evaluation by qualified HVAC technician for pricing to upgrade this unit in the near future.

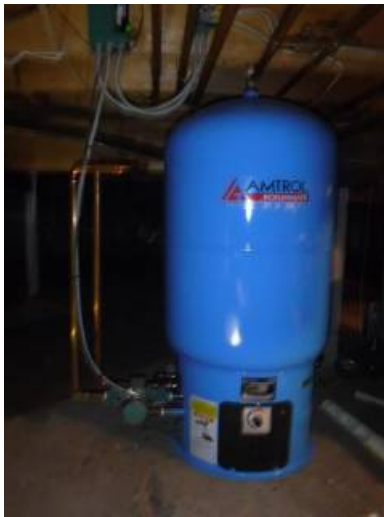
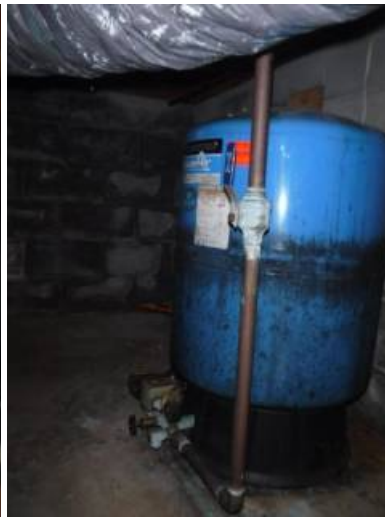
- Well water. Two well bladder tanks were noted in the basement. One newer near the crawlspace steps and one appears older at the rear corner of the crawlspace. Each has a separate water line coming through the back wall of the home. Consult seller for more information on why there are two.

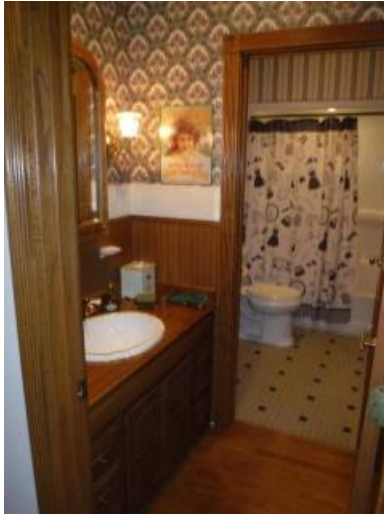
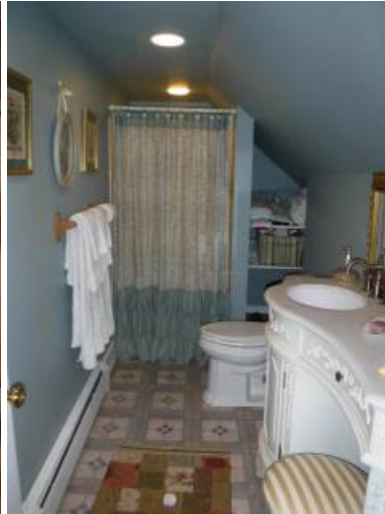
Missing ventilation noted at bathroom over the garage and at 2nd floor hall bathroom. A vent fan or openable window is required for ventilation at all bathrooms. Recommend installing an exterior venting fan as needed.

- ⊙ Missing ventilation noted at bathroom over the garage and at 2nd floor hall bathroom. A vent fan or openable window is required for ventilation at all bathrooms. Recommend installing an exterior venting fan as needed.

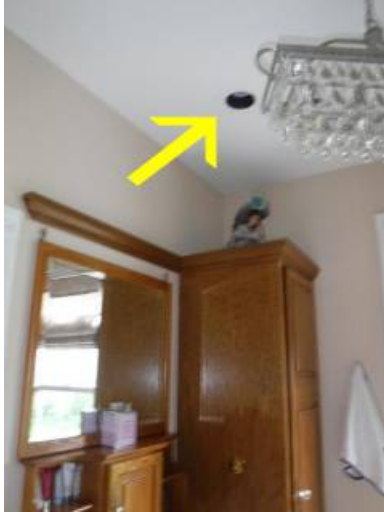
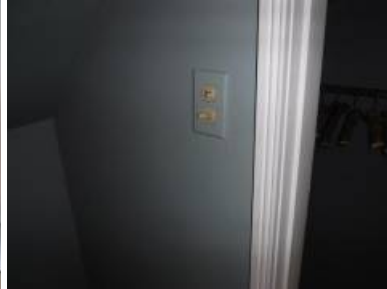
- Recessed light over master bath sink did not function. Recommend replacing light bulb and testing prior to contacting and electrician.
- Loose light switch noted in bathroom above garage. Recommend repair by a qualified electrician for safety.

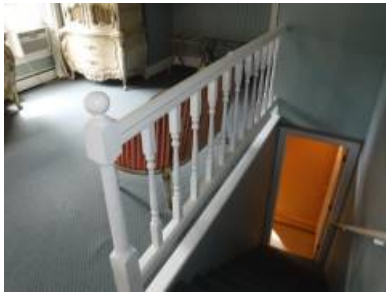
- Loose railing noted at top of stairs to bedroom over garage. Recommend repair by a qualified contractor for safety.

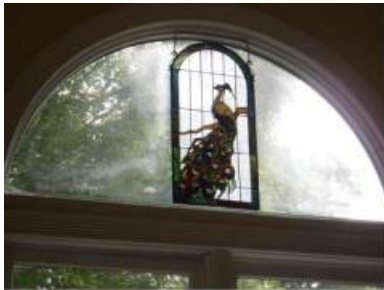
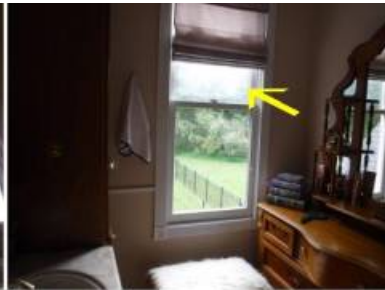
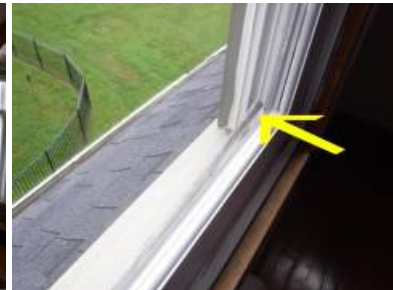
- Damage window mullion noted at 3rd floor rear window in room at top of stairs (farthest right window viewed from interior) Recommend repair by a qualified window specialist to prevent worsening conditions.

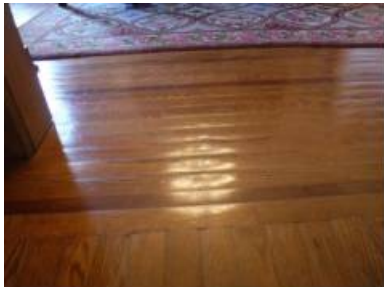
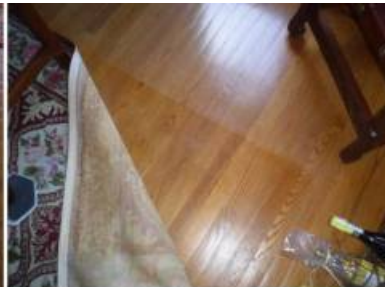
- Wood flooring. Some cupping noted at entrance to dining room from foyer. Faded finish noted under rug at dining room. These are cosmetic defects and can be corrected as needed by a qualified contractor.
