CCR Unit: SCA #2 Ash Landfill

Owner: Sunnyside Cogeneration Associates

Annual Inspection: January 2022

This annual inspection has been completed by S. Scott Carlson, PE 187727 in accordance with CCR Rules § 257.84 (b) and Utah State code R315-319-84.

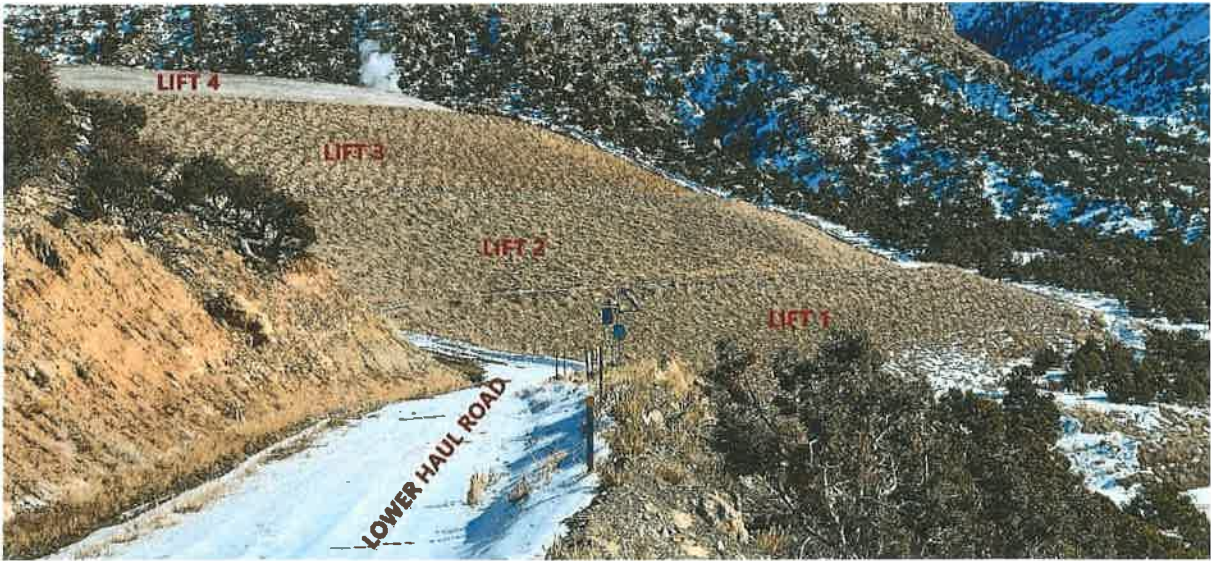
SCA#2 Ash Landfill –looking southeasterly

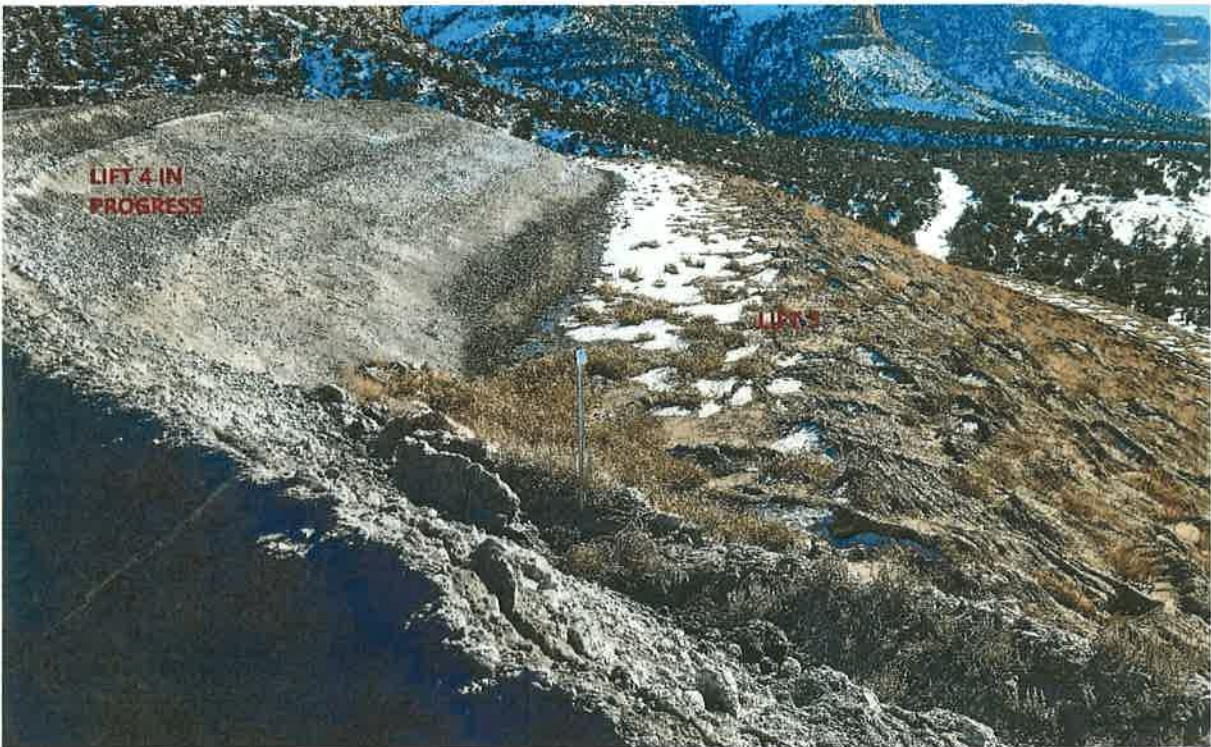
SCA#2 Ash Landfill – west face looking southerly
Lift #3 covered and seeded. Lift #4 in progress

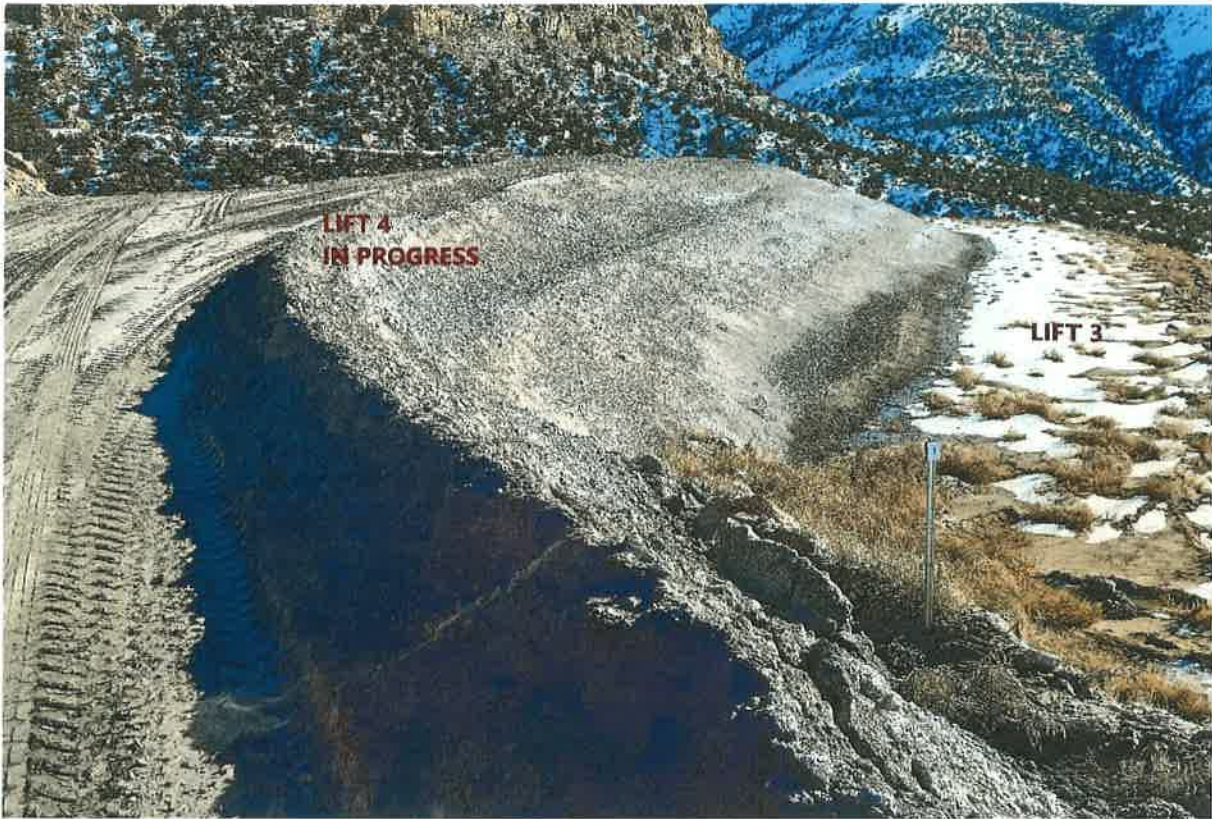
Surface of Lift #4 in process – photo looking south-southeast

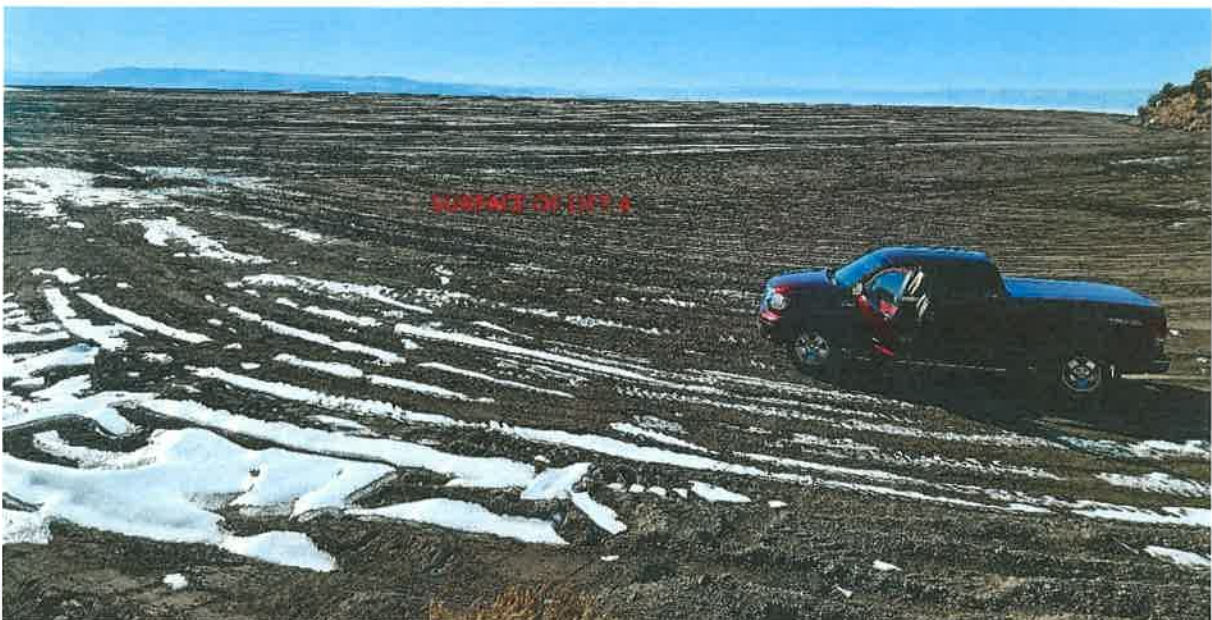
Surface of Lift #4 in process – photo looking northwesterly
Compaction appears satisfactory. Dust suppression appears satisfactory
Surface slopes east towards the hill to prevent storm water run-on

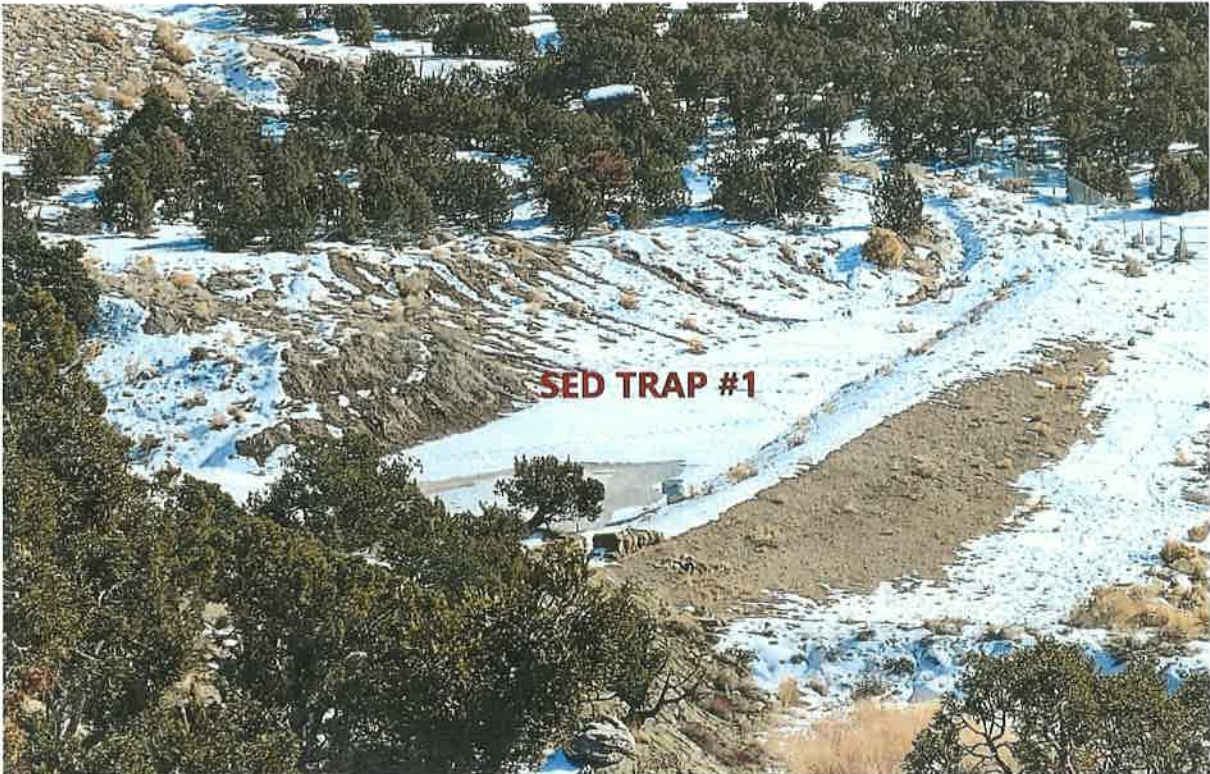
Sediment Trap #1 is empty and clean
water flows from trap to pond 018 in normal open condition

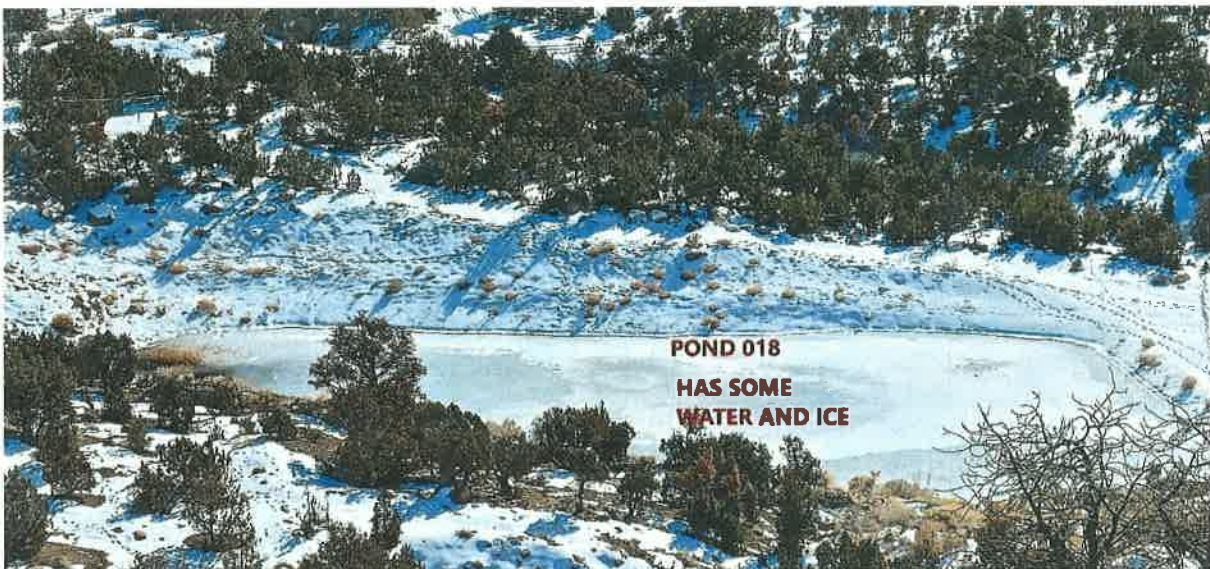
Sediment Pond 018, located west of Sed Trap #1 – photo looking westerly
Pond has water with a surface ice layer and recent snow cover.
No discharge in 2021
