Country Club Ridge Condominiums

Level 1 Reserve Study

Report Period – 01/01/2021 – 12/31/2021

Executive Summary – Country Club Ridge Condominiums – ID # 18677

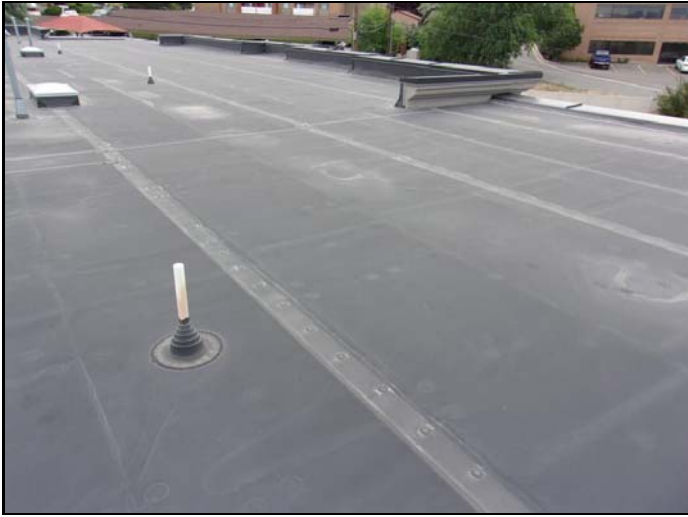
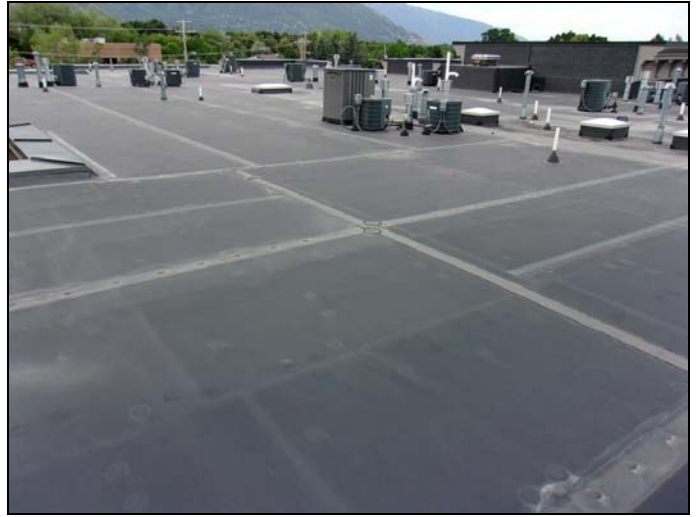
Comp #: 104 Flat Roof - Replace

Location: **Building Roof**

The flat roof is generally in good condition. We recommend funding to replace this component approximately every 20 - 25 years. Remaining life based on current age.

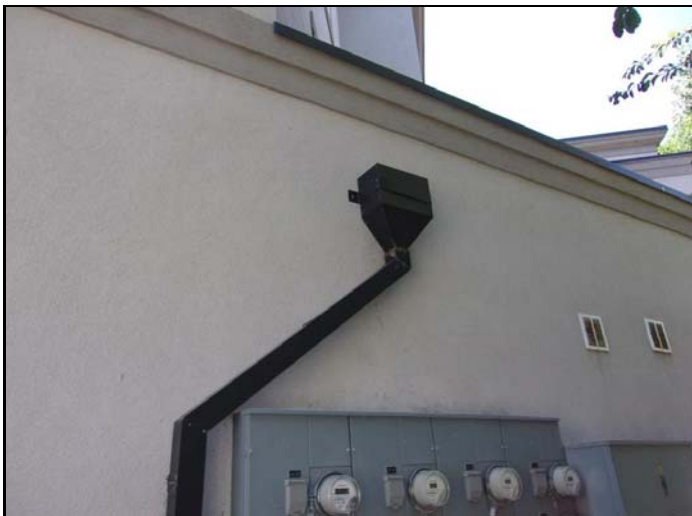
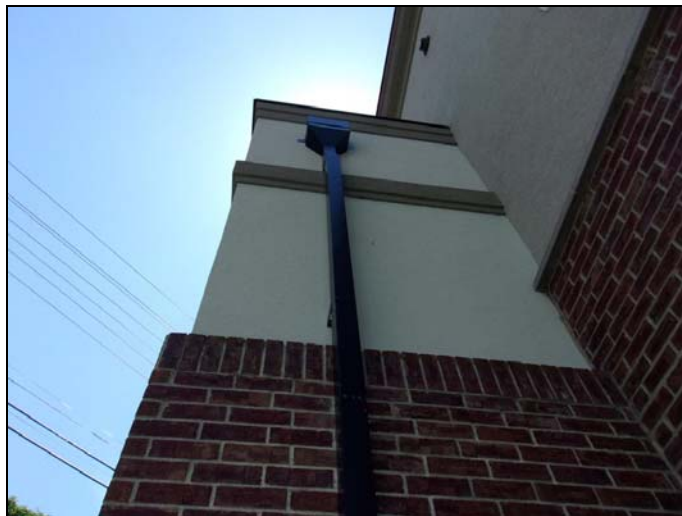
Comp #: 120 Rain Gutters/Downspouts - Replace

Location: **Building Exterior**

The rain gutters and downspouts are in good condition. We recommend funding to replace this component approximately every 25 - 30 years. Remaining life based on current age.

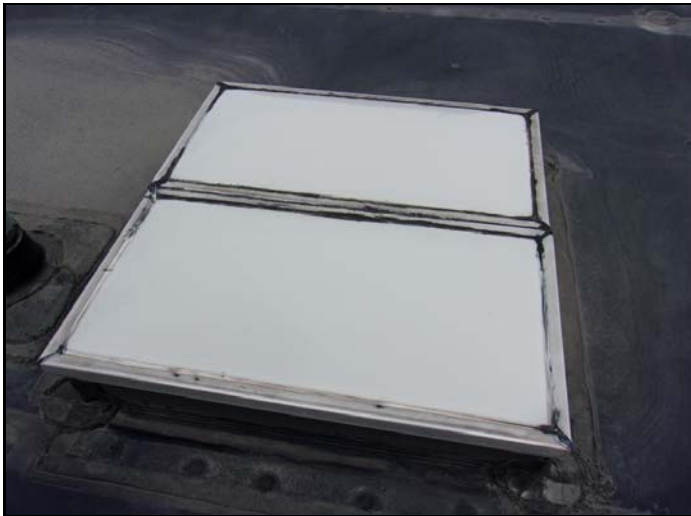
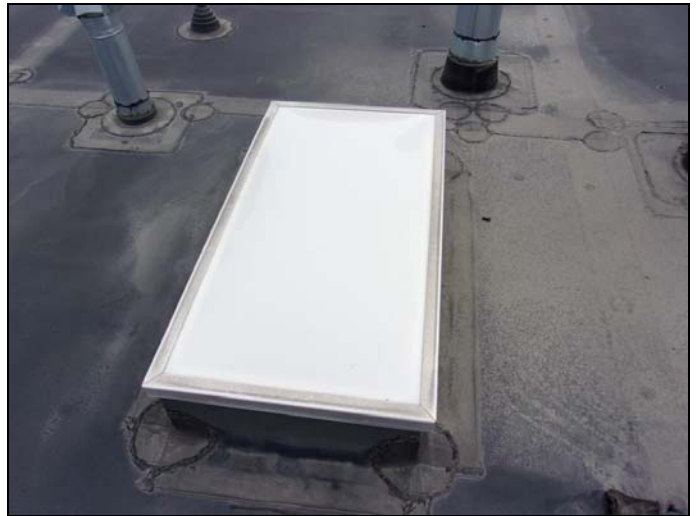
Comp #: 190 Skylights - Replace

Location: **Building Roof**

The skylights appear to be in good to fair condition. We recommend funding to replace this component approximately every 15 - 20 years.

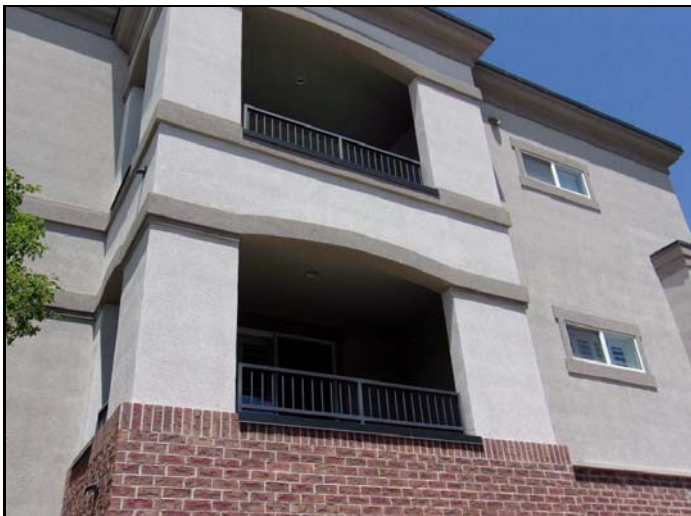
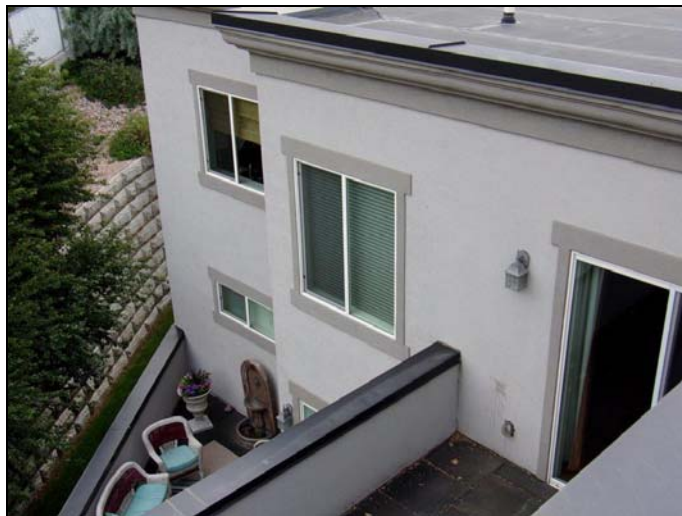
Comp #: 201 Stucco Surfaces - Repair/Repaint

Location: **Building Exterior**

The stucco surfaces are in good condition. We recommend funding to repair/repaint this component approximately every 12 - 15 years. Remaining life based on current age.

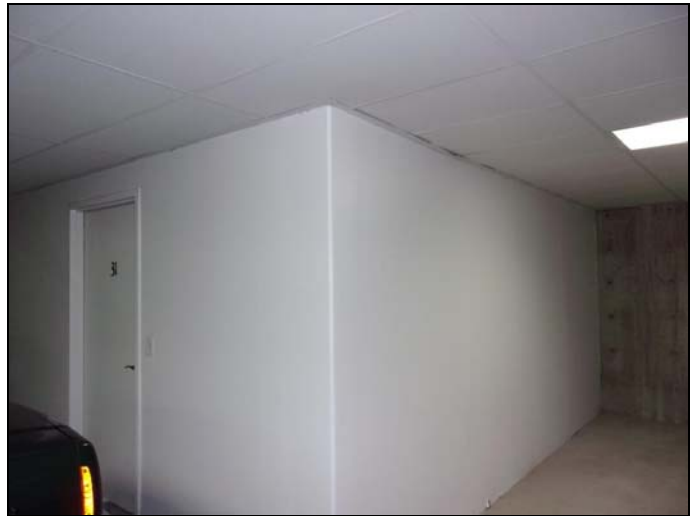
Comp #: 203 Parking Garage Surfaces - Repaint

Location: **Parking Garage**

The painted garage interior surfaces are in fair to poor condition. We recommend funding to repaint this component approximately every 10 - 12 years. Remaining life based on current age.

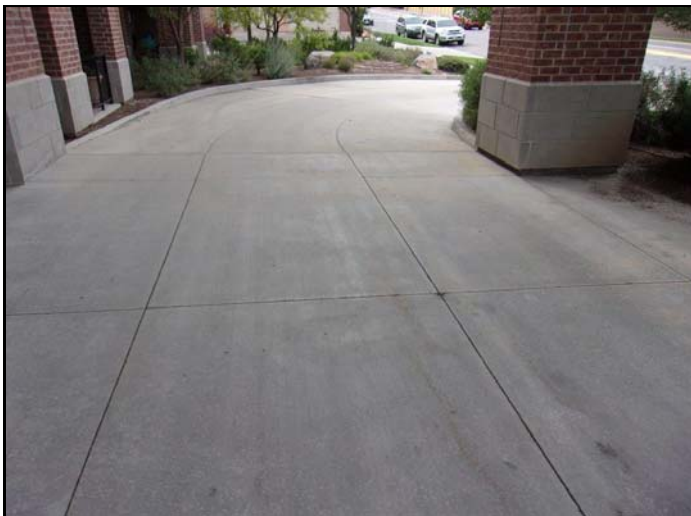
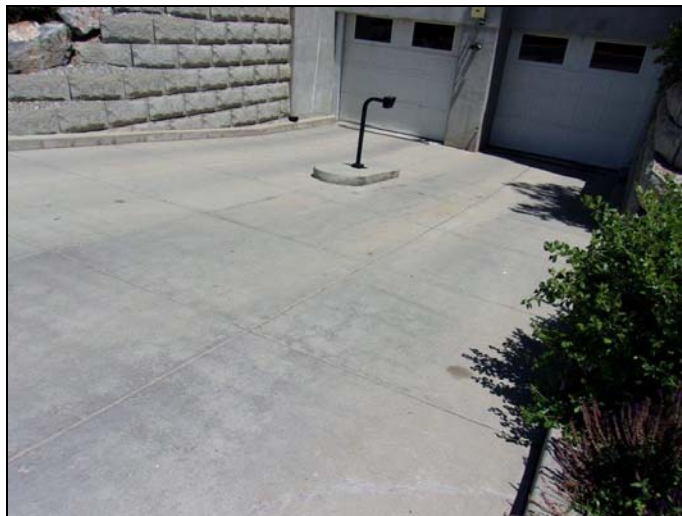
Comp #: 403 Concrete - Partial Repair/Replace

Location: **Common Area**

The concrete is in good condition. This component has an extended useful life under normal conditions. We recommend funding to make repairs and partially replace this component approximately every 10 years. Remaining life based on current age.

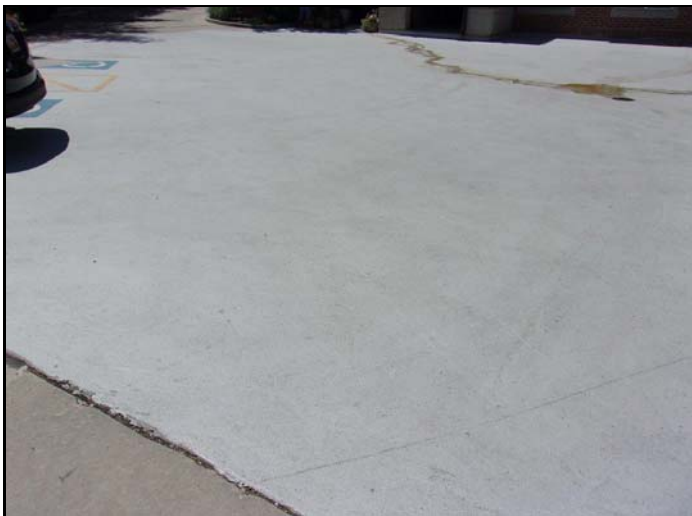
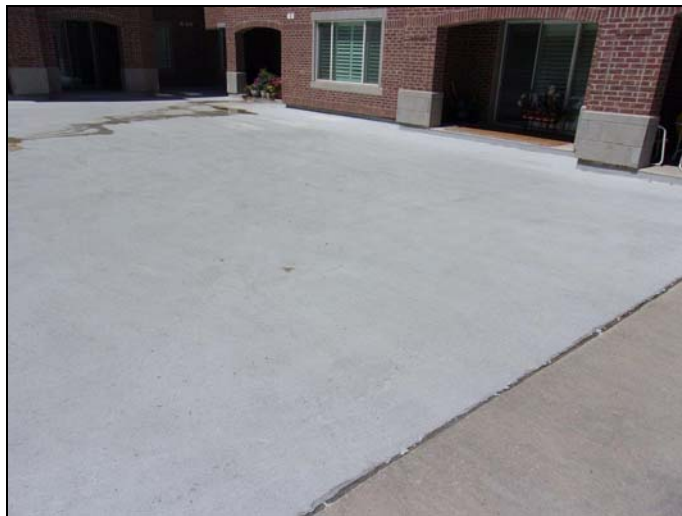
Comp #: 490 Concrete Waterproofing - Replace

Location: **Common Area**

The concrete waterproofing is in good condition. We recommend funding to replace this component approximately 10 - 12 years. Remaining life based on current age.

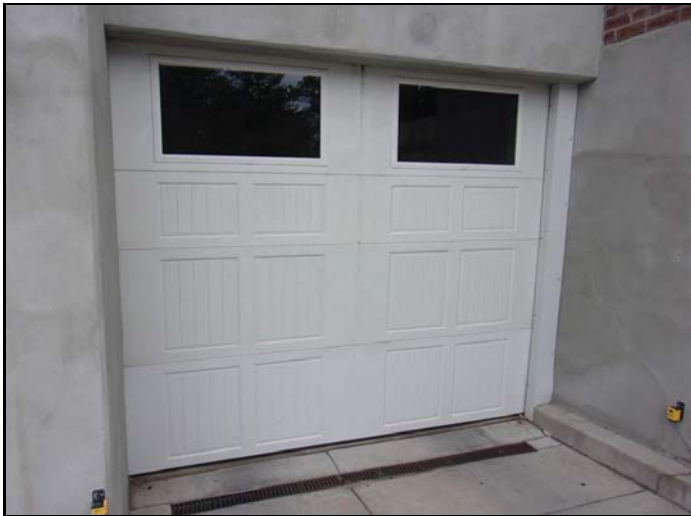
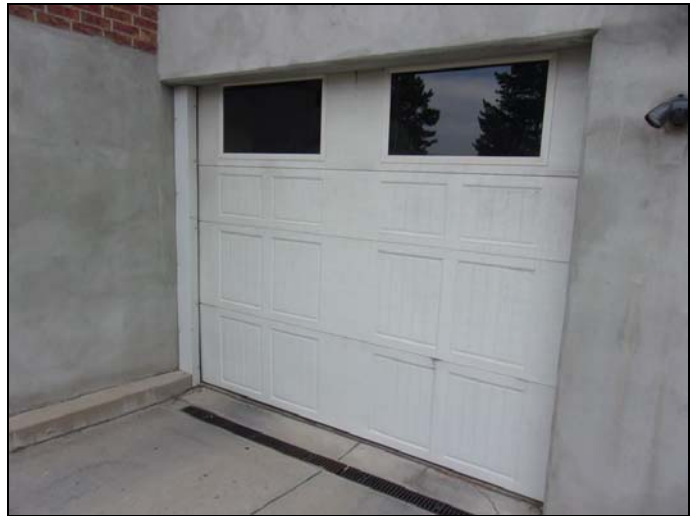
Comp #: 502 Garage Doors - Replace

Location: **Parking Garage Entrance**

The garage doors are in good condition. We recommend funding to replace this component approximately every 20 years. Remaining life based on current age.

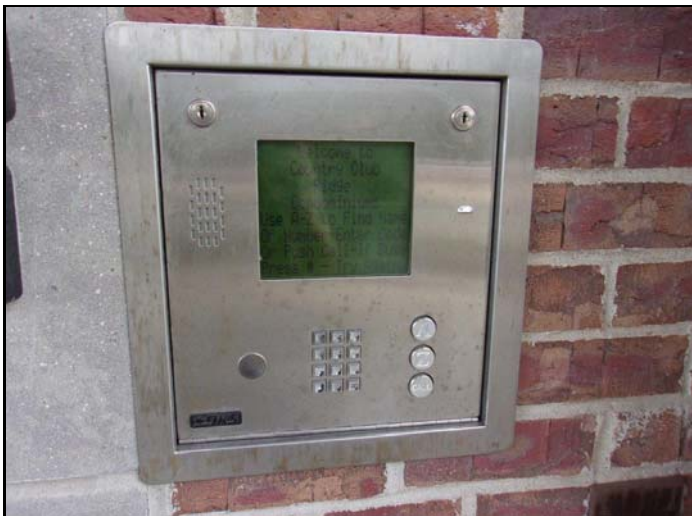
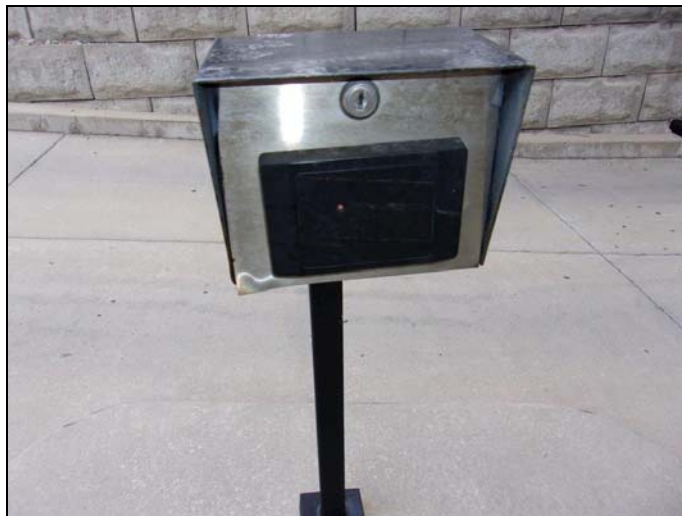
Comp #: 508 Access Control System - Replace

Location: **Building Entrances**

The access control system is in working condition. We recommend funding to replace this component approximately every 10 - 12 years. Remaining life based on current age and condition.

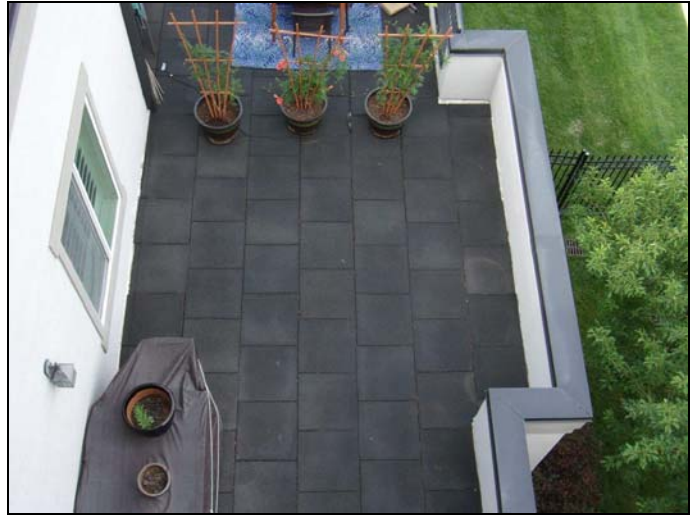
Comp #: 604 Decks - 2009 - Resurface

Location: Unit Decks

Unable to inspect this component at the time of the site visit. Research with the client reveals this component is in good condition. We recommend funding to resurface this component approximately every 15 - 20 years. Remaining life based on current age.

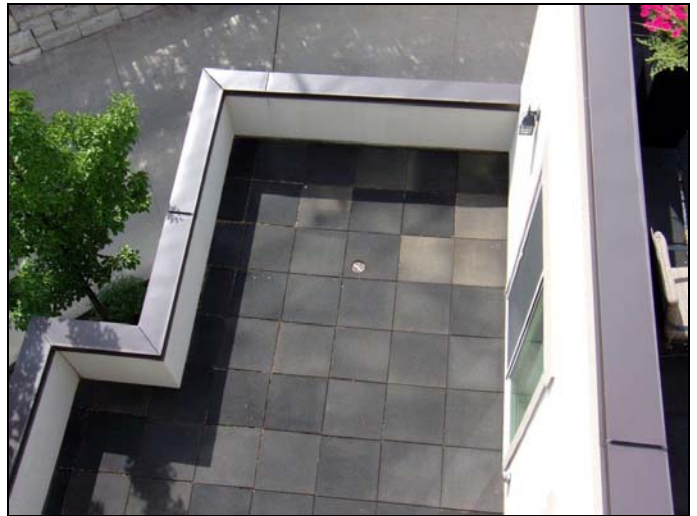
Comp #: 604 Decks - 2019 - Resurface

Location: **Unit Decks**

Unable to inspect this component at the time of the site visit. Research with the client reveals this component is in good condition. We recommend funding to resurface this component approximately every 15 - 20 years. Remaining life based on current age.

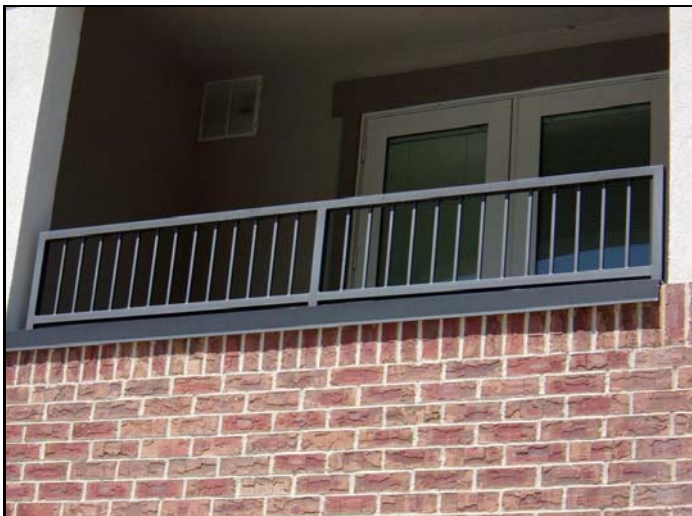
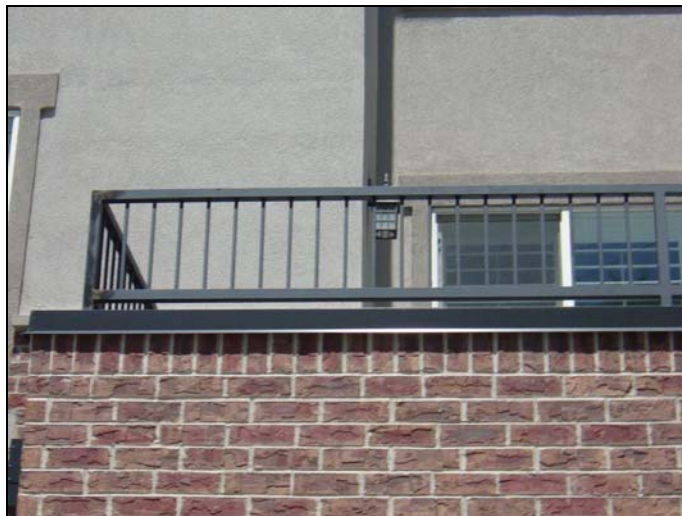
Comp #: 690 Deck Railing - Replace

Location: Unit Decks

The deck railing is in good condition. We recommend funding to replace this component approximately every 40 - 50 years. Remaining life based on current age.

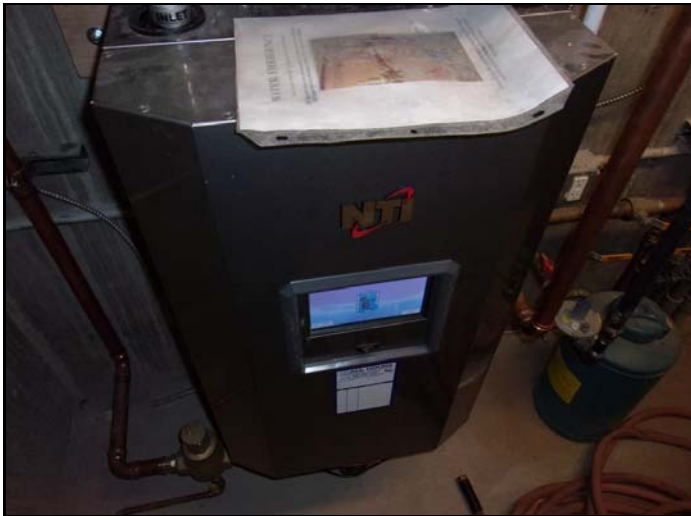
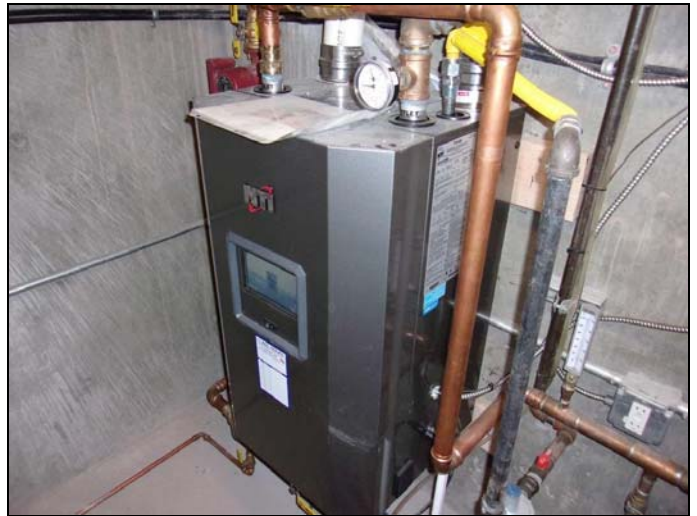
Comp #: 702 Boiler - Replace

Location: **Parking Garage**

The boiler system is in working condition. We recommend funding to replace this component approximately every 20 - 25 years. Remaining life based on current age.

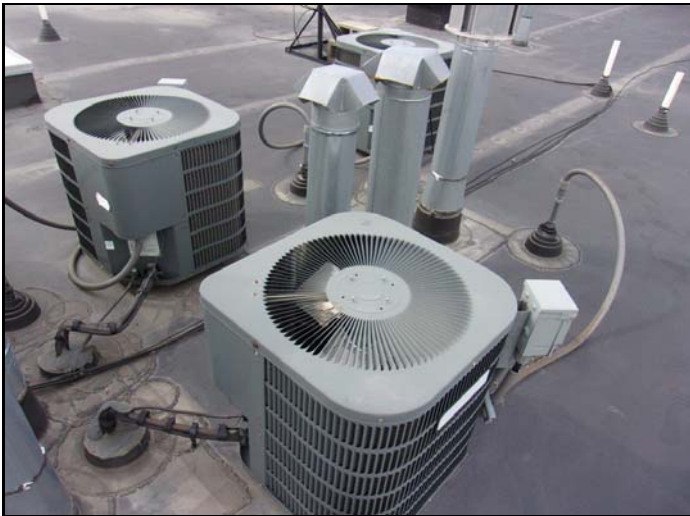
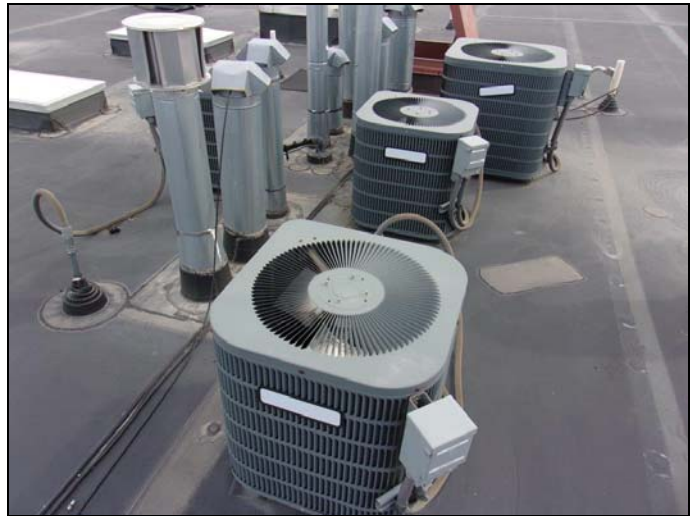
Comp #: 705 HVAC Condensers - Replace

Location: **Building Roof**

The HVAC condenser is in working condition. We recommend replacing this component approximately every 20 years. Remaining life based on current age.

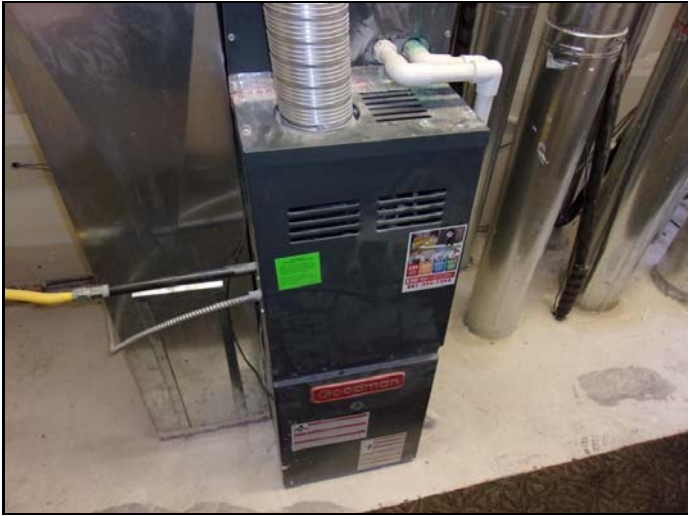
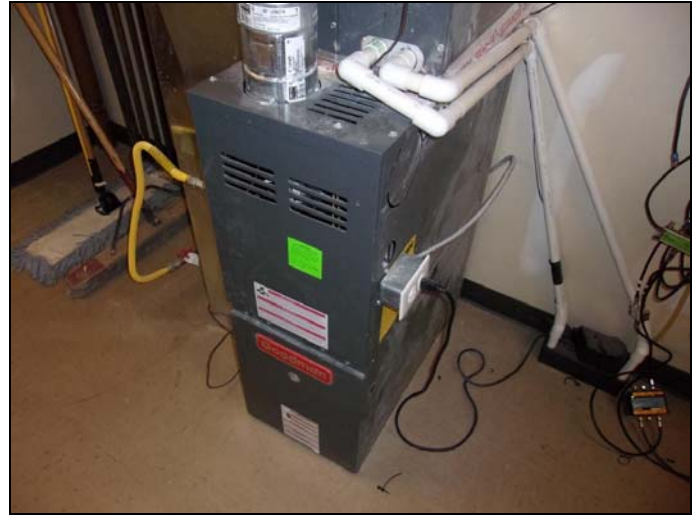
Comp #: 706 HVAC Furnaces - Replace

Location: **Mechanical Rooms**

The HVAC condenser is in working condition. We recommend replacing this component approximately every 20 years. Remaining life based on current age.

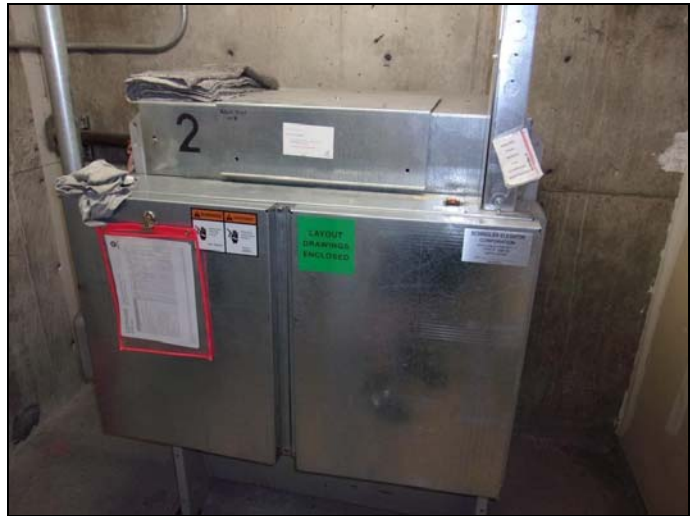
Comp #: 707 Elevators - Modernize

Location: **Building Interior**

The elevators are in working condition. We recommend funding to modernize this component approximately every 25 - 30 years. Modernization consists of controller replacement, door package upgrade, and control panel replacement. Remaining life based on current age.

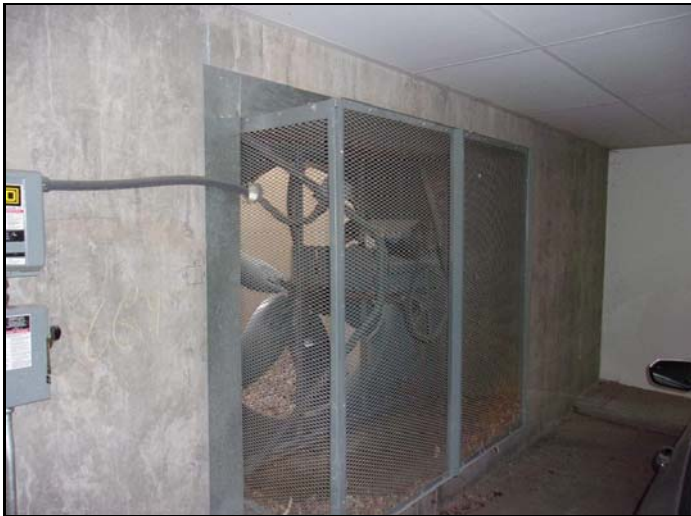
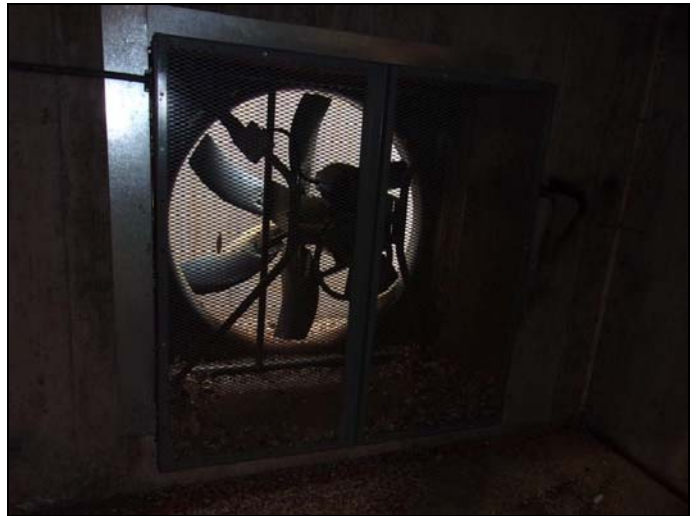
Comp #: 714 Exhaust Fans - Replace

Location: **Parking Garage**

Due to the minimal cost of maintaining and replacing this component, reserve funding is not appropriate. Repair and replace as necessary as an operating expense. No reserve funding necessary.

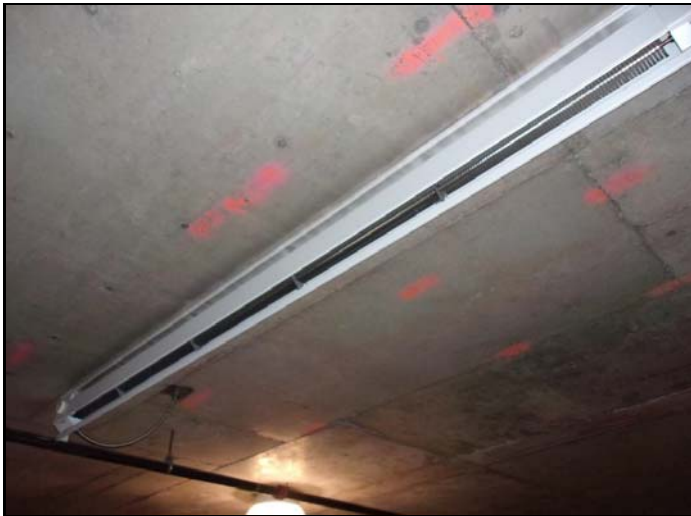
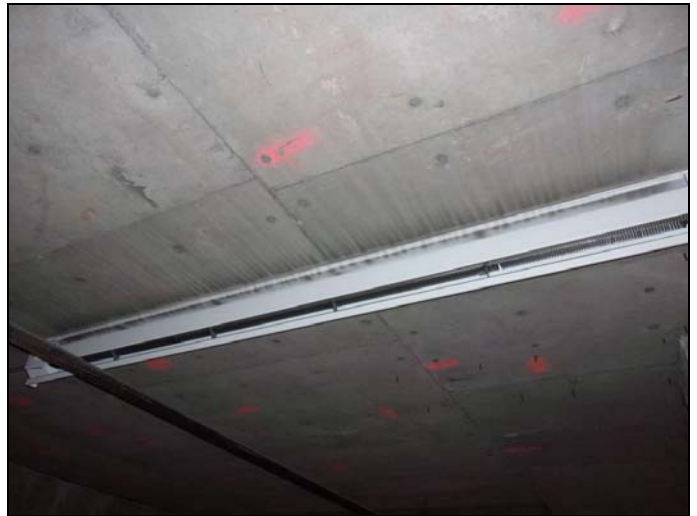
Comp #: 717 Garage Heaters - Replace

Location: **Parking Garage**

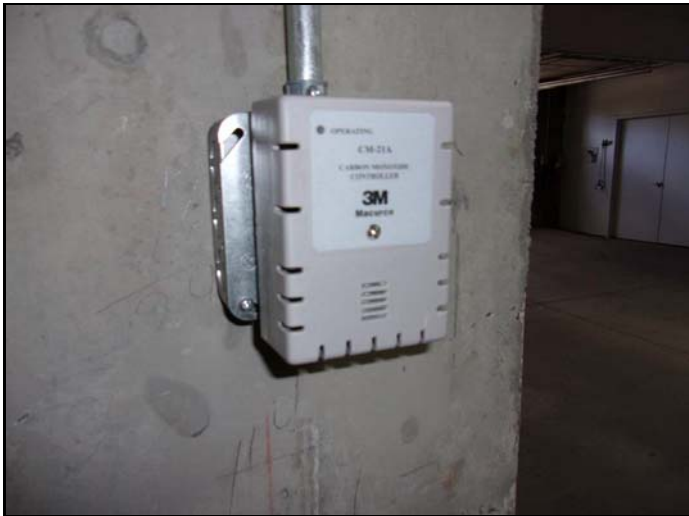
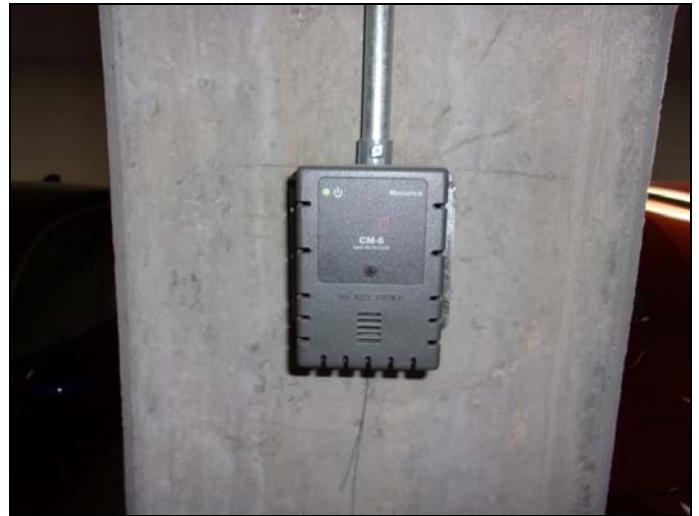
Comp #: 790 Carbon Monoxide Detectors - Replace

Location: **Parking Garage**

Research with the client reveals this component is replaced as necessary as an operating expense.

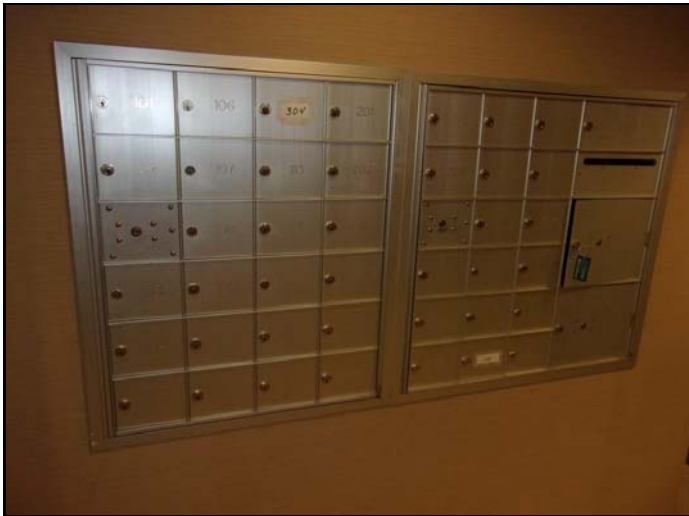
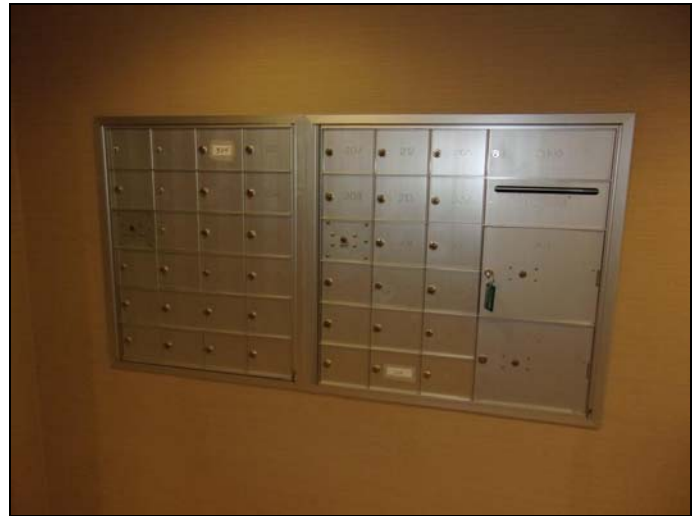
Comp #: 803 Mailboxes - Replace

Location: **Building Interior**

The mailboxes are in good condition. We recommend funding to replace this component approximately every 25 - 30 years. Remaining life based on current age.

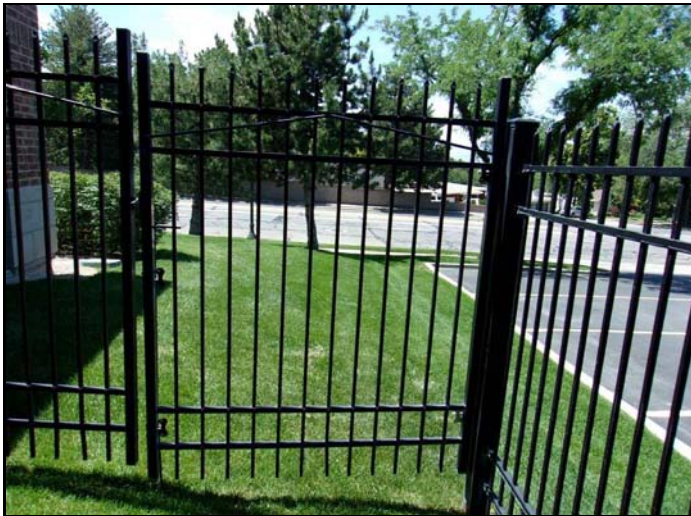
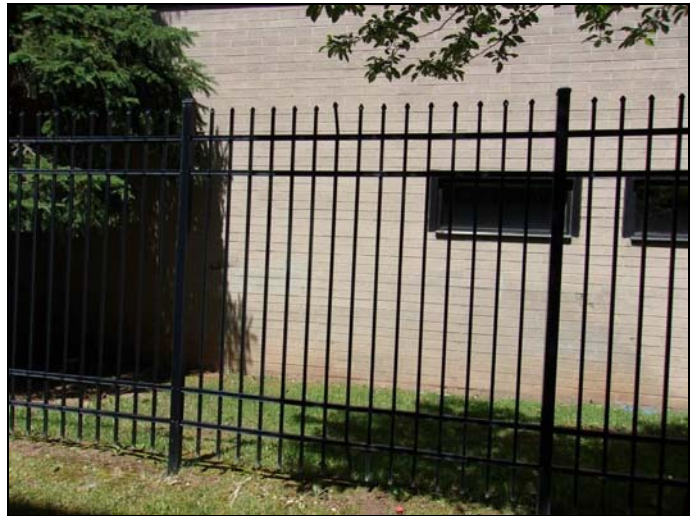
Comp #: 1002 Metal Fencing - Replace

Location: **Community Perimeter**

The metal fencing is in good condition. We recommend funding to replace this component approximately every 40 - 50 years. Remaining life based on current age.

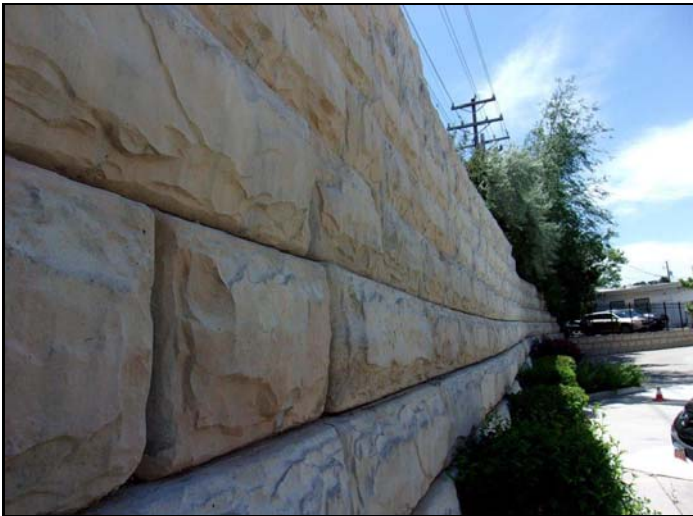
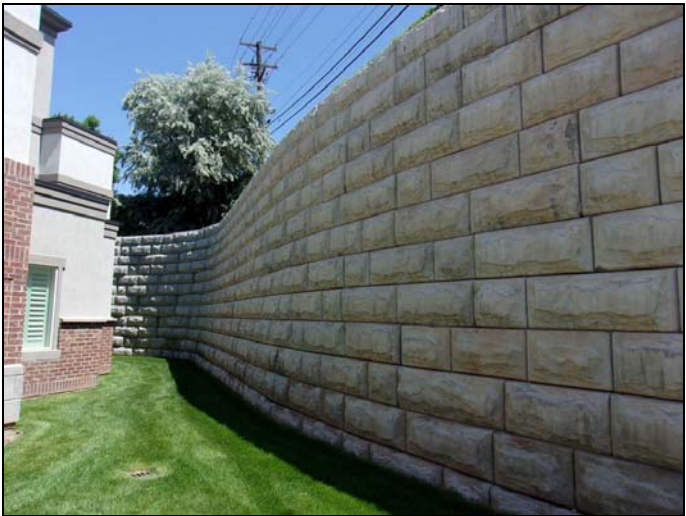
Comp #: 1011 Retaining Wall - Repair

Location: **Common Area**

This component has an extended useful life under normal conditions. No reserve funding necessary.

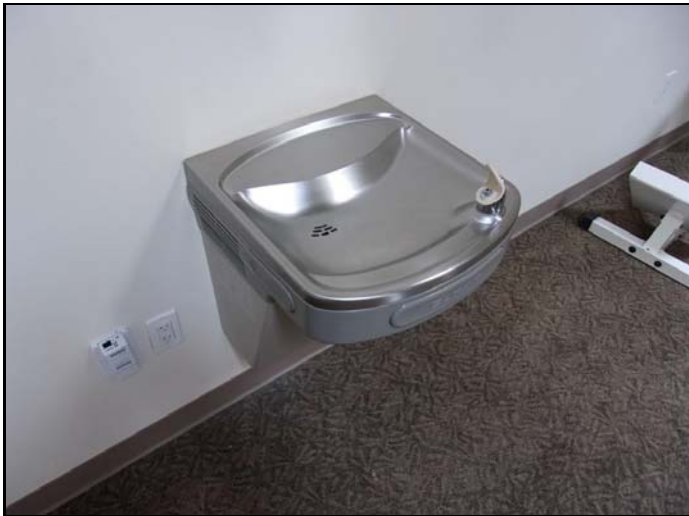
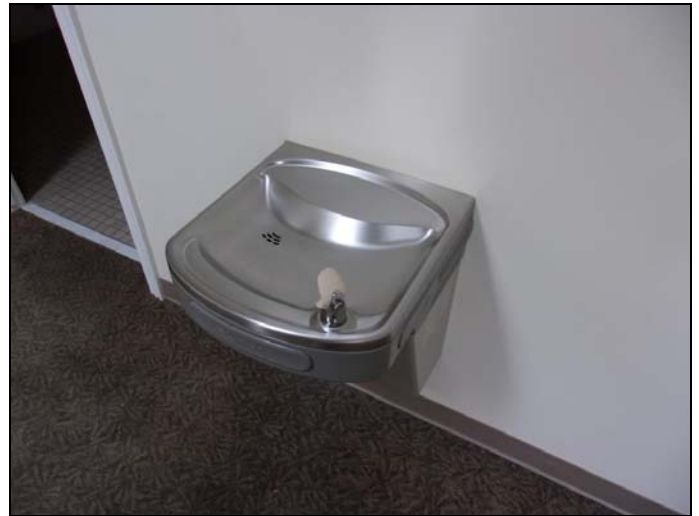
Comp #: 1304 Drinking Fountain - Replace

Location: **Building Interior**

The drinking fountain is in working condition. We recommend funding to replace this component approximately every 15 - 20 years. Remaining life based on current age.

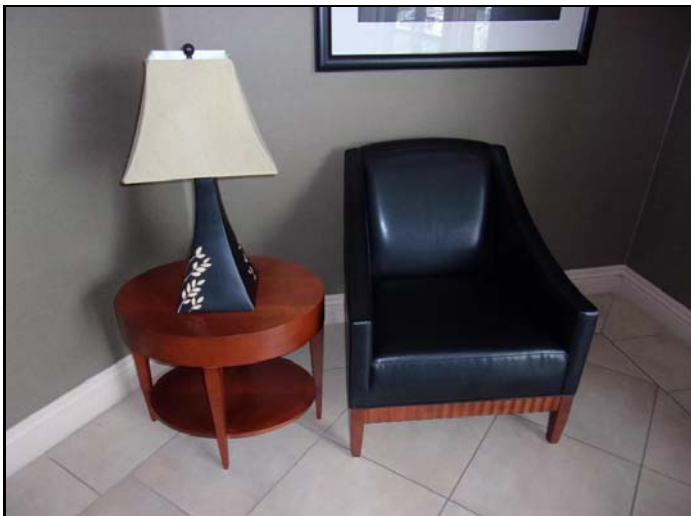
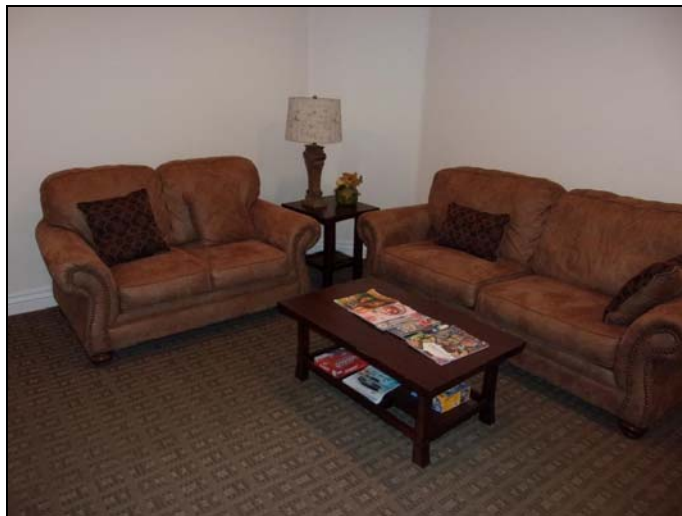
Comp #: 1405 Furniture - Replace

Location: **Building Interior**

The furniture is in good condition. We recommend funding an allowance to make replacements approximately every 10 years. Remaining life based on current age.

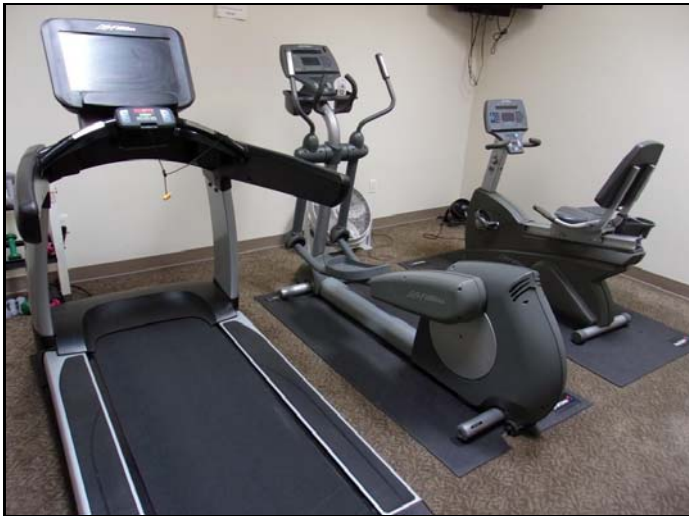
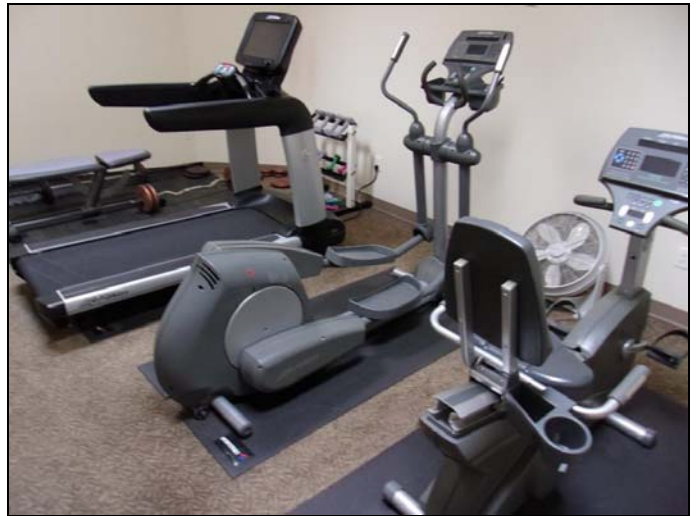
Comp #: 1406 Fitness Equipment - Replace

Location: **Fitness Room**

The fitness equipment is in working condition. We recommend funding to replace this component approximately every 10 years. Remaining life based on current age.

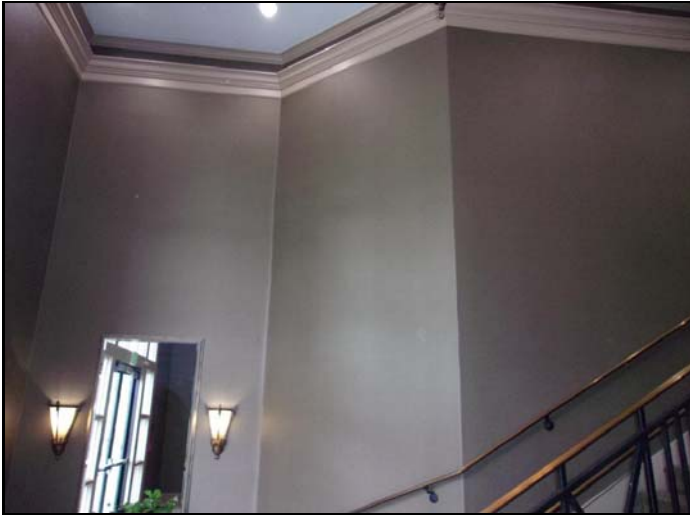
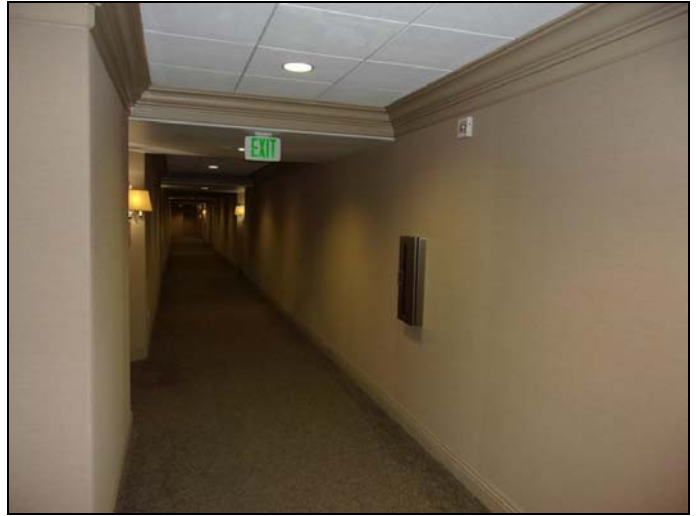
Comp #: 1421 Wall Paper - Replace

Location: **Building Interior**

The wall paper is in good condition. Typically we recommend funding to replace this component approximately every 12 - 15 years, but due to low traffic we recommend funding to replace this component approximately every 20 - 25 years. Remaining life based on current age.

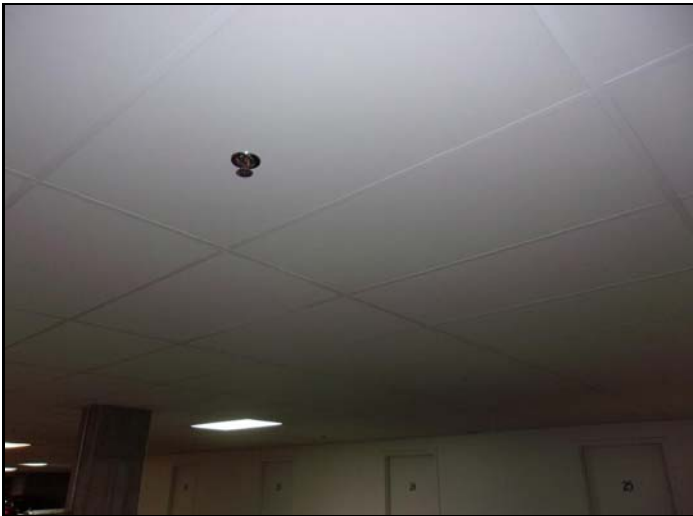
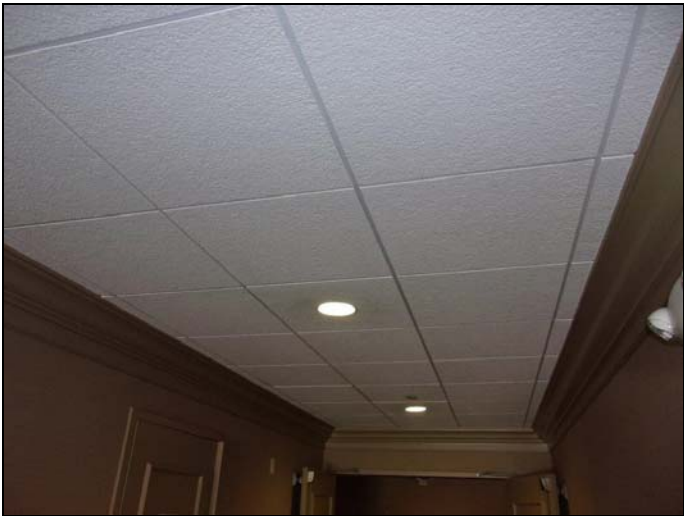
Comp #: 1490 Ceiling Tiles - Replace

Location: **Building Interior**

Research with the client reveals this component is replaced as necessary as an operating expense.

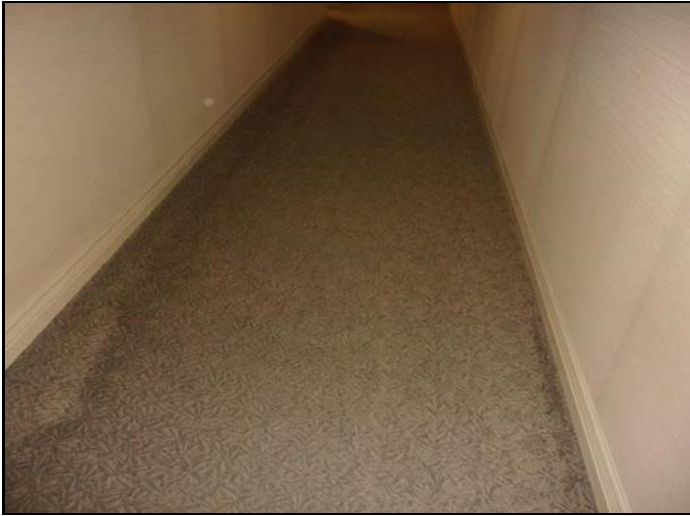
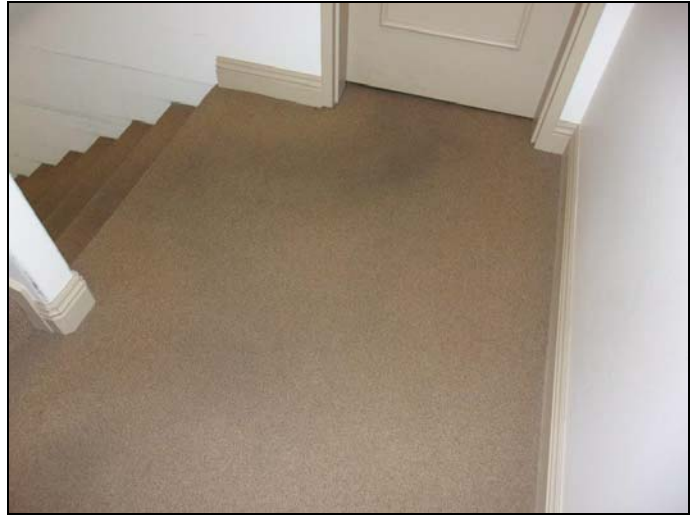
Comp #: 1501 Carpeting - Replace

Location: **Building Interior**

The carpeting is generally in fair condition. Typically we recommend funding to replace this component approximately every 8 - 10 years, but due to low traffic we recommend funding to replace this component approximately every 15 - 20 years. Remaining life based on current age.

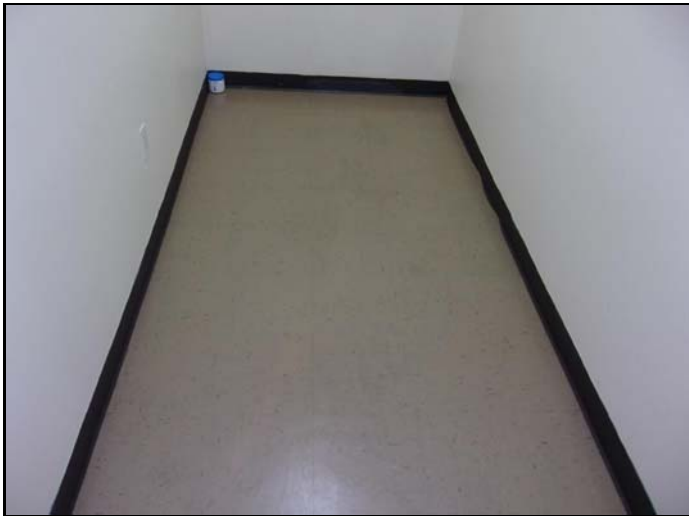
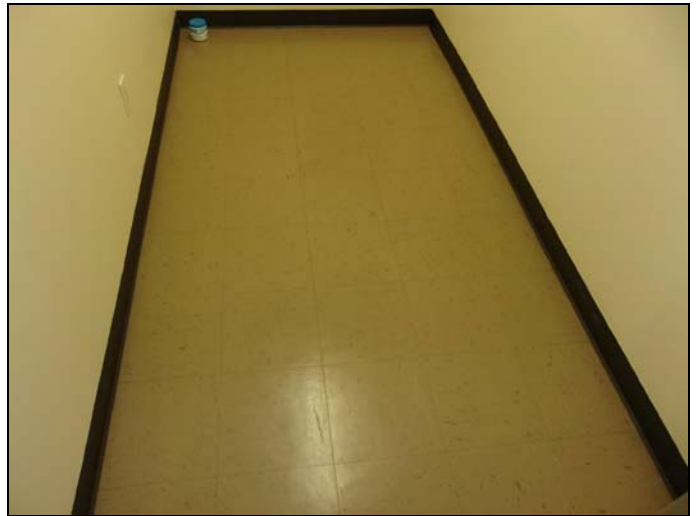
Comp #: 1502 Linoleum Flooring - Replace

Location: **Trash Rooms**

The linoleum flooring is in good condition. We recommend funding to replace this component approximately every 25 - 30 years. Remaining life based on current age.

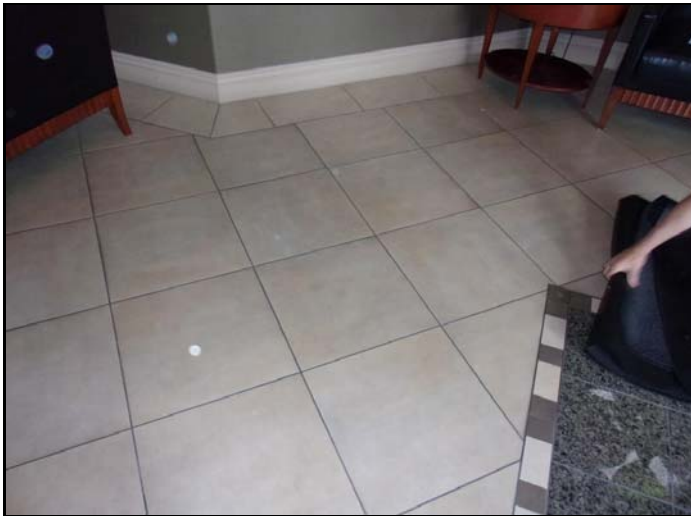
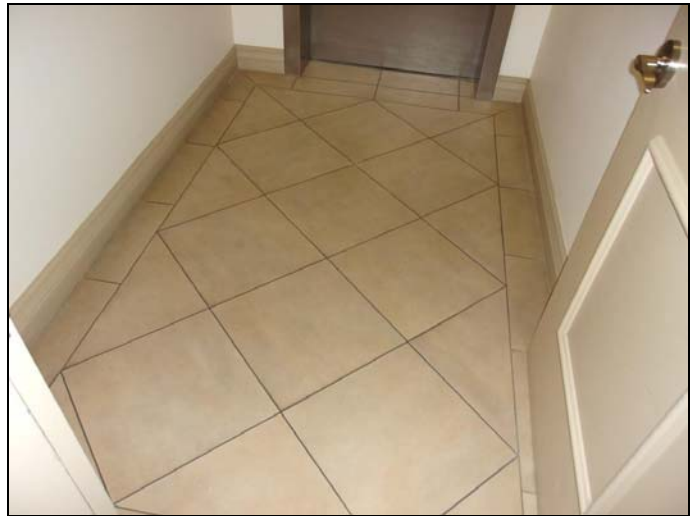
Comp #: 1503 Tile Flooring - Replace

Location: **Building Interior**

The tile flooring is in good condition. We recommend funding to replace this component approximately every 30 years. Remaining life based on current age.

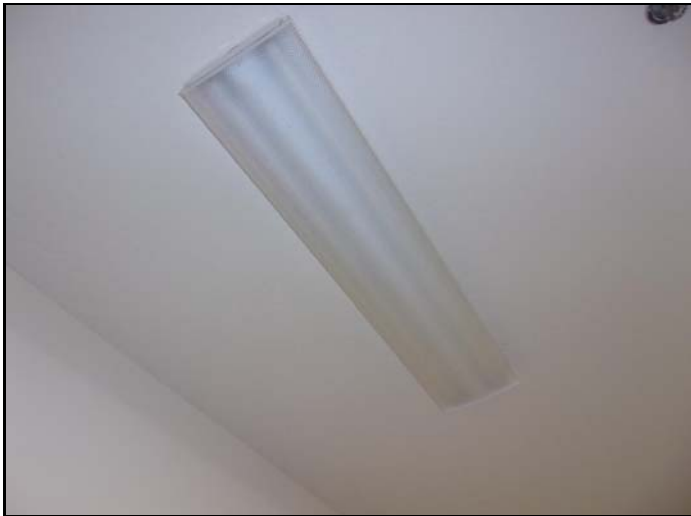
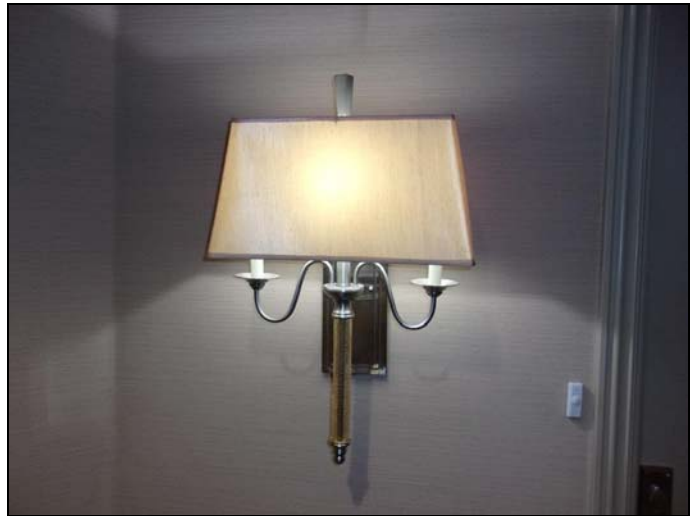
Comp #: 1601 Interior Light Fixtures - Replace

Location: **Building Interior**

The interior light fixtures are in good condition. We recommend funding to replace this component approximately every 20 - 25 years. Remaining life based on current age.
