Country Club Ridge Condominiums

Level 1 Reserve Study

Report Period – 01/01/2021 – 12/31/2021

Executive Summary – Country Club Ridge Condominiums – ID # 18677

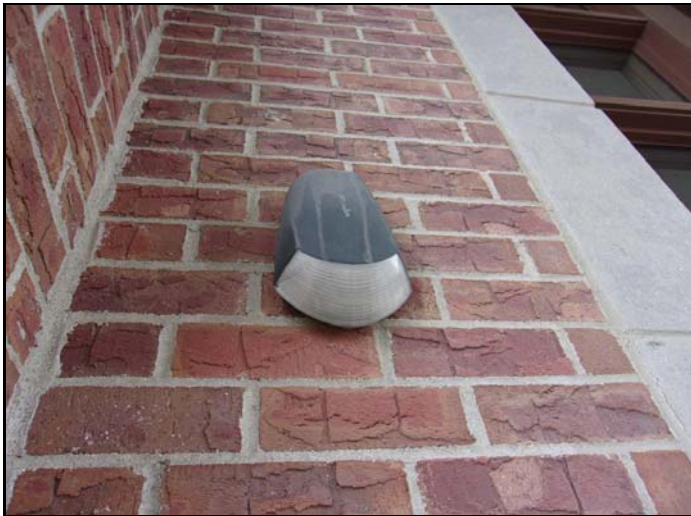
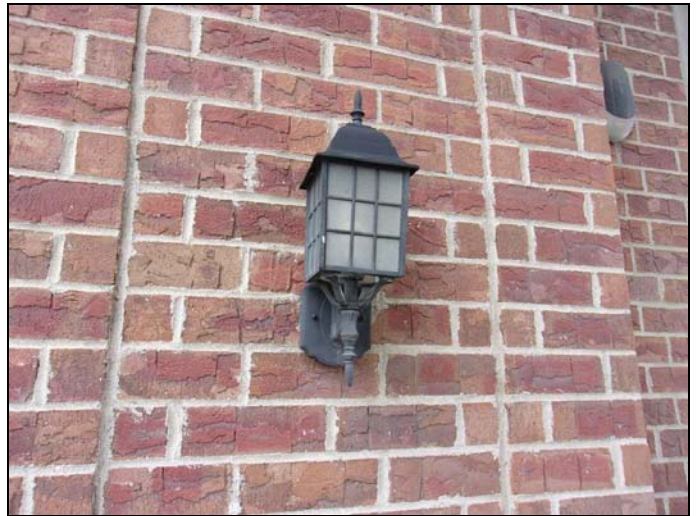
Comp #: 1602 Exterior Light Fixtures - Replace

Location: **Building Exterior**

The exterior light fixtures are in good condition. We recommend funding to replace this component approximately every 16 - 20 years. Remaining life based on current age.

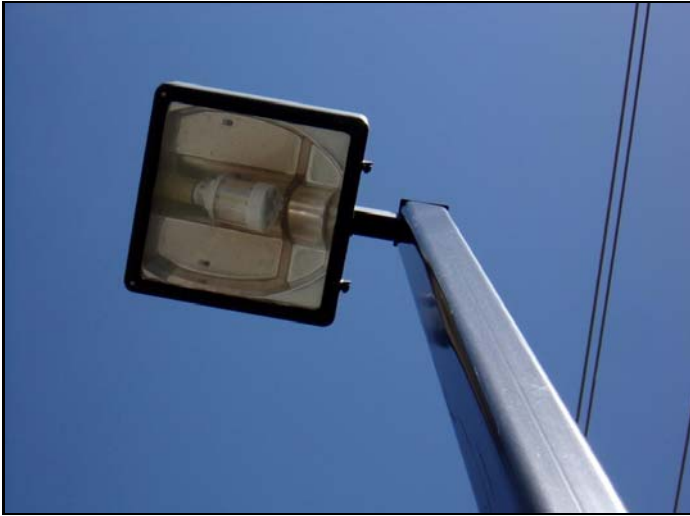
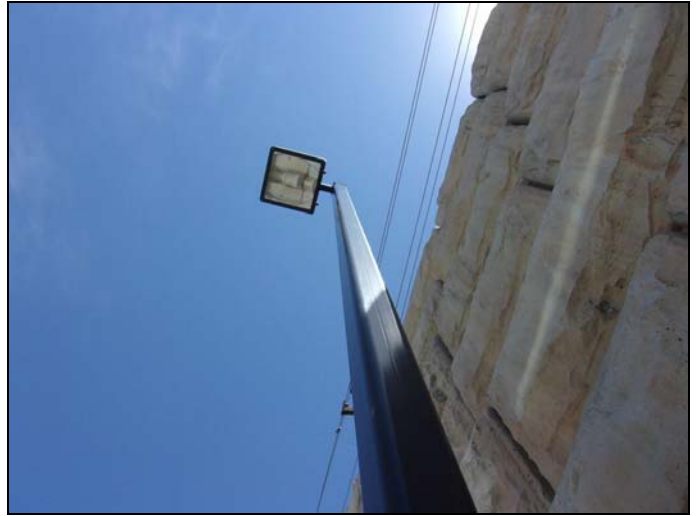
Comp #: 1609 Street Light Fixture - Replace

Location: Common Area

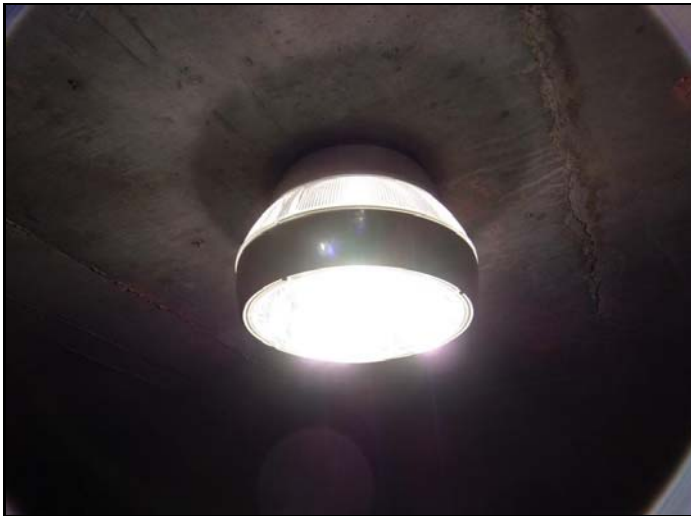
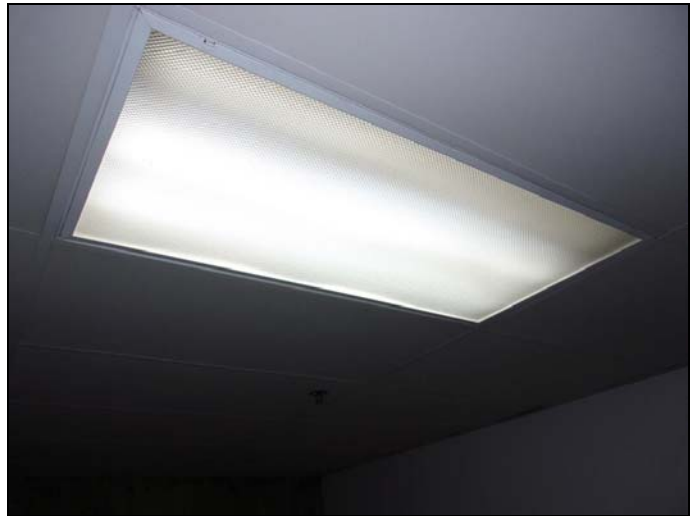
Comp #: 1690 Parking Garage Light Fixtures - Replace

Location: **Parking Garage**
