Complete Home Inspections

Home Buyer
Inspection Site: Somewhere in Georgia

REPORT SUMMARY

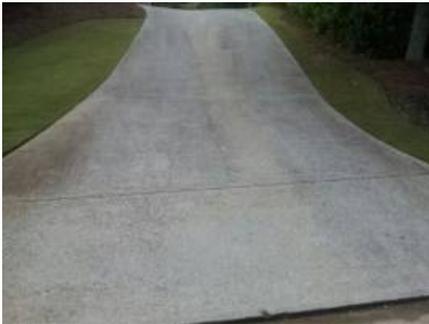
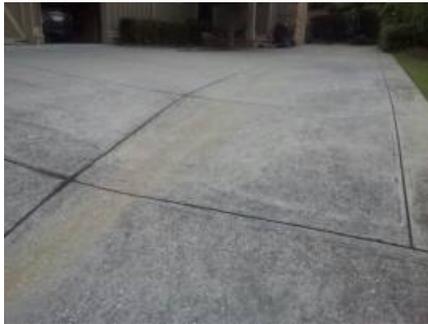
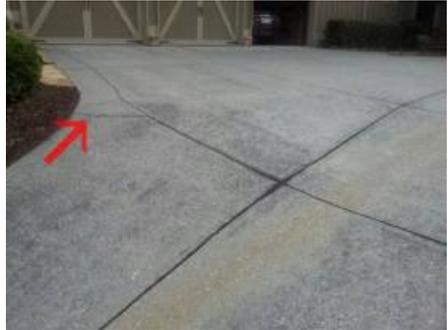
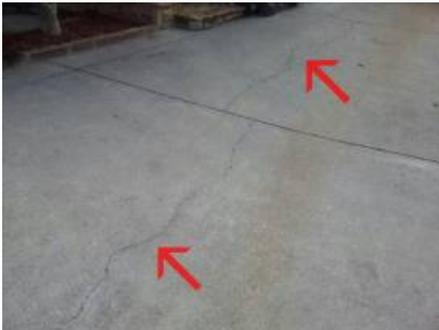
Common cracks were observed in the driveway. These are primarily a cosmetic concern. No immediate action is recommended, however I suggest sealing all cracks in surfaces to prevent water penetration as routine maintenance.

If the cracks shift or widen over time, further evaluation would be required.

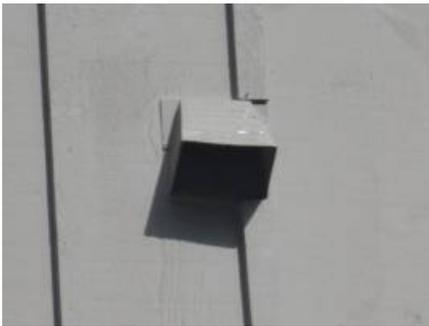
The vent flap on the outside vent on the rear of the home appears to be stuck open. This can lead to moisture and animal entry.

The vent flap on the outside vent on the rear of the home appears to be stuck open. This can lead to moisture and animal entry.

I recommend this be repaired.

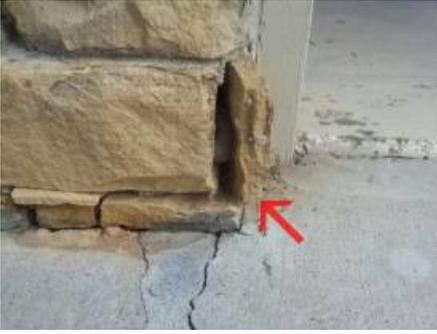
A piece of the stone work between the doors has been secured with silicon. The stone is loose.

A piece of the stone work between the doors has been secured with silicon. The stone is loose. I recommend cleaning and re-attaching with an exterior adhesive.

I recommend cleaning and re-attaching with an exterior adhesive.

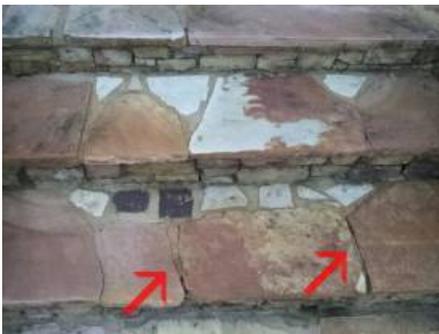
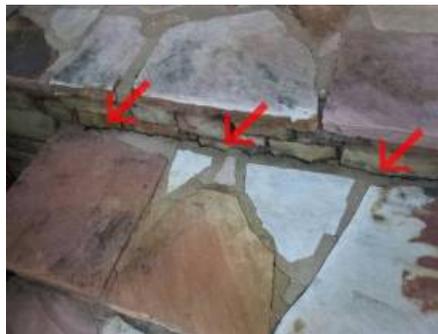
Front Steps Condition:

The stone steps have some loose stones and the mortar has started to crack and is loose. The steps have settled a little.

I recommend this be repaired by a qualified mason.

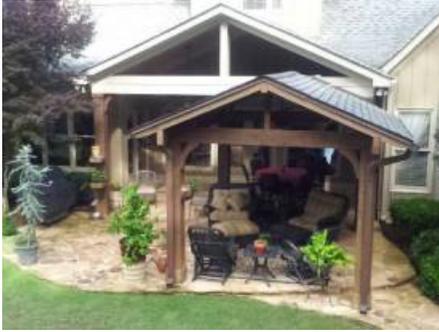
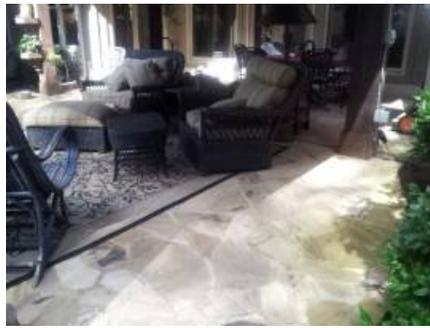
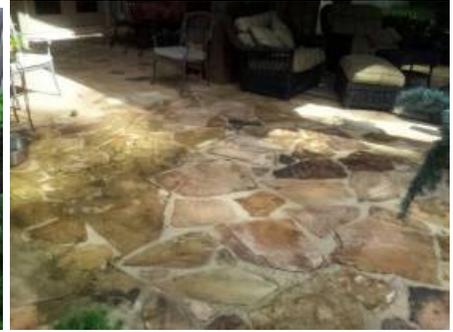
Appears to be in good condition, Cracks noted are typical. I recommend sealing the cracks with a good cement crack repair/epoxy.

If the cracks shift or widen over time, further evaluation would be required.

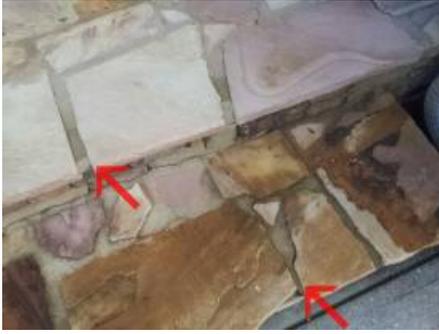
Some of the mortar is cracked and loose.

I recommend this be repaired by a qualified mason.

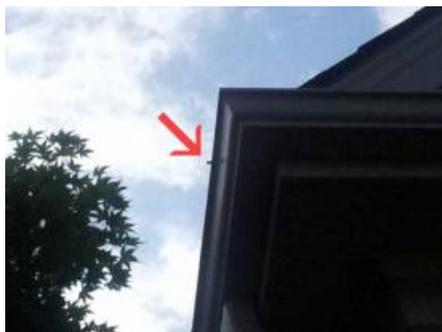
There was a nail coming out of gutter. This is very common for this type of gutter system.

There are full, complete gutters on the home. There was a nail coming out of gutter. This is very common for this type of gutter system.

I recommend removing nail, applying sealant and re-inserting nail.

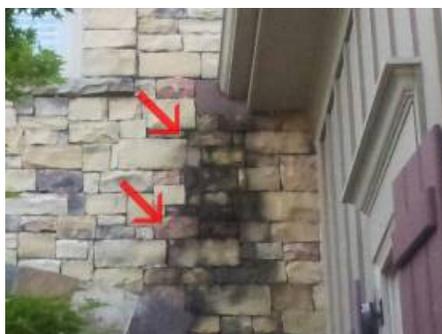
It appears the gutter to the right of the front door has overflowed and caused some staining on the stone.

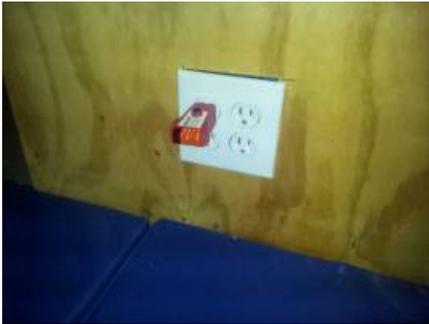
The basement outlets in the unfinished part of the basement are not ground fault protected. I recommend these be repaired by a qualified electrician.

The basement outlets in the unfinished part of the basement are not ground fault protected.

I recommend these be repaired by a qualified electrician.

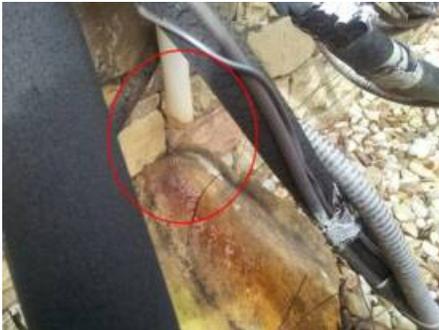
Condensate Line:

The condensation line is too close to the foundation wall. I recommend extending the condensate line out 2-3 feet from the foundation to prevent water from running down the foundation wall.

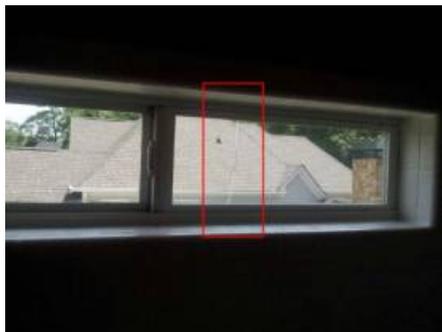
The small window over the bath tub in the upper bath room is broken. I recommend this be repaired.

The small window over the bath tub in the upper bath room is broken.

I recommend this be repaired.

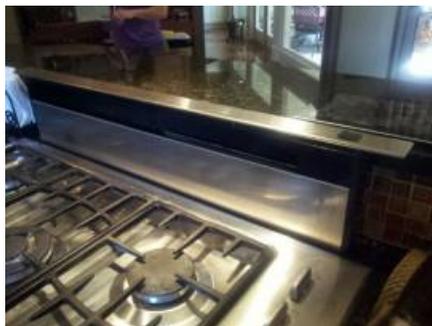
Unit vents to the outside of the home. The fan was tested and would not operate at first. It did operate after several attempts.

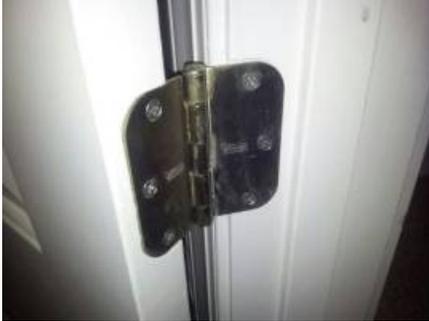
The front left bedroom door, bottom hinge was loose. Repair as required.

The front left bedroom door, bottom hinge was loose.

Repair as required.

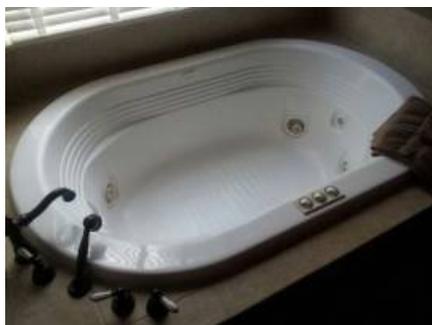
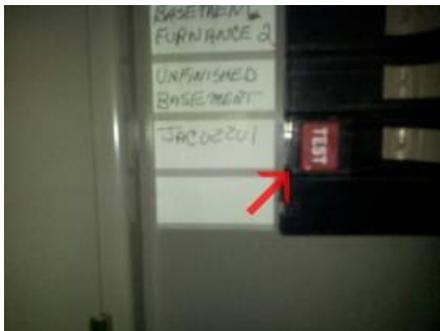
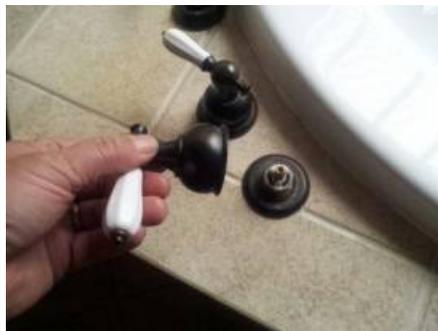
One of the faucet handles on the master tub was loose. Tighten as needed.

One of the faucet handles on the master tub was loose.

Tighten as needed.

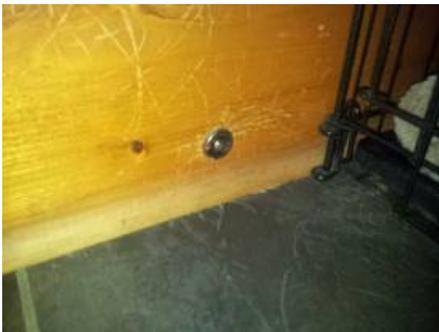
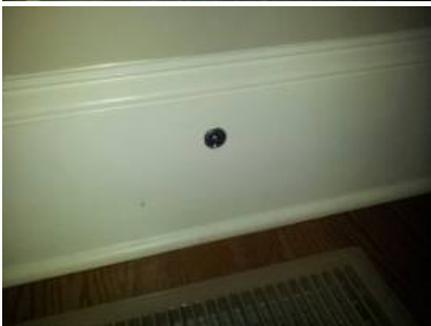
There were several door stops missing.
