## SAMPLE MARINE SURVEY

May 7, 2015

1929 N.J. Blanchard Boat company

*"BOAT NAME"*

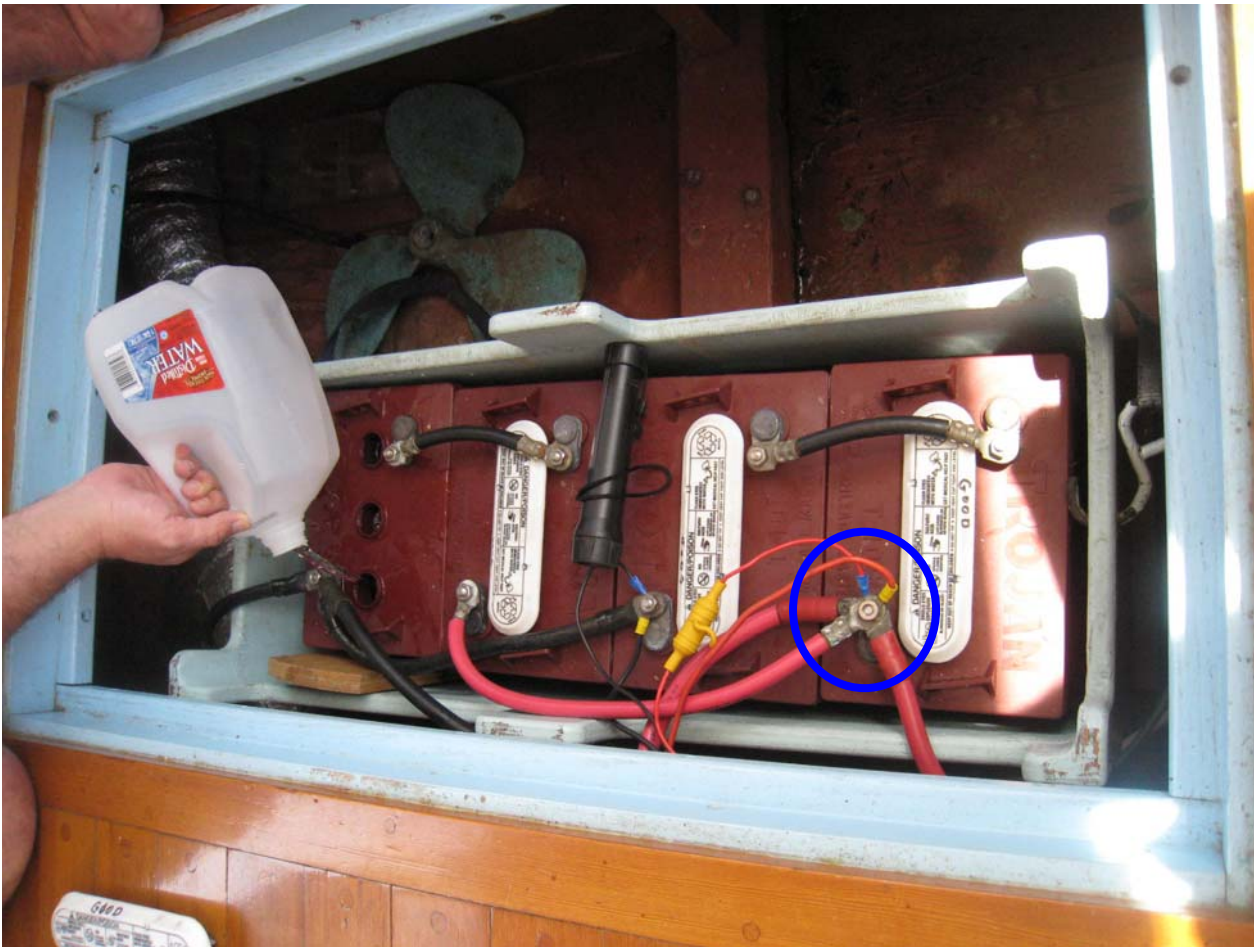
House service: Four (4) 6 volt batteries wired two each in series. House batteries appear be damaged due to gassing and loss of electrolyte from overcharging by the Trace battery charger. Once active battery material is allowed to dry out when the core is exposed, it is permanently lost. The batteries do not hold current without a charging source present for even a short period of time.

House battery bank being topped off with water. Per ABYC E-11. No more than four (4) terminals shall be mounted to a single battery stud.

It is recommended that each battery in the house bank be tested and replaced if necessary. The surveyor observed over one gallon of water from the boat's fresh water tanks added to top off the batteries. It is recommended that only distilled water be added to the batteries and never water from a possibly chlorinated source. The output of the Trace battery charger/inverter should be adjusted by a qualified marine electrician or replaced with a more modern unit. ABYC E-11 limits the number of terminals attached to a single battery post to four (4). One battery had five on a post. Remove one terminal to another positive battery post.

(§B-2) House batteries need testing and should be replaced if they fail to hold a charge under load. Battery charger/inverter needs adjustment or replacement with a more modern unit that will not over charge the batteries.

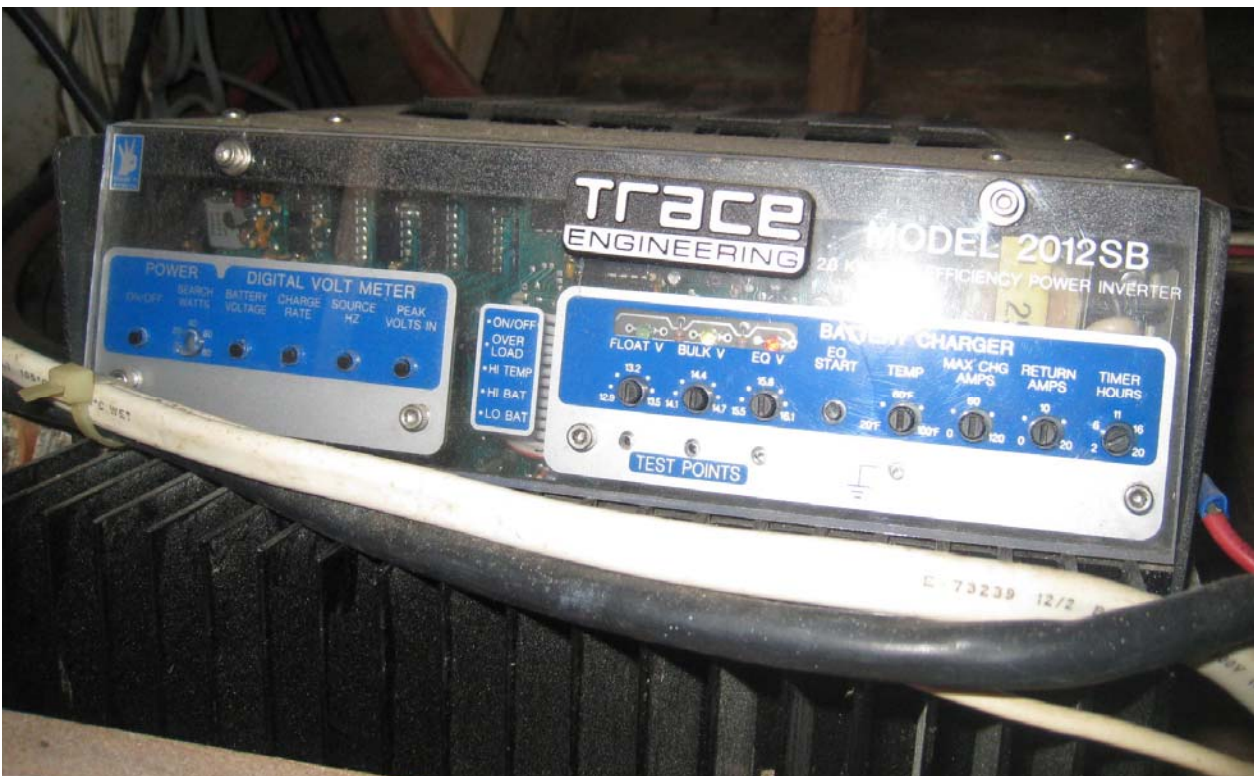
The battery charger appears to have the capability to be manually adjusted.  
 "Boat Name" Surveyed by Island Marine Group, LLC  
 Isle of Palms, SC 29451

Trace battery charger/inverter model 2012 SB (See notes under batteries)

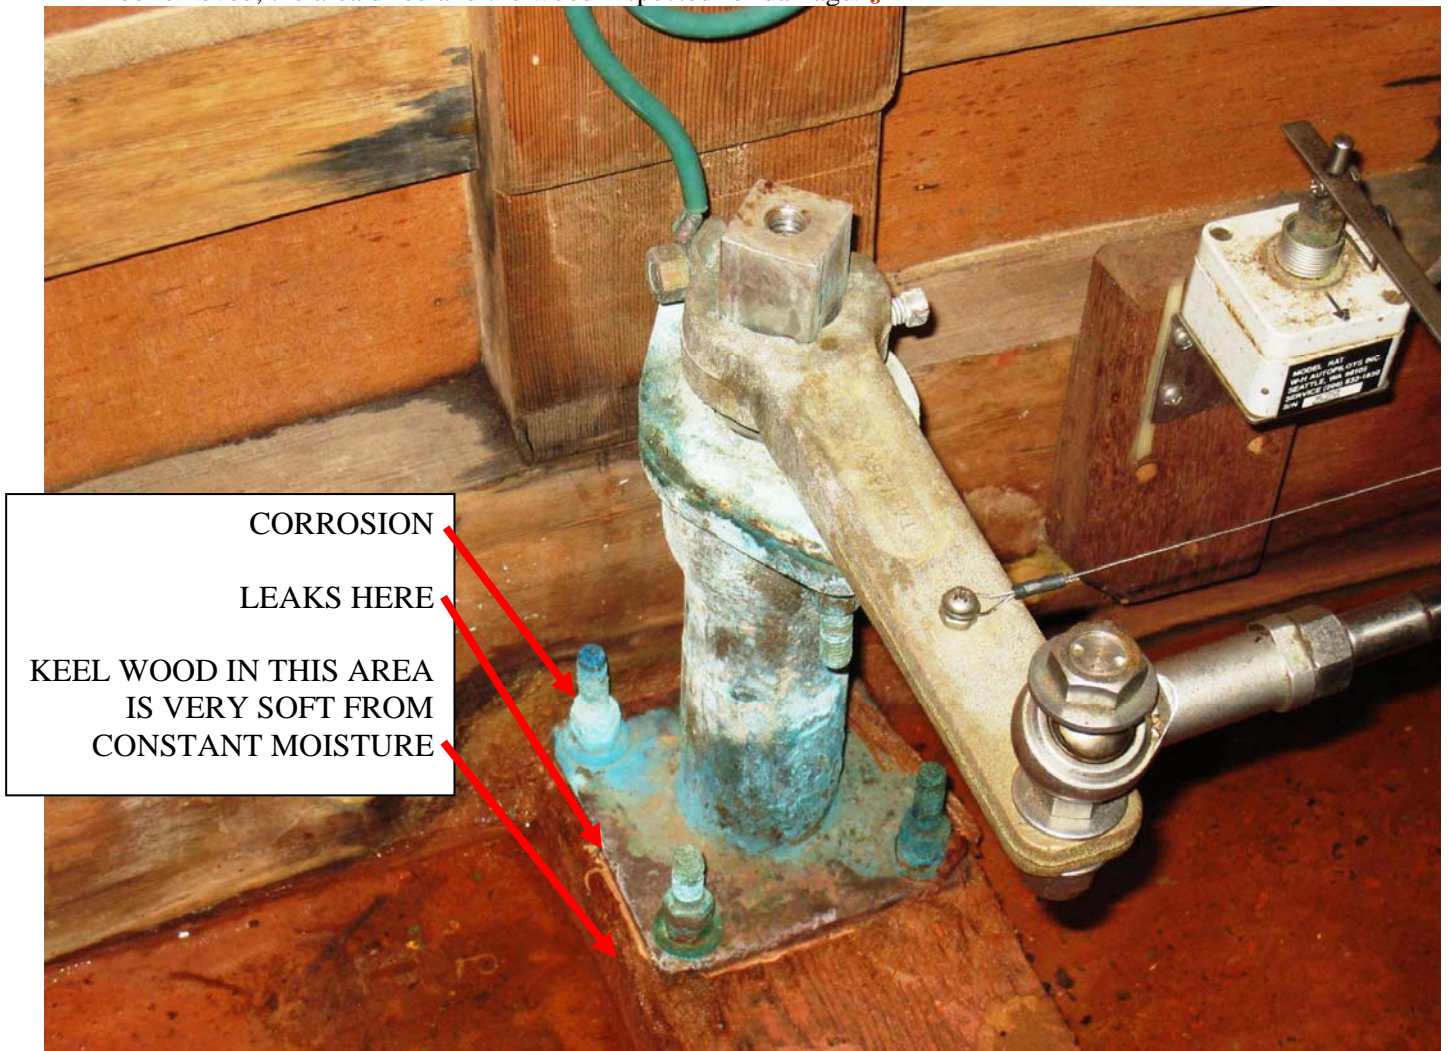
Hull is leaking where rudder post attaches. Fasteners show advanced corrosion. At haul out, rudder post should be removed, the area dried and the wood inspected for damage. **§A-1**

(§A-1) Rudder post has a leak where it attaches to the keel. This caused the wood keel to soften in this area. It is recommended that the rudder post be removed during the current haul out. The keel should be carefully inspected.

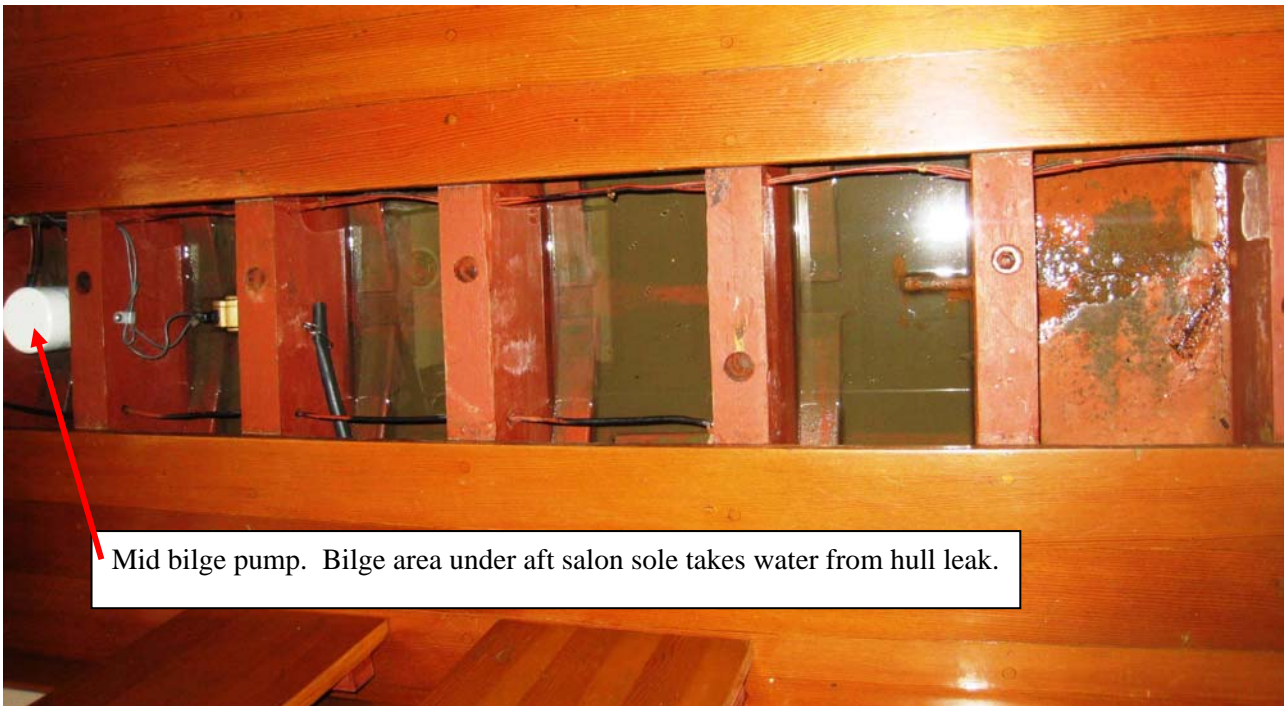
Shows wear and tear especially near the waterline. Some re-caulking is necessary. This vessel is over due for a haul out. It is recommended that a vessel of this age be hauled annually. Any defects should be tended to immediately. The hull appears to leak around mid-ship. The mid bilge pump float switch cycles on the pump about every twenty minutes while the boat is at the slip. Failure of the mid bilge pump or float switch could result in catastrophic failure. The source of the leak could not be determined during the survey. There are several areas shown in the photos that should be investigated by an experienced marine carpenter. §A-3

(§A-3) There is a substantial amount of water ingress somewhere around the forward engine room bulkhead. The source of this leak could not be located by the attending surveyor. The leak causes the bilge area to be constantly wet and the mid bilge pump to cycle at approximately 20 minute intervals. With the noted electrical deficiencies of this vessel, this hull leak could be catastrophic and potentially result in loss of vessel and life.
