1998 Cabo 45 Express

GHOST RIDER

Report of Marine Survey

6/25/2019

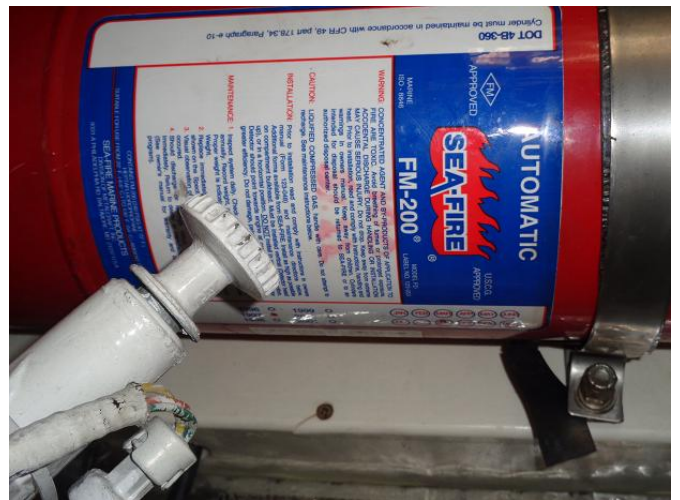
Fire Suppression System

FINDINGS	RECOMMENDATIONS
*Note: Sea Fire FM-200 auto suppression system in the engine space is not tagged current.	<i>Comply with NFPA and ABYC recommendations for fire suppression systems. The automatic Halon system in the engine room, at one year intervals, a full maintenance check should be made by a qualified fire extinguishing system service facility in accordance with the manufacturers maintenance instructions. A tag should be attached showing the date of such maintenance check. Per NFPA 302. B-4.1 & ABYC A-4.Ap.6.3.</i>

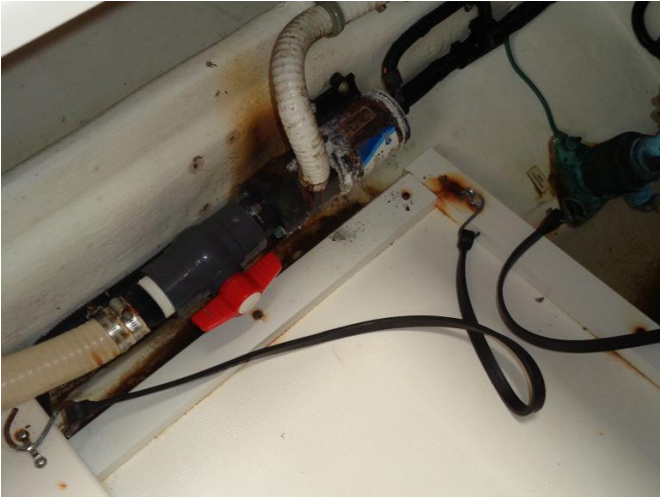
MSD Macerator

*Note: The head macerator located on the centerline in the forward shallow bilge area, the macerator housing is leaking into the bilge.

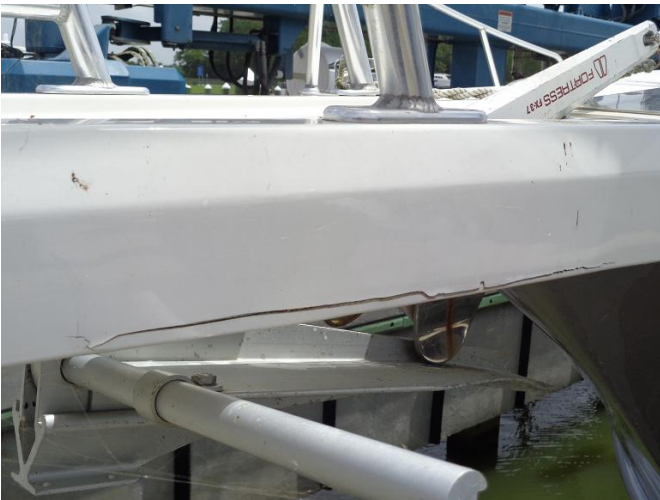
Pulpit

*Note: The bow pulpit FRP shows a 12 inch horizontal crack to the filler.

FINDINGS	RECOMMENDATIONS
<p>*Note: The bow pulpit FRP shows a 12 inch horizontal crack to the filler.</p>	<p><i>The area was inspected, sounded and meter tested and found to be mostly sound in the visible crack area. The crack appears to be in the filler at the gelcoat, de lamination does not appear existent at this time. At next scheduled haul out have inspected by a fiberglass technician and repair as necessary.</i></p>
