The “Lightning” Newsletter

Volume 4, Number 3
March, 2011

Service Bulletin AASB-1-1-2011

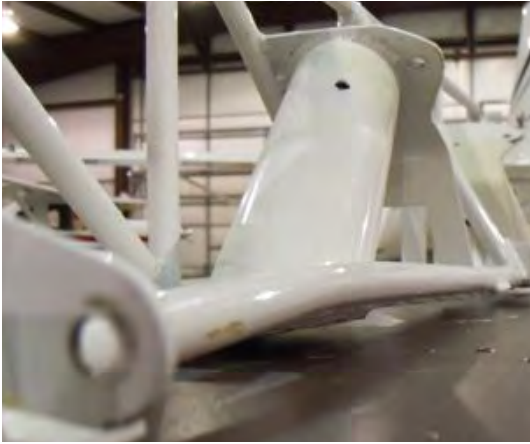
Figure 1: deformation of rear 1/2" tube box V1 socket plate V1

Refer to figure 1: The lowest and most aft tube adjacent to the gear plate must be inspected. This tube is about 1/2" in diameter and should be flat with no upwards bowing to it. If deformed upwards it will be the greatest at the outboard end of the lower socket plate. Use a straight edge on the tube to determine if it is bent. Any deformation in this tube is cause for replacement.

If it is found that upon inspection the rear spar-box has deformed, section 4 of this SB must be complied with, within the next 25 hours of service. Arion Aircraft LLC must be notified before any service is to take place.

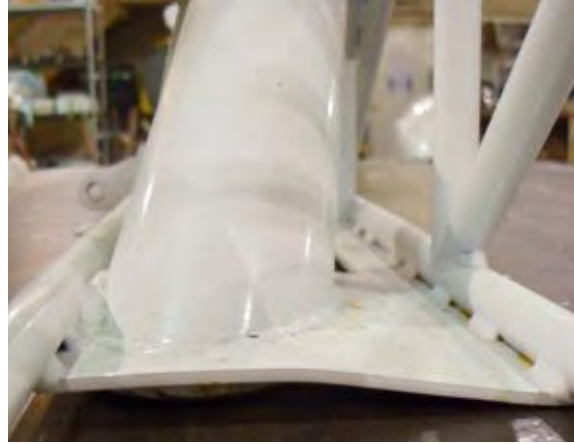
Figure 2: deformation of lower socket plate V1

Refer to figure 2: The lower socket plate must be inspected as well. This plate may have up to 1/16" flex upwards and be with in serviceable tolerance. However should more than

that be found upon inspection the box should be replaced. Check by using a short straight edge set between the spar box tubes across the plate. Measure the deflection if any.

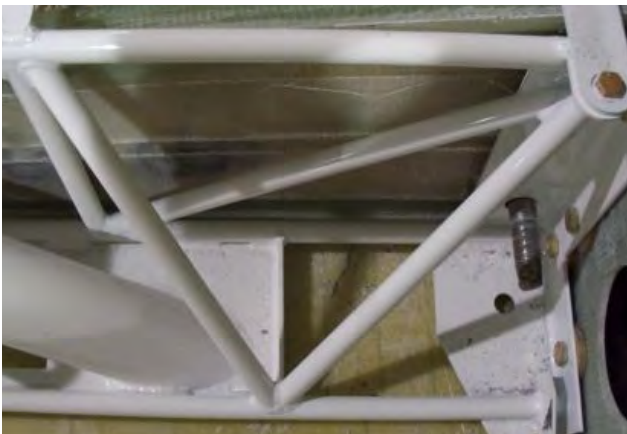
Figure 3: Compression tubes added V2 plate V2

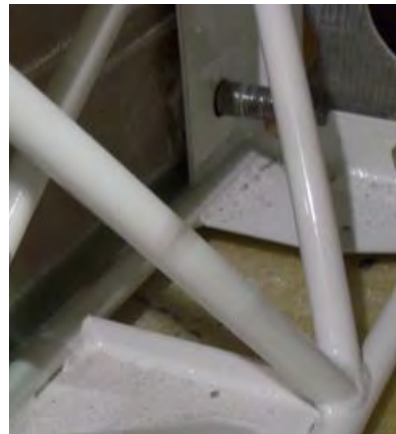
Figure 4: Gusset added to lower plate V2
