Az Superior Home Inspections

SUMMARY REPORT

Inspection Address: Example , Phoenix, Arizona 85050
Inspection Date: 8/25/2012 Start: 9:30 am End: 3:30 pm

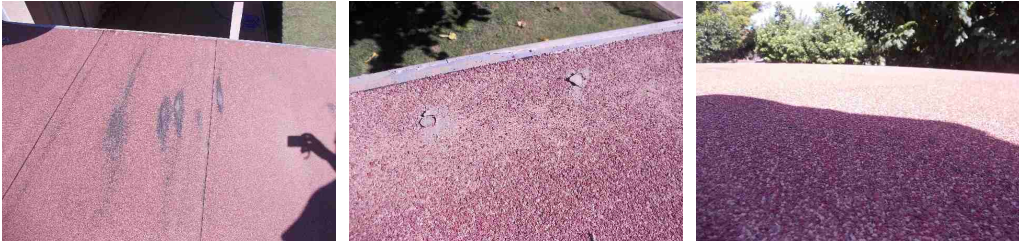
- The roof has a flat-roofed addition, and flat roofs can be problematic if they are not properly maintained. They must be kept clean and inspected regularly. However, this flat roof needs serviced for the following reasons: E.G. The granules have been worn away more than likely from the tree limbs at one time not being maintained. There is also some blistering in a few spots. The flat roof appears to have been done by an amateur as nails

were used to secure the roof material, these nails were then sealed, but there are a few nails that have lifted. This roof has approximately two years of useful life and should be replaced. You may also elect to have an elastomeric roof coating rolled on to seal the roof and may be able to get an additional 5 years out of the roof. We can elaborate on this issue, but it should be serviced before the close of escrow or it may leak, because our service does not include any guarantee against leaks, although, at this time I see no evidence of leaking..

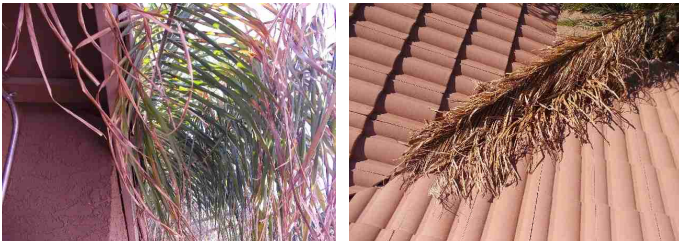
- The roof needs to be cleaned and any foliage trimmed away to facilitate drainage. E.G. Palm tree in front should be trimmed, there are currently limbs laying on the roof valley that can impede the water drainage.

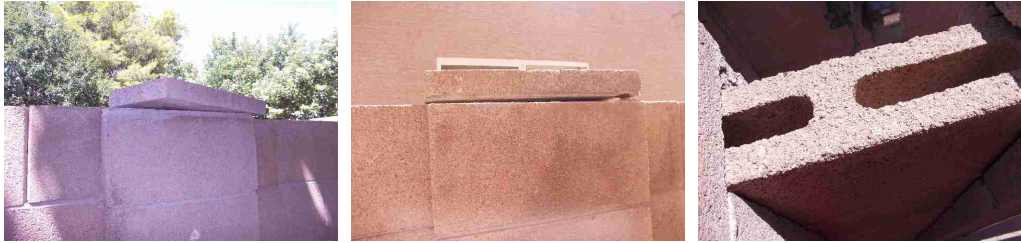
- There are a couple loose fence caps that are loose and will need serviced. Also an open cell that can allow water to drain inside the wall and rust the rebar that will weaken the wall. E.G. One cap on east and west walls that should be secured. Also open cell near side gate on east side that should be filled in with mortar.
