# Castle Rock County Water District

## Facilities Condition Assessment and Evaluation

September 2015

Causey Consulting  
733 Cree Court  
Walnut Creek, CA 94598

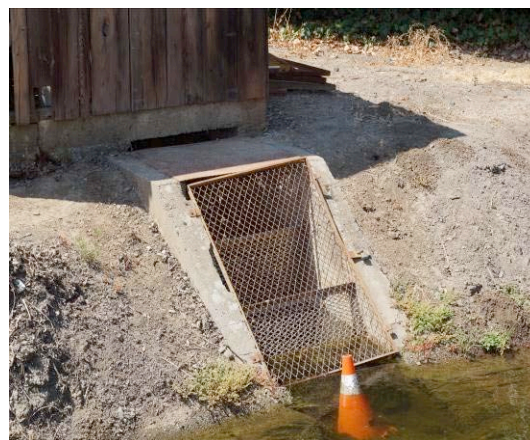
**Figure 5: Pump Station Inlet Screen**

Raw untreated water enters the pump station through a bar screen in the concrete lining of the canal (See Fig 5). The water then enters the wet well where two (2) hollow shaft motors are available to pump the untreated water to the District service area and the terminal redwood stave storage tank described below. The wet well is 8.33' x 6' x 7.5 and contains an approximate maximum volume of 2800 gallons. The District operates only one pump at a time using the second pump as an emergency backup.

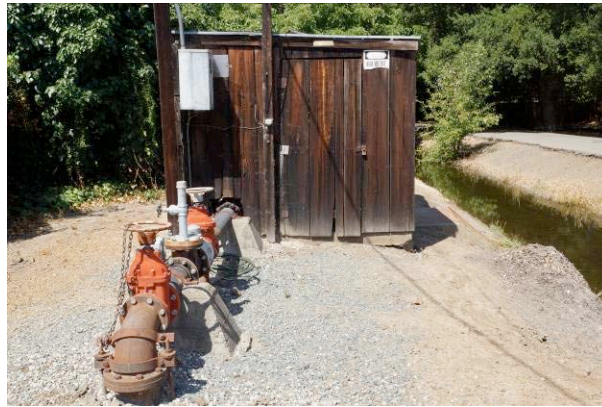
**Figure 6: Pump House and Discharge Pipe**

The pump house is a wooden structure that is 8.75 feet by 8.83 feet with a single locked access door to the pumps and electrical controls facing Oak Grove Road (see Figure 6 below) and a locked roof opening for access for the removal and replacement of the motors and pumps .

The pump house is open to the weather and does leak during the winter rains. The old wood is aged and cracked but continues to provide serviceable containment for the pump facilities. The inside of the pump house did evidence a large quantity of cobwebs and dust during the field inspection which should be dealt with on a regular basis to assure that the electrical components are not damaged or affected by insects or spiders. This is especially true for the electrical cabinet in the station as these bugs and spider cobwebs can create problems for the electrical components if allowed to remain in the cabinet.

Of current concern is the condition of the pump house that has had no major repairs or improvements in the memory of the current Board or from the historical maintenance records attached to the Pump Station Field Inspection Report. The pump house shows signs of deterioration and the current locking mechanism on the access door is minimal and shows signs of needing repair. While the pump house has since inception not experienced any vandalism or other malicious mischief, it does present an attractive target especially since the current fencing allows complete access to the pump house at all times. The interior of the pump house is open to the weather and the station has a significant number of cobwebs throughout the interior. These should be removed regularly because they can cause problems for the electrical components.

10. The shrubs along the southern fence need attention and pruning.
11. The hinges on the access door to the pump house need either repair or replacement to strengthen access to the interior of the pump house by other than appropriate persons.

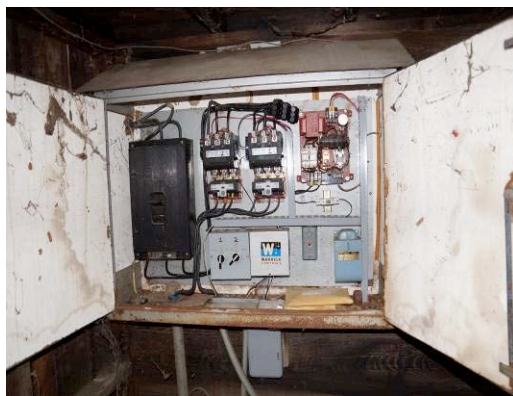
**Figure 7: Pump Controls in Pump House**

The pump house contains two pumps, discharge piping, isolation valving, pressure gauges and all electrical controls for the pumps including a time clock and dedicated telephone line that transmits the float signals from the storage tank to turn the pumps on/off during normal operating hours (See Figures 7 and 8). The District’s normal operating hours are from 6:00 PM to noon the following day. No pumping is done during the high-energy rate hours of noon to 6:00 PM.

8. The District should establish a regular pump house and electrical panel-cleaning program to assure that bugs and insects do not cause failures of the electrical components.

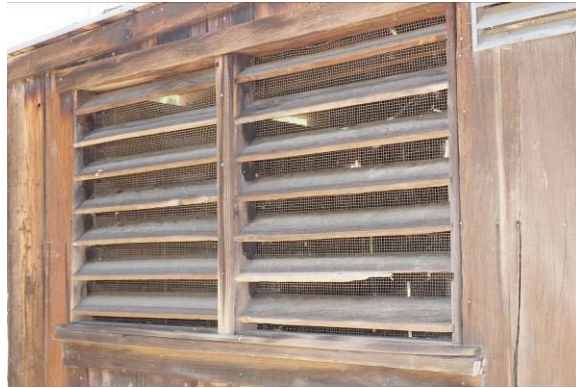
**Figure 9: Pump House Ventilation – Western Exposure**

The western exposure of the pump house provides ventilation and cooling for the motors and is screened to prevent access or vandalism to the inside of the pump house (See Figure 9).

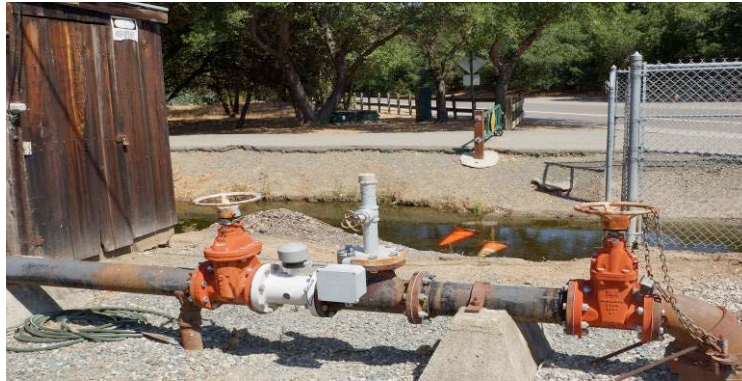
**Figure 10: Discharge Header from Pump House**

The discharge lines from the pumps are four inches in diameter and include isolation gate valves inside the pump house. There also is a pressure gauge on the discharge header. The discharge header exits the pump house, increases in size to six inches and remains above ground for approximately 15 feet before moving underground for the transmission to the service area along the eastern shoulder of Oak Grove Road. The discharge header includes two additional isolation valves and a CCWD meter and telemetry system for the raw untreated water purchased by the District. These pieces of equipment are fully exposed above ground and one of the gate valves is locked to prevent illegal operation (See Figure10 below)

The discharge lines from each of the pumps and from the pump house appear in good shape with minor corrosion. The valves appear to have only primer coatings and should be painted with a finish coat to assure they reach the expected service life for these mechanical components. In addition, there is no valve exercise program but rather valves are just replaced when they will not shut off or close properly. The above ground metal discharge pipes have not had any corrosion protection added and it is suggested that these pipes also receive an exterior coating of paint to assure that corrosion is minimized.

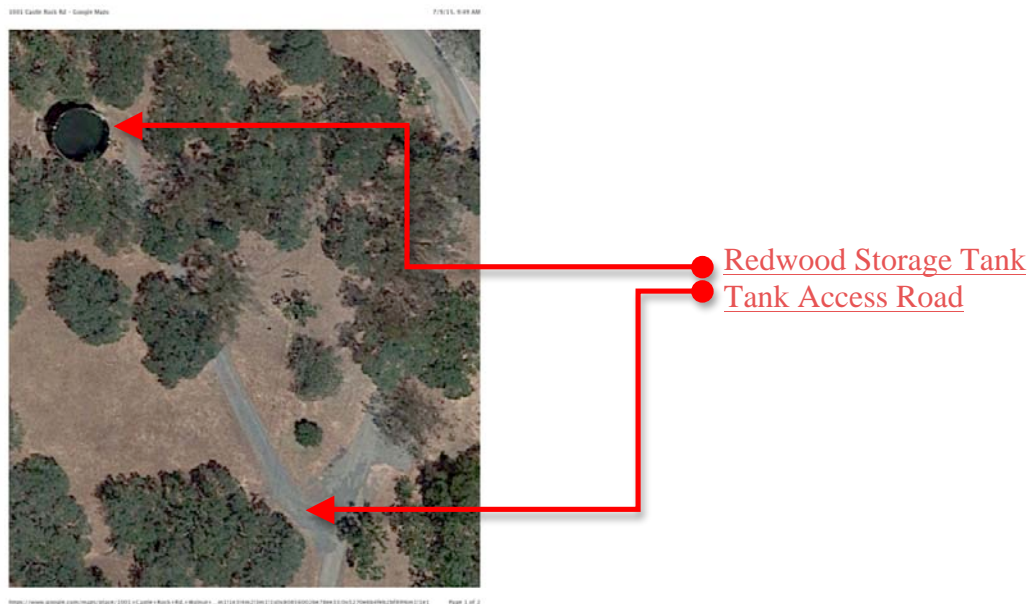
**Figure 12: Aerial Photo of Redwood Tank Site**

This tank was purchased used and installed in 1956 and was placed on a 34-foot diameter reinforced concrete engineered foundation. The tank is an open reservoir 33 feet in diameter with twenty (20) foot tall walls with an estimated capacity of approximately 125,000 gallons. The walls of the tank are secured in place with steel circumferential tension hoops. The rods are  $\frac{3}{4}$ -inch threaded rods in horizontal rings spaced across the full height of the tank based upon the loads placed on the walls by the water in the tank.

Plans for this concrete foundation are included in the 1956 construction plans. The concrete base appears in good condition where visible as it rests on a rock base. Very minor spalling is localized to the eastern edge of the ring and no major cracks were seen during the field inspection of the exterior of the tank. No inspection of the interior of the tank was conducted as part of this work as the tank was in full operation at the time of the field inspection. The Board President indicates that the tank and the concrete base have never had any seismic problems or has experienced any known seismic damage. However there has never to his knowledge been any seismic evaluation of the storage tank before or since the original installation in 1956.

The tank access road (See Fig. 12) is steep and over the years has required maintenance to retain accessibility to the tank. The current road especially at the bottom is rutted where a sharp right turn off of the City dirt road is required. In addition, the road surface up the slope is gravel and dirt that appears to be in need of repair again. It was stated during the inspection that a four-wheel drive vehicle is required to access the tank site. It appears that the condition of the road during wet weather could create access concerns. The road has been regraded in 2007, 2008 and 2012 and should be considered for repair currently.

16. The access road to the redwood tank needs to be evaluated and possibly considered for repair before the next winter.

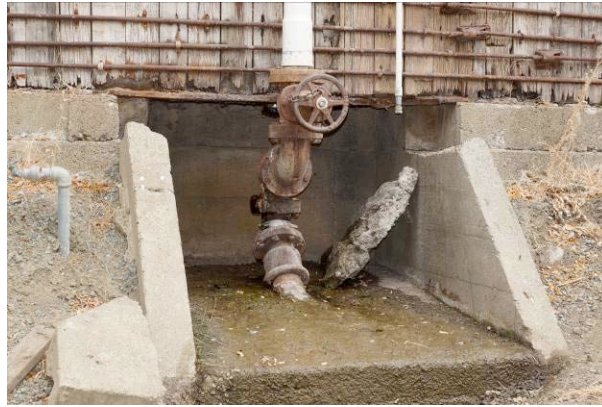
**Figure 18: Tank Shut Off Valve and Fill Line**

The siphon originates from a tank isolation valve just below the bottom of the tank on the northern exposure (see Figure 18 below) that sits atop a metal pipe system where the fill/discharge asbestos pipe transmission line rises from the ground. This gate valve and pipe angles appear old and in need of corrosion protection as evidenced by the current leakage from the foot valve inside the tank which is leaking directly onto this gate valve and pipe configuration. The gate valve is protected from vandalism or illegal use by a chain and lock to prevent the operation of the valve by unauthorized persons.

15. The foot valve inside the redwood tank needs to be replaced and the isolation and pipe fittings outside the tank should have corrosion protect applied to these metal components.

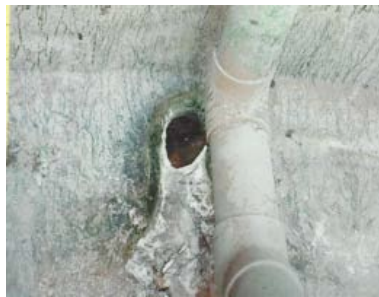
**Figure 19: Tank Foot Valve, detail**

A foot valve inside the tank is used during cleaning and maintenance to drain the tank and remove any built up debris on the floor of the tank (See Figure 19 below). The current foot valve is leaking and in need of replacement to assure a tight seal and prevent leaking onto the isolation valve, etc.

The tank includes a series of valves and discharge pipes below the northern exposure of the tank for the cleaning and removal of debris from the tank (see Fig19). These facilities access the tank through the concrete base and provides a foot valve used only during maintenance activities described below.

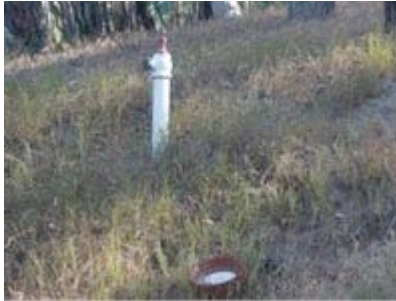
**Figure 20: District Wharf Hydrant**

The distribution system includes nine (9) wharf hydrants (See Fig. 20 below) used to bleed air from the system or to assist with maintenance needs in particular areas of the District. These hydrants appear to be used very seldom and there is no regular maintenance program for the hydrants or a replacement philosophy for these hydrants when they fail.
