CCR Unit: SCA #2 Ash Landfill

Owner: Sunnyside Cogeneration Associates

Annual Inspection: January 2023

This annual inspection has been completed by S. Scott Carlson, PE 187727 in accordance with CCR Rules § 257.84 (b) and Utah State code R315-319-84.

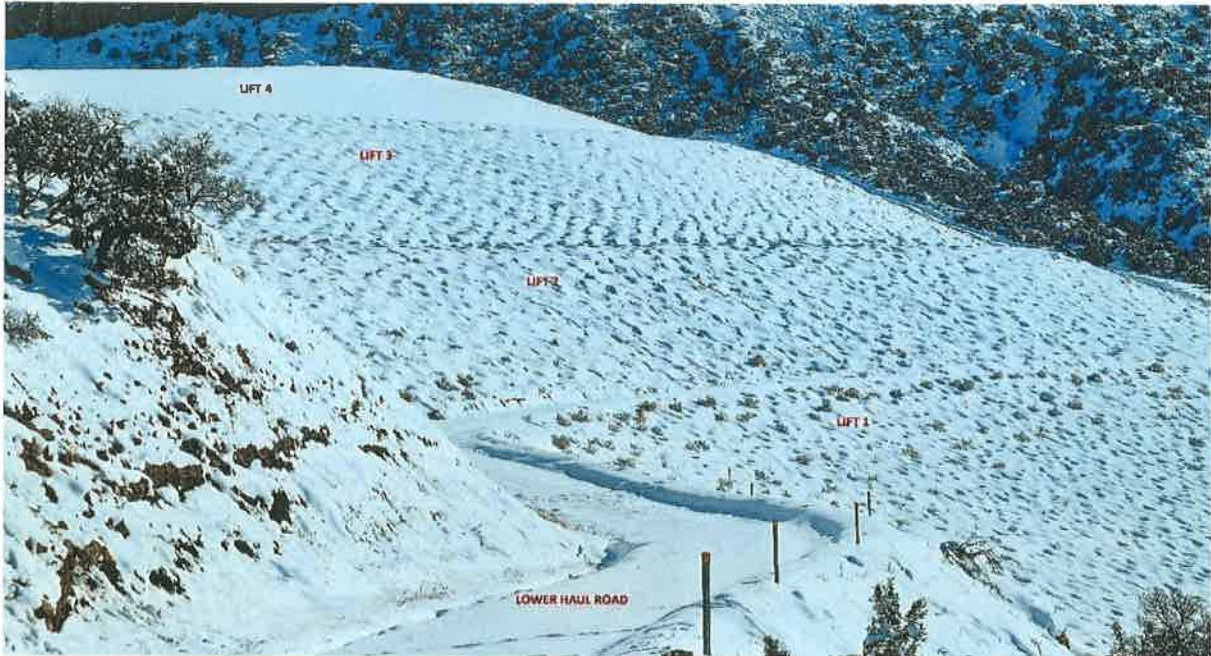
SCA#2 Ash Landfill –looking southeasterly

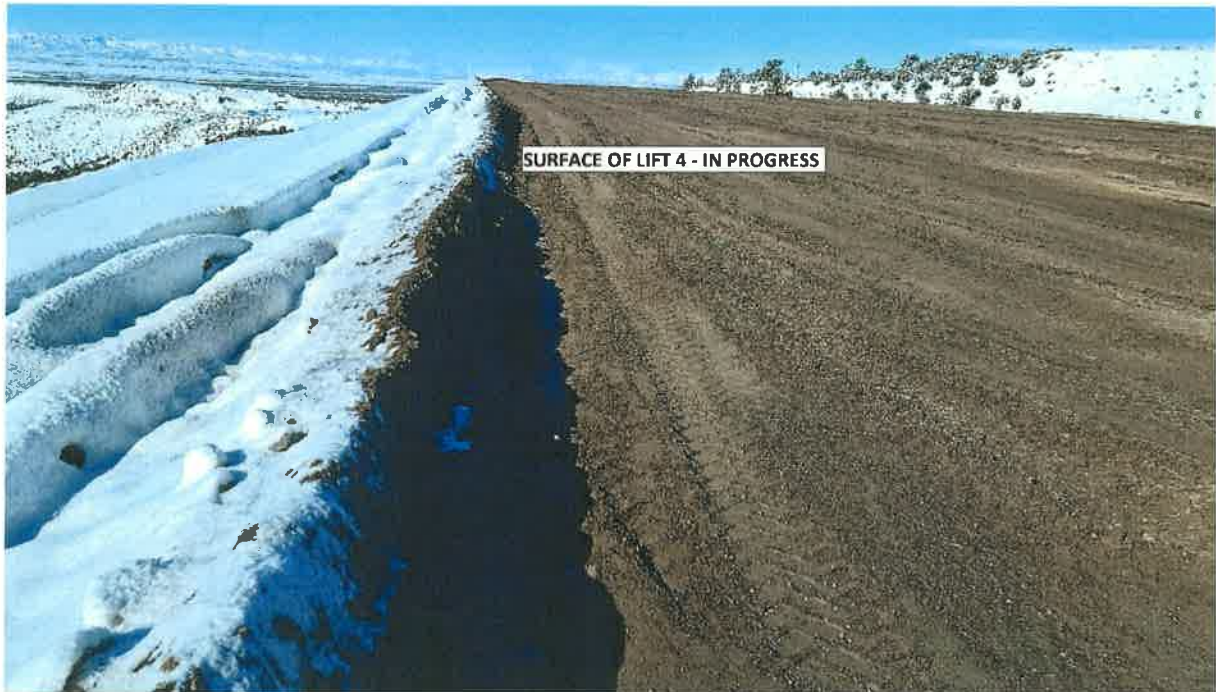
SCA#2 Ash Landfill – Current surface northwesterly
Lift #4 in progress

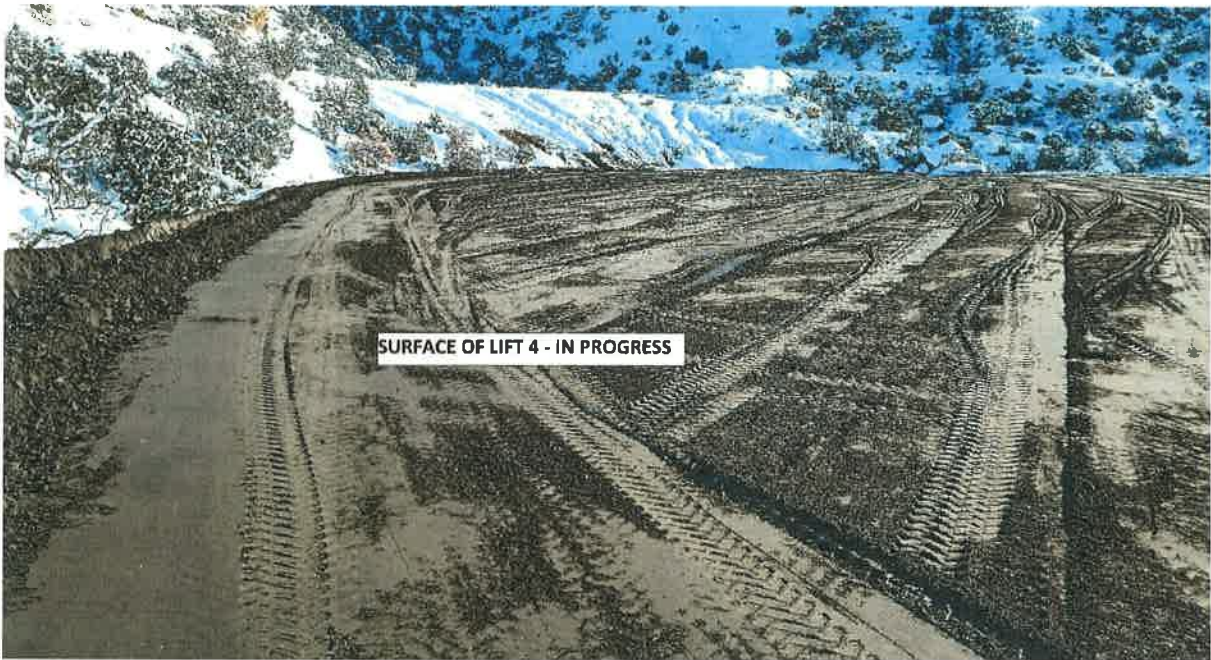
Surface of Lift #4 in process – photo looking east - southeast

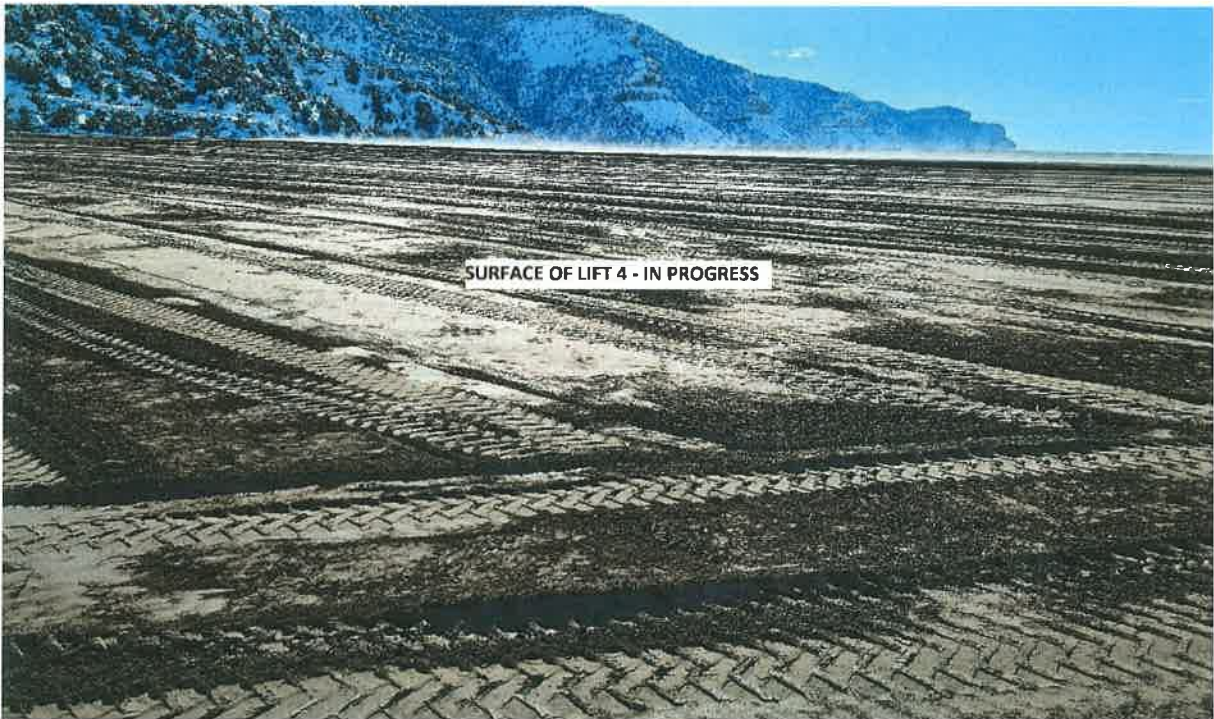
Surface of Lift #4 in progress – photo looking west - southwest
Compaction appears satisfactory. Dust suppression appears satisfactory
Surface slopes east towards the hill to prevent storm water run-on

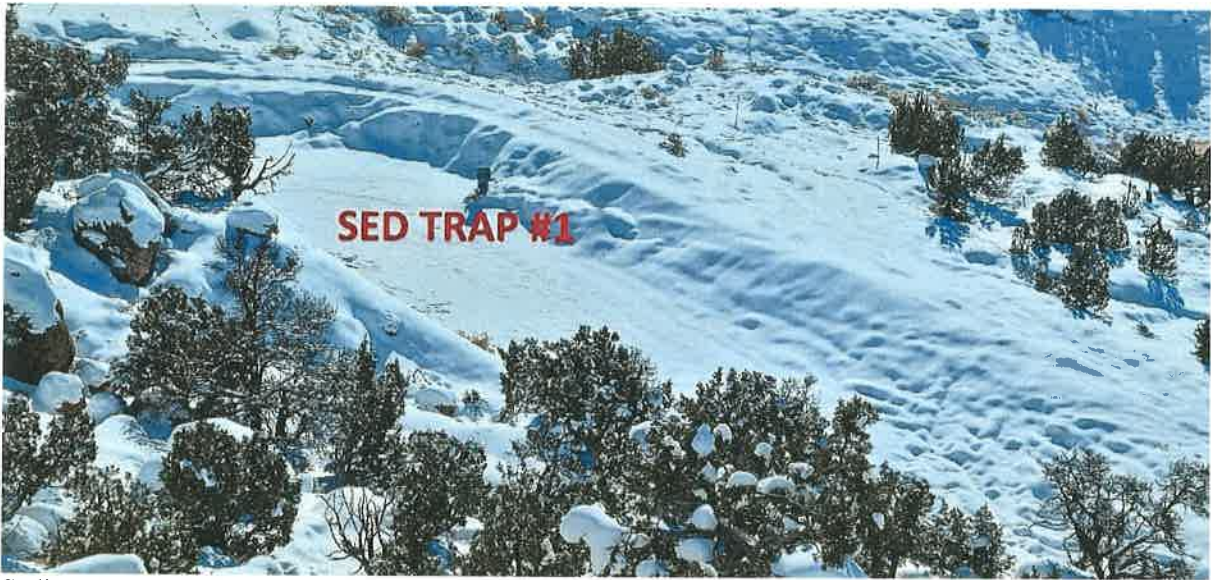
Sediment Trap #1 is empty and clean
water flows from trap to pond 018 in normal open condition.

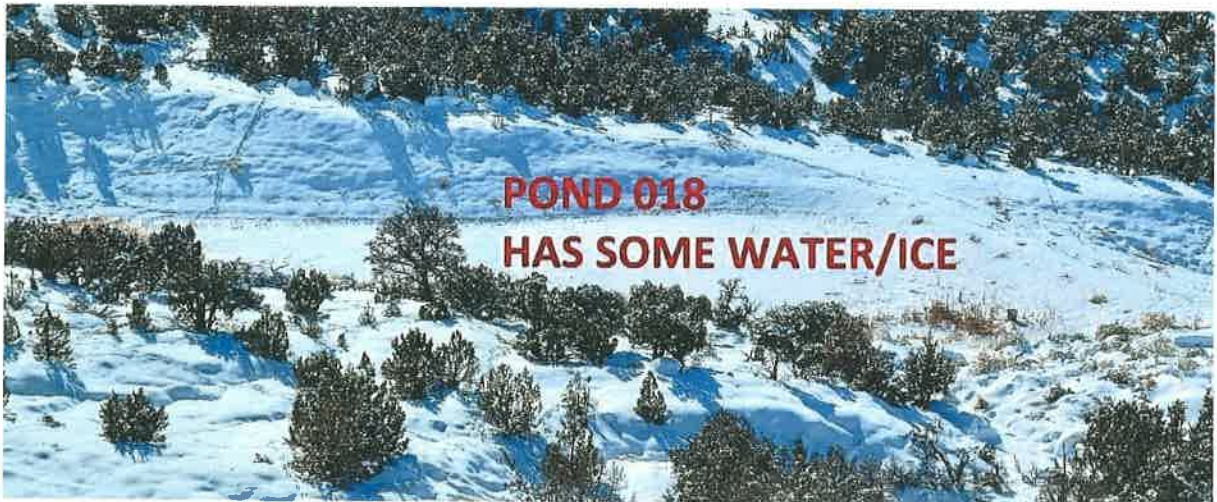
Sediment Pond 018, located west of Sed Trap #1 – photo looking southwesterly
Pond has water with a surface ice layer and recent snow cover.
No discharge in 2022
