Confidential Inspection Report

LOCATED AT: 123 Sample Street
RSM, CA 92688

INSPECTED ON: Monday, April 18, 2016

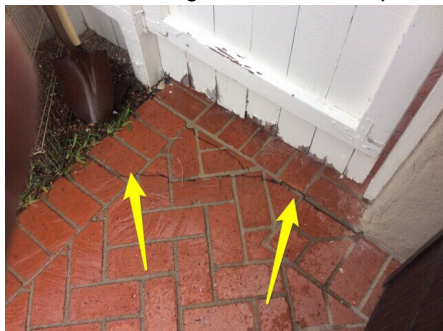
23: - Damaged surfaces. Replacement is expensive. Recommend you get an estimate for repair and or replacing.

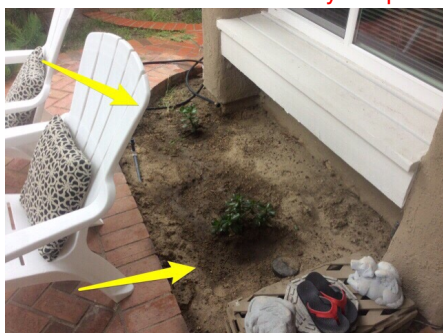
27: - Planters along the perimeter of the house. This is a defect in design. Planters are designed to retain moisture for the plants inside. This also keeps moisture against the siding. Soil should be no less than 6" below the weep screed. This is a moisture intrusion hazard. If you opt to keep the planters, ensure these planters have a means to drain away from the house.

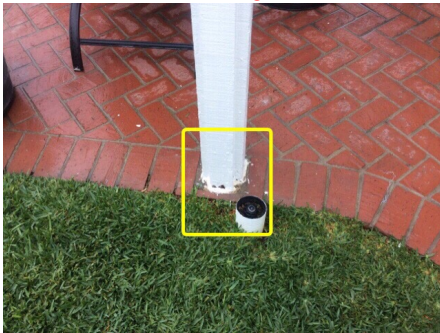
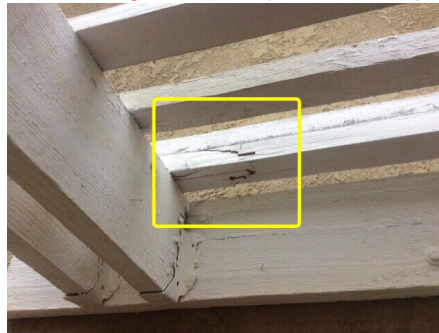
WARN 53: - **Wood damage noted. Recommend contacting a licensed pest control specialist for further evaluation.**

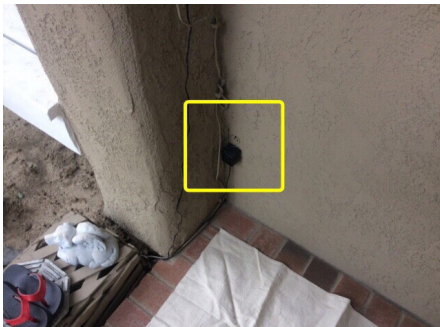
!!! 57: - **Outdoor receptacle missing a weatherproof cover. This is a safety hazard. Recommend one be installed by a licensed electrical contractor.**

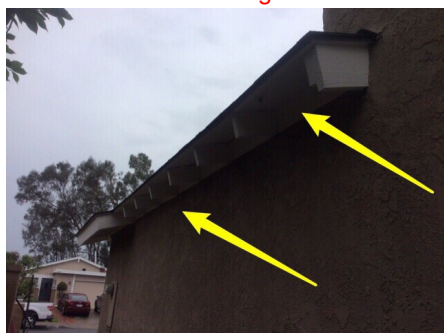
WARN **74:** - **Facia missing. Recommend replacement by a licensed roofing contractor.**

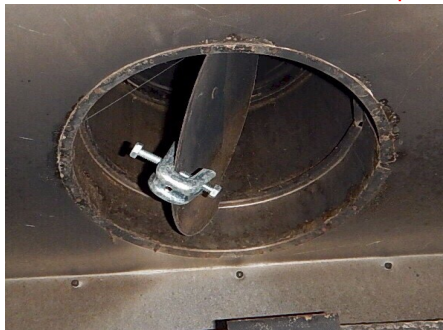
!!! **83:** - Damper not in a fixed open position where a gas fire is present. No damper clamp installed. This is an important safety feature that helps ensure that gases will be vented into the atmosphere instead of being trapped in the fireplace. An approved damper clamp should be installed for safety. A "Fireplace Damper Stop Clamp" can be purchased at a place like Amazon for around \$6. FYI - this is what a damper clamp looks like.

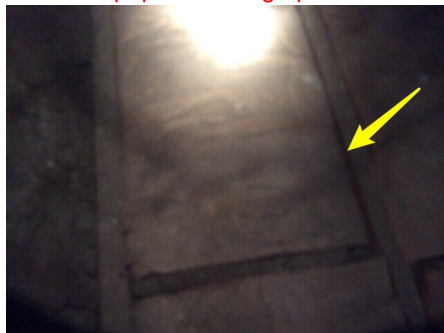
!!! 100: - Insulation was installed wrong side up. This is a fire hazard. The kraft paper backing has a better chance of burning when the paper is facing up. In the attic, paper side should be down.

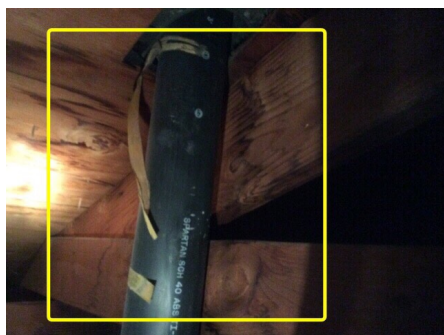
WARN 105: - Water stains present. Evidence of past leak noted. The leak appears to be repaired. Recommend you ask the seller about this condition and/or check the disclosures.

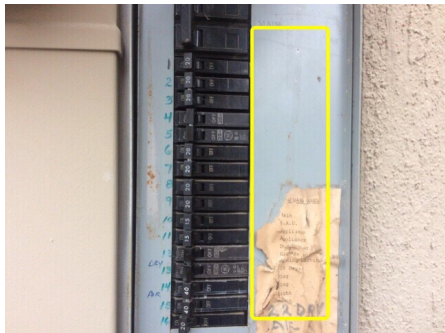
110: - Breakers are not labeled correctly. This is a safety concern. Recommend you have all breakers labeled correctly by a licensed electrician.

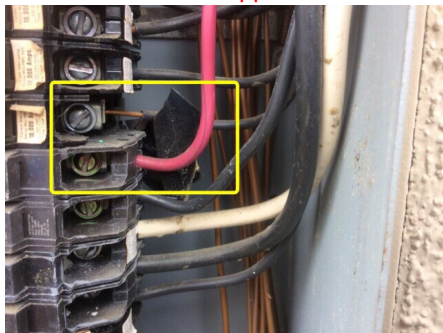
112: - Breaker appears to be damaged. This is a safety hazard. Recommend replacement by a licensed electrician.

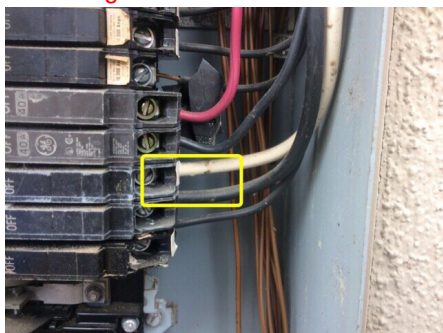
113: - White wire used as "hot" wire. White wires used as "hot" wires should be marked with black tape. Recommend contacting a licensed electrician to mark the wire.

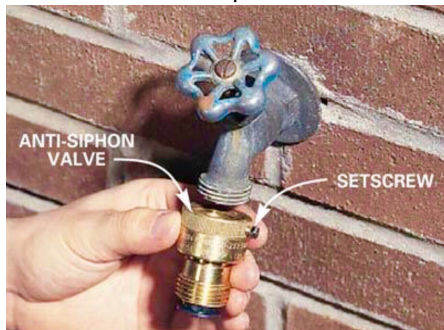
WARN 131: - External faucets around the house appear to be functional, but does not include anti-siphon valve. These valves are required by current standards to help prevent dangerous backflow of contaminated water into the potable water system of the house. Recommend the addition of these devices to all faucets. These devices are relatively inexpensive and can be purchased at the nearest home improvement store.

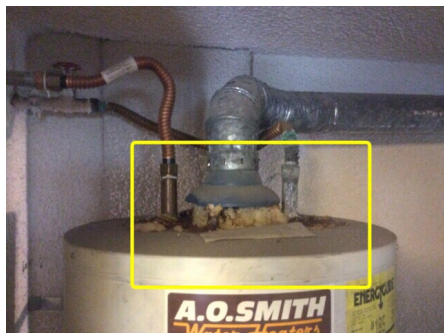
WARN 141: - Corrosion present. This is a moisture intrusion hazard. Recommend repair or replacement by a licensed plumbing contractor.

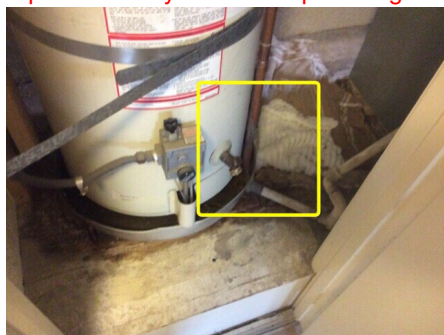
WARN 146: - Water heater base shows signs of water damage. This is a moisture intrusion hazard. Recommend repair or replacement by a licensed plumbing contractor.

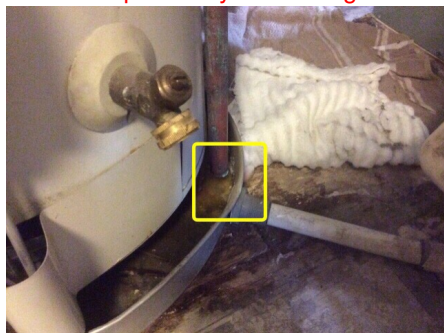
!!! 153: - Discharge tube discharges in the drip pan, this should be moved to discharge above the floor, by a licensed plumber, due to the possibility of scalding should a discharge situation happen (6" - 24" from the floor). This is a potential safety hazard.

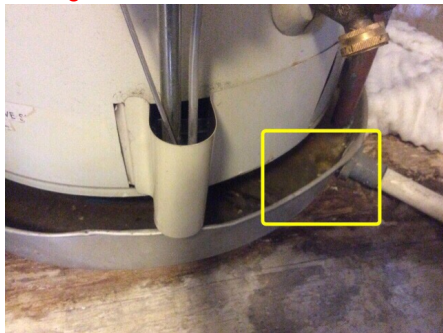
159: - Drip pan appears to be rusted through. This is a moisture intrusion hazard. Unable to tell if there is additional hidden damage under the floor. Recommend repair or replacement by a licensed plumbing contractor.

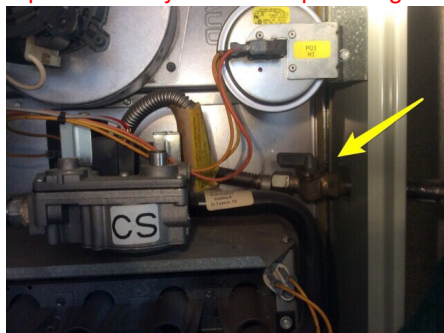
168: - Valve inside the furnace cabinet. Valve should be outside the cabinet. This is a safety hazard. Recommend replacement by a licensed plumbing contractor.

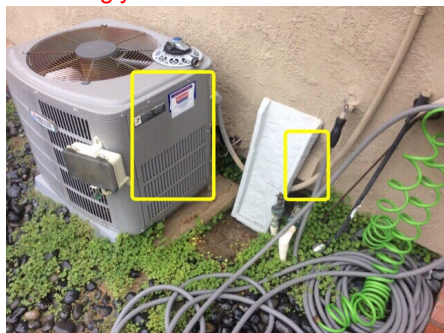
WARN 179: - Dryer vent within 3' of the A/C compressor unit. Recommend a licensed HVAC contractor move the compressor unit accordingly.

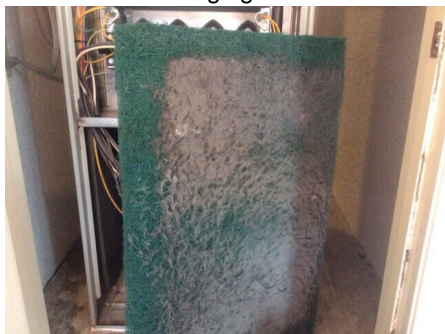
197: - Filter is dirty. Filters clean the air before it passes through the blower, heat exchanger and evaporator coil. This helps to keep these components working efficiently. Filters also help clean the house air, making the environment more pleasant. Recommend changing the filter and then regular maintenance and inspection.

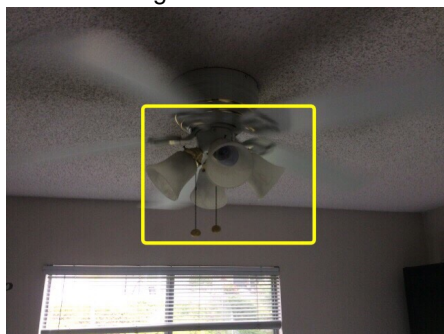
204: - Light does not work. Recommend repair or replacement by a licensed electrical contractor.

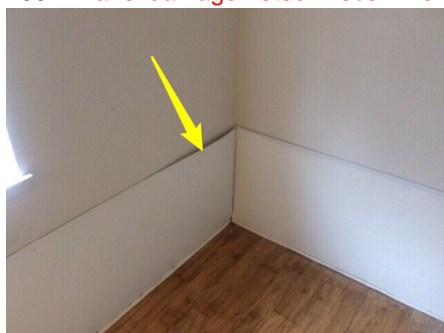
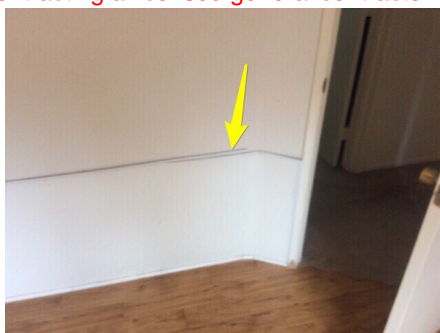
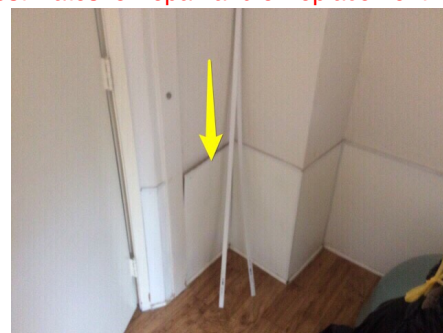
206: - Panel damage noted. Recommend contracting a licensed general contractor for estimates for repair and/or replacement.

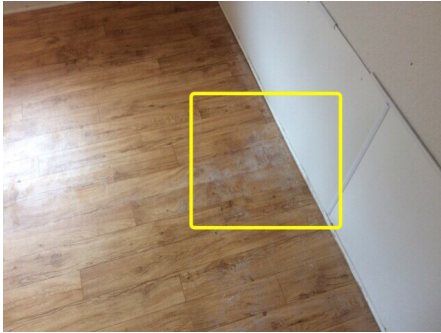
207: - Floor is damaged. Recommend repair or replacement by a licensed general contractor.

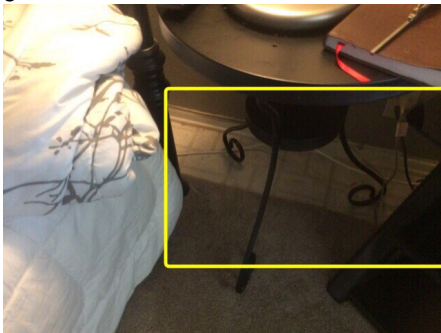
210: - Flooring is carpet and vinyl squares. Carpet does not cover entire floor. Recommend repair or replacement by a licensed general contractor.

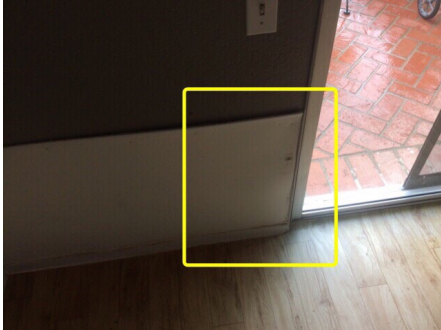
214: - Panel damage noted. Recommend contracting a licensed general contractor for estimates for repair and/or replacement.

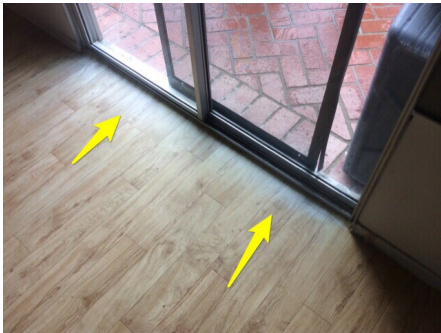
215: - Floor is damaged. Recommend repair or replacement by a licensed general contractor.

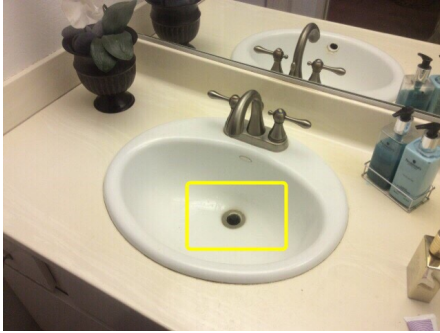
219: - Drain stop is missing.

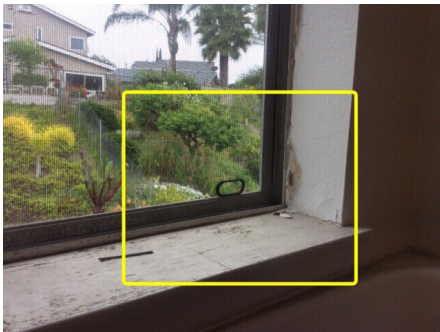
221: - Deterioration noted due to contact with moisture. Recommend replacement by a licensed general contractor.

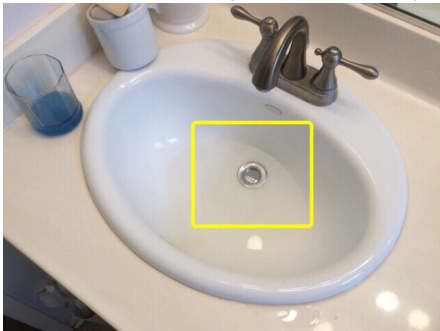
222: - Drain stop does not work properly. Recommend repair or replacement by a licensed plumbing contractor.

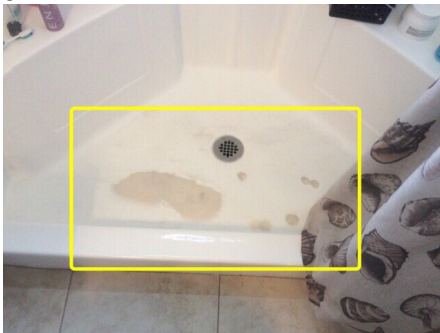
226: - Floor is damaged in shower, no leaks observed at the time of inspection. Recommend repair or replacement by a licensed general contractor.

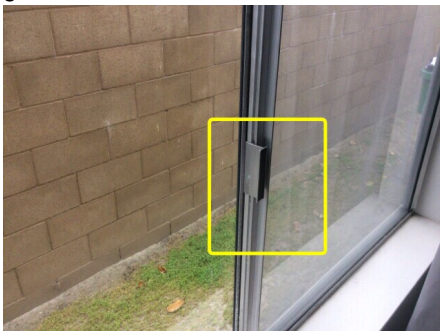
228: - Window did not lock/latch properly, recommend repairs for enhanced security/safety to occupants, by a licensed general contractor.

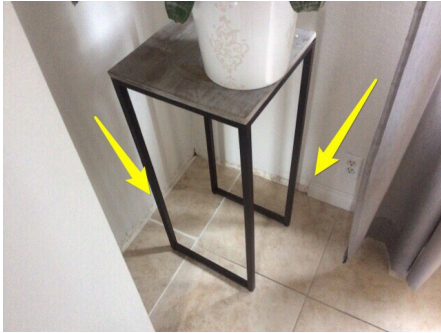
229: - Damage to baseboard; however, no active moisture detected during the inspection.

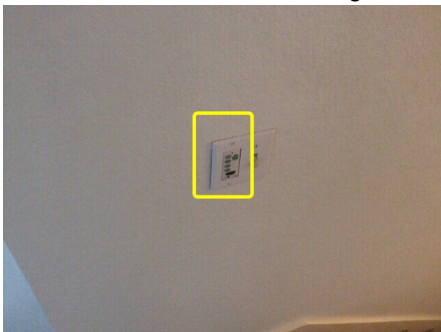
233: - Switch doesn't seem to turn anything on. Recommend you ask seller to demonstrate what this switch operates, prior to the end of the final walkthrough.

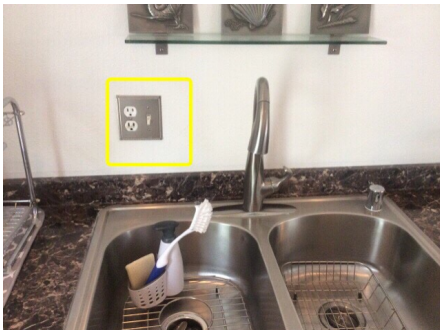
!!! 258: - Receptacle is located directly over the basin. This is a safety hazard. Recommend relocating the receptacle by a licensed electrical contractor.

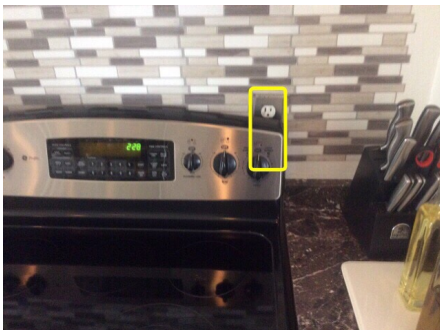
!!! 259: - Receptacle is located directly over the stovetop. This is a safety hazard. Recommend relocating the receptacle by a licensed electrical contractor.

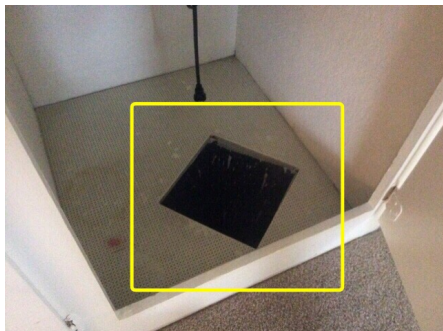
272: - Door on chute is not fire rated. This is a fire hazard. Recommend one be installed by a licensed general contractor.

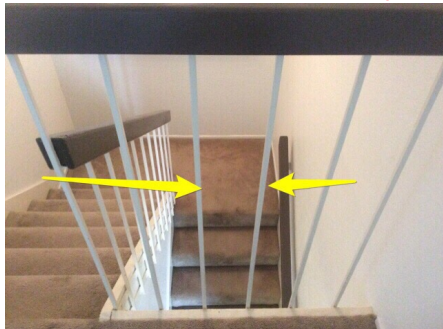
276: - Balusters are over 4" apart. This is a safety hazard. Recommend corrections be made by a licensed contractor.

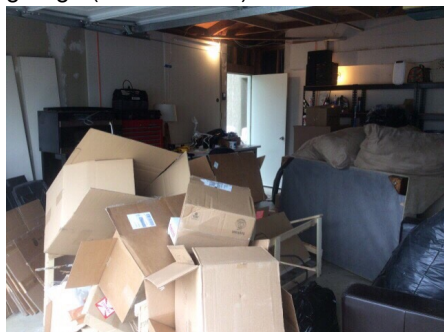
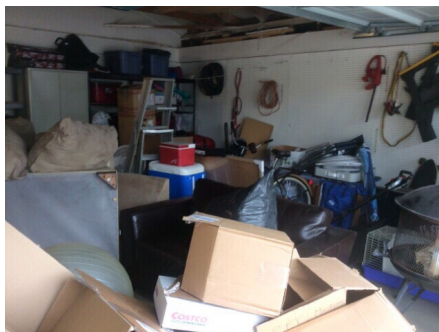
283: - Limited inspection, garage contained an unordinary amount of personal items. I was unable to see many parts of the garage (50% blocked).

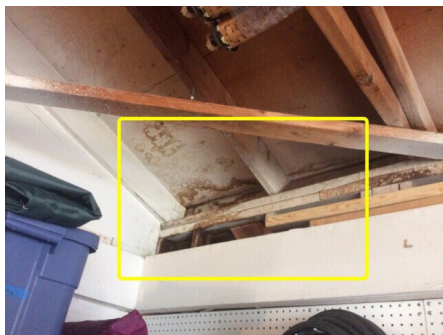
WARN 285: - Evidence of previous water damage. Tested dry. Unable to determine if repairs are effective. Recommend you check disclosures or ask the seller about this.

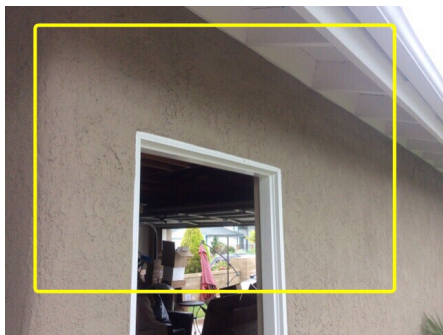
WARN 292: - No garage side door lighting present. It is common industry practice to have at least one wall light by the garage side door. This switch should be located at the door. Recommend a licensed electrician install the side garage light and switch.

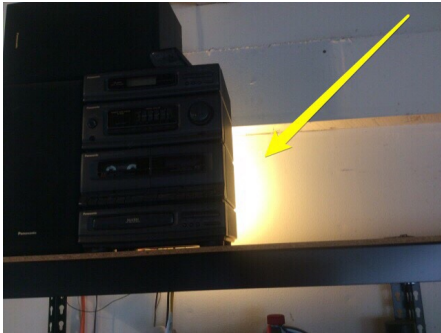
WARN 293: - Light is an exposed bulb. Due to the near proximity of combustible material, this is a fire hazard. Recommend having a licensed Electrician replace with a proper protected lighting fixture.

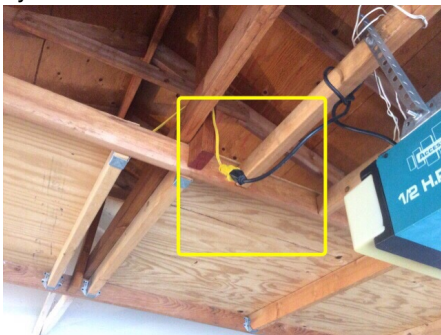
WARN 295: - Extension cord used as permanent cabling. Extension cords should not be permanently installed or be routed through walls, floors or partitions. This is a safety hazard. Recommend removing all extension cords and have the proper cable installed by a licensed electrical contractor.

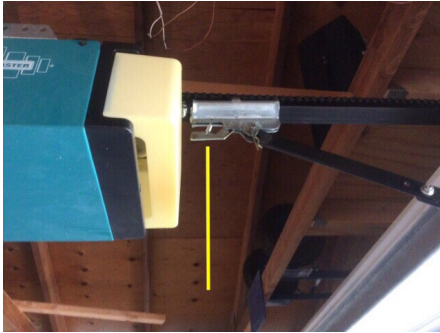
300: - Manual release rope is missing. Recommend repair or replacement by a licensed general contractor.

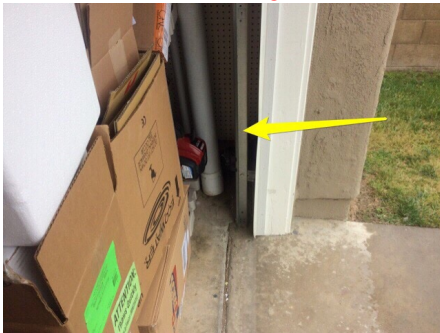
302: - Photoelectric eye is more than 6" from the ground. This is a safety hazard. Recommend you reposition the eye between 4 - 6" from the ground.
