SERVICE BULLETIN	
Service Bulletin #	AASB-1-5-2012
Superseded Bulletin #	N/A
Issue Date	5-24-2012
Effective Date	5-24-2012
Limitations for Completion	Prior to Next Flight
Make & Model Affected	Lightning LS-1 SLSA & ELSA
	SN78 thru SN142
Page 1 of 2

1. Applicability: Arion Aircraft Produced LS-1 SLSA & ELSA aircraft. SN78 thru SN142

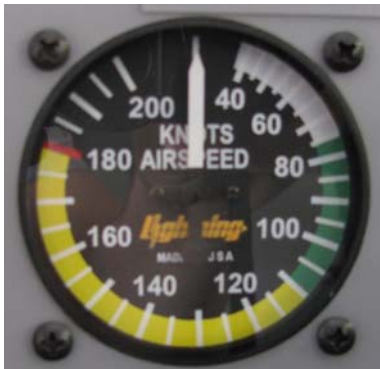
2. Background: 2.25" Airspeed Indicators installed for back up purposes have been found to be mis-marked. See figure 1. The white arc for flap operation is correctly marked for airspeed limitations; however the arc overlaps the full range of the green arc. The green arc incorrectly stops at 75knts IAS; this should extend down to the clean stall speed of the aircraft, 45knts IAS. The White arc and Green arc should both be visible for the appropriate airspeed range, see figure 2.

Figure1. Incorrect Markings

3. Compliance with- Implementation Schedule. Before the next flight the 2.25" ASI must be placarded INOP with a clearly labeled decal on the face of the ASI. The owner or operator of the aircraft must notify Arion Aircraft that the ASI has been placarded thru email or phone call. Arion Aircraft will provide the correctly marked ASI in exchange for the incorrectly marked ASI.

1. Remove the primary (left) EFIS screen in your aircraft; it is not necessary to unplug the electrical or Pitot/static connections.
2. Remove the 4 mounting screws from the face of the ASI. This will allow you to pull the ASI over to the EFIS hole.
3. Inspect the back of the ASI for the position of the Pitot and Static lines
4. Clearly label the pitot and static lines. Failure to do so will cause loss of Airspeed indication and most likely altitude indication for all systems.
5. Remove the lines from the back of the ASI.
6. Remove the barbed or quick disconnect fittings from the back of the ASI.
7. Install those fittings in the new ASI.
8. Correctly hook the Pitot line to the pitot port and the static line to the static port on the back of the ASI.
9. Install the ASI back into the panel with the 4 screws removed earlier.
10. Install the EFIS screen that was removed as well

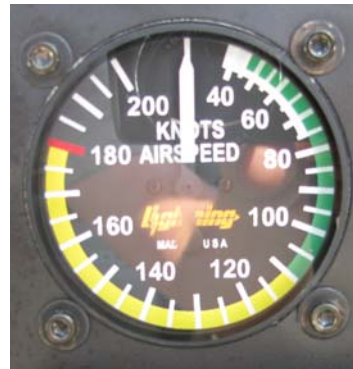
Figure 2. Correct Markings
