SAGUACHE CREEK DIVERSION INFRASTRUCTURE INVENTORY

Structure Name: WERNER ARROYA D

WERNER ARROYA DITCH

Saguache Creek Stream Management Plan

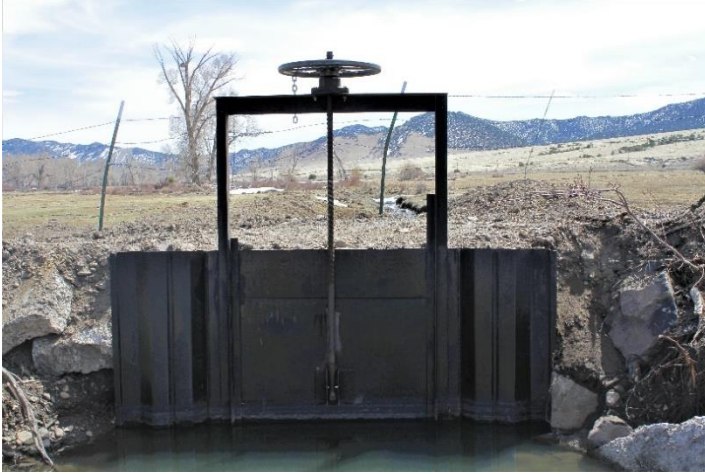
Headgate looking downstream

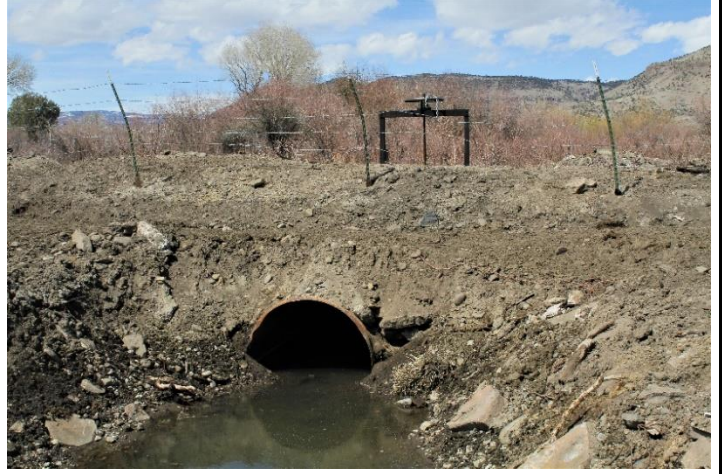
Headgate outlet

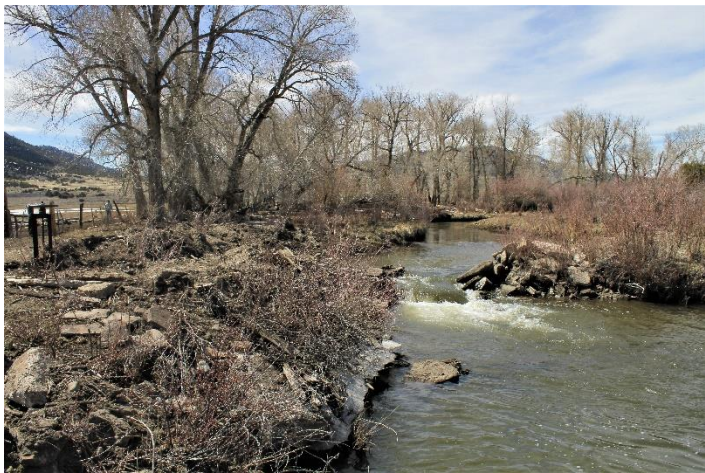
Repair(s) or Improvement(s) Currently Needed: The headgate was recently replaced and is in excellent condition. The diversion dam is negatively affected by a significant sediment deposition. One potential solution is to move the diversion dam downstream to address the sedimentation issue. Fish passage should be maintained and riparian restoration should be considered as part of any future repairs or improvements.

Headgate and diversion dam

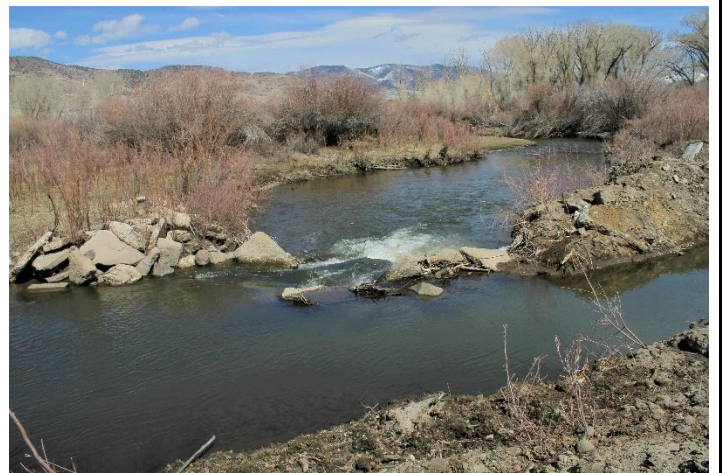
Diversion dam

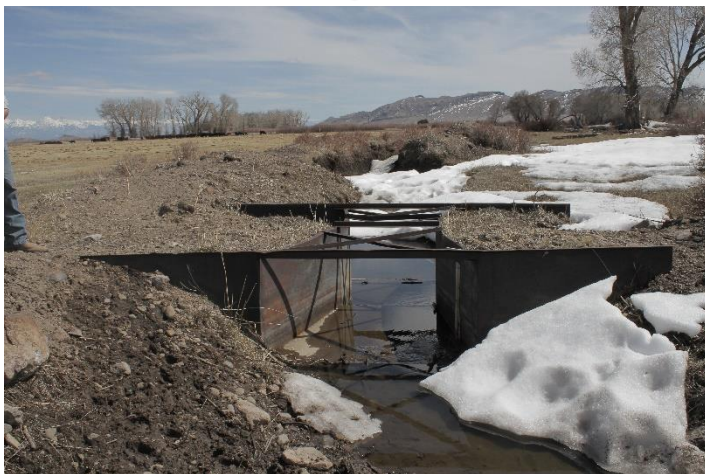
Flume looking downstream

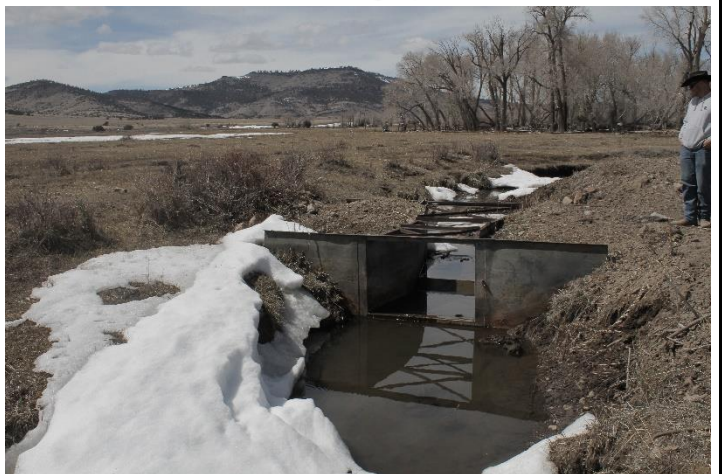
Flume looking upstream
