Home Inspection Report

1234 Sample St.
Portland, OR 92345

Prepared for: **Joe & Joanne Homebuyer**

Prepared by: **Sommers Home Inspections LLC**

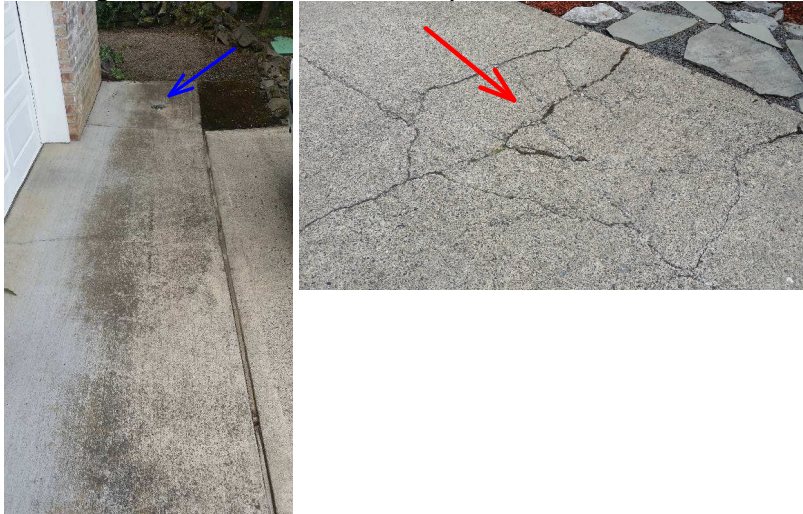
1. ☒ ☐ ☐ ☐ ☐ **Driveway:** Concrete. The driveway slopes towards the garage and then to a drain on the side of the garage. Be sure to keep the drain free of debris so water will not back up. Some cracking was noted in the driveway.

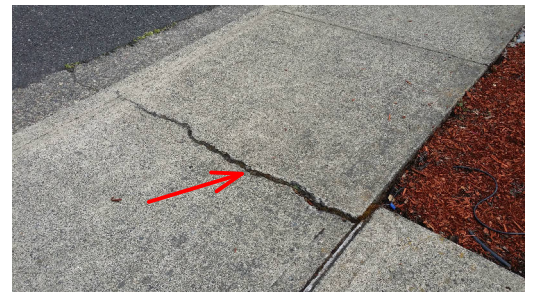
2. ☒ ☐ ☐ ☒ ☐ **Walks:** Concrete. A crack was found near the driveway. This may pose a trip hazard. Repair as needed.

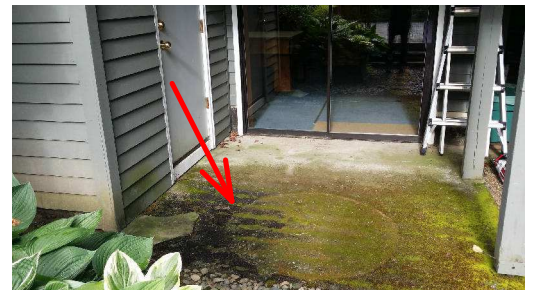
3. ☒ ☐ ☐ ☐ ☐ **Steps/Stoops:** Concrete
4. ☐ ☐ ☐ ☒ ☐ **Patio:** Concrete. I recommend power washing the concrete patio. The moss will be very slippery when it is wet.

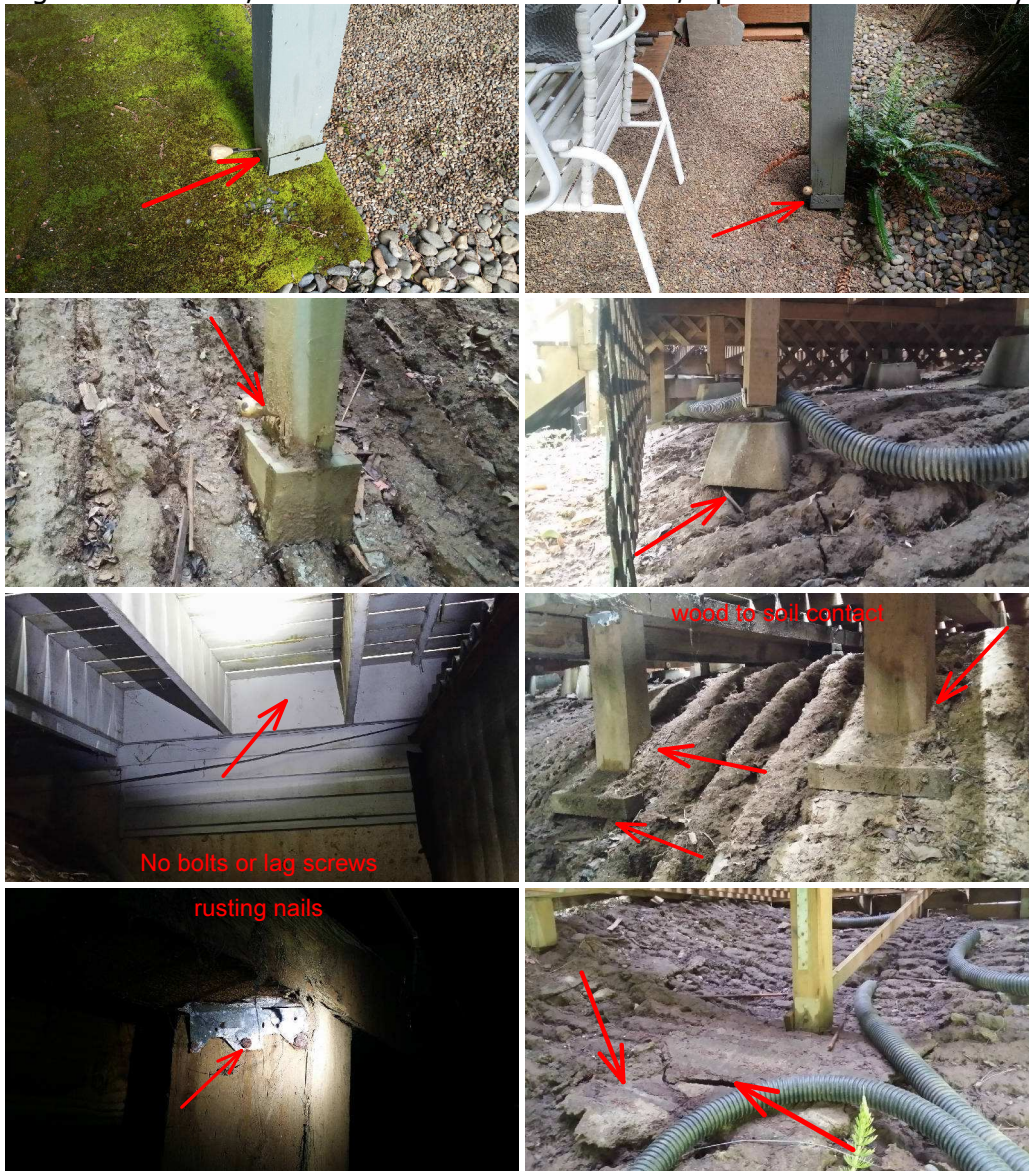
5. ☐☐☐☒☐ **Deck:** Treated wood, Untreated wood. I observed rot at the bottom of some concrete patio posts as well as under the main deck. The soil is moving downhill and some of the concrete piers are exposed underneath. It appears that the deck was installed against the siding. Ideally the siding should have been removed and metal flashing be installed. There is no flashing visible on top of the ledger board which can cause moisture intrusion. I can also not find any bolts on the ledger on board. This should be added for safety. Some nails are rusting and should be evaluated. Eventually they will fail. The ground has given away under the lower section of the deck. The concrete piers have cracked in places or are exposed. The south-facing handrail on the far East deck is loose and needs to be attached. Remove the tree branches that have fallen onto the handrail. I recommend evaluation by a soil engineer and repair by a licensed contractor. Avoid wood to soil contact as it will cause rot overtime and invite wood destroying organisms. Overall, this is an older deck and repairs/replacement can be costly.

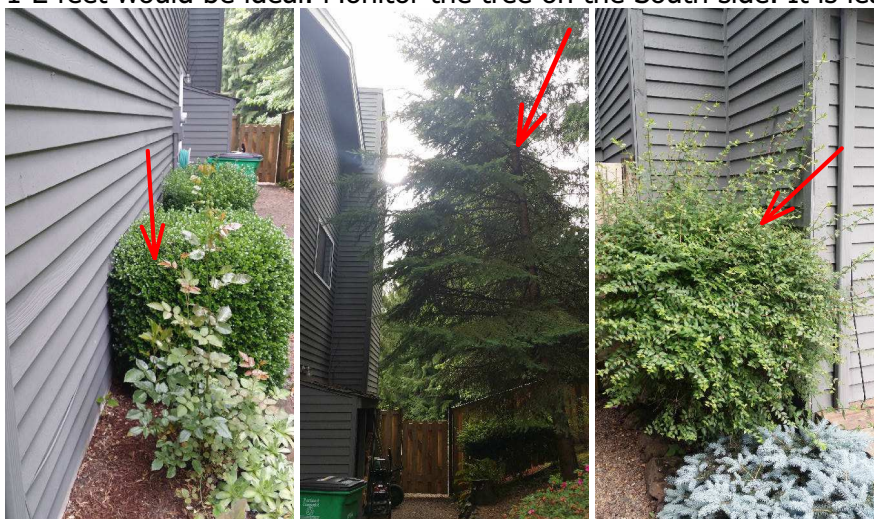
6. ☒ ☐ ☐ ☐ ☐ **Balcony:** Stained wood
7. ☐ ☐ ☐ ☒ ☐ **Grading:** Steep slope
8. ☐ ☐ ☐ ☒ ☐ **Vegetation:** Shrubs and trees. Maintain a clearance between shrubs/trees and the siding. 1-2 feet would be ideal. Monitor the tree on the South side. It is leaning toward the house.

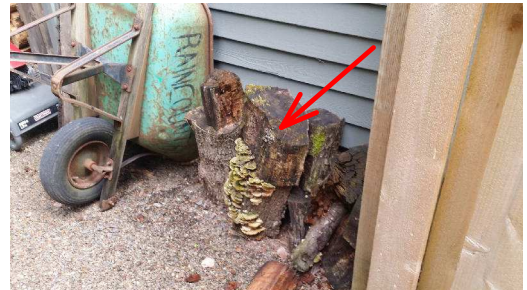
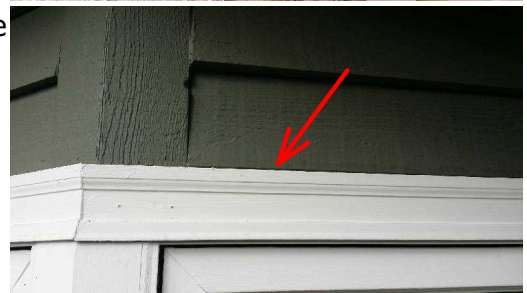
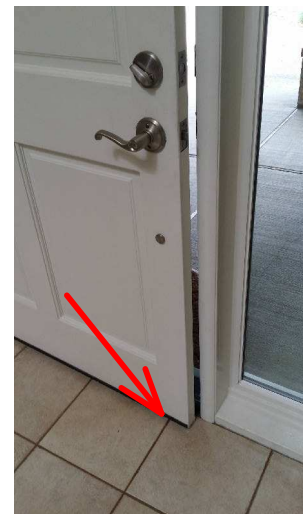
1. ☒ ☐ ☐ ☐ ☐ **Type:** Wood lap siding. It is not recommended to store firewood close to the house as it invites wood destroying organisms. Maintain the paint and caulk around the house to keep the siding protected.
2. ☒ ☐ ☐ ☐ ☐ **Trim:** Wood. By today's standard, flashing would have been installed above the trim. It is very important to maintain the caulk between the trim and siding to prevent moisture intrusion. When you replace the older windows make sure that all trim is adequately flashed.
3. ☒ ☐ ☐ ☐ ☐ **Fascia:** Wood
4. ☒ ☐ ☐ ☐ ☐ **Eaves/Overhang:** Wood
5. ☒ ☐ ☐ ☐ ☐ **Door Bell:** Hard wired
6. ☐ ☐ ☐ ☒ ☐ **Entry Doors:** Wood. The front door scrapes over the tile in one spot. Adjust as needed.

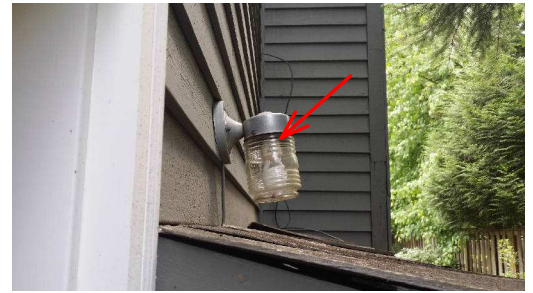
10. ☐☐☐☒☐ **Exterior Lighting:** Surface mounted lamps front and rear. The light fixture off the laundry room does not work. Repair as needed.

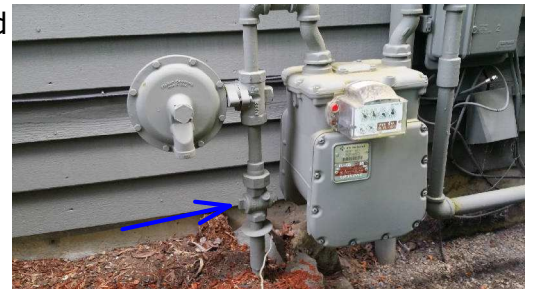
14. ☒☐☐☐☐ **Main Gas Valve:** Located at gas meter. I recommend having a wrench readily available at the gas meter in case you need to turn it off quickly during an emergency.

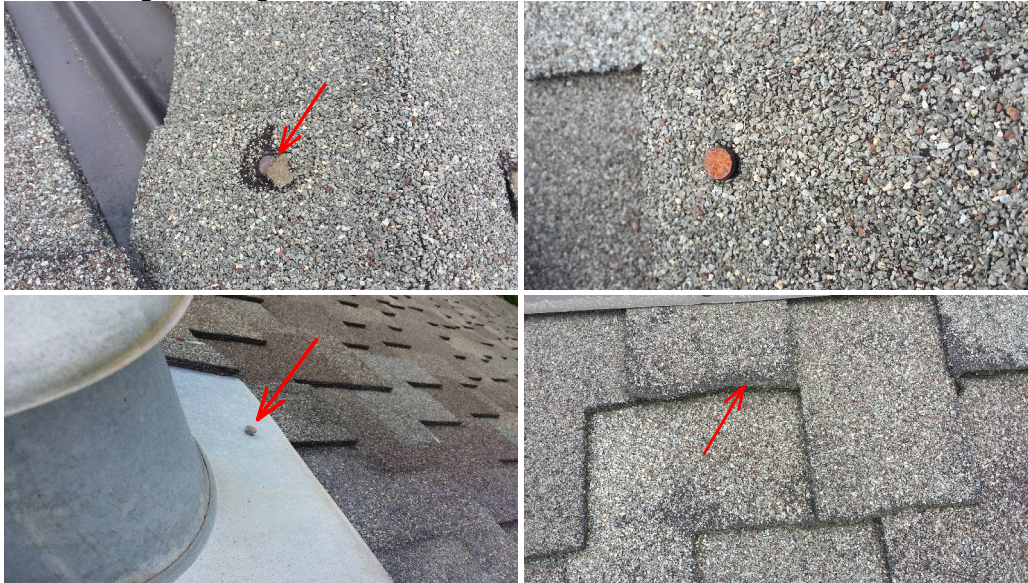
1. **Method of Inspection:** On roof
2. ☒ ☐ ☐ ☐ ☐ **Material:** Asphalt shingle. Architectural shingle.
3. ☐ ☐ ☐ ☒ ☐ **Deficiencies:** Various. Maintain the caulking on the nail heads to prevent moisture intrusion. Most of them however have flashing installed underneath which eliminates the need for caulking. Some granulated loss is noted.

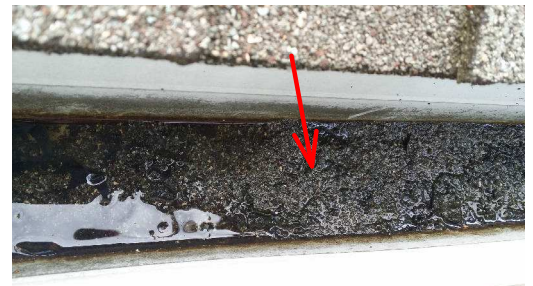
4. **Type:** Gable
5. **Approximate Age:** 6-8 years
6. ☒ ☐ ☐ ☐ ☐ **Flashing:** Metal
7. ☒ ☐ ☐ ☐ ☐ **Valleys:** Preformed metal
8. ☒ ☐ ☐ ☐ ☐ **Skylights:** Insulated glass
9. ☒ ☐ ☐ ☐ ☐ **Plumbing Vents:** ABS
10. ☒ ☐ ☐ ☐ ☐ **Electrical Mast:** Underground utilities
11. ☒ ☐ ☐ ☐ ☐ **Gutters:** Metal. I recommend cleaning the gutters now and regularly moving forward. There is some granulate and standing water in the front gutters.

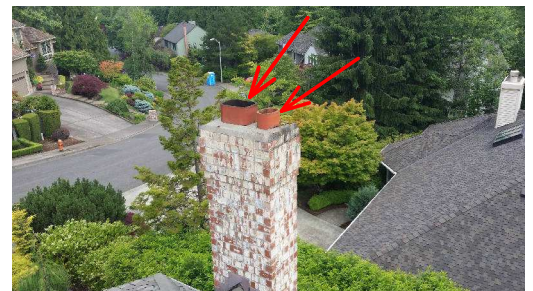
16. ☒☐☐☐☐ **Chimney:** Brick
17. ☐☐☐☒☐ **Flue/Flue Cap:** Concrete. I recommend installing a rain cap.

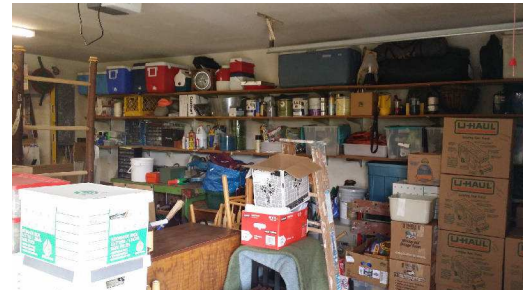
**4.** ☒ ☐ ☐ ☐ ☐ **Door Opener:** Genie**5.** ☒ ☐ ☐ ☐ ☐ **Service Doors:** Fire rated**6.** ☒ ☐ ☐ ☐ ☐ **Ceiling:** Texture paint**7.** ☒ ☐ ☒ ☐ ☐ **Walls:** Drywall. Due to stored items on the wall and floor I was not able to inspect those areas. Re inspect when everything has been removed.

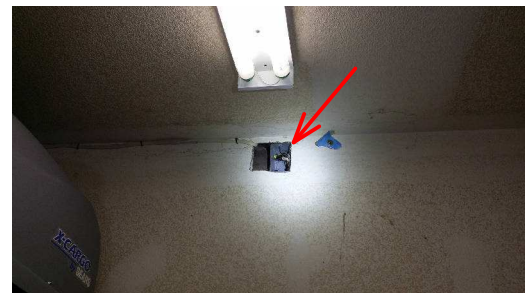
**8.** ☒ ☐ ☐ ☐ ☐ **Floor/Foundation:** Poured concrete**9.** ☐ ☐ ☐ ☒ ☐ **Electrical:** 110 VAC GFCI. All junction boxes need to be covered with plates.

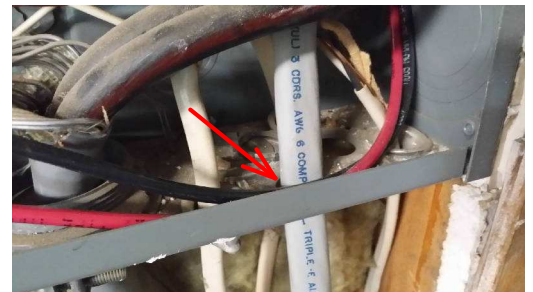
8. ☐ ☐ ☐ ☒ ☐ **Bushings:** Secured. The wire for the hot tub is not security with a clip. I recommend adding it for safety. It can easily slide out. I did not see a hot tub on the property, if it was removed then the breaker should be switched off.

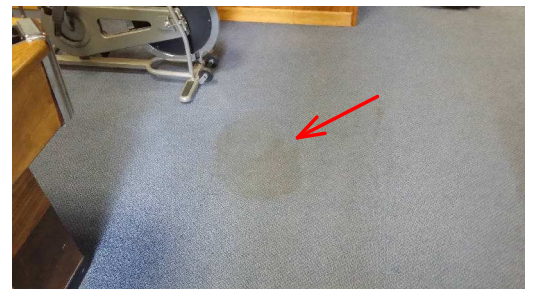
2. ☒ ☐ ☐ ☐ ☐ **Walls:** Wallpaper, paneling
3. ☐ ☐ ☐ ☒ ☐ **Floor:** Carpet. I recommend cleaning the basement carpet.

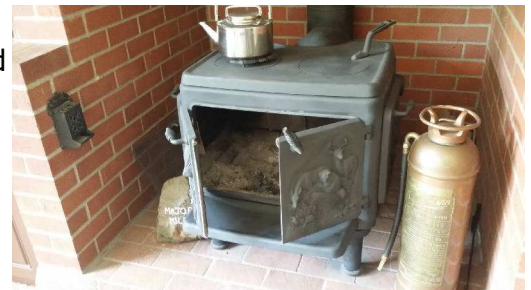
1. ☒ ☐ ☐ ☐ ☐ **Freestanding Stove:** Wood burning. There is no DEQ certificate on this wood stove. You may be required to remove it if there is no paper work verifying it.

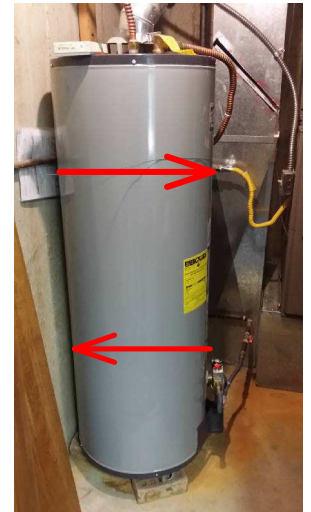
10. **Type:** Natural gas **Capacity:** 50 Gal.
11. **Approximate Age:** 2000 **Area Served:** Whole building
12. ☒ ☐ ☐ ☐ ☐ **Flue Pipe:** Double wall
13. ☒ ☐ ☐ ☐ ☐ **TPRV and Drain Tube:** Copper
14. ☐ ☐ ☐ ☒ ☐ **Earthquake strapped** ☐ Yes ☒ No I recommend adding earthquake strapping for safety.

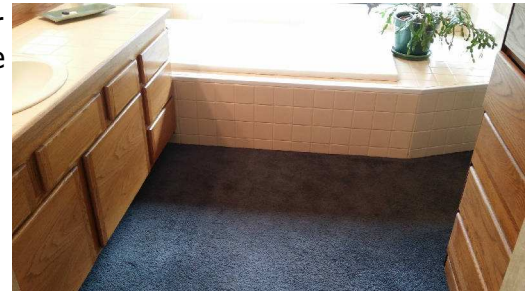
1. ☒ ☐ ☐ ☐ ☐ **Closet:** Walk In
2. ☒ ☐ ☐ ☐ ☐ **Ceiling:** Drywall and paint
3. ☒ ☐ ☐ ☐ ☐ **Walls:** Wallpaper
4. ☐ ☐ ☐ ☒ ☐ **Floor:** Carpet. Carpet is not an ideal floor covering for a bathroom as it can trap moisture and lead to rot in the sub floor. I recommend replacing it with a better suited covering for a bathroom.

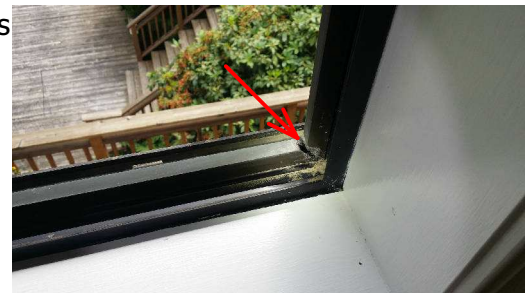
5. ☒ ☐ ☐ ☐ ☐ **Doors:** Pocket door
6. ☐ ☐ ☐ ☒ ☐ **Windows:** Aluminum slider. The exterior frame of this window is cracked on the lower right side. If you decide to replace this window at some point be sure to install a tempered glass window again as this is required behind the bathtub.

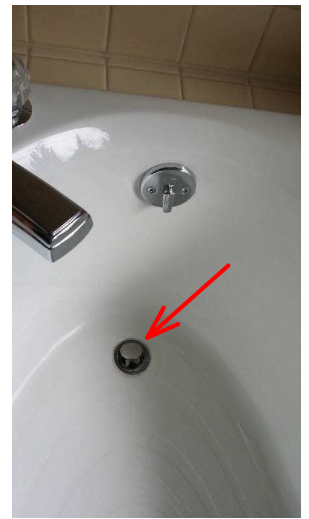
11. ☐☐☐☒☐ **Tub/Surround:** Fiberglass tub and ceramic tile surround. The stopper does not work properly. Repair as needed.

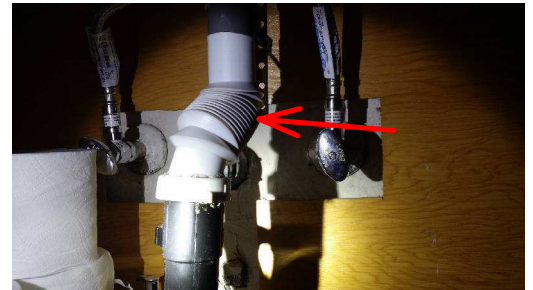
16. ☒☐☐☐☐ **Ceiling:** Drywall and paint
 17. ☒☐☐☐☐ **Walls:** Drywall and Paint
 18. ☒☐☐☐☐ **Floor:** Tile
 19. ☒☐☐☐☐ **Doors:** Hollow wood
 20. ☒☐☐☐☐ **Electrical:** 110 VAC GFCI
 21. ☒☐☐☐☐ **Counter/Cabinet:** Wood, granite
 22. ☒☐☐☐☐ **Sink/Basin:** Porcelain coated
 23. ☐☐☐☒☐ **Faucets/Traps:** Chrome fixtures with plastic traps. Flexible drain pipe is not recommended. It will clog over time. Install a rigid drain instead.

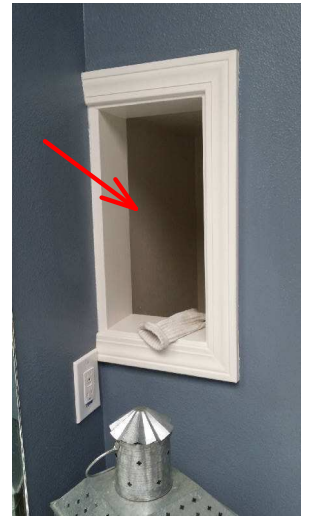
28. ☐☐☐☒☐ **Walls:** Drywall and Paint. The laundry chute is in this area. Laundry chutes can be hazardous with kids. Be very careful or install a door in front of it.

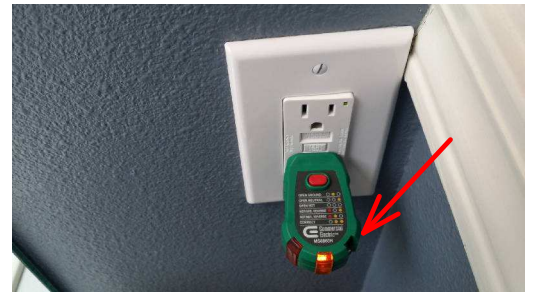
29. ☒☐☐☐☐ **Floor:** Vinyl floor covering
 30. ☒☐☐☐☐ **Doors:** Hollow wood
 31. ☒☐☐☐☐ **Windows:** Skylight
 32. ☐☐☐☒☐ **Electrical:** 110 VAC GFCI. The GFCI outlet has an open ground. I recommend repair.

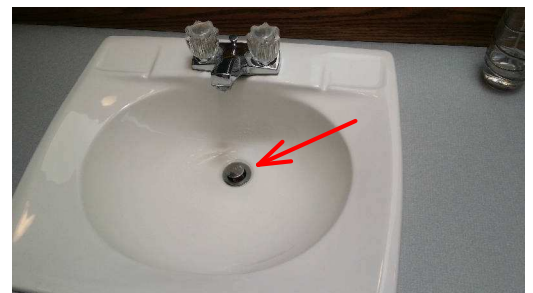
33. ☒☐☐☐☐ **Counter/Cabinet:** Laminate and wood
 34. ☒☐☐☐☐ **Sink/Basin:** Porcelain coated
 35. ☐☐☐☒☐ **Faucets/Traps:** Chrome fixtures with plastic traps. The stopper in the left sink does not work. Repair as needed.

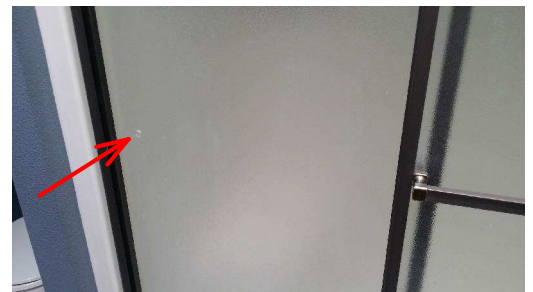
36. ☒☐☐☒☐ **Shower/Surround:** Fiberglass pan and fiberglass surround. The handle is missing on the left side glass door. It is hard to open from the outside.

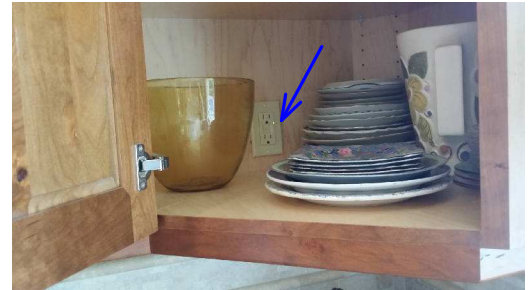
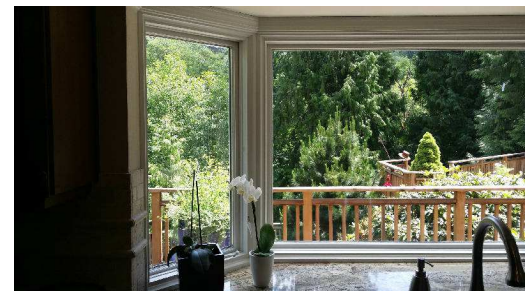
15. ☒ ☐ ☐ ☐ ☐ **Floor:** Tile
 16. ☒ ☐ ☐ ☐ ☐ **Doors:** French
 17. ☒ ☐ ☐ ☐ ☐ **Windows:** Wood casement. It seems that the windows are not used much. They were hard to open.

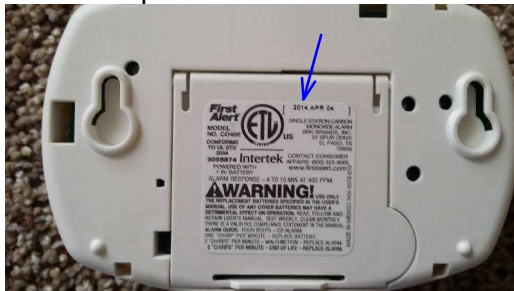
9. ☐ ☐ ☐ ☒ ☐ **Smoke Detector:** Hard wired. The carbon monoxide alarm is from 2014, add one on each level. The upstairs smoke alarm is from 2006. I recommend installing smoke alarms in each room for added protection. Make sure that the smoke detectors meet the requirements of the State of Oregon. Go to www.oregon.gov/OSP/SFM for the latest updates on smoke detectors and carbon monoxide alarms. Smoke detectors need to be replaced within 10 years, carbon monoxide alarms within 5 years. The installation of photoelectric alarms is recommended. Several studies have found that they outperform ionization alarms. Carbon monoxide alarms should be placed within 15 feet of each bedroom and one on each level.

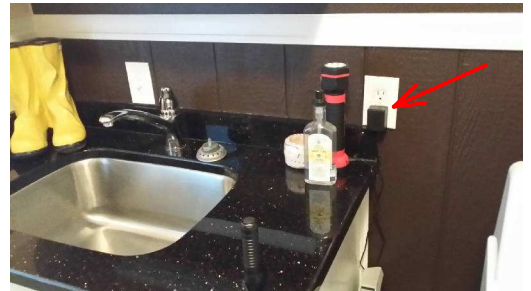
6. ☒ ☐ ☐ ☒ ☐ **Electrical:** 110 VAC. I recommend installing a GFCI outlet next to the sink.

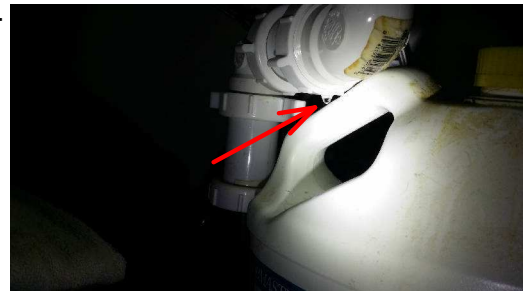
9. ☐ ☐ ☐ ☒ ☐ **Laundry Tub Drain:** PVC, ABS. There is a leak under the sink. Repair as needed.

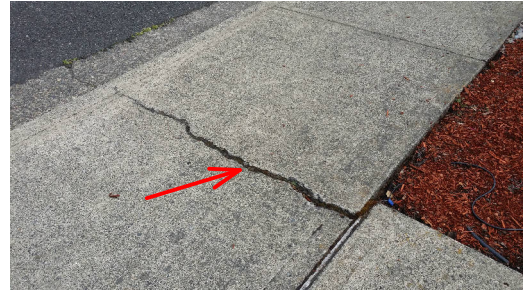
1. **Walks:** Concrete. A crack was found near the driveway. This may pose a trip hazard. Repair as needed.

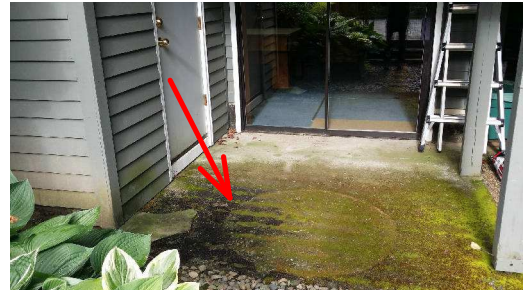
2. **Patio:** Concrete. I recommend power washing the concrete patio. The moss will be very slippery when it is wet.

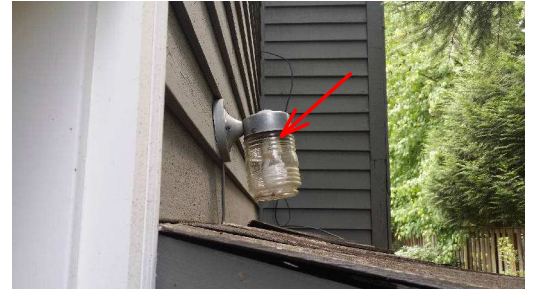
- 7. Exterior Lighting:** Surface mounted lamps front and rear. The light fixture off the laundry room does not work. Repair as needed.

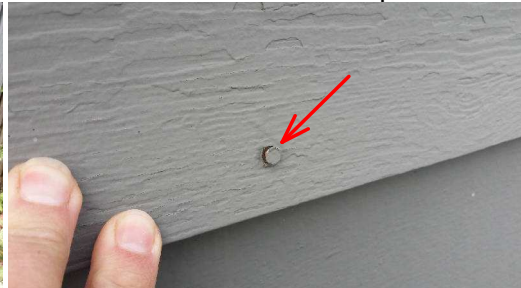
- 9. South Chimney Chimney:** Framed. Rot was found on the trim. Replace as needed. Some of the siding boards are loose and the nails are pushing out. This should be fastened when the trim is replaced.

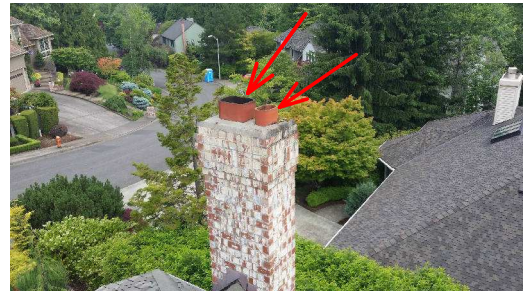
- 10. North Chimney Flue/Flue Cap:** Concrete. I recommend installing a rain cap.

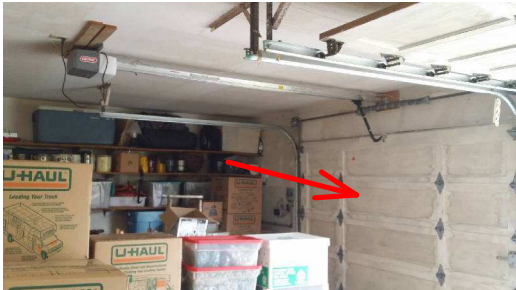
- 11. Attached Garage Door Operation:** Mechanized. I was not able to operate the left side garage door. The upper button may be for this door but it did not work. Have the seller verify that the door is in working condition.

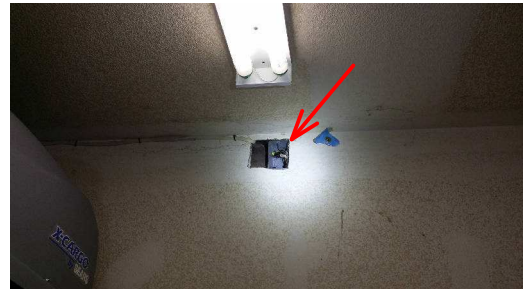
- 12. Attached Garage Electrical:** 110 VAC GFCI. All junction boxes need to be covered with plates.

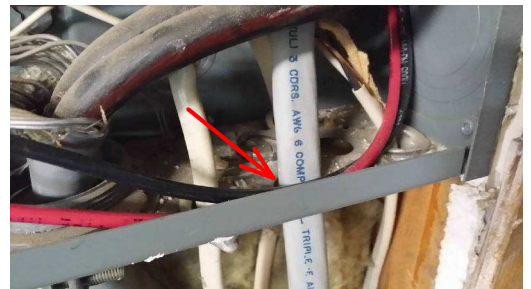
- 13. Garage Electric Panel Bushings:** Secured. The wire for the hot tub is not security with a clip. I recommend adding it for safety. It can easily slide out. I did not see a hot tub on the property, if it was removed then the breaker should be switched off.

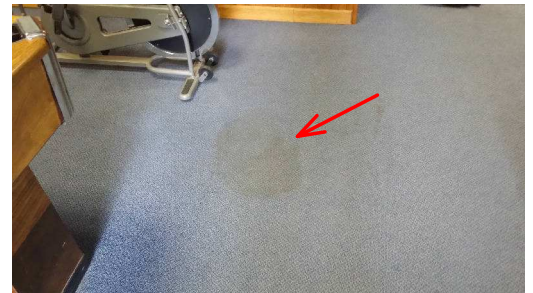
- 15. Main Basement Floor: Carpet.** I recommend cleaning the basement carpet.

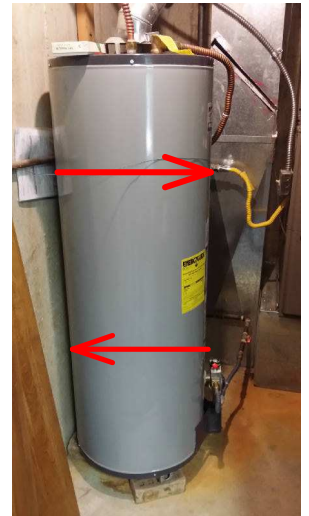
- 20. Basement, Utility Room Water Heater Earthquake strapped** No I recommend adding earthquake strapping for safety.

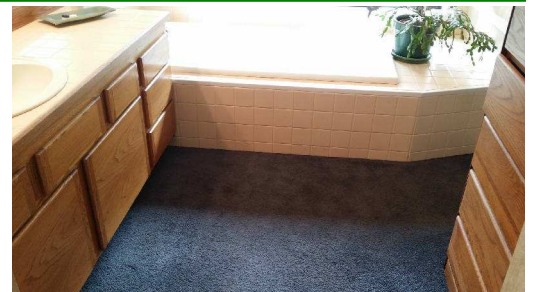
- 21. Master Bathroom Floor:** Carpet. Carpet is not an ideal floor covering for a bathroom as it can trap moisture and lead to rot in the sub floor. I recommend replacing it with a better suited covering for a bathroom.

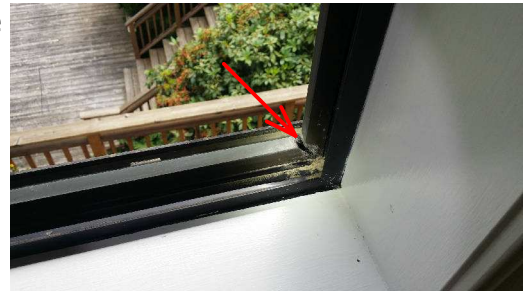
- 22. Master Bathroom Windows:** Aluminum slider. The exterior frame of this window is cracked on the lower right side. If you decide to replace this window at some point be sure to install a tempered glass window again as this is required behind the bathtub.

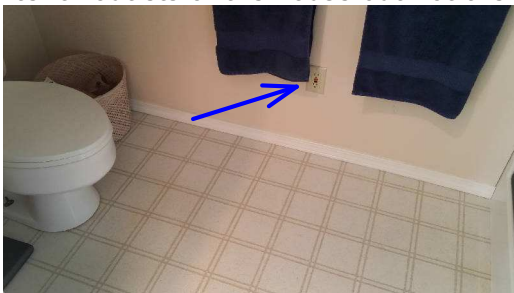
- 23. Master Bathroom Electrical:** 110 VAC, 110 VAC GFCI. The GFCI outlet near the toilet only protects the exterior outlets of the house but not the bathroom. I recommend installing a GFCI outlet next to the sink.

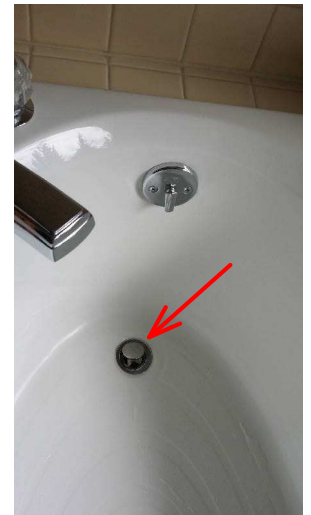
- 24. Master Bathroom Tub/Surround:** Fiberglass tub and ceramic tile surround. The stopper does not work properly. Repair as needed.

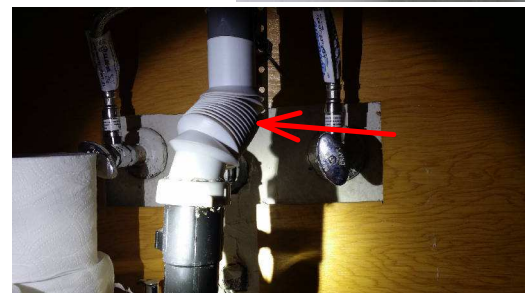
- 25. 1st floor main Half Bathroom Faucets/Traps:** Chrome fixtures with plastic traps. Flexible drain pipe is not recommended. It will clog over time. Install a rigid drain instead.

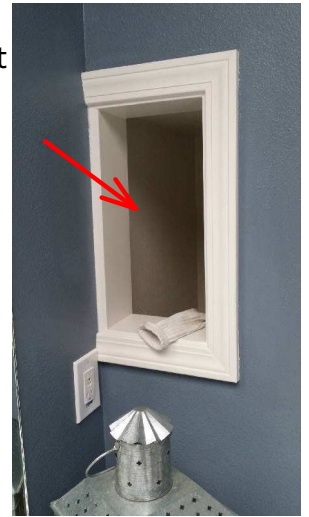
- 26. 2nd floor main Bathroom Walls:** Drywall and Paint. The laundry chute is in this area. Laundry chutes can be hazardous with kids. Be very careful or install a door in front of it.

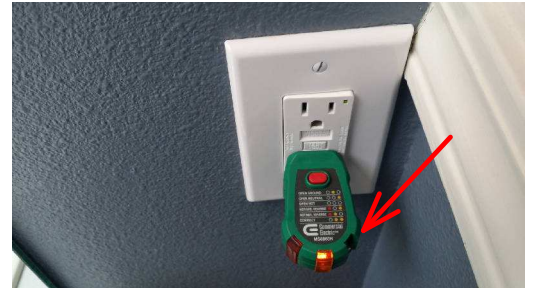
- 27. 2nd floor main Bathroom Electrical:** 110 VAC GFCI. The GFCI outlet has an open ground. I recommend repair.

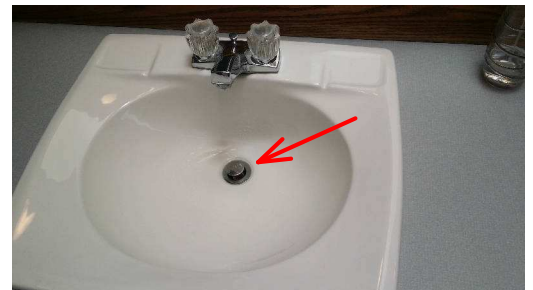
- 28. 2nd floor main Bathroom Faucets/Traps:** Chrome fixtures with plastic traps. The stopper in the left sink does not work. Repair as needed.

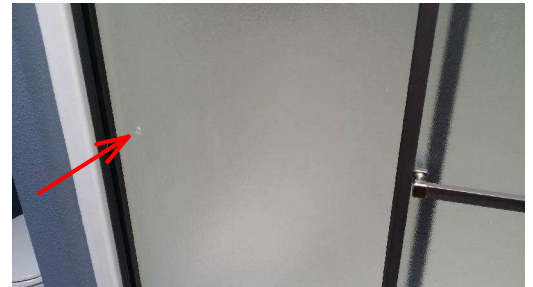
- 29. 2nd floor main Bathroom Shower/Surround:** Fiberglass pan and fiberglass surround. The handle is missing on the left side glass door. It is hard to open from the outside.

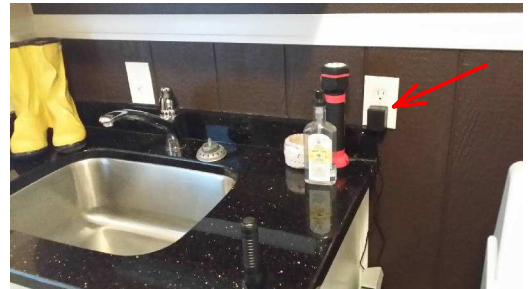
- 32. 1st Floor Laundry Room/Area Electrical:** 110 VAC. I recommend installing a GFCI outlet next to the sink.

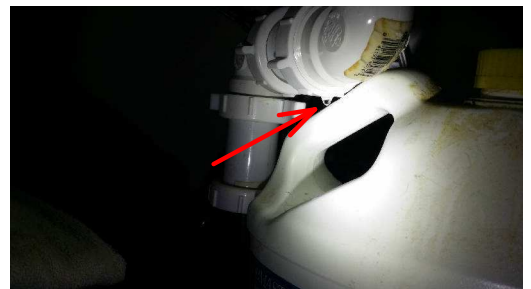
- 33. 1st Floor Laundry Room/Area Laundry Tub Drain:** PVC, ABS. There is a leak under the sink. Repair as needed.
