Pre-Purchase Inspection Survey

"Sea Bass"
1994 Cabo, 35 Express

Gary Friend, MMS, SA
on
10/23/2009

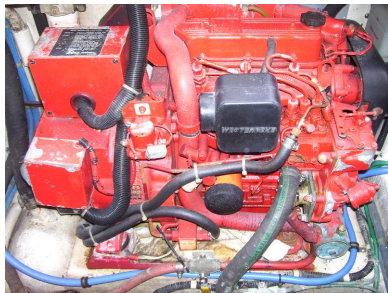
1994 Westerbeke generator

An oil leak on the generator appears to be coming from the dip stick hole. Repair as required**

The generator exhaust hose is cracking and deteriorating. Replacement is required**

The generator did not start during the inspection. Have unit serviced by a certified Westerbeke dealer to determine the cause**

It is highly recommended that a certified Westerbeke diesel engine technician survey the generator for proper working condition**
